Source Water Assessment

A Hydrogeologic Susceptibility and Vulnerability Assessment for Fox Roadhouse Drinking Water System, Fairbanks area, Alaska PWSID # 314815

November 2002

DRINKING WATER PROTECTION PROGRAM REPORT Report 777
Alaska Department of Environmental Conservation

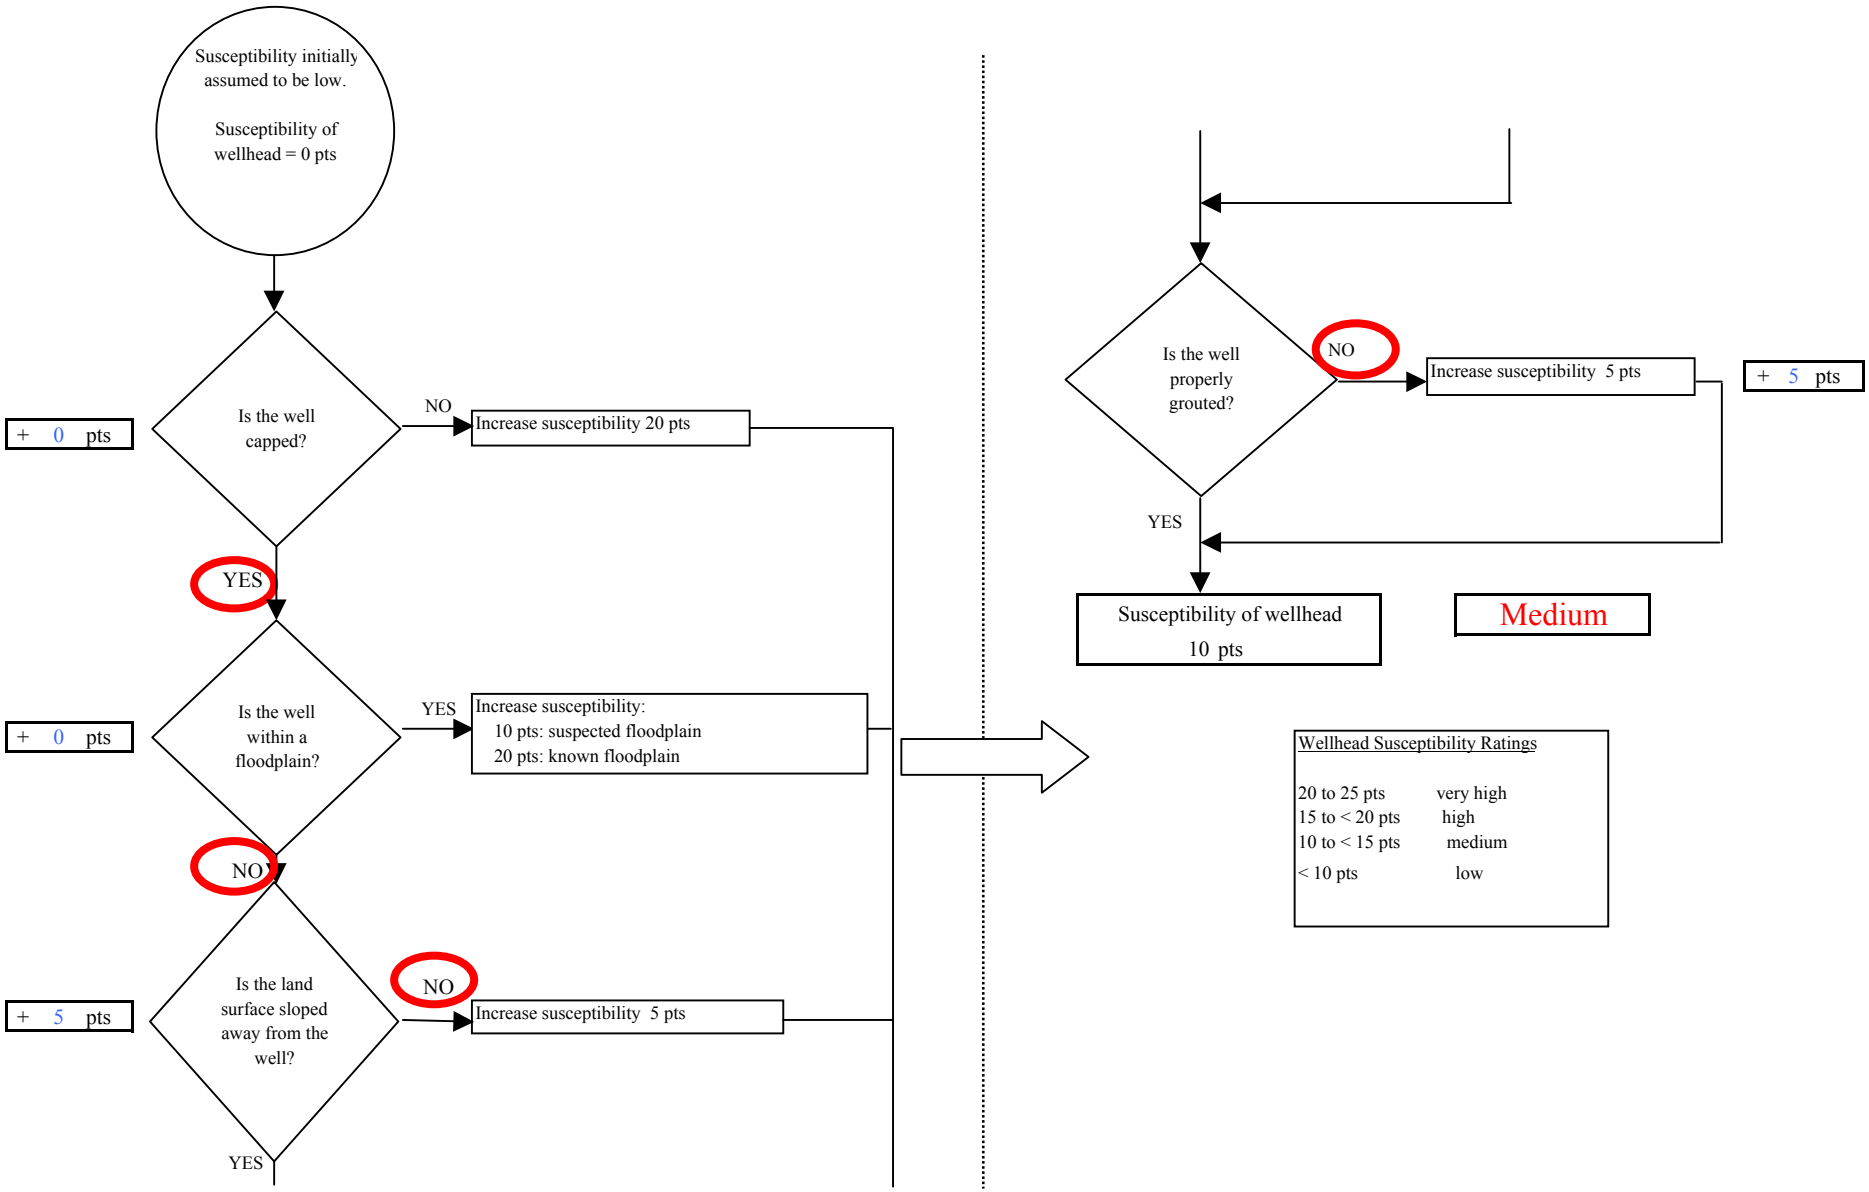
Chart 1. Susceptibility of the wellhead - Fox Roadhouse

The Sanitary Survey (8/2/01) for the water system indicates the sanitary seal on the well is properly installed. The well has not been grouted. The well pad area is not sloped away from the well allowing the surface water to collect in the area. Proper drainage on the surface as well as grouting the well help to prevent potential contaminants from travelling down the well casing. The well is not located in a known floodplain.

The well for the Fox Roadhouse is completed in an unconfined fractured bedrock aquifer. The lack of an impermeable layer above the aquifer allows contaminants to travel uninhibited downward from the surface with the precipitation and surface water runoff. The private and public wells within the protection area also offer an easy pathway for contaminants to travel down into the aquifer and potentially towards the well. Table 2 shows the Susceptibility scores and ratings for Fox Roadhouse.

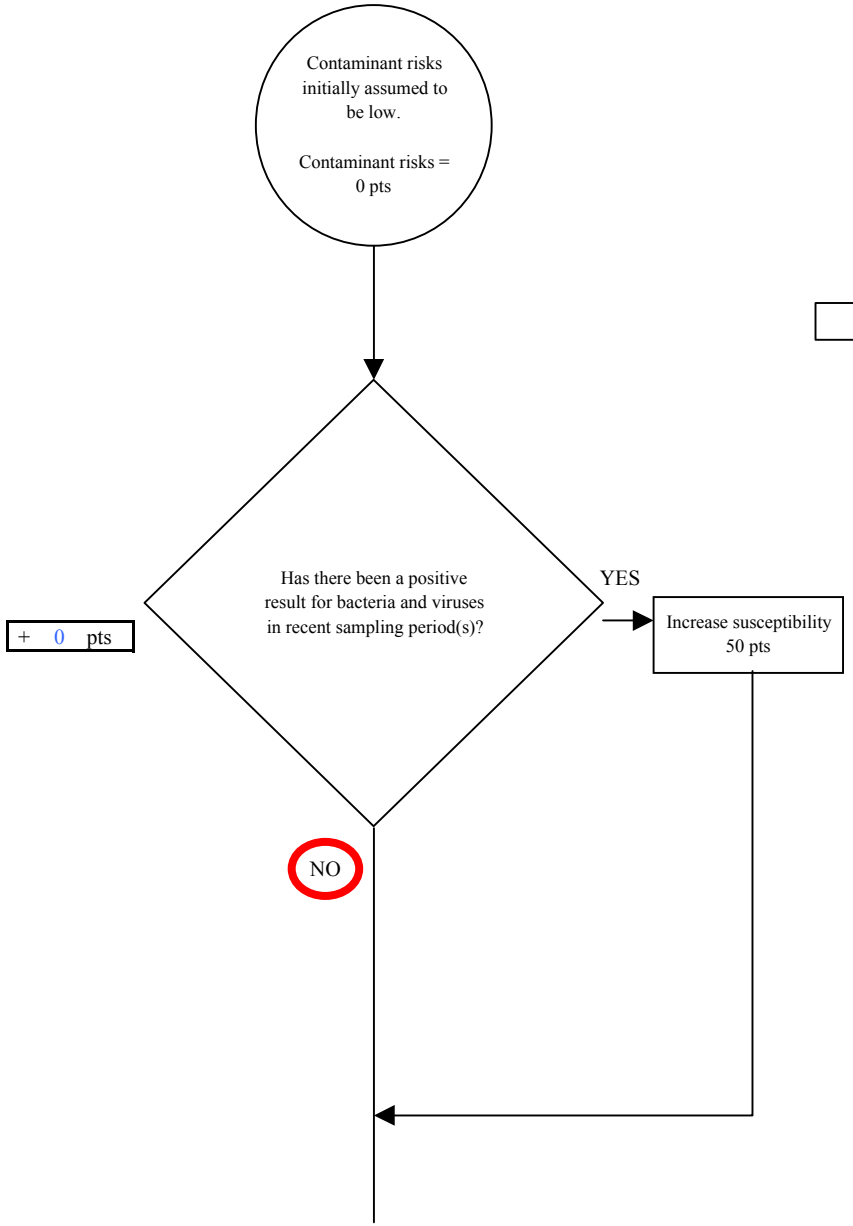
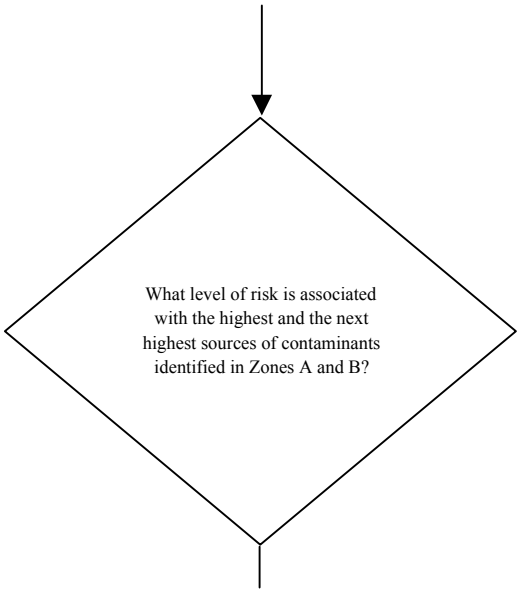
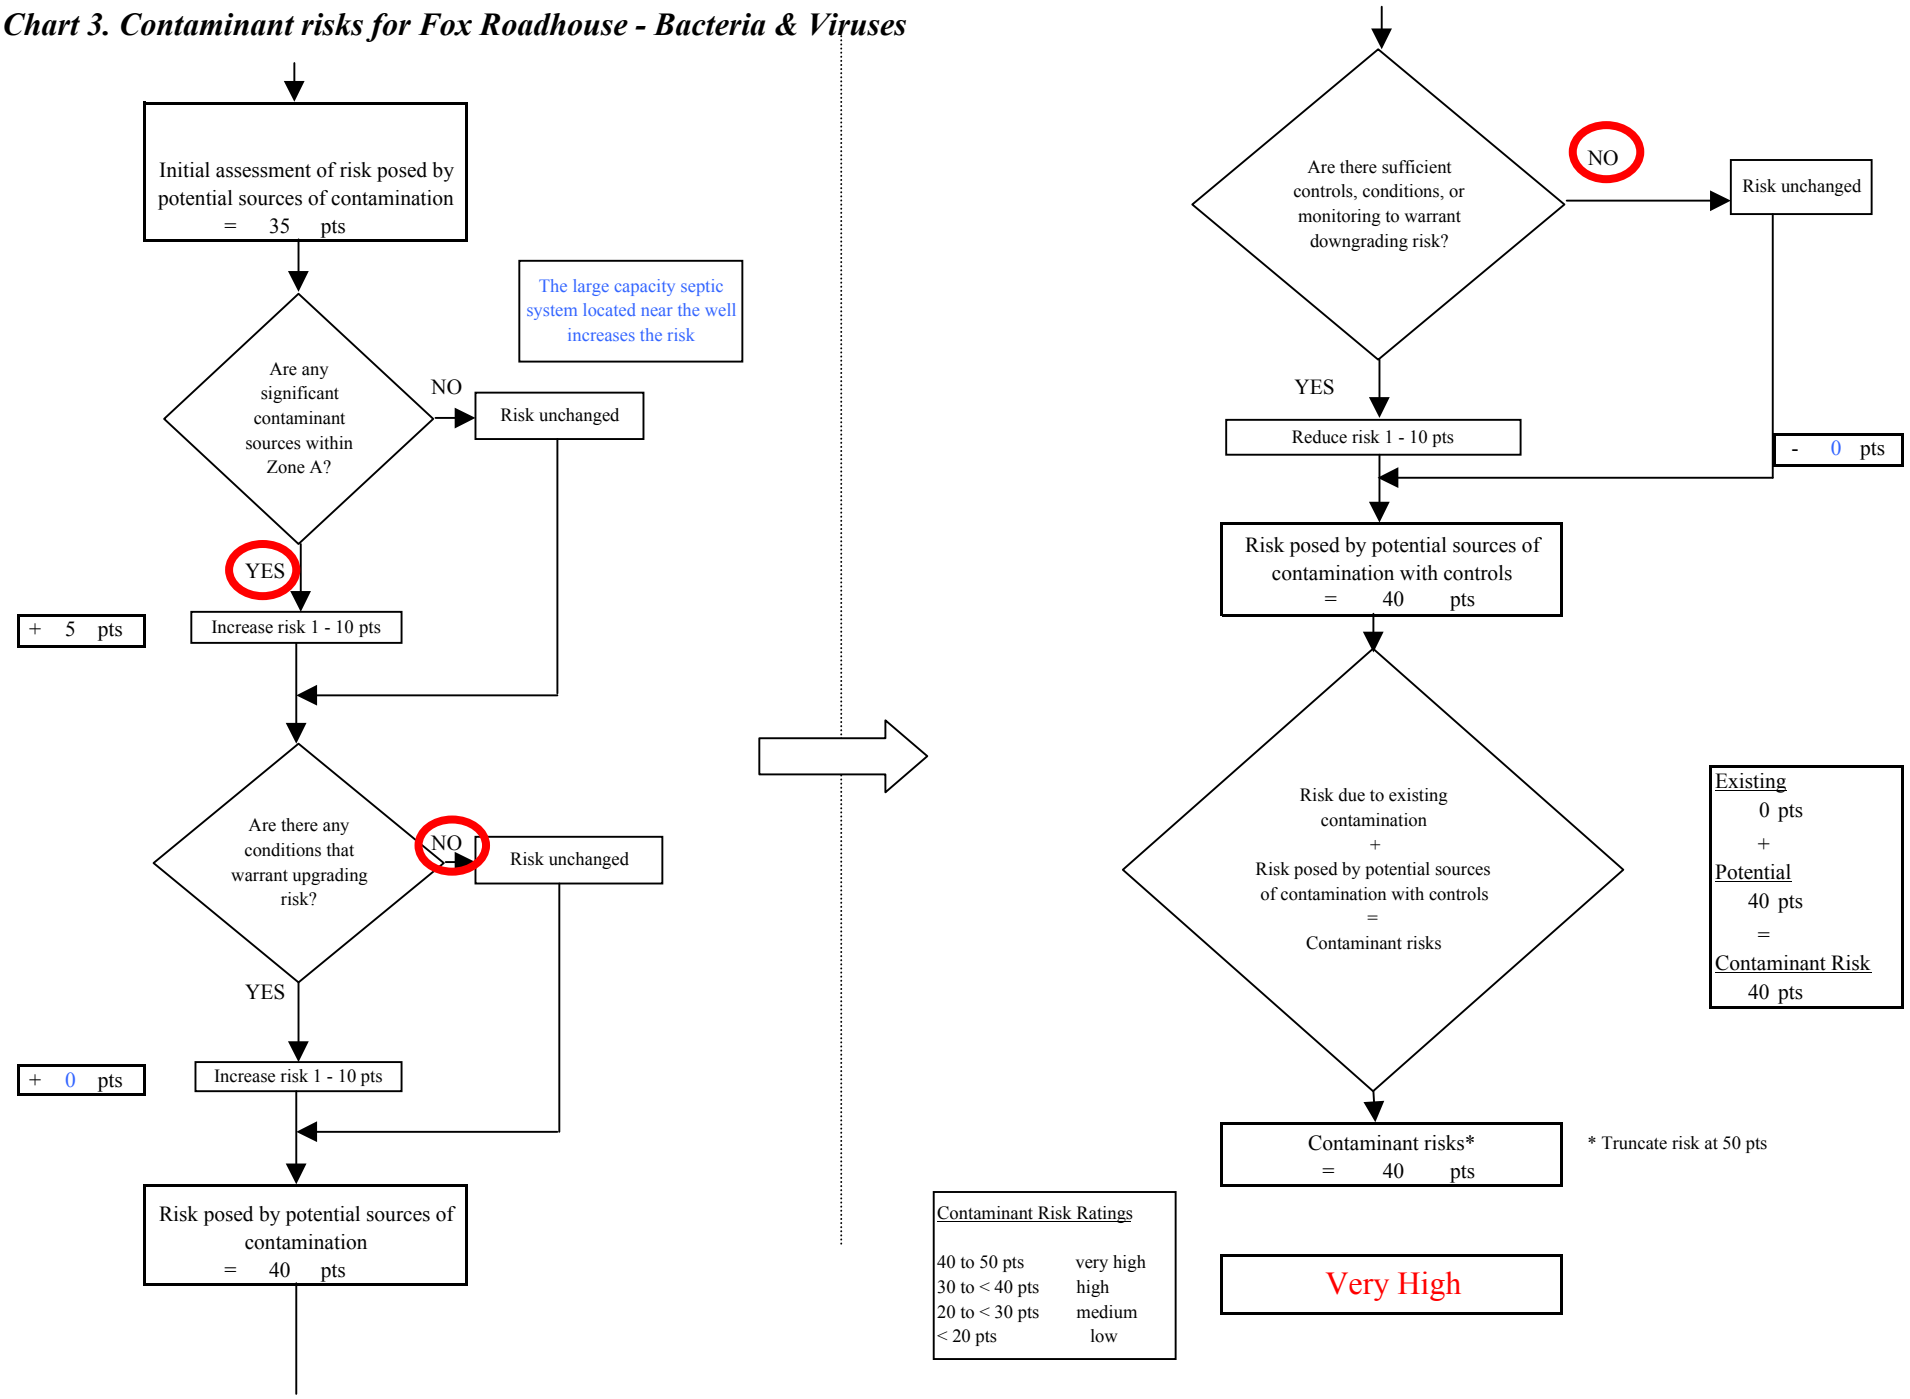
Chart 3. Contaminant risks for Fox Roadhouse - Bacteria & Viruses

The contaminant risk for bacteria and viruses is very high with the large capacity septic system and the density of residential septic systems nearest to the well representing the greatest risk to the drinking water well (See Chart 3 – Contaminant Risks for Bacteria and Viruses in Appendix D). Large capacity septic systems, designated a type of Class V Injection well by the Environmental Protection Agency (EPA), differ from residential septic systems in that they serve multiple dwellings, businesses, or communities.

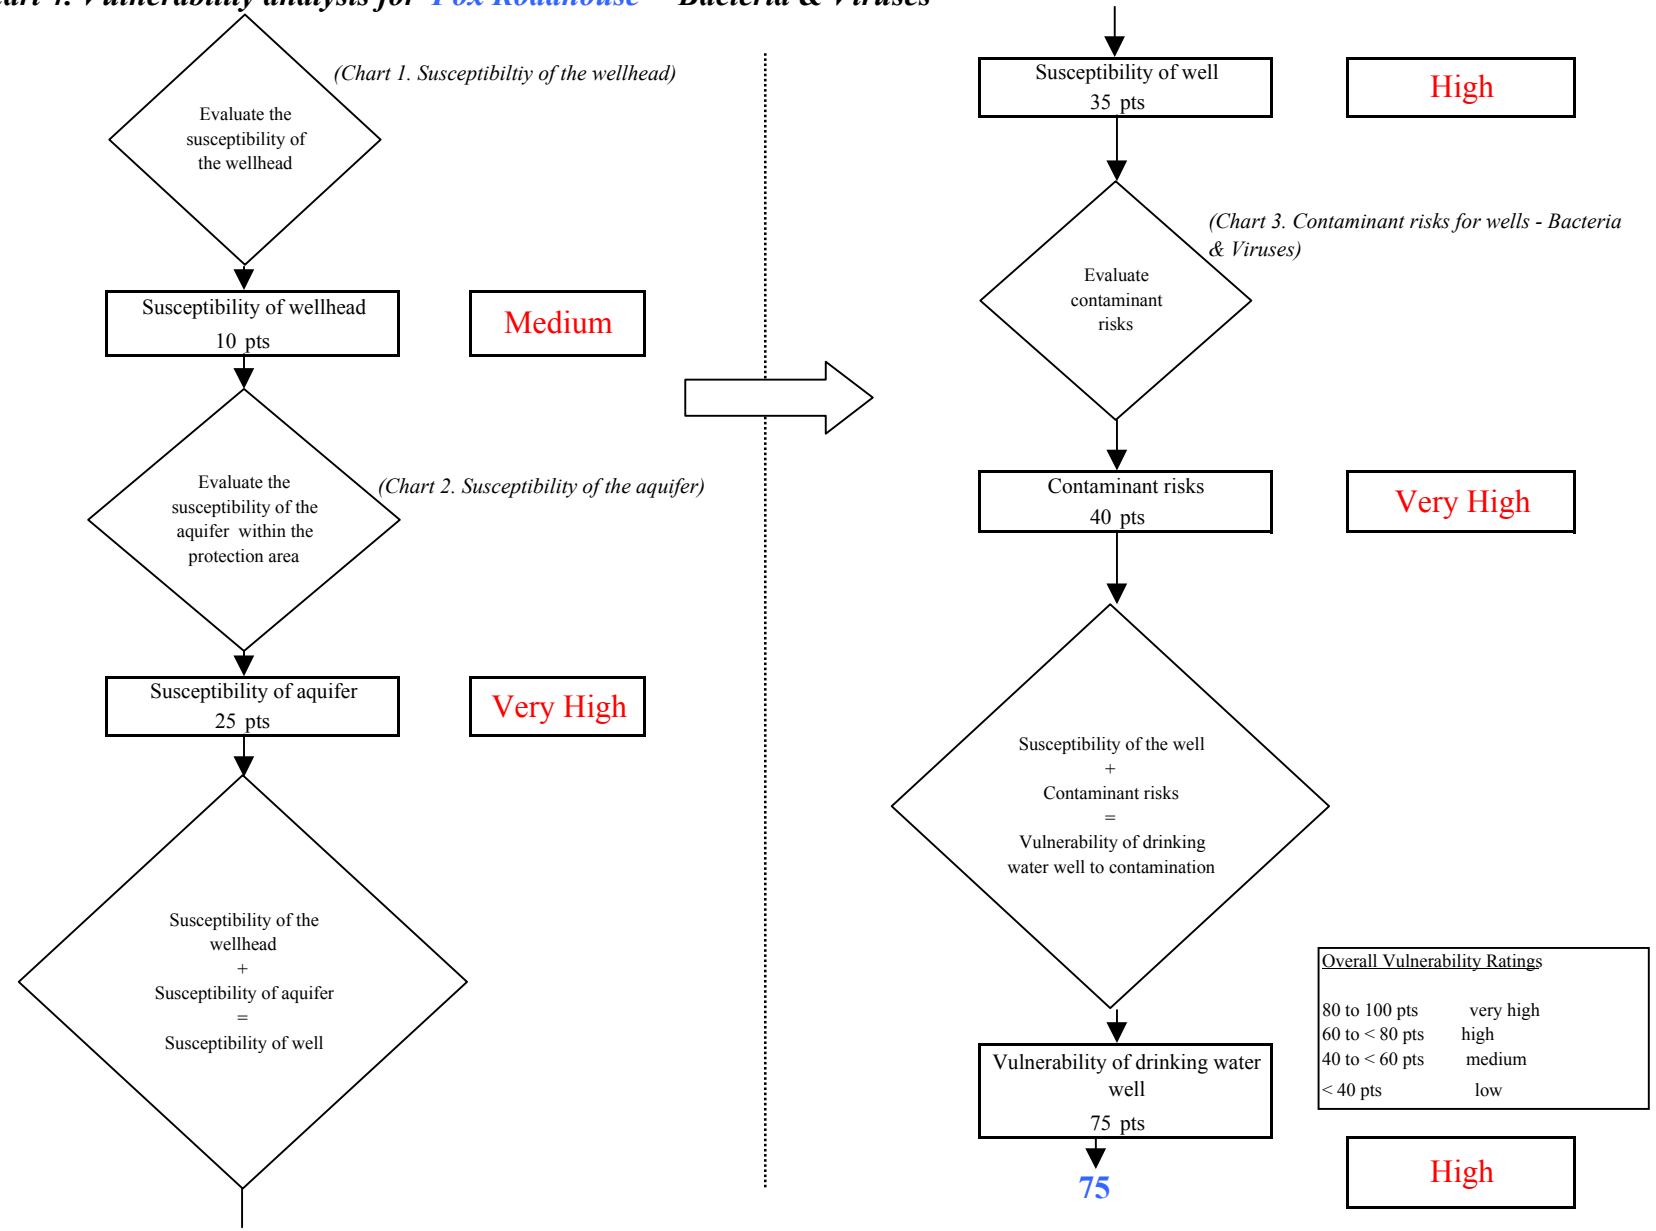
Chart 4. Vulnerability analysis for Fox Roadhouse - Bacteria & Viruses

Only a small amount of bacteria and viruses are required to endanger public health. Bacteria and viruses have not been detected during recent sampling of this water system. After combining the contaminant risk for bacteria and viruses with the natural susceptibility of the well, the overall vulnerability of the well to contamination is high.

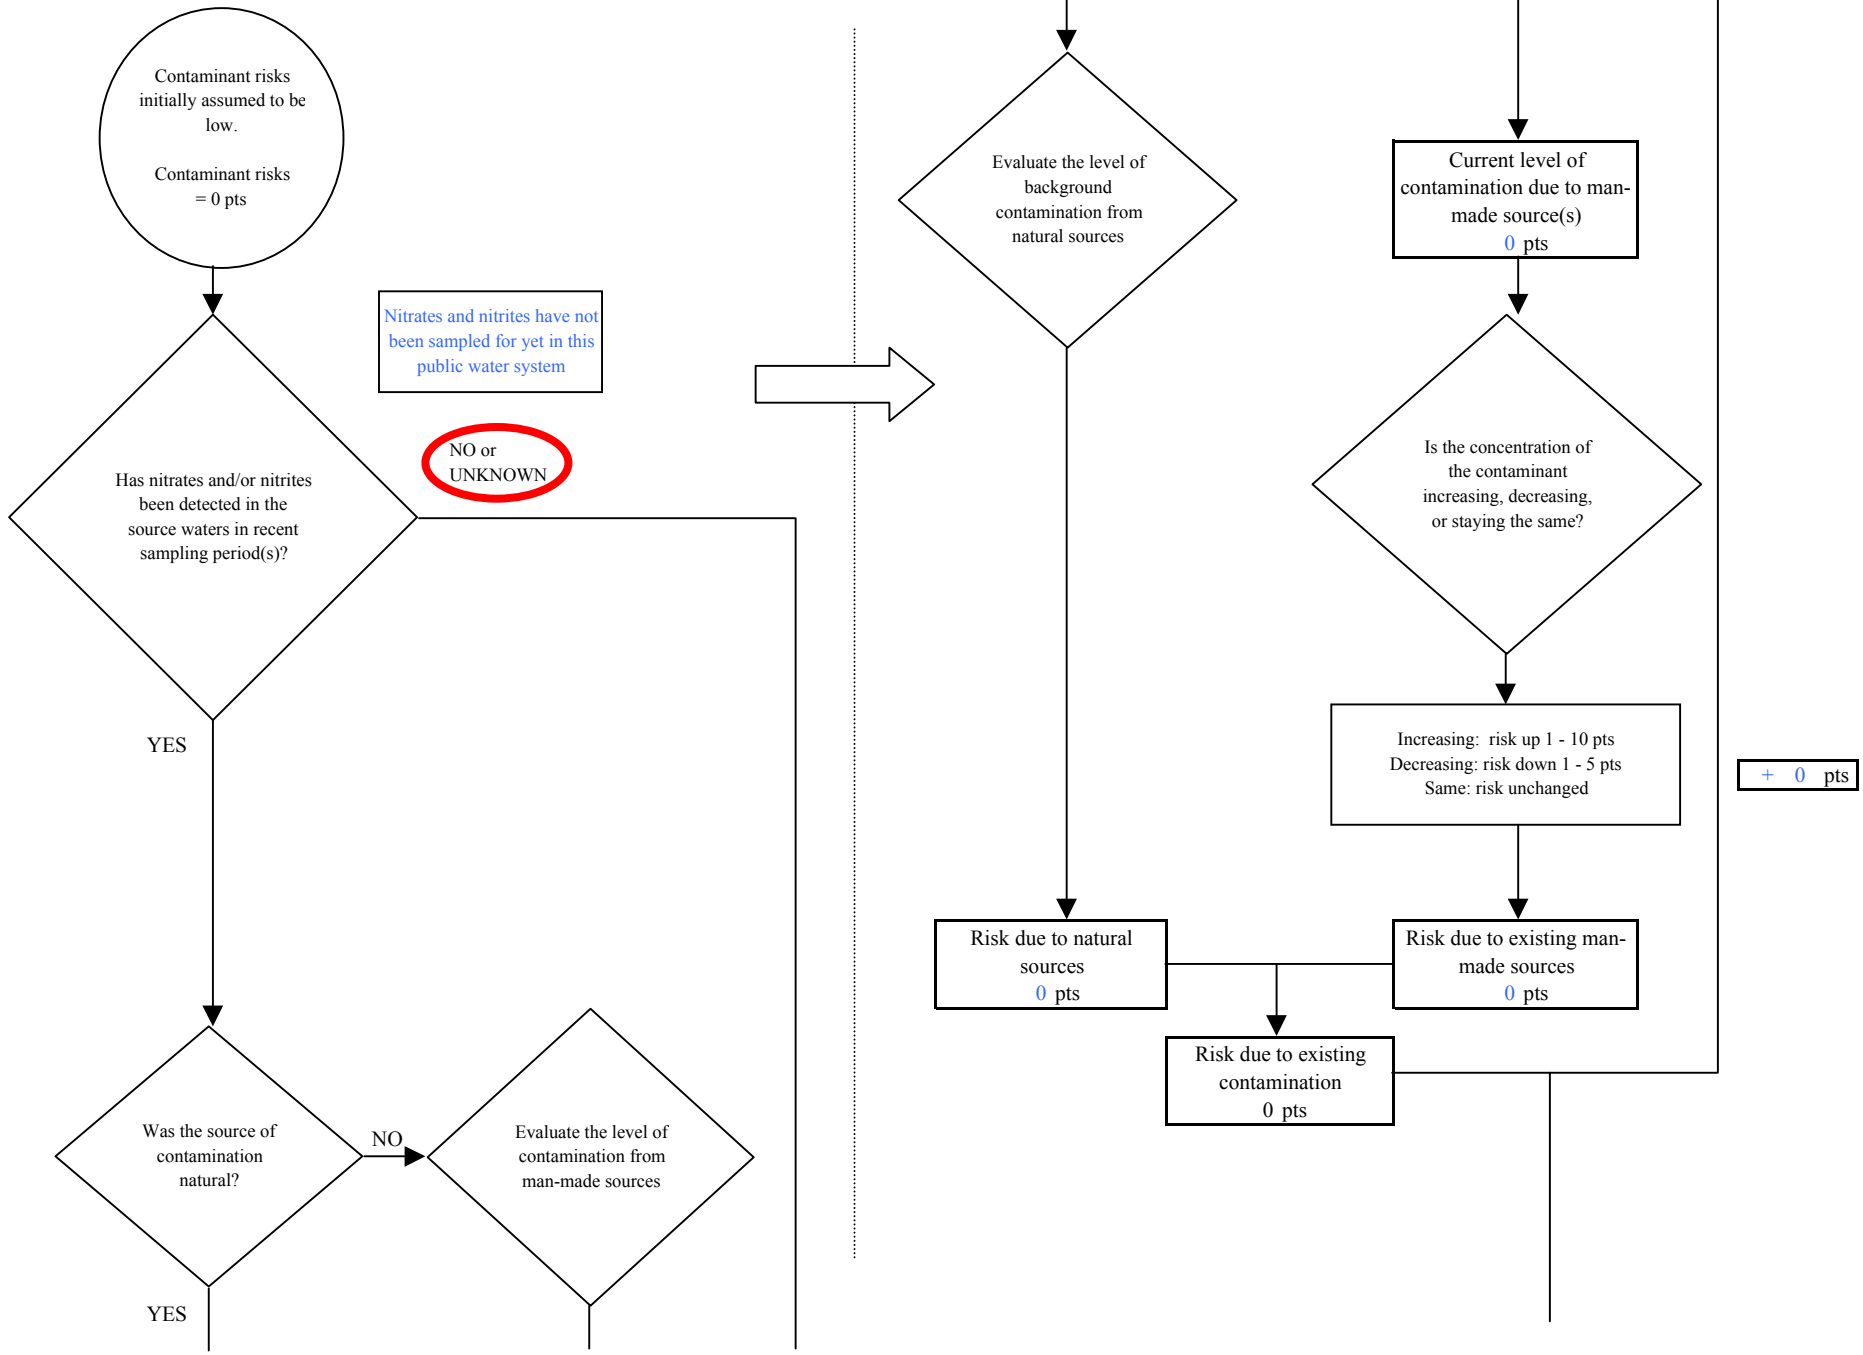
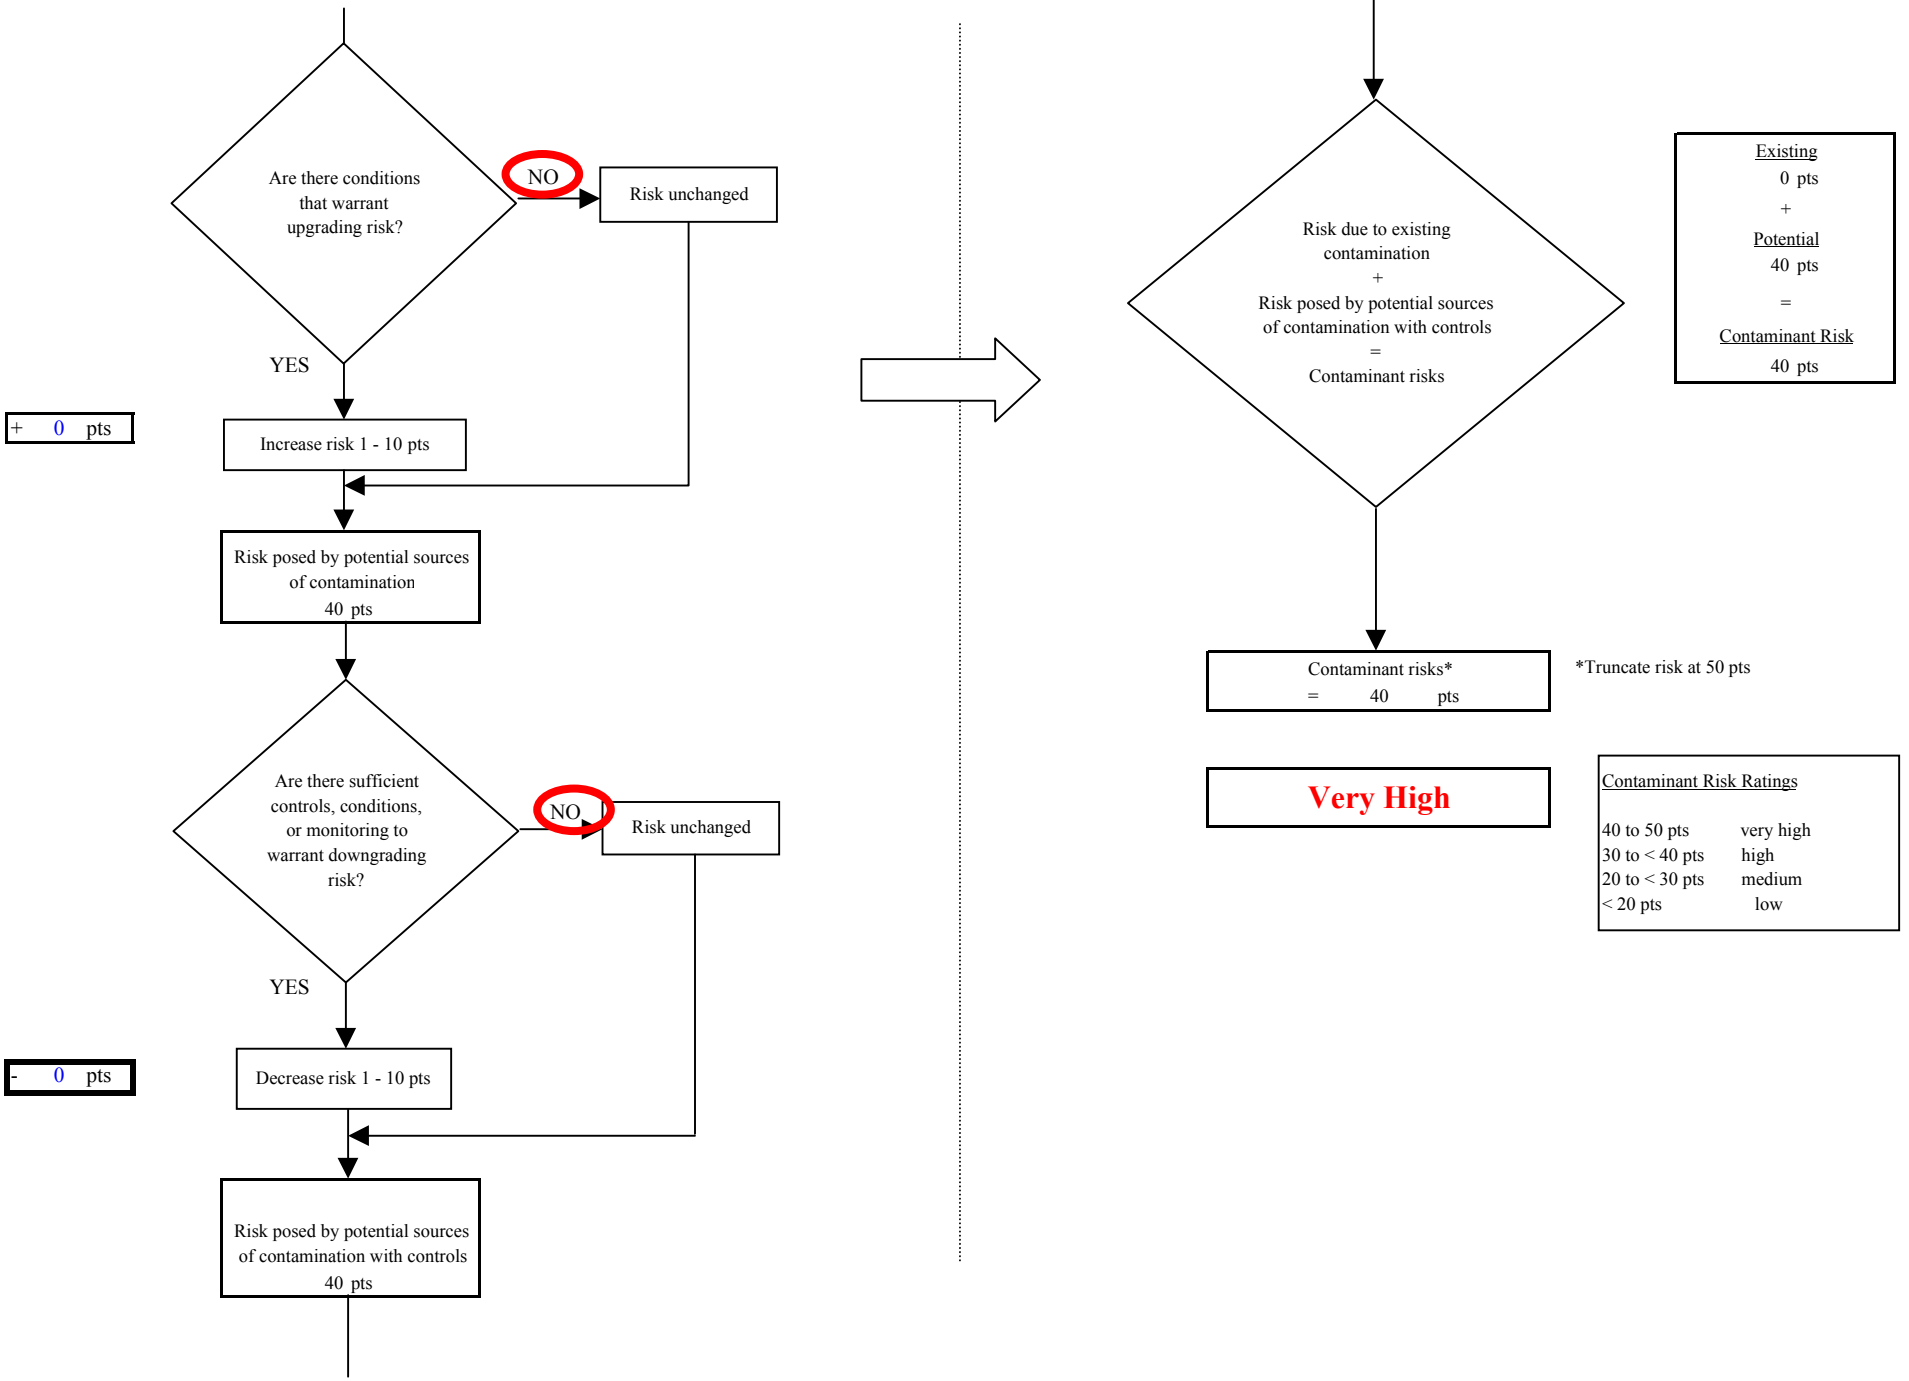
Chart 5. Contaminant risks for Fox Roadhouse - Nitrates and Nitrites

The contaminant risk for nitrates and nitrites is also very high with the large capacity septic system and the density of residential septic systems nearest the well representing the risk to this source of public drinking water (See Chart 5 - Contaminant Risks for Nitrates and/or Nitrites in Appendix D).

The large capacity septic system located near the well increases the risk

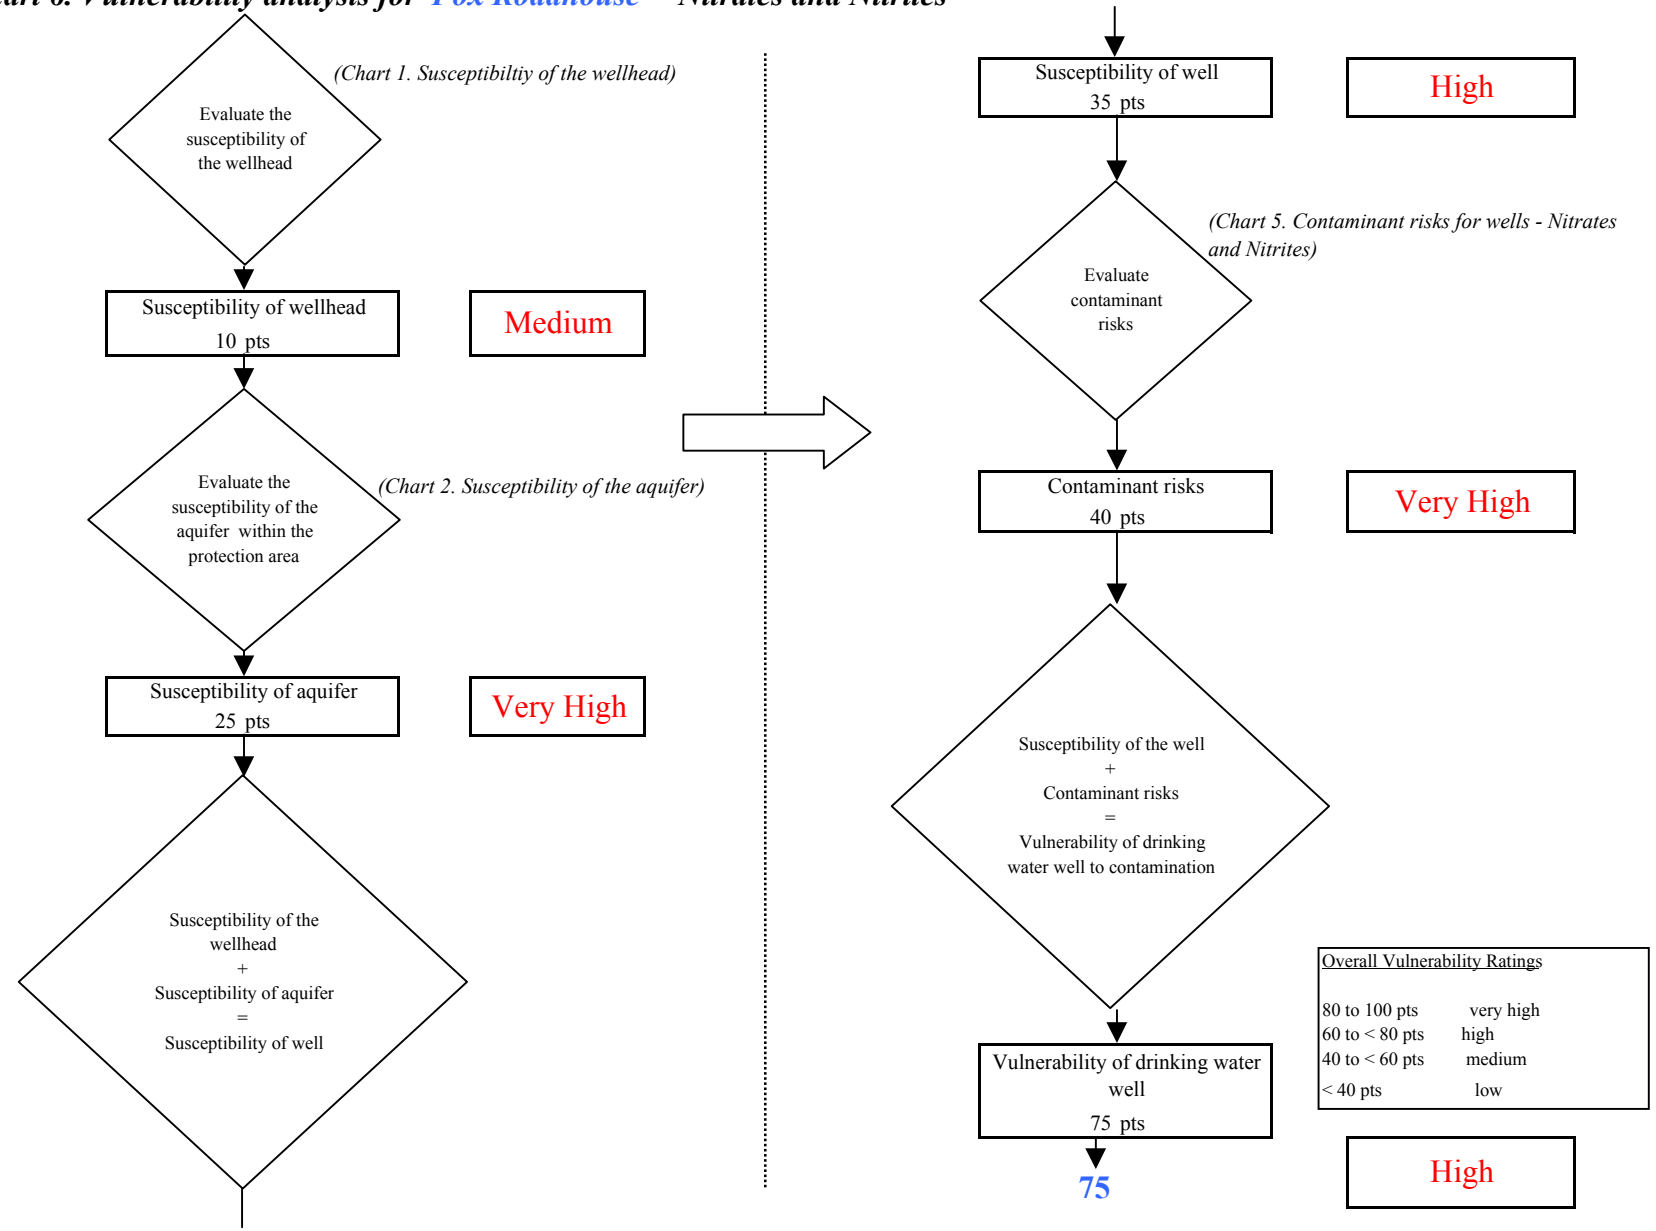
Chart 6. Vulnerability analysis for Fox Roadhouse - Nitrates and Nitrites

Nitrates are very mobile, moving at approximately the same rate as water. Nitrates have not yet been sampled for in this water system. After combining the contaminant risk for nitrates and nitrites with the natural susceptibility of the well, the overall vulnerability of the well to contamination is high.

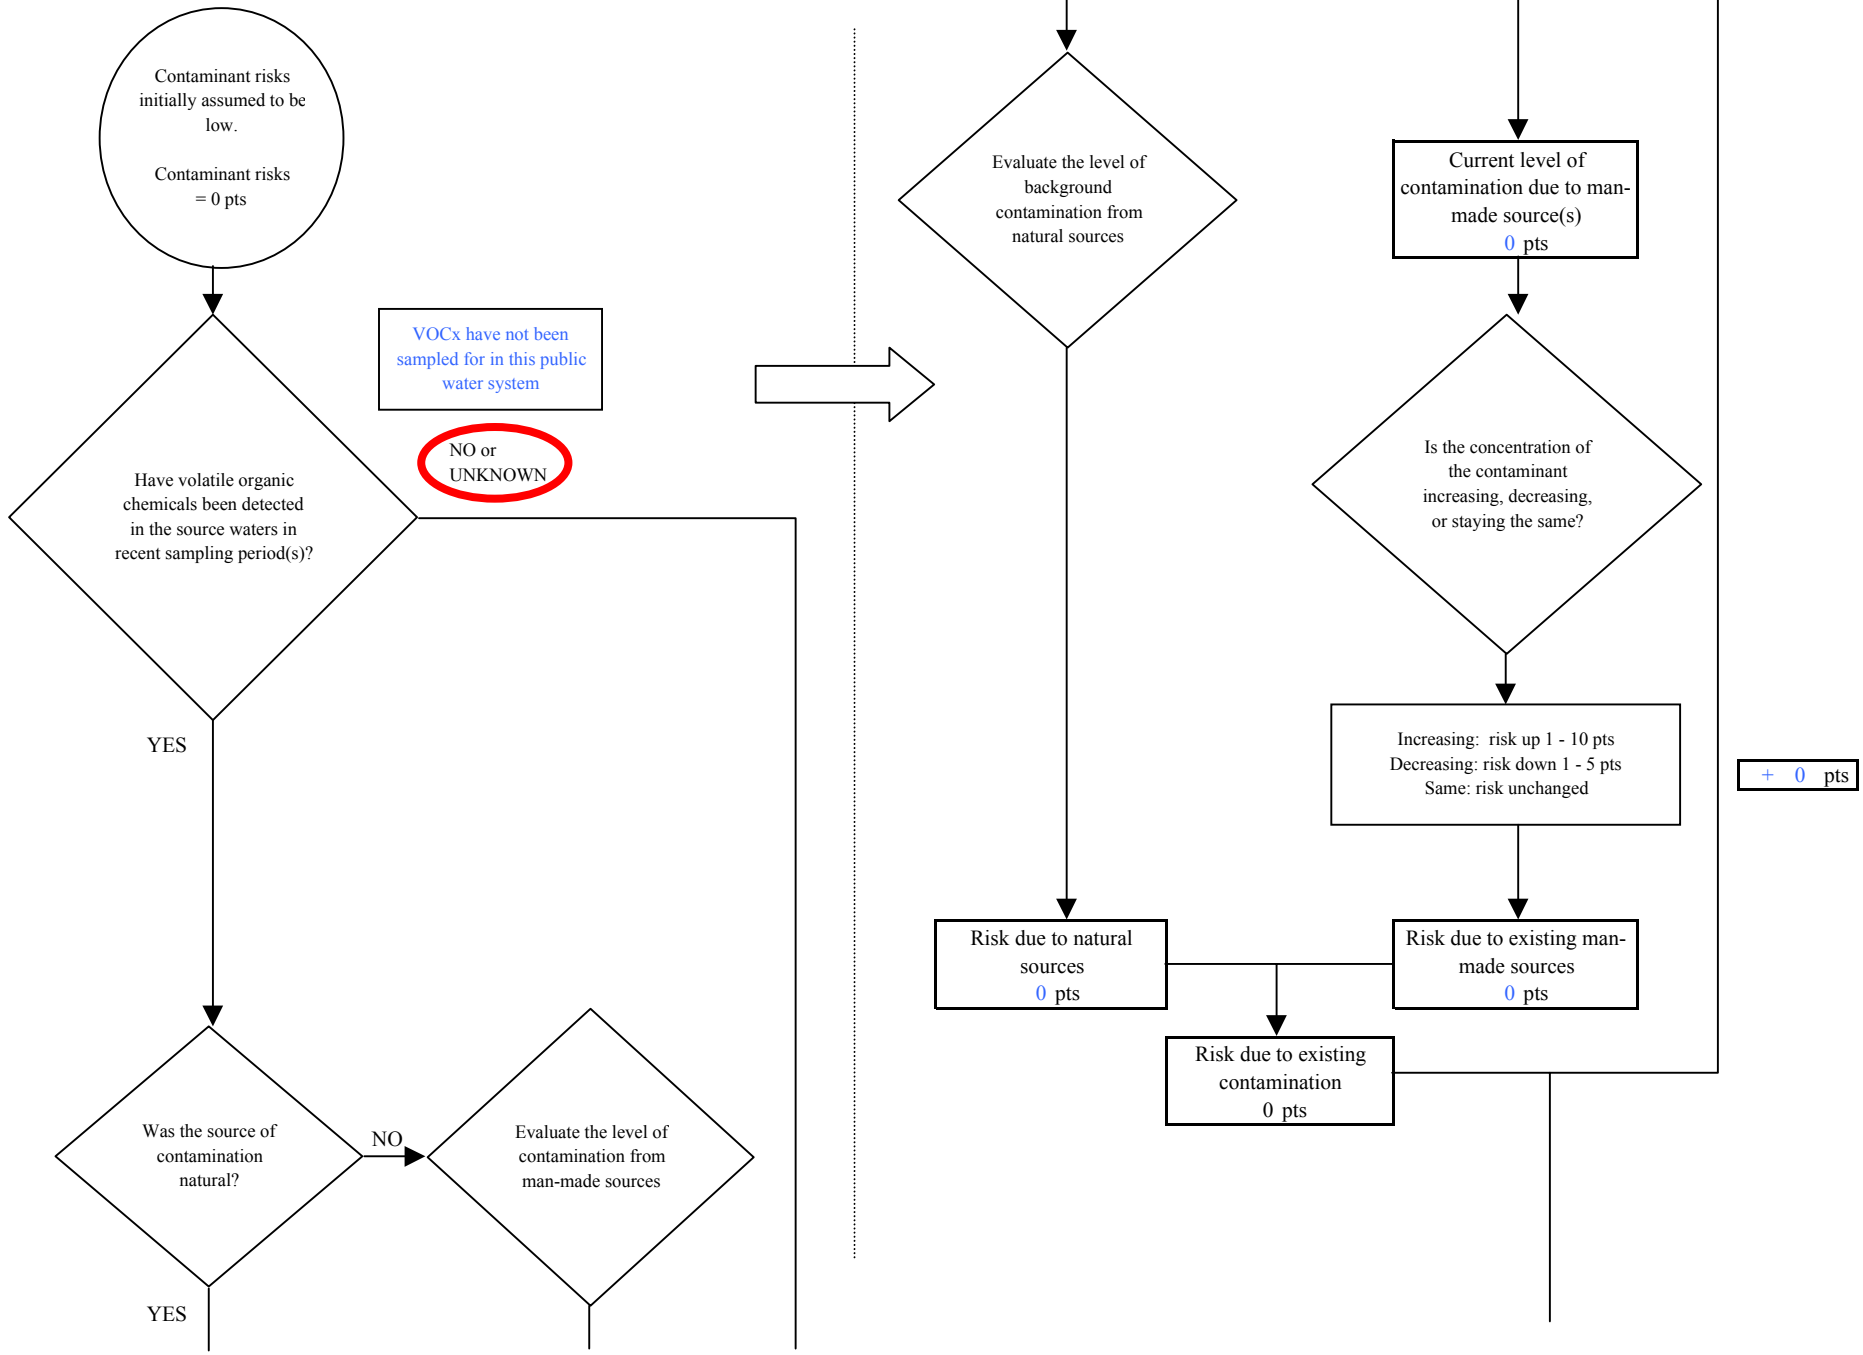
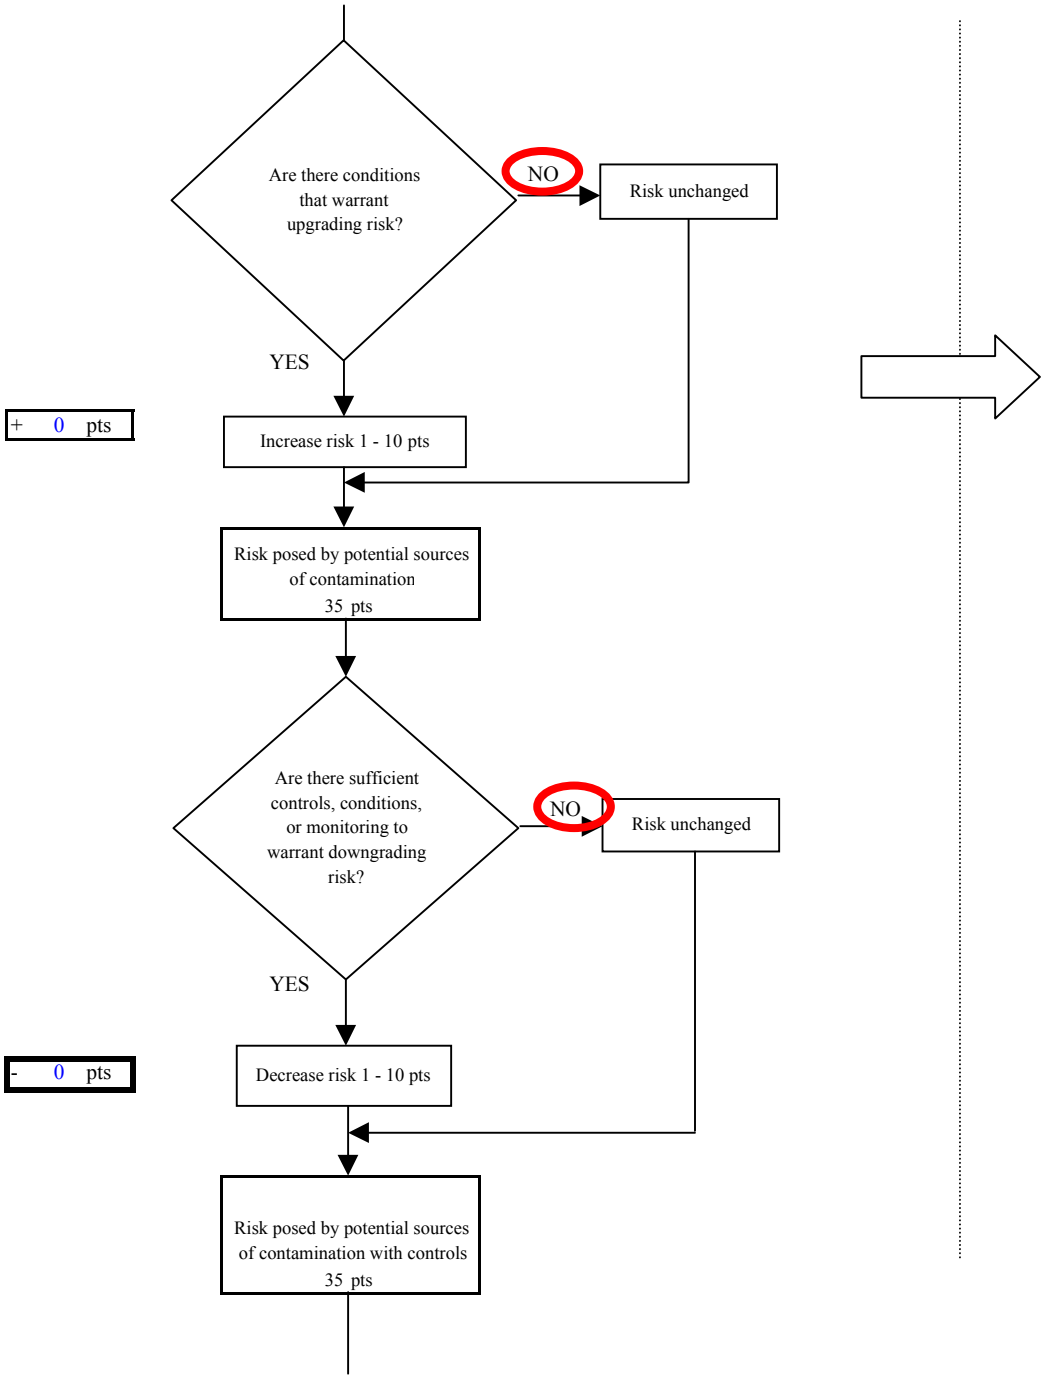
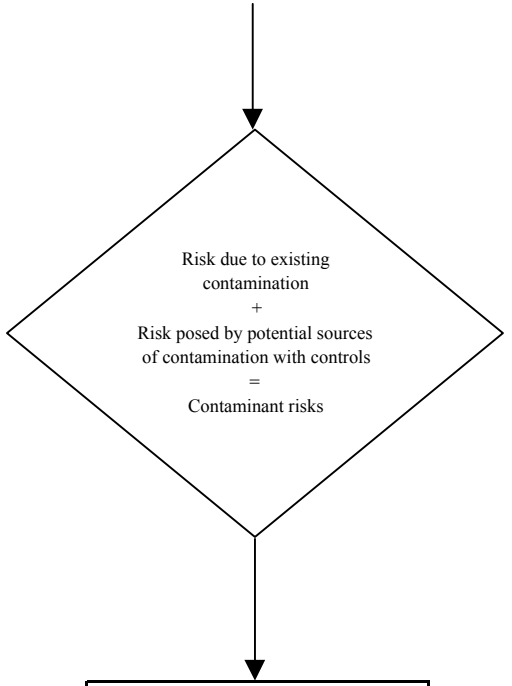
Chart 7. Contaminant risks for Fox Roadhouse - Volatile Organic Chemicals

The contaminant risk for volatile organic chemicals is high with the density of heating oil storage tanks nearest to the well creating the greatest risk for volatile organic chemicals (See Chart 7 – Contaminant Risks for Volatile Organic Chemicals in Appendix D).

The density of residential heating oil storage tanks increase the risk

Both underground and above ground heating oil storage tanks are the standard way of heating homes and businesses in the area surrounding Fairbanks. The most common causes of fuel leaks of these heating oil systems are overfilling the tank, ruptured fuel lines, leaking storage tanks, damaged or faulty valves and vandalism. Regular system maintenance can help prevent many of these harmful fuel leaks.
