A Hydrogeologic Susceptibility and Vulnerability Assessment for Roads End RV Park Drinking Water System, Fairbanks area, Alaska PWSID 370502

July 2003

DRINKING WATER PROTECTION PROGRAM REPORT Report 1021
Alaska Department of Environmental Conservation

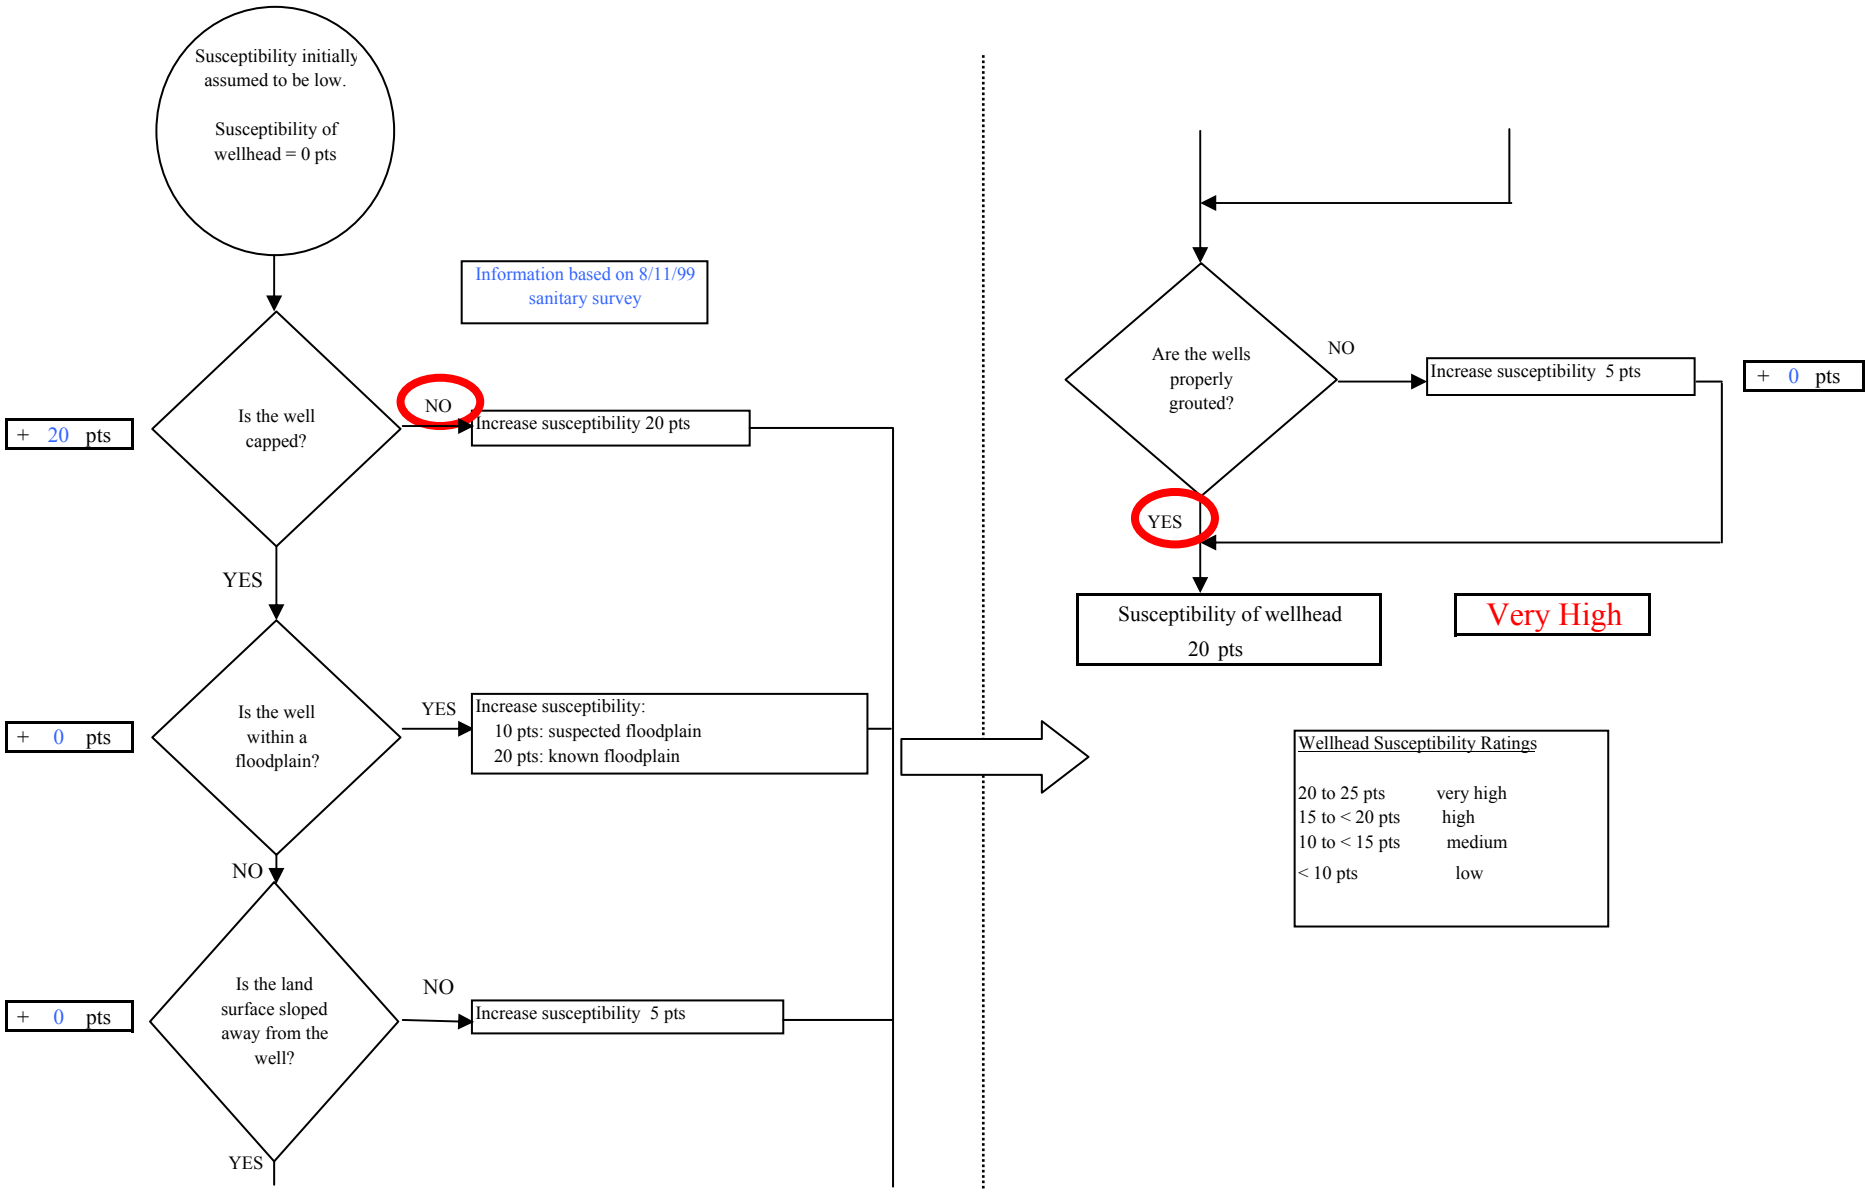
Chart 1. Susceptibility of the wellhead - Roads End Trailer Court

The wellhead for the Roads End RV Park received a Very High Susceptibility rating. According to the 8/11/99 sanitary survey, the well is not properly capped with a sanitary seal. The land surface is sloped away from the well and the well is grouted. A sanitary seal prevents potential contaminant from entering the well while sloping of the land surface and grouting help to prevent potential contaminants from traveling down the outside of the well casing.

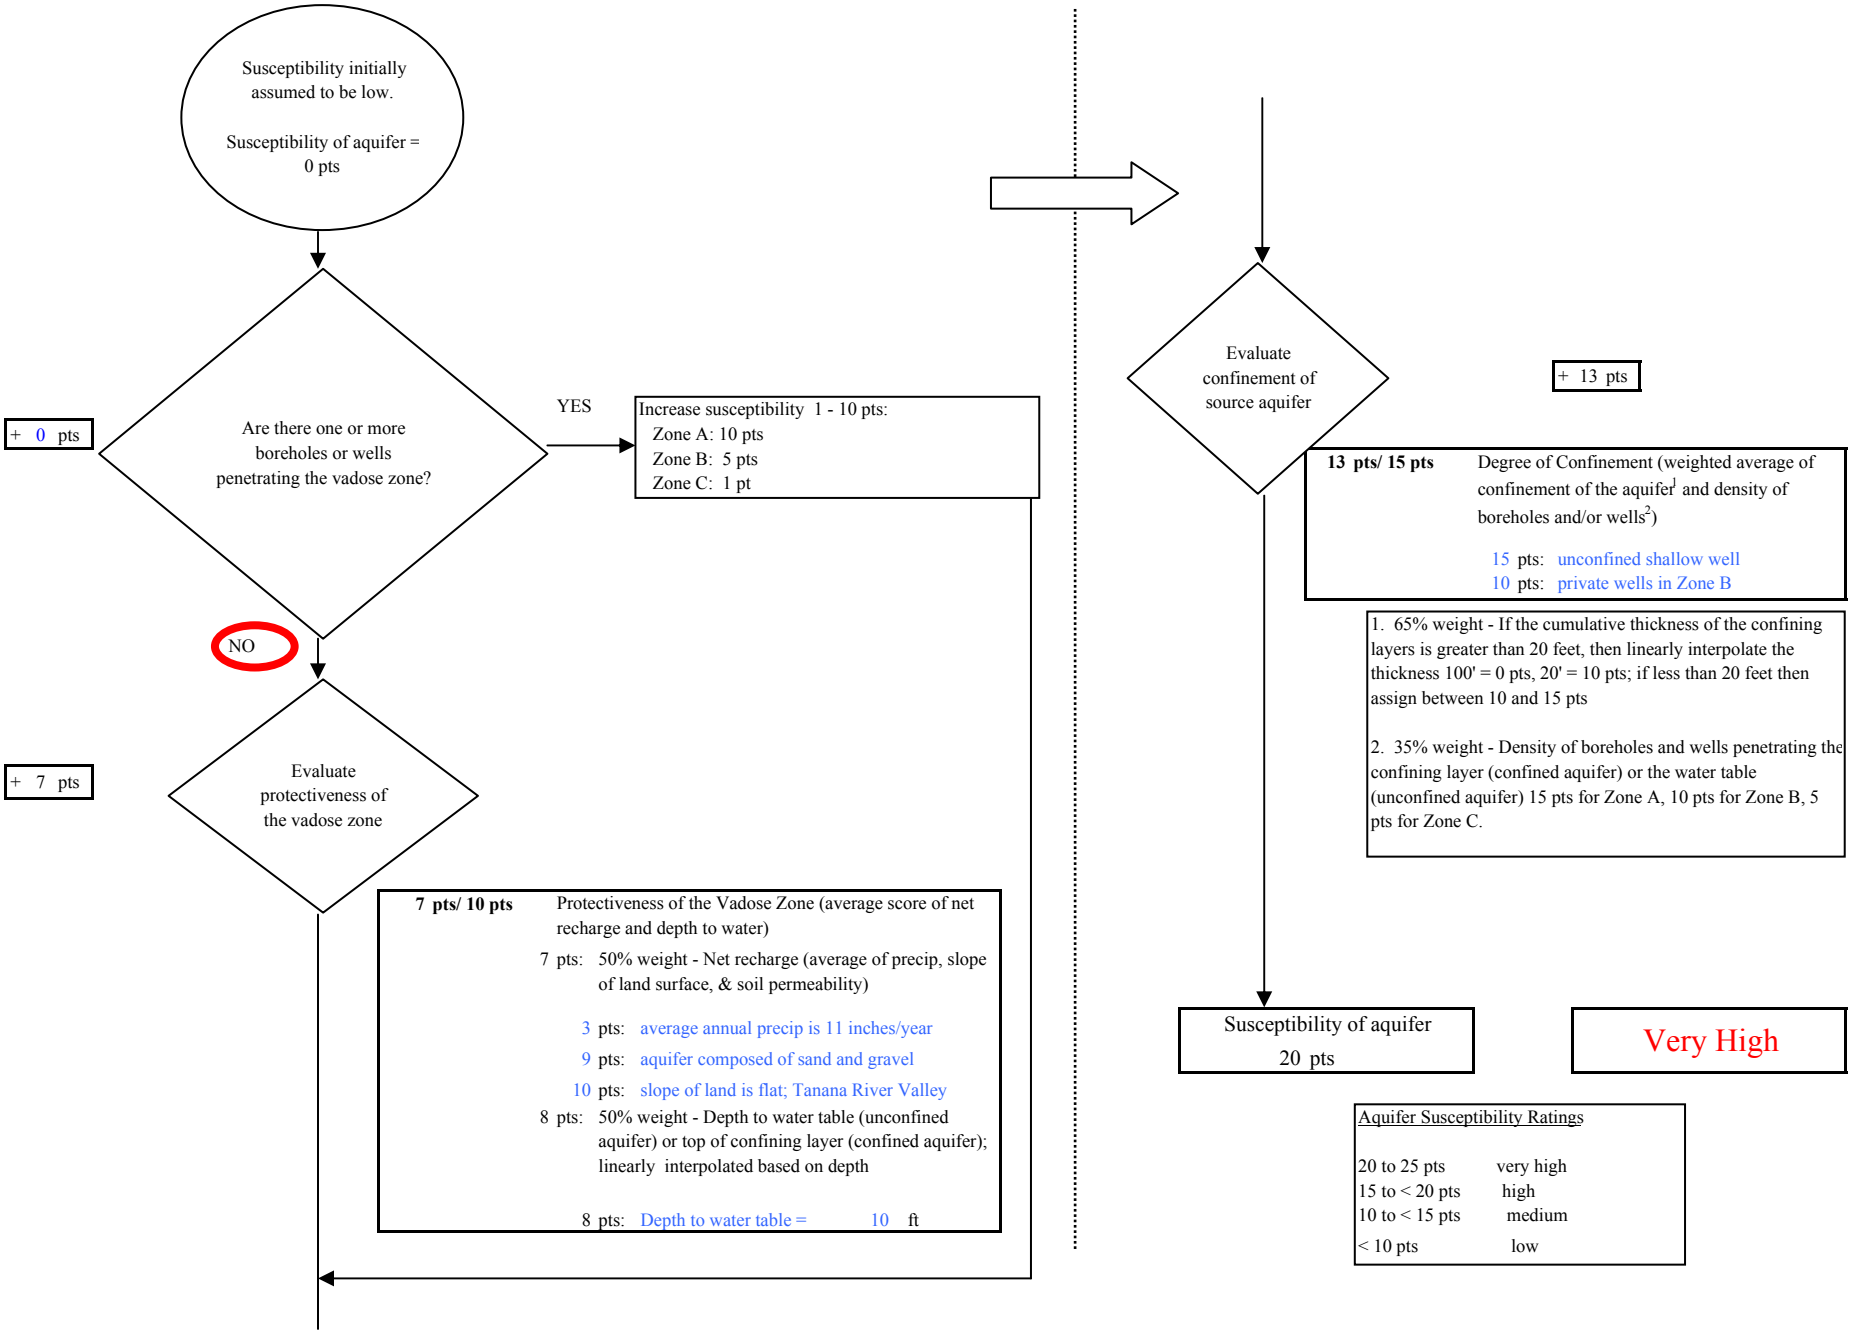
Chart 2. Susceptibility of the aquifer - Roads End Trailer Court

The aquifer the Roads End RV Park well is completed in received a Very High Susceptibility rating. The highly transmissive aquifer material and the high water table in the area allow contaminants to travel downward from the surface with the precipitation and surface water runoff. Table 2 summarizes the Susceptibility scores and ratings for Roads End RV Park.
