Source Water Assessment

A Hydrogeologic Susceptibility and Vulnerability Assessment for Alaska Bible College Drinking Water System, Glennallen, Alaska

PWSID # 292099.001

DRINKING WATER PROTECTION PROGRAM REPORT 1364
Alaska Department of Environmental Conservation

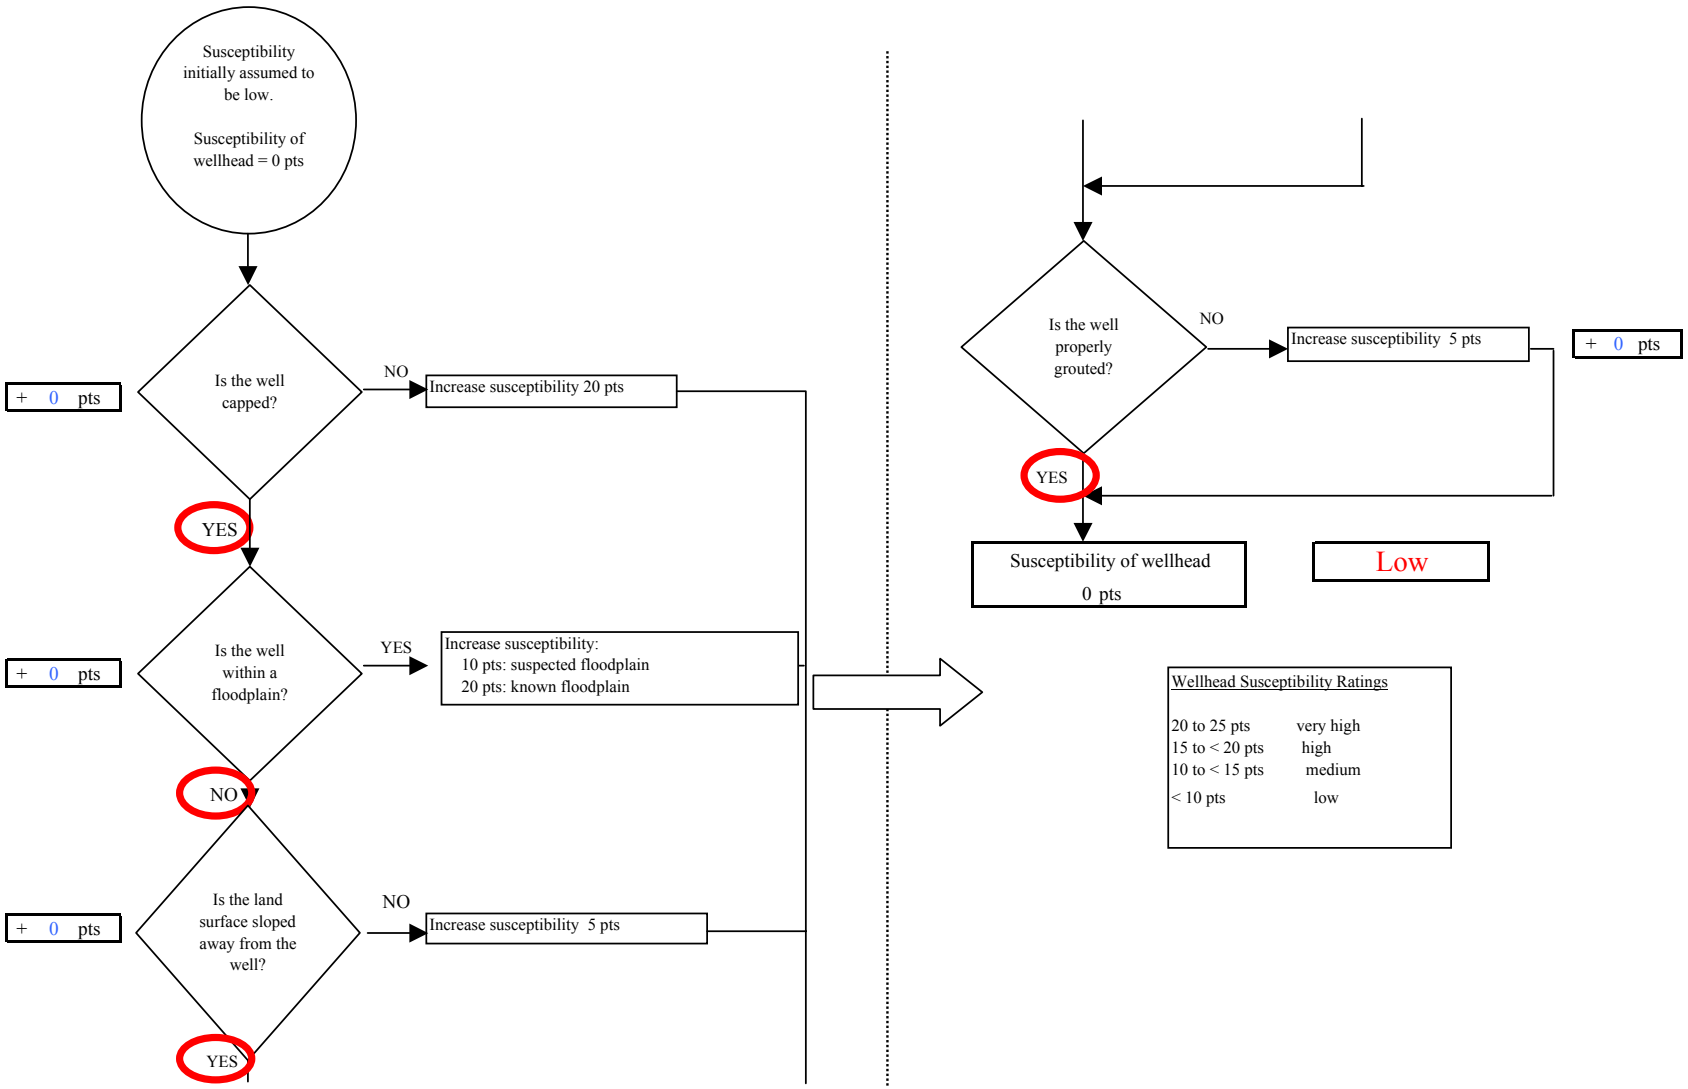
Chart 1. Susceptibility of the wellhead - Alaska Bible College (PWS No. 292099.001)

Score	Rating
Susceptibility of the Wellhead	0	Low
Susceptibility of the Aquifer	20	Very High

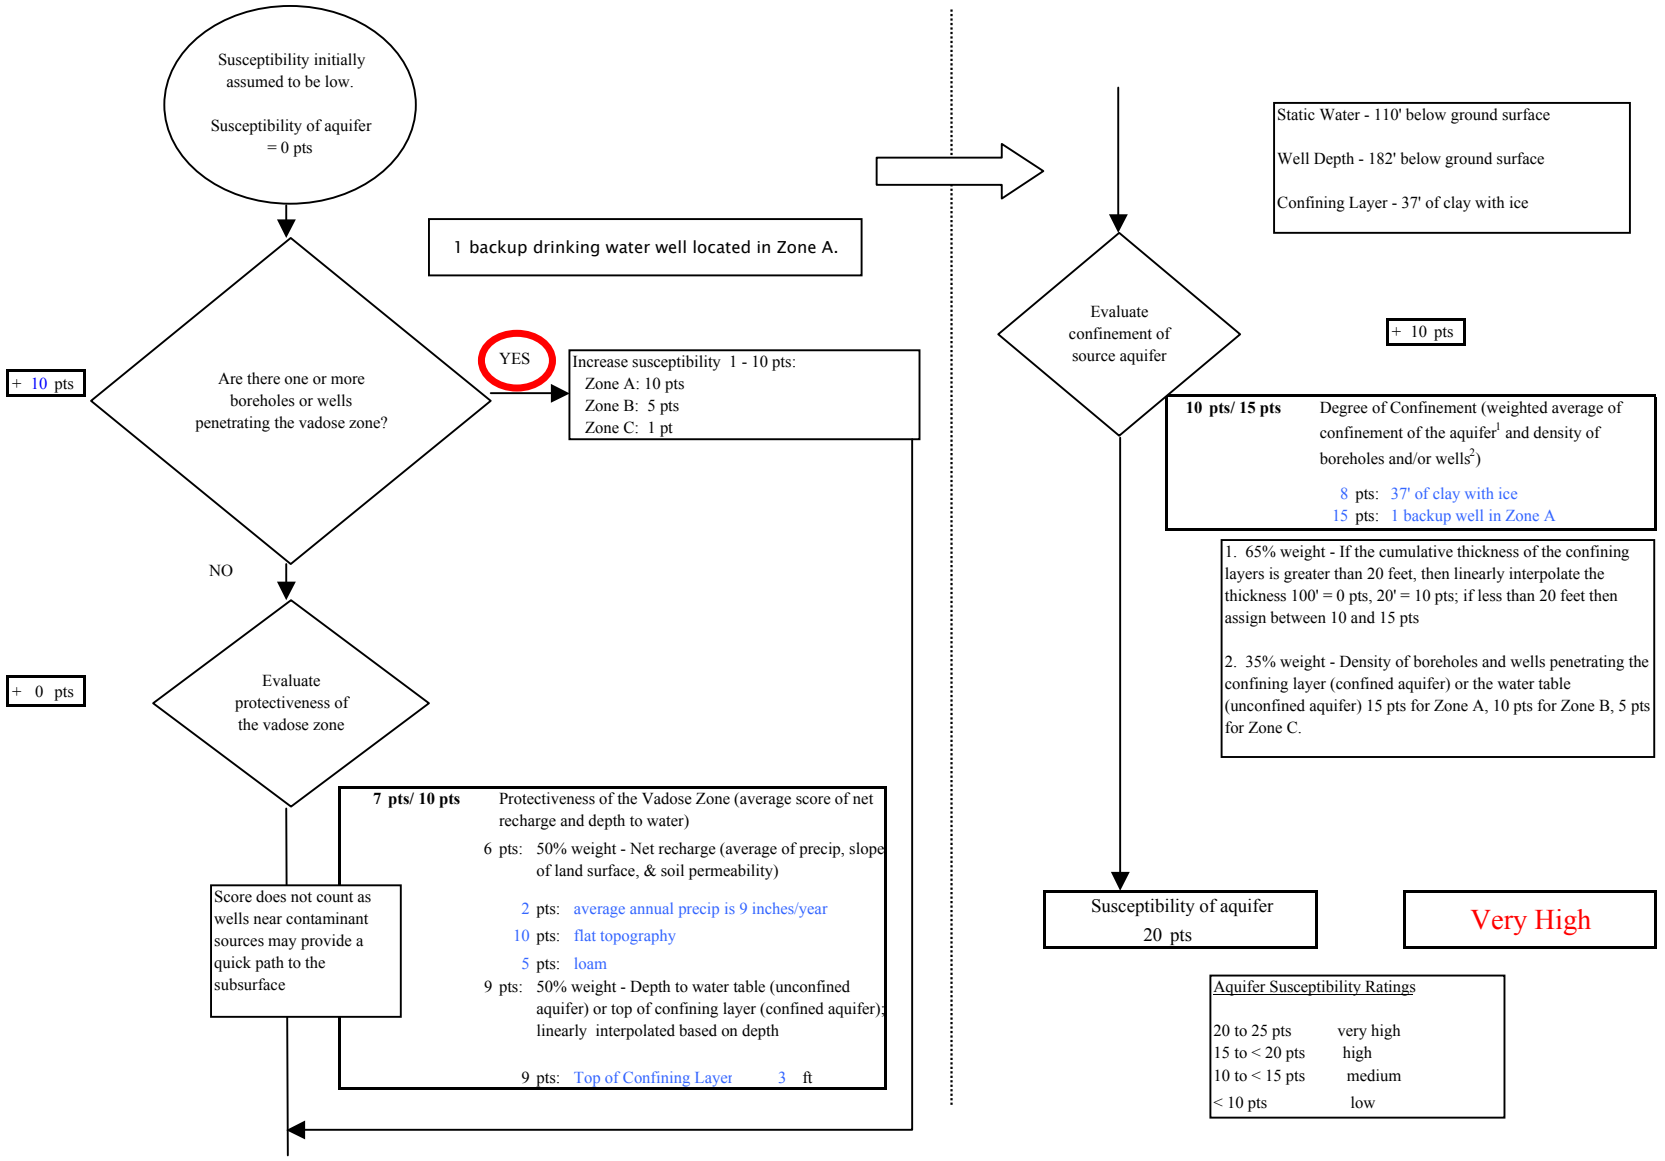
Chart 2. Susceptibility of the aquifer Alaska Bible College (PWS No. 292099.001)

The Alaska Bible College water well is assumed to be in a confined aquifer. Unconfined aquifers are more susceptible to potential groundwater quality impacts posed by the migration of surface water contaminants downward from the surface. Table 2 shows the susceptibility scores and ratings for this PWS.

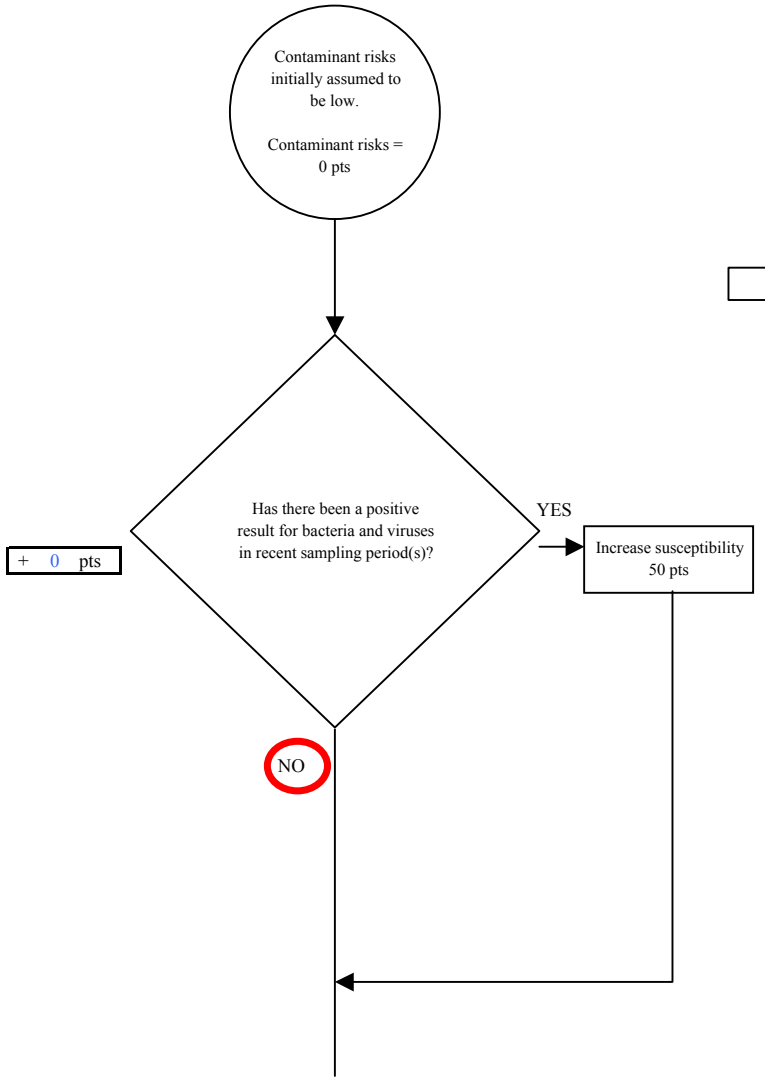
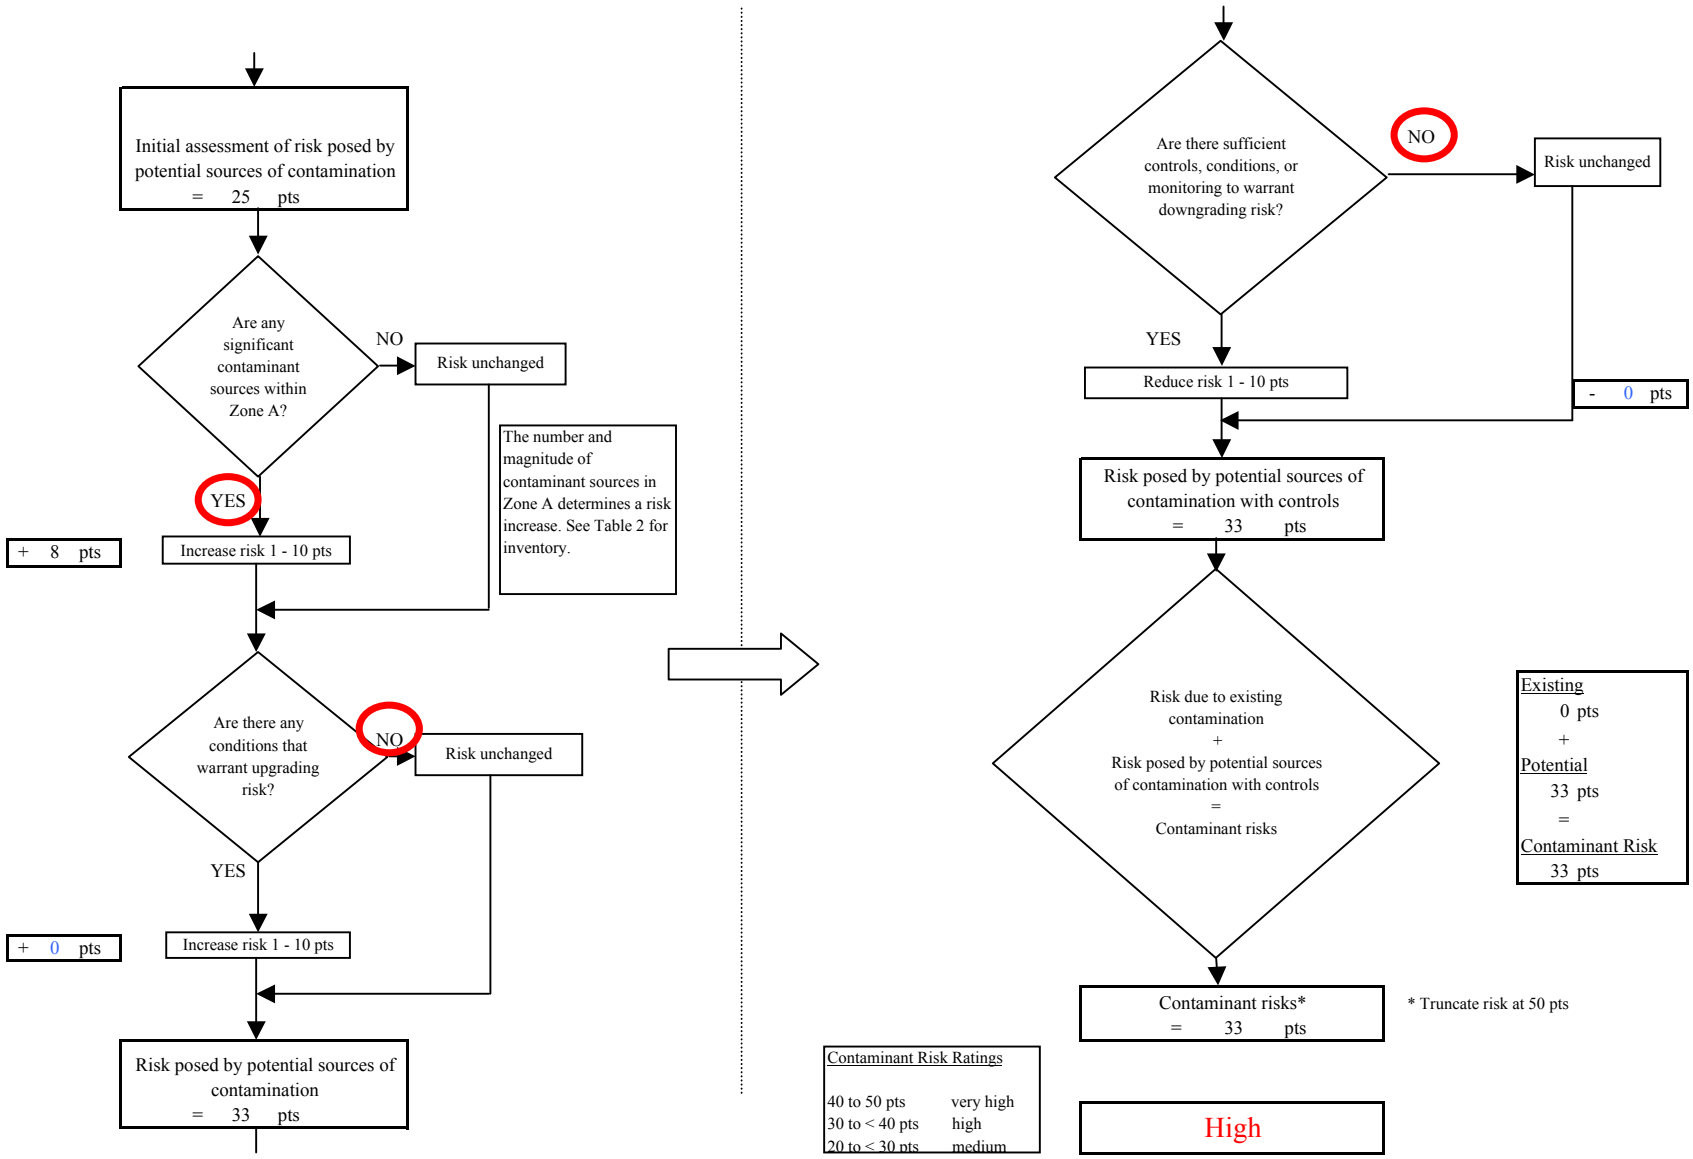
Chart 3. Contaminant risks for Alaska Bible College (PWS No. 292099.001) - Bacteria & Viruses

The contaminant risk for bacteria and viruses is **High**. The risk is primarily attributed to the presence of a domestic wastewater collection in Zone A (see Table 2 – Appendix B).

No positive bacteria counts have been reported in recent (within five years) sampling events (See Chart 3 – Contaminant Risks for Bacteria and Viruses in Appendix D). Only a small amount of bacteria and viruses are required to endanger public health.

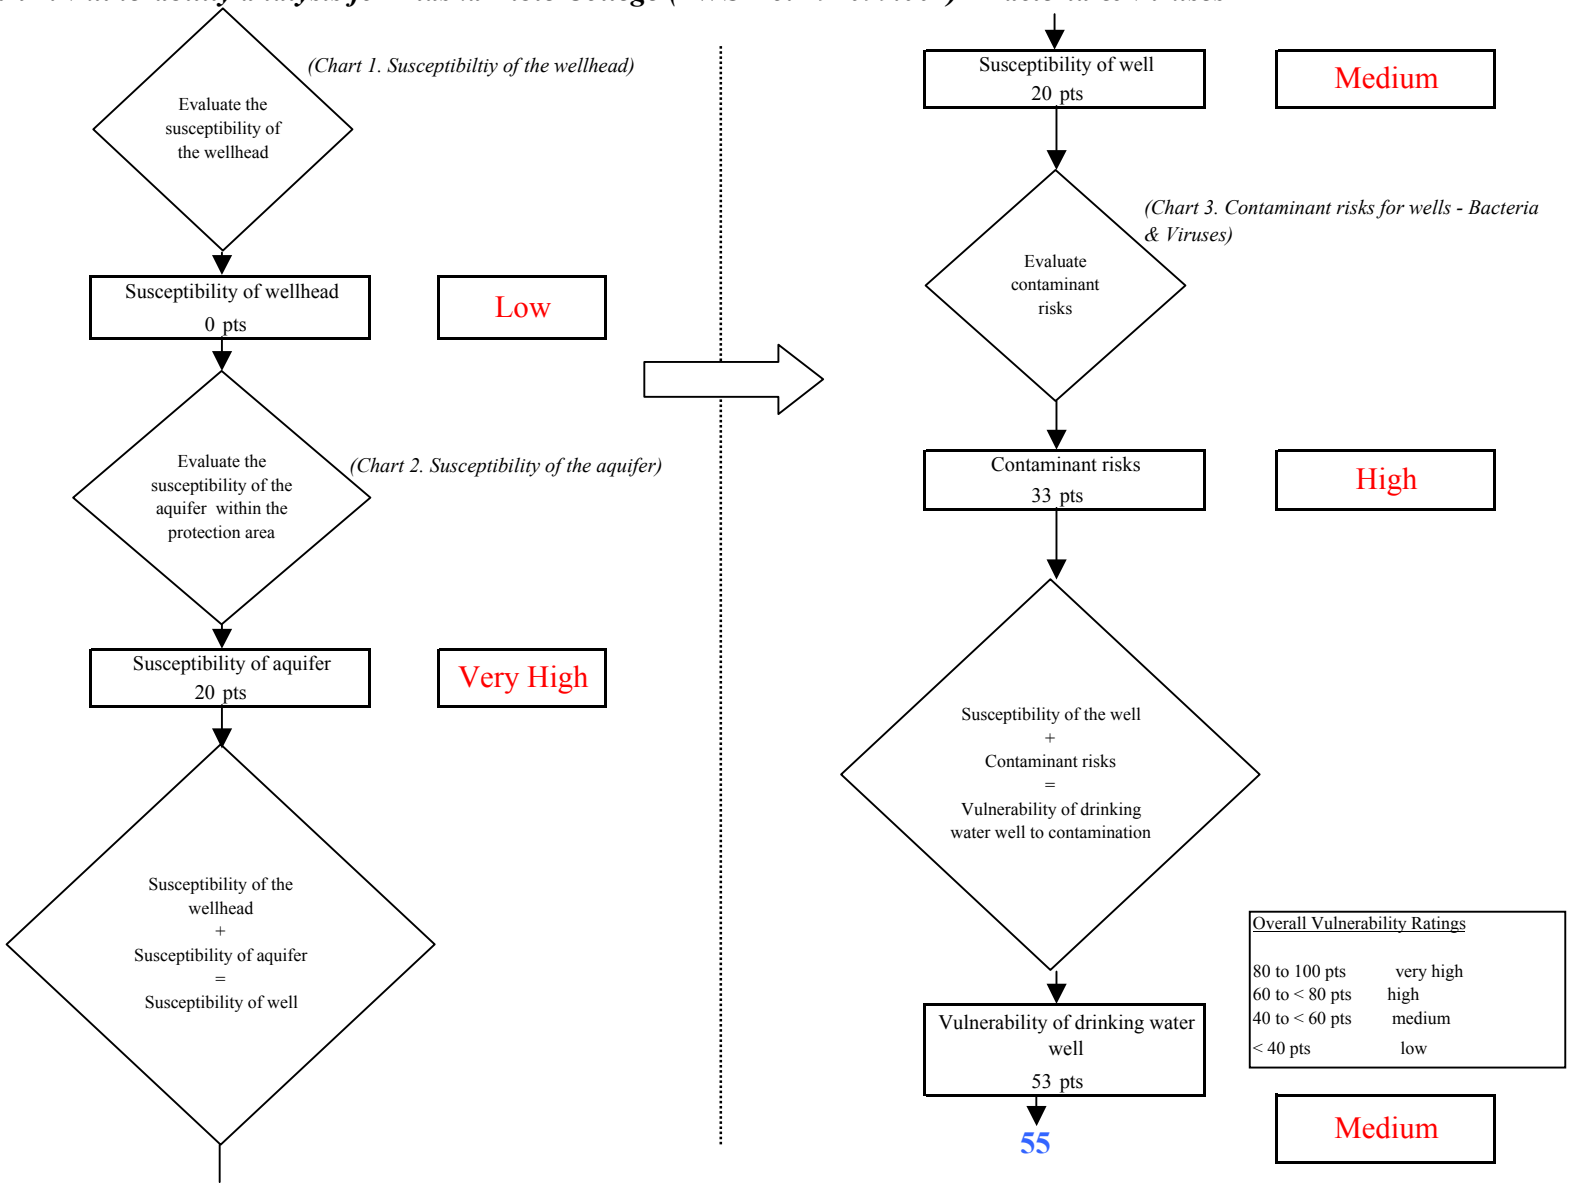
Chart 4. Vulnerability analysis for Alaska Bible College (PWS No. 292099.001) - Bacteria & Viruses

After combining the contaminant risk for bacteria and viruses with the natural susceptibility of the well, the overall vulnerability of the well to contamination is **Medium**.

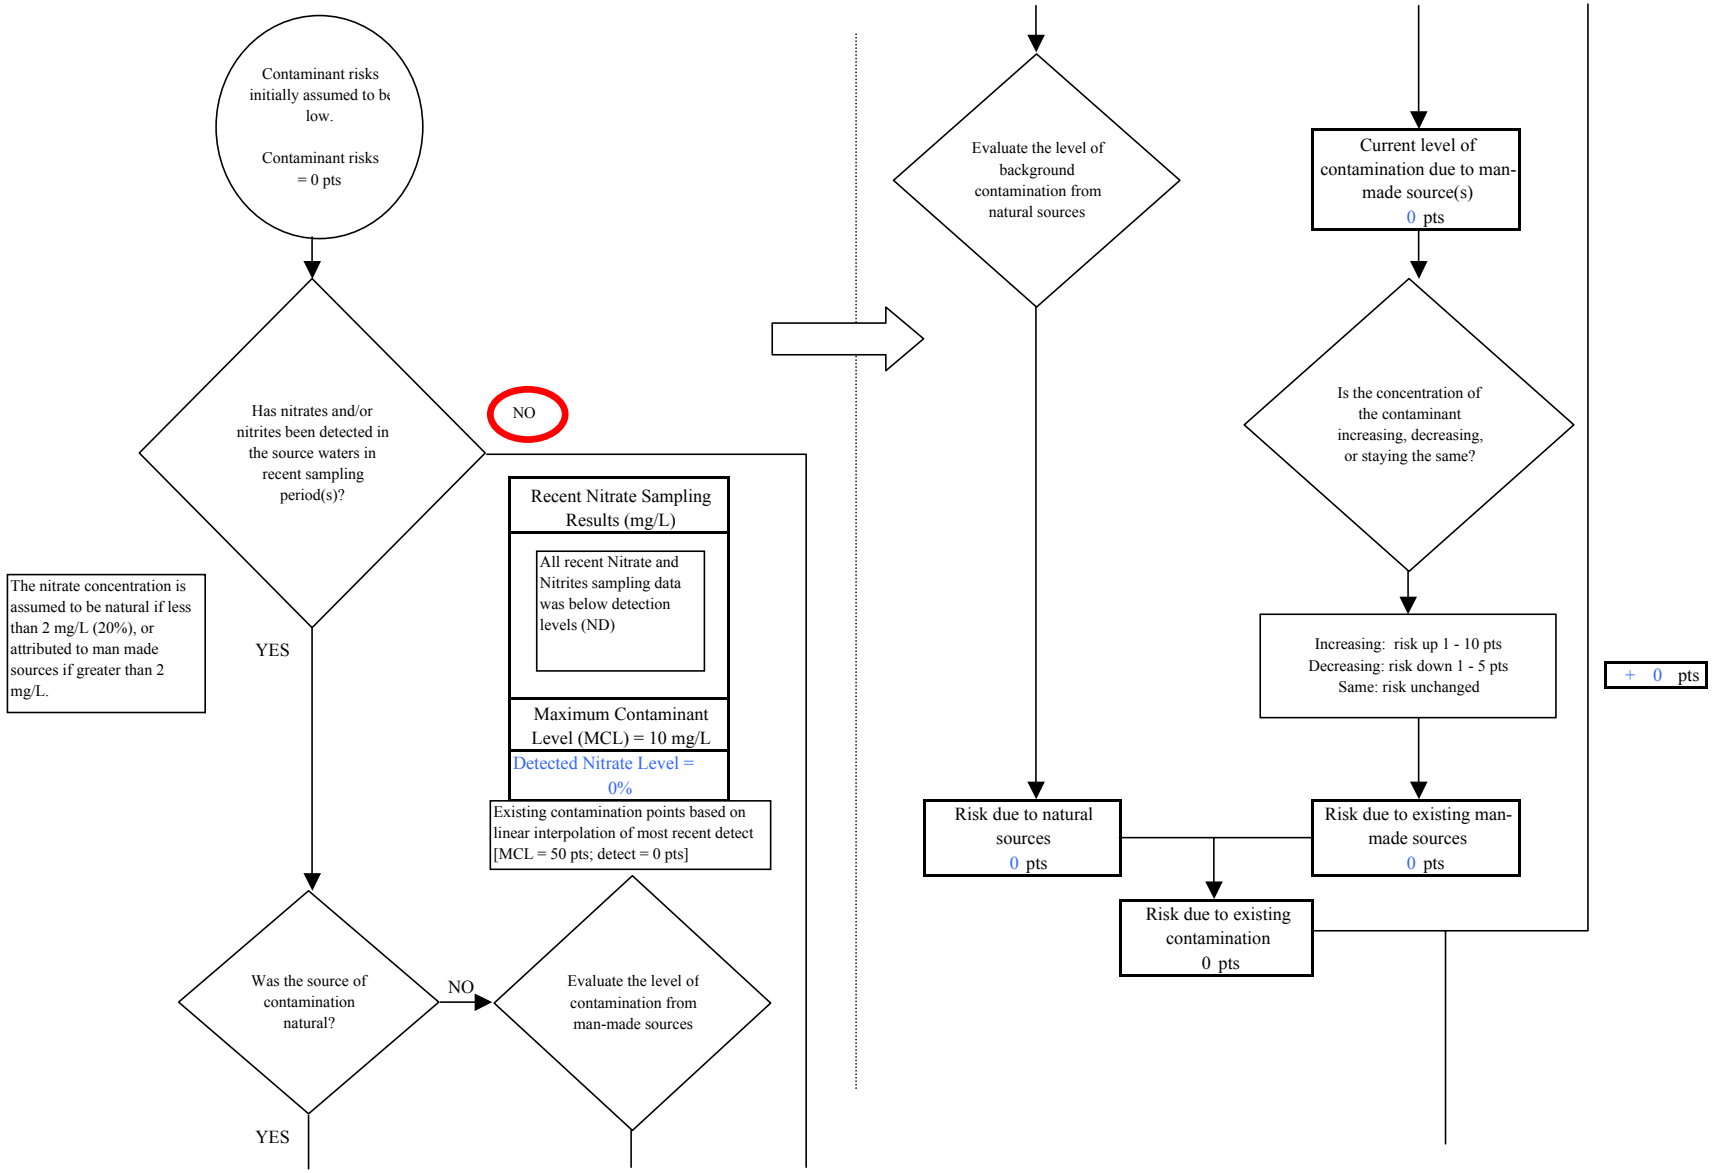
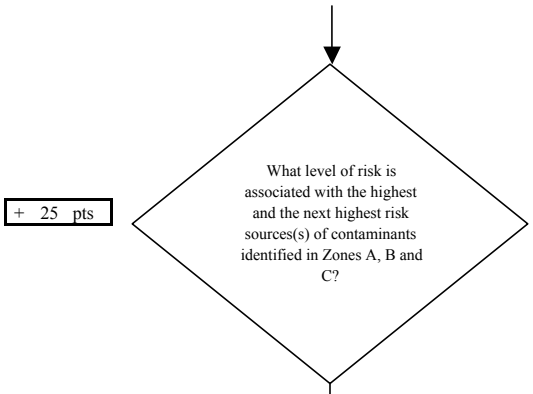
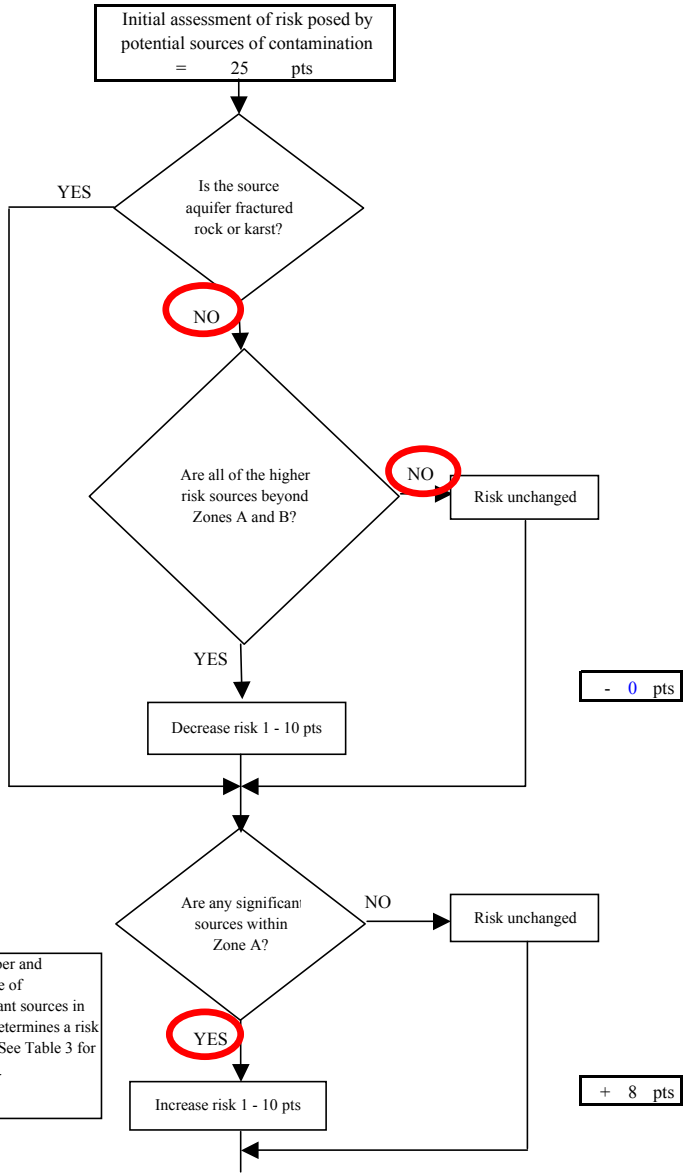
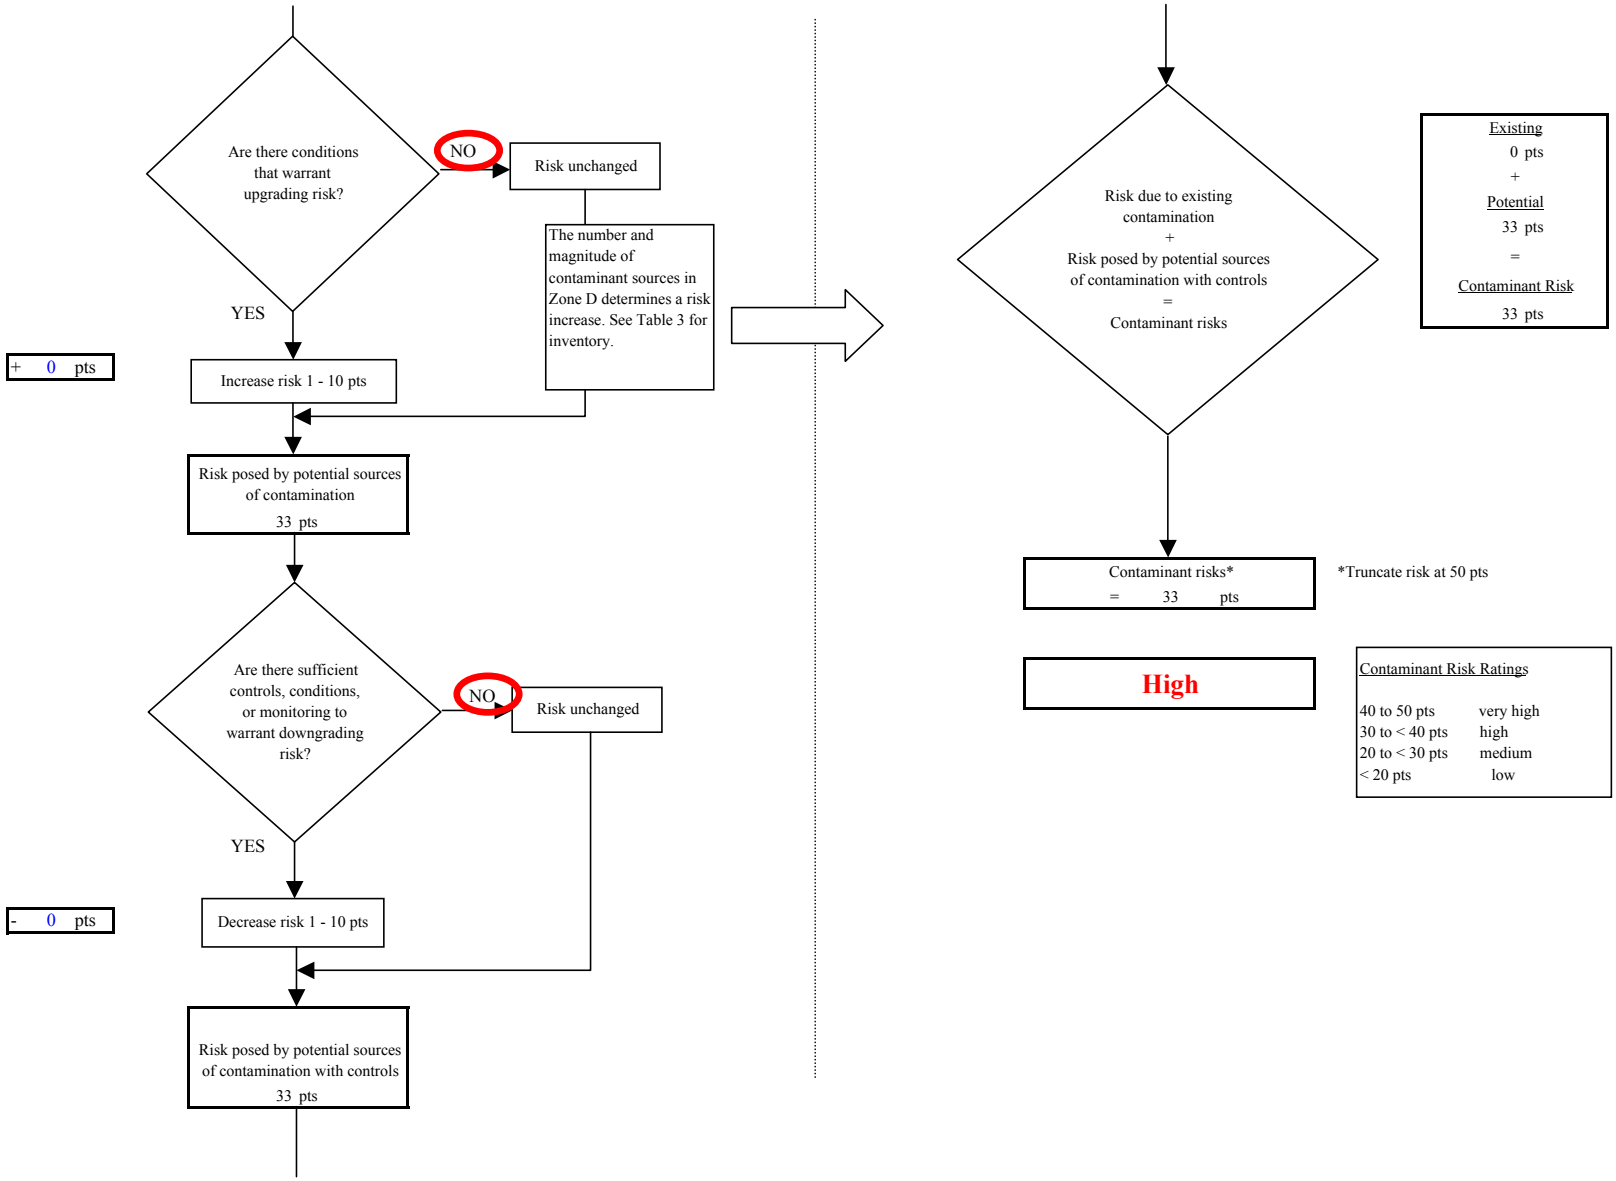
Chart 5. Contaminant risks for Alaska Bible College (PWS No. 292099.001) - Nitrates and Nitrites

The contaminant risk for nitrates and nitrites is **High**. The risk to this source of public drinking water is primarily attributed to to the presence of a domestic

wastewater collection in Zone A (see Table 3 – Appendix B).

Nitrates are very mobile, moving at approximately the same rate as water. The sampling history for this well indicates nitrates have been below the detection level in recent sampling events.

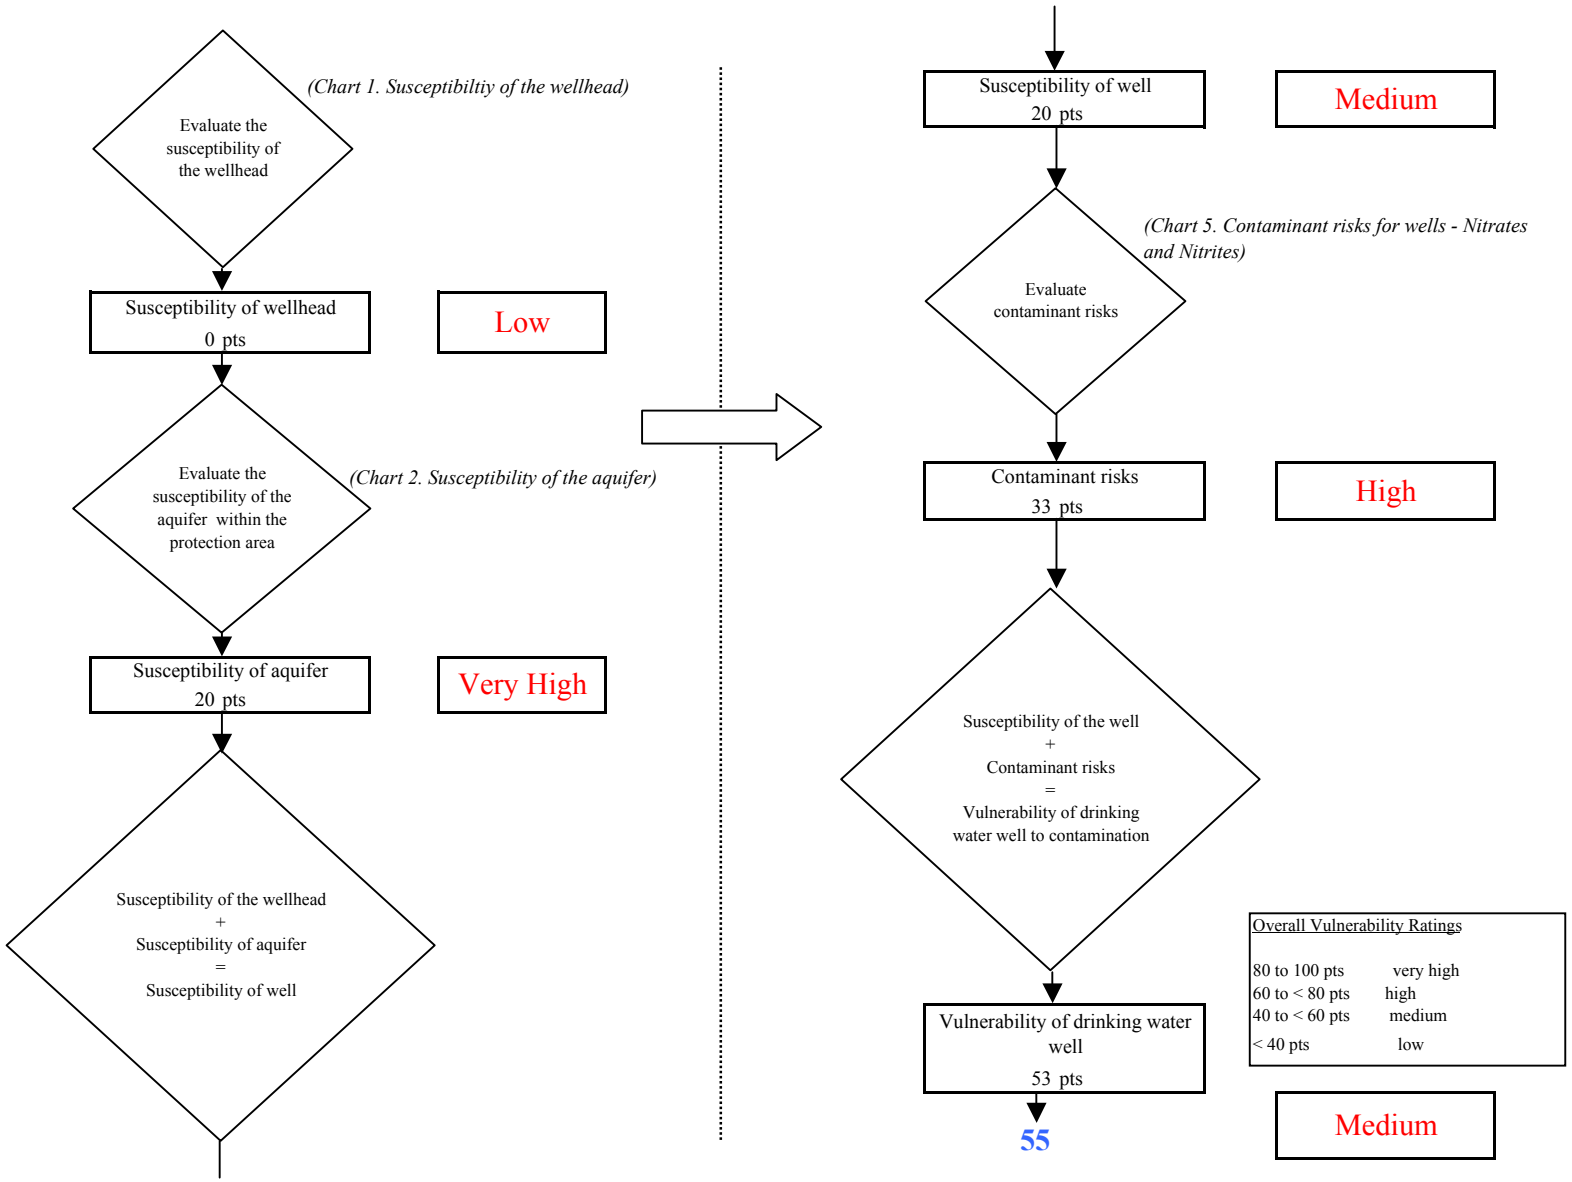
Chart 6. Vulnerability analysis for Alaska Bible College (PWS No. 292099.001) - Nitrates and Nitrites

After combining the contaminant risk for nitrates and nitrites with the natural susceptibility of the well, the overall vulnerability of the well to nitrate and nitrite contamination is **Medium**.

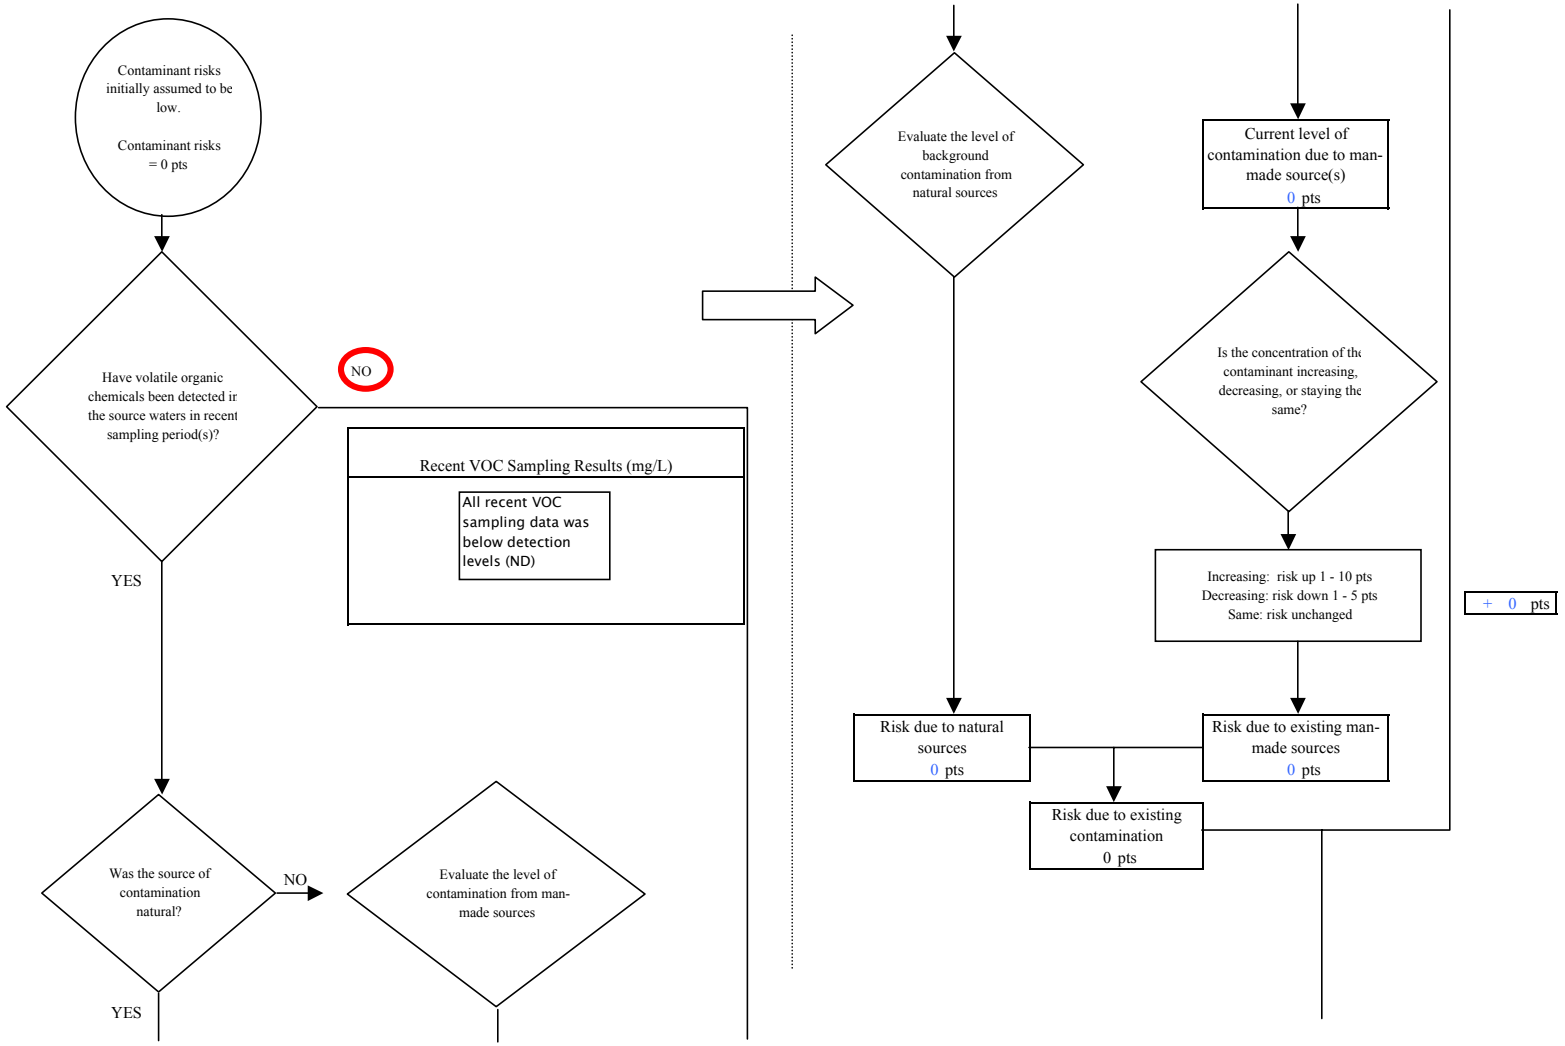
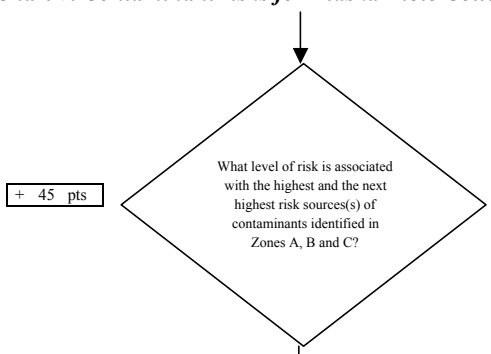
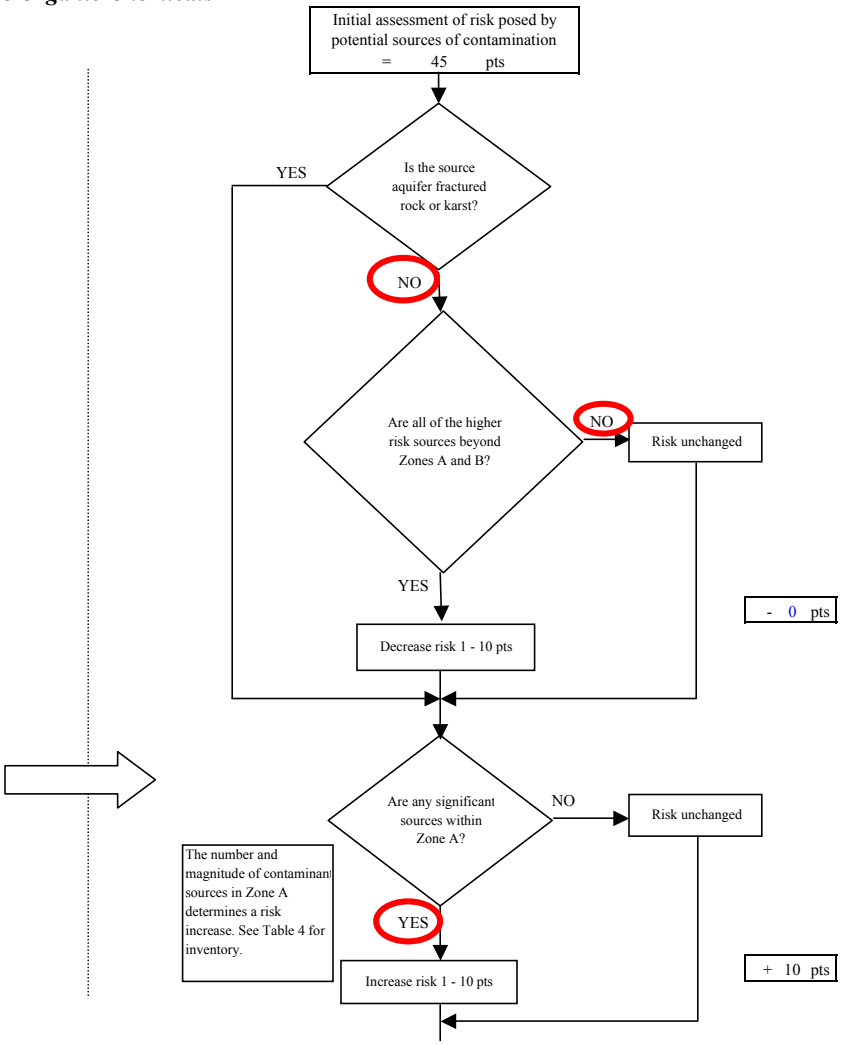
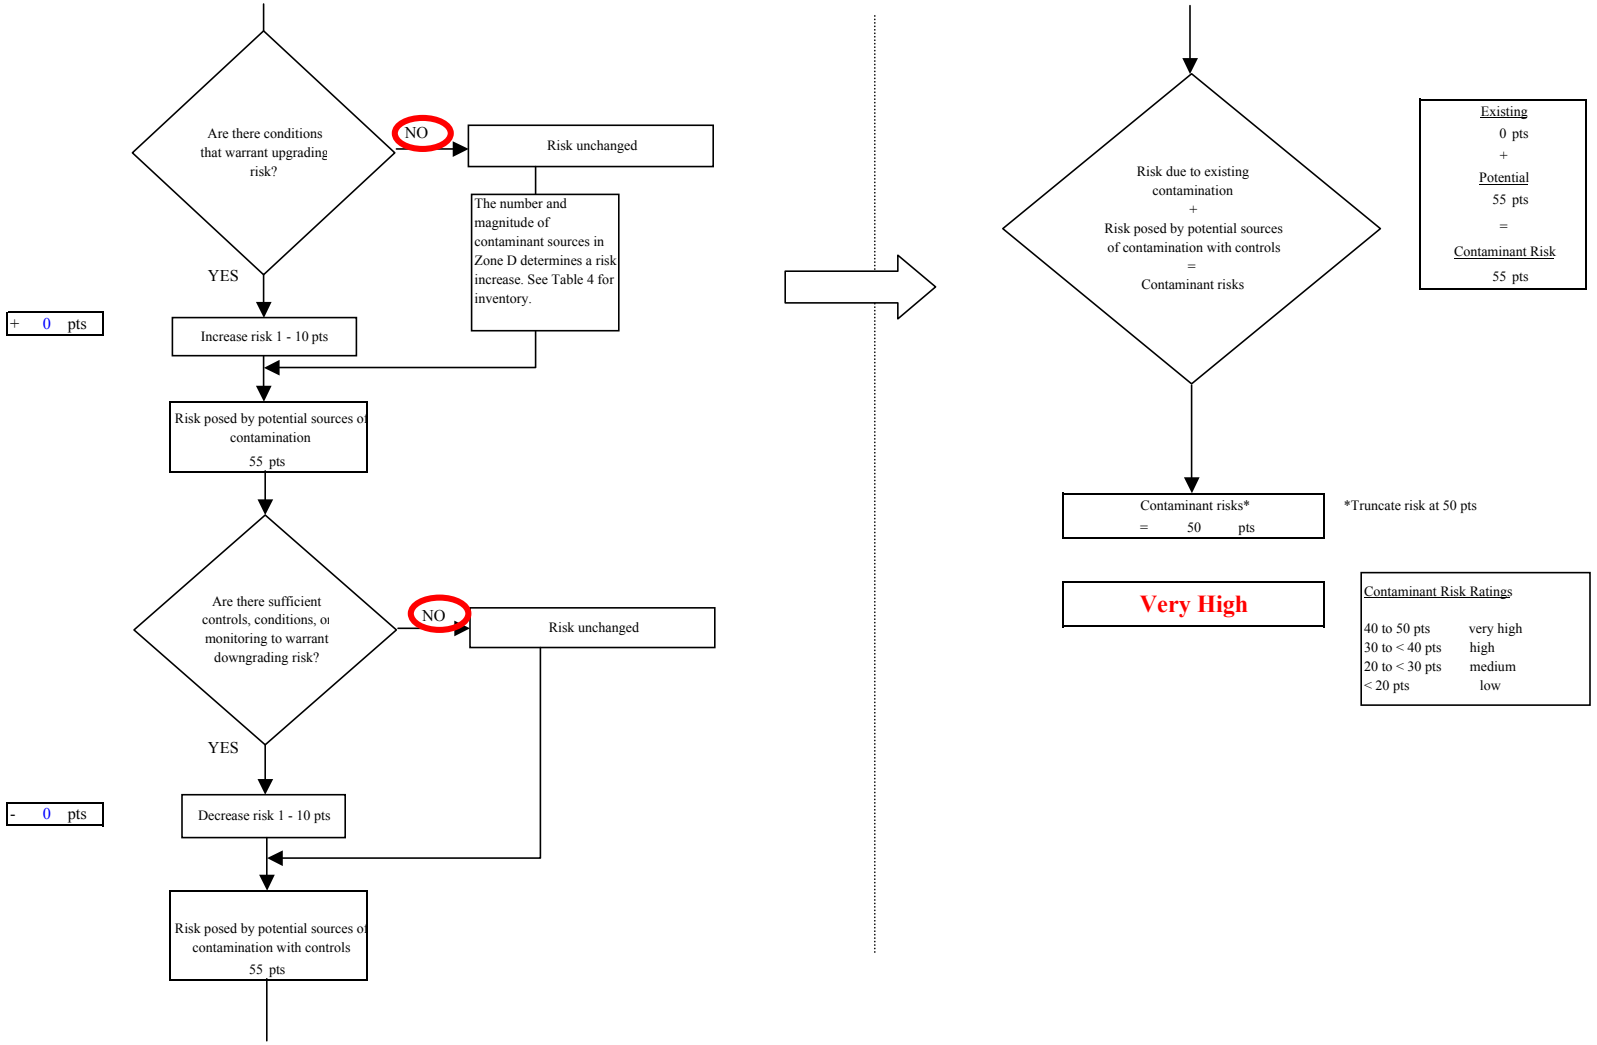
Chart 7. Contaminant risks for Alaska Bible College (PWS No. 292099.001) - Volatile Organic Chemicals

The contaminant risk for volatile organic chemicals is **Very High**. The risk is primarily attributed to the presence of a petroleum product bulk station/terminal located in Zone A. Other potential contaminant sources are also found within the protection area (see Table 4 – Appendix B).

All recent sampling data for VOCs were below the detection levels for Alaska Bible College (See Chart 7 – Contaminant Risks for Volatile Organic Chemicals in Appendix D).

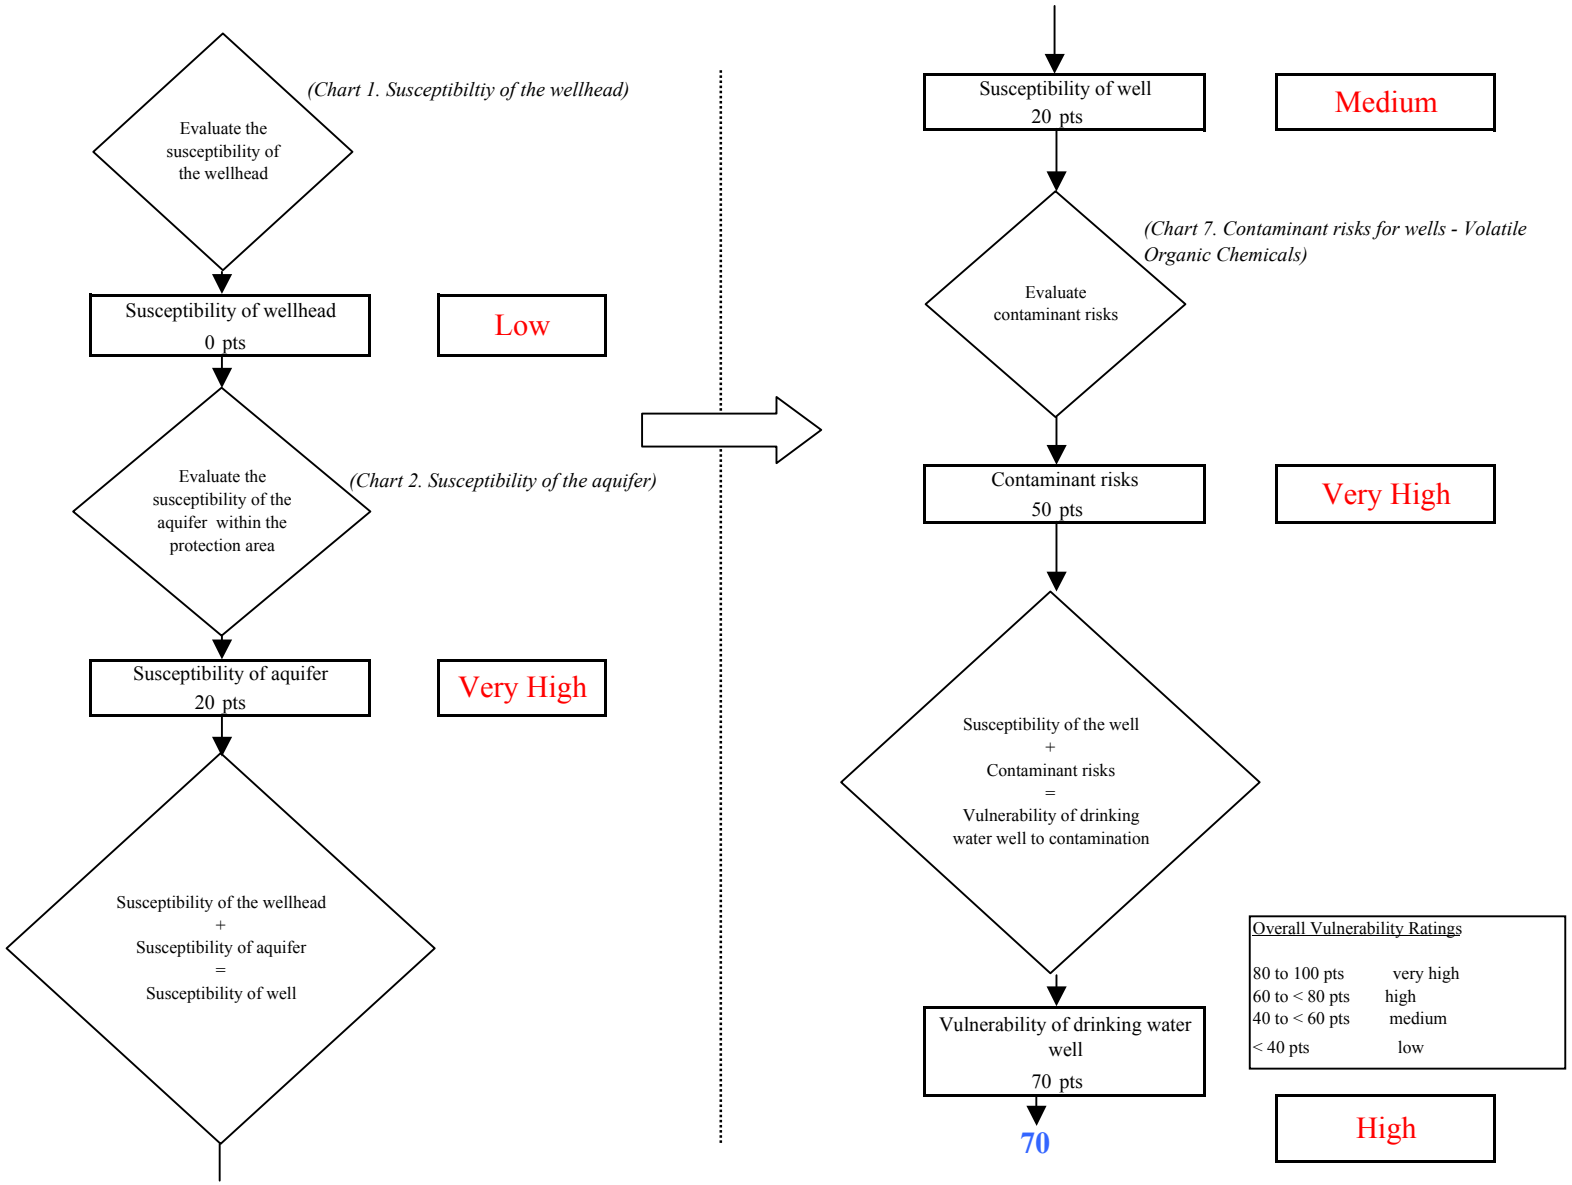
Chart 8. Vulnerability analysis for Alaska Bible College (PWS No. 292099.001) - Volatile Organic Chemicals

After combining the contaminant risk for volatile organic chemicals with the natural susceptibility of the well, the overall vulnerability of the well to contamination is **High**.
