Source Water Assessment

A Hydrogeologic Susceptibility and Vulnerability Assessment for Alaska Bible College Drinking Water System, Glennallen, Alaska

PWSID # 292099.001

DRINKING WATER PROTECTION PROGRAM REPORT 1364
Alaska Department of Environmental Conservation

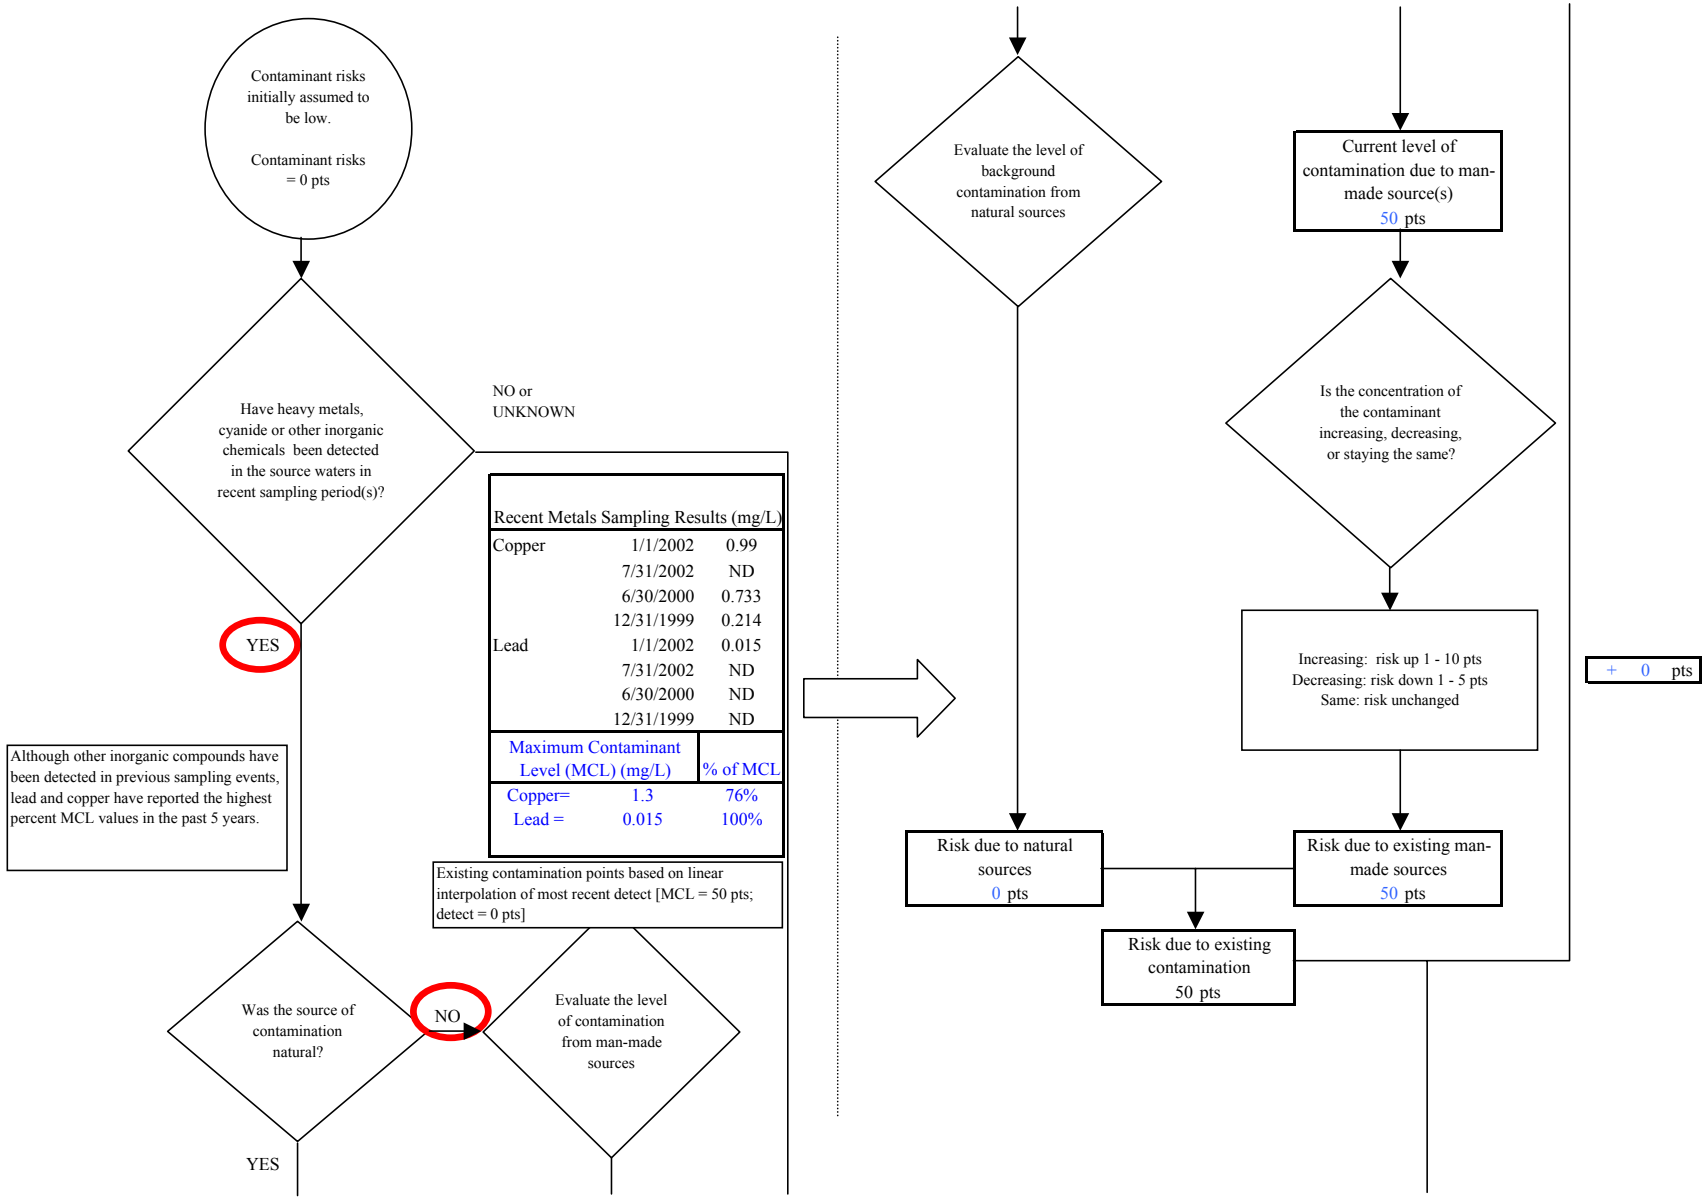
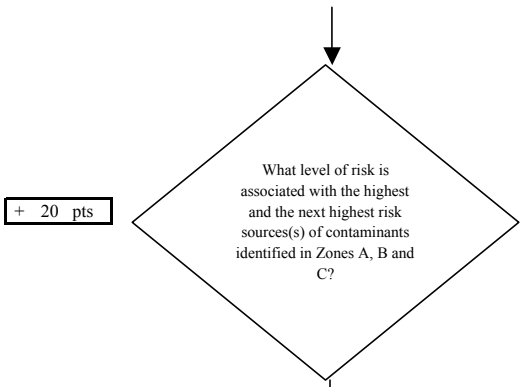
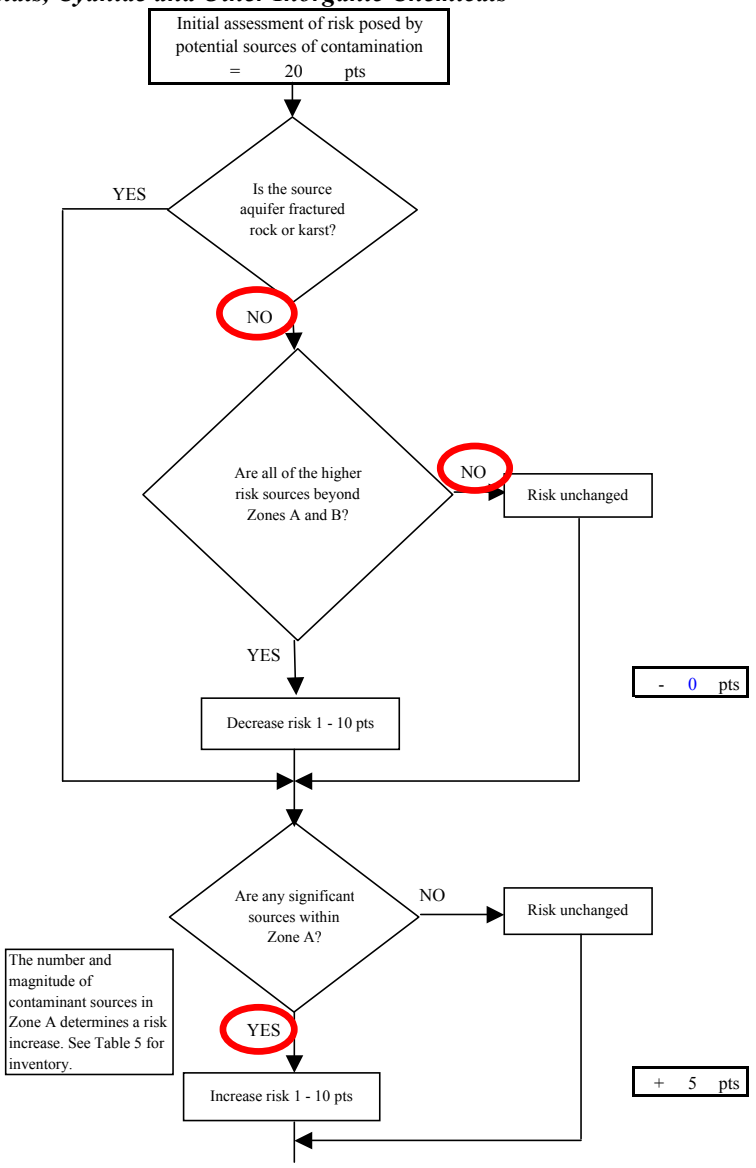
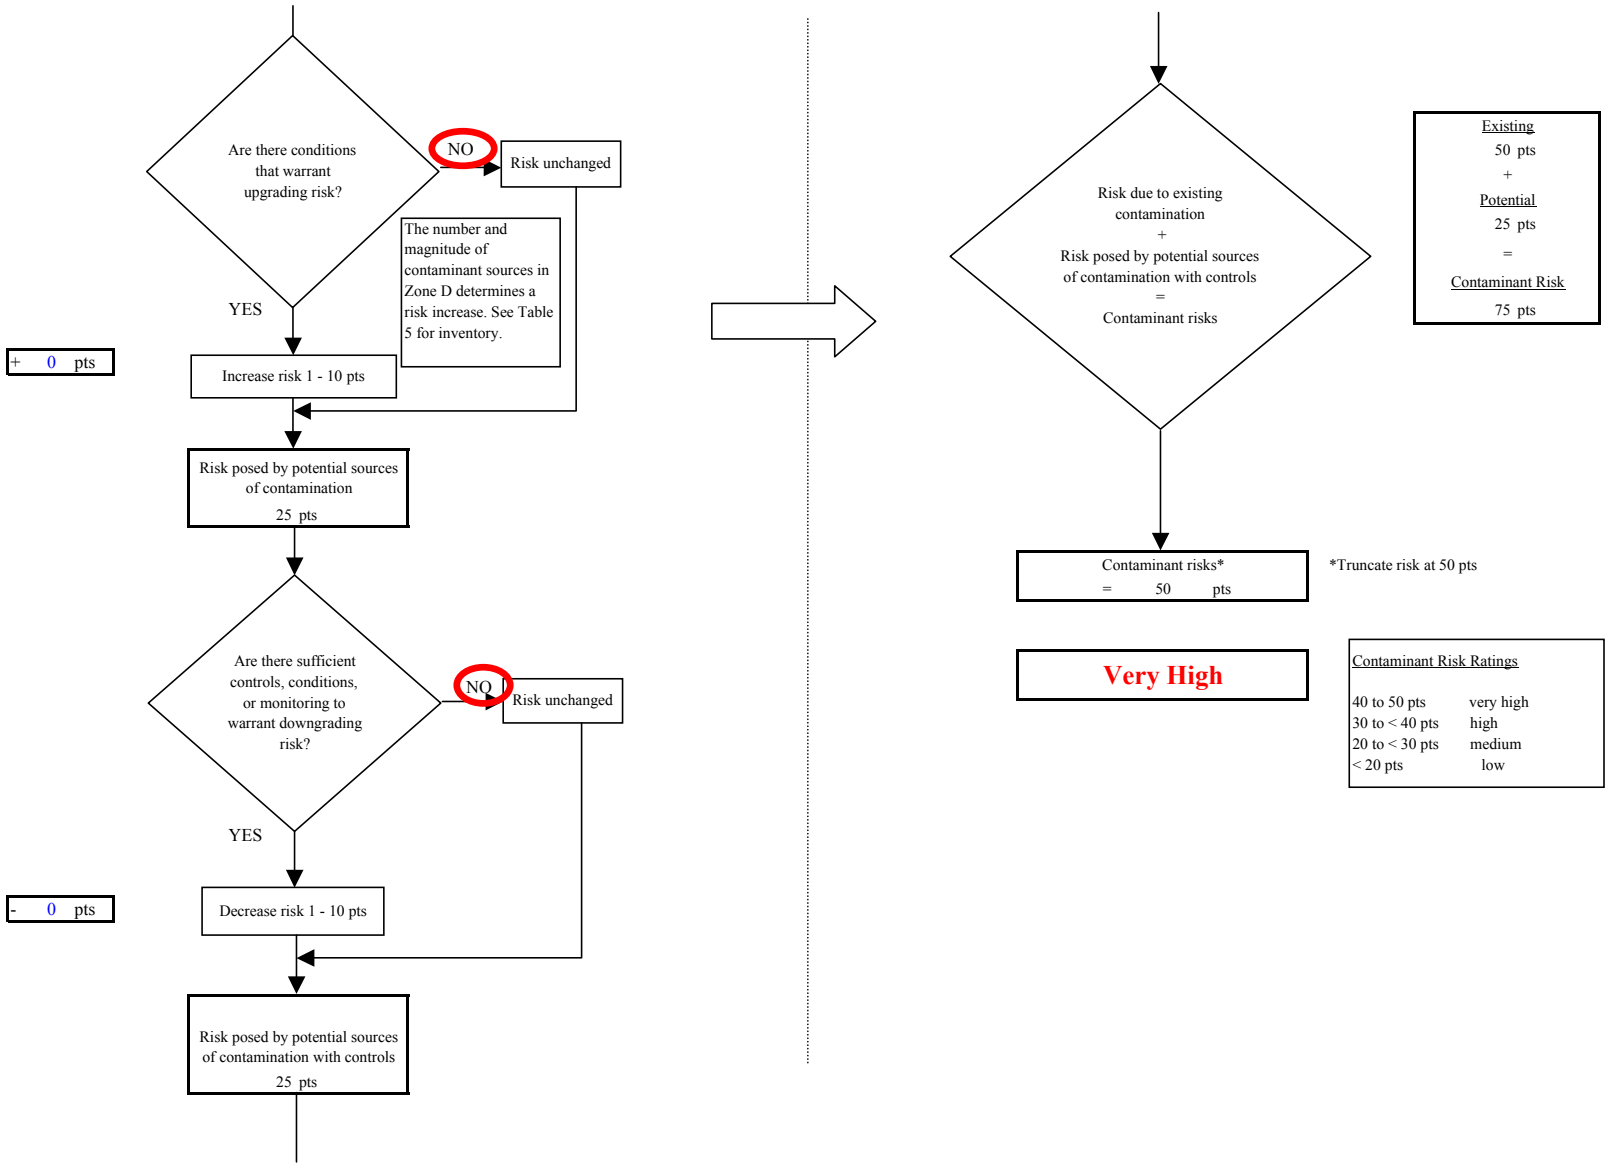
Chart 9. Contaminant risks for Alaska Bible College (PWS No. 292099.001) - Heavy Metals, Cyanide and Other Inorganic Chemicals

The contaminant risk for heavy metals, cyanide and other inorganic chemicals is **Very High**. The risk is primarily attributed to the presence electric power generation facility using fossil fuels located in Zone A (see Table 5 – Appendix B).

Based on review of recent sampling records for this public water system, high levels of copper and lead have been detected in recent sampling history, and lead has exceeded the MCL (1.3 mg/L and 0.015 mg/L, respectively) (see Chart 9 – Contaminant Risks for Heavy Metals, Cyanide, and Other Inorganic Chemicals in Appendix D).

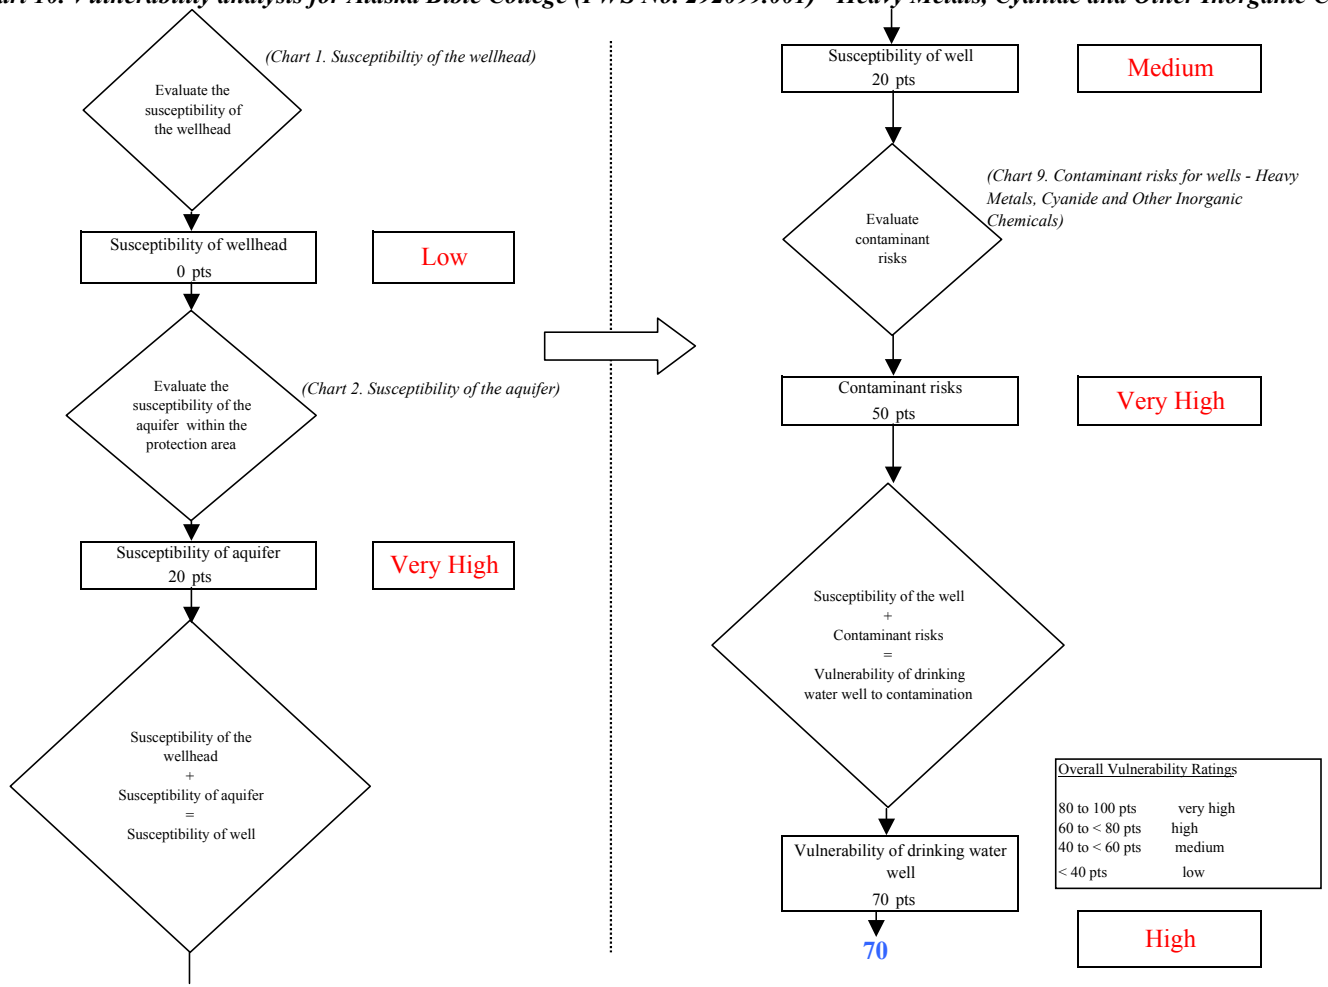
Chart 10. Vulnerability analysis for Alaska Bible College (PWS No. 292099.001) - Heavy Metals, Cyanide and Other Inorganic Chemicals

After combining the contaminant risk for heavy metals, cyanide and other inorganic chemicals with the natural susceptibility of the well, the overall vulnerability of the well to contamination is **High**.

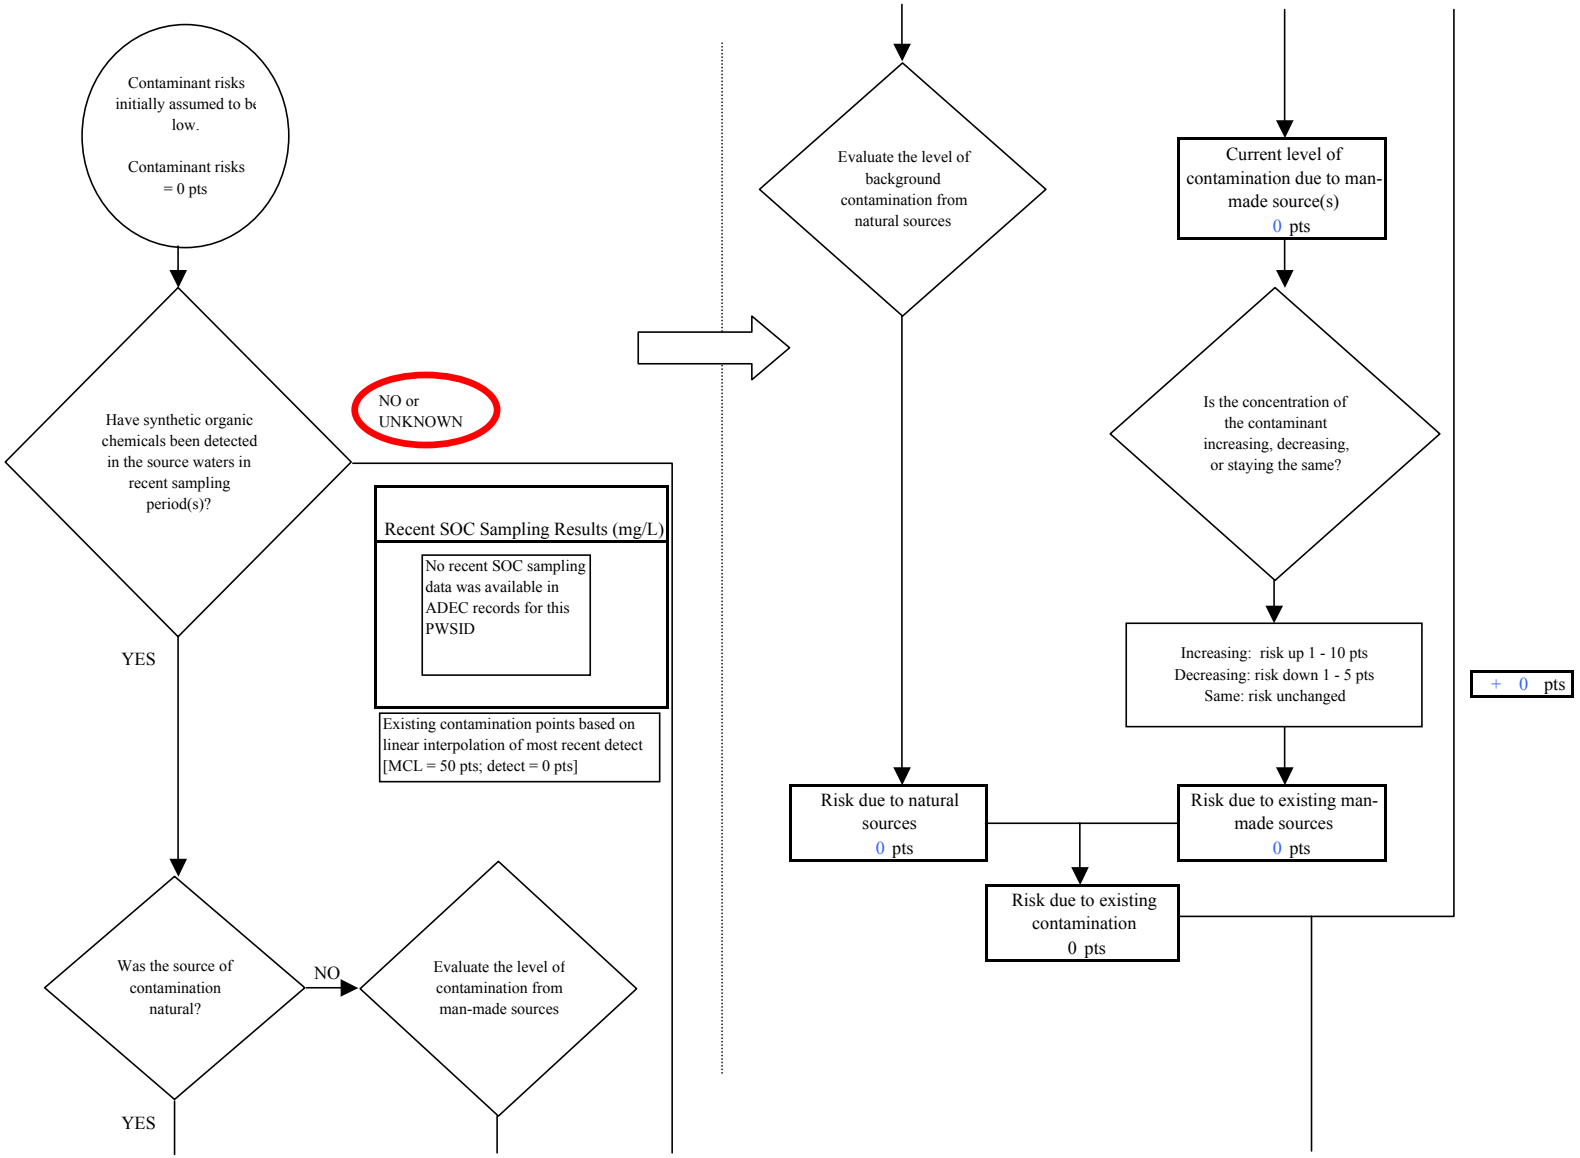
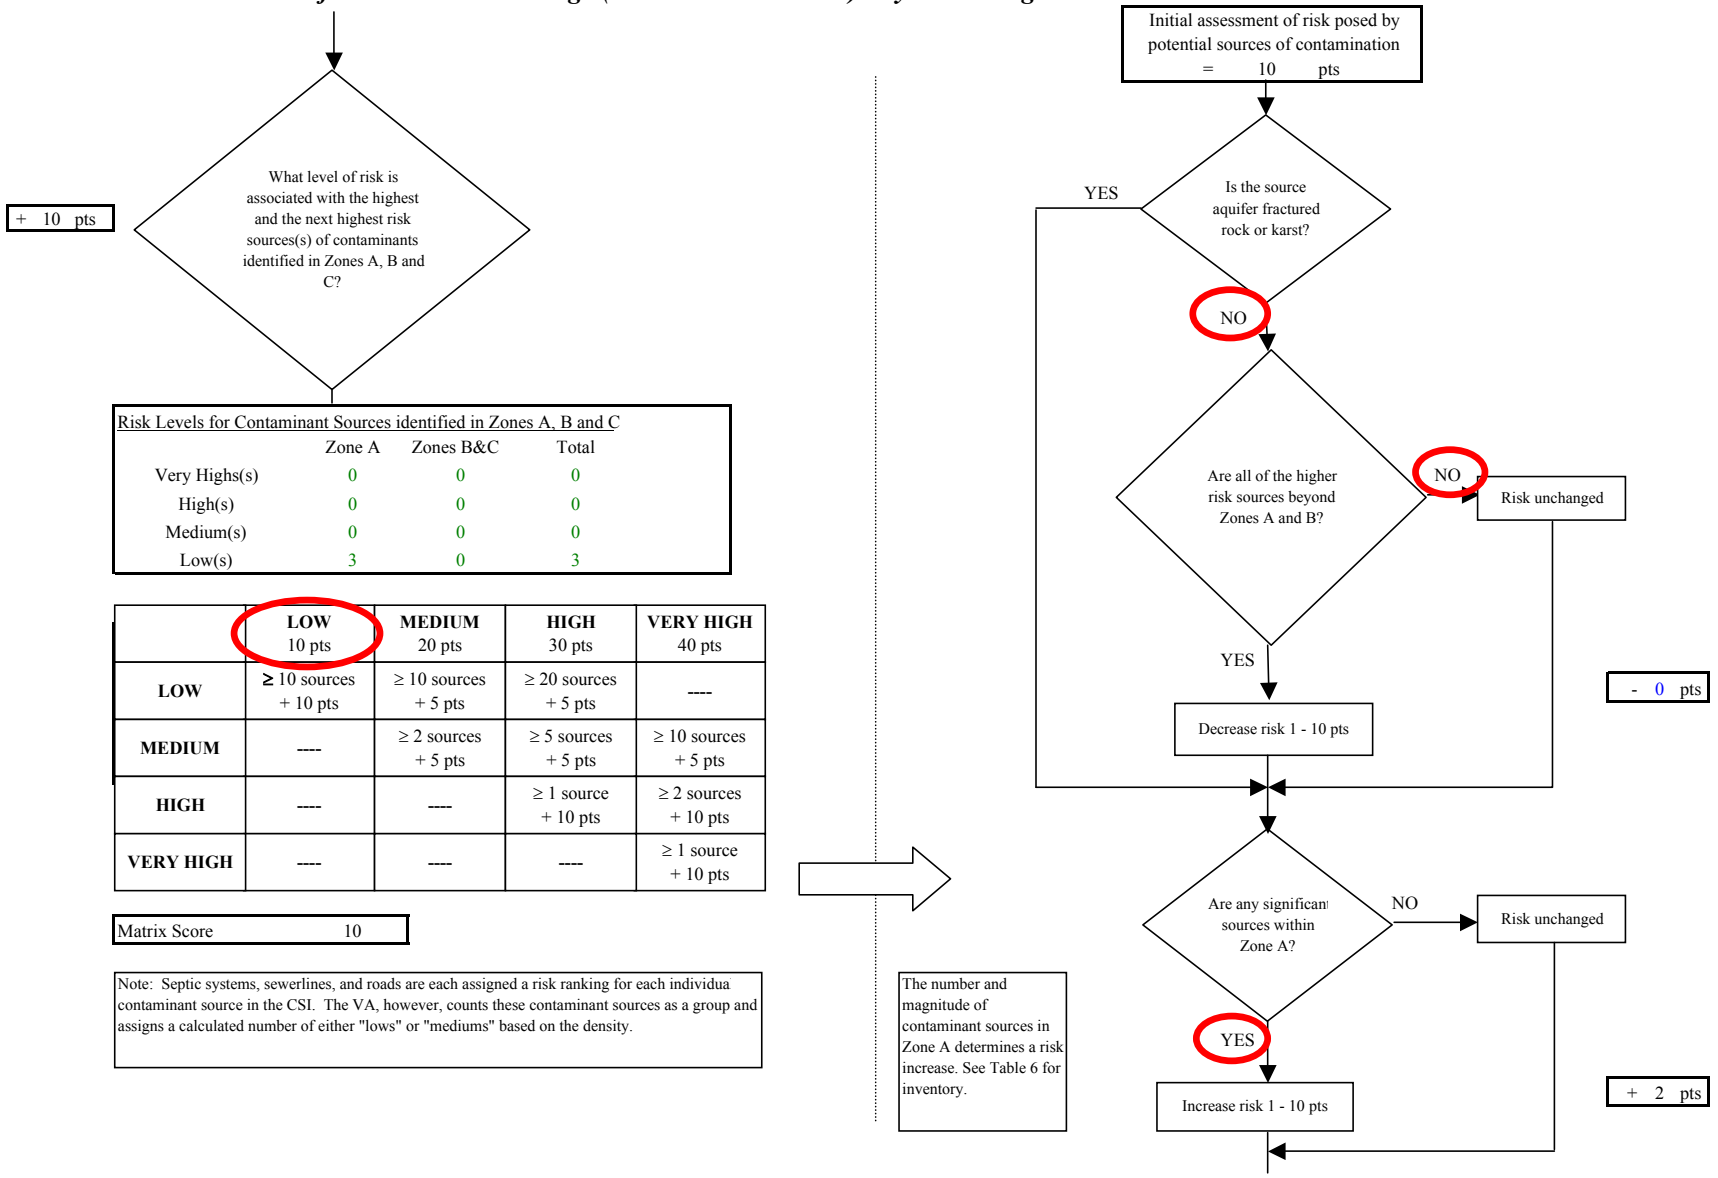
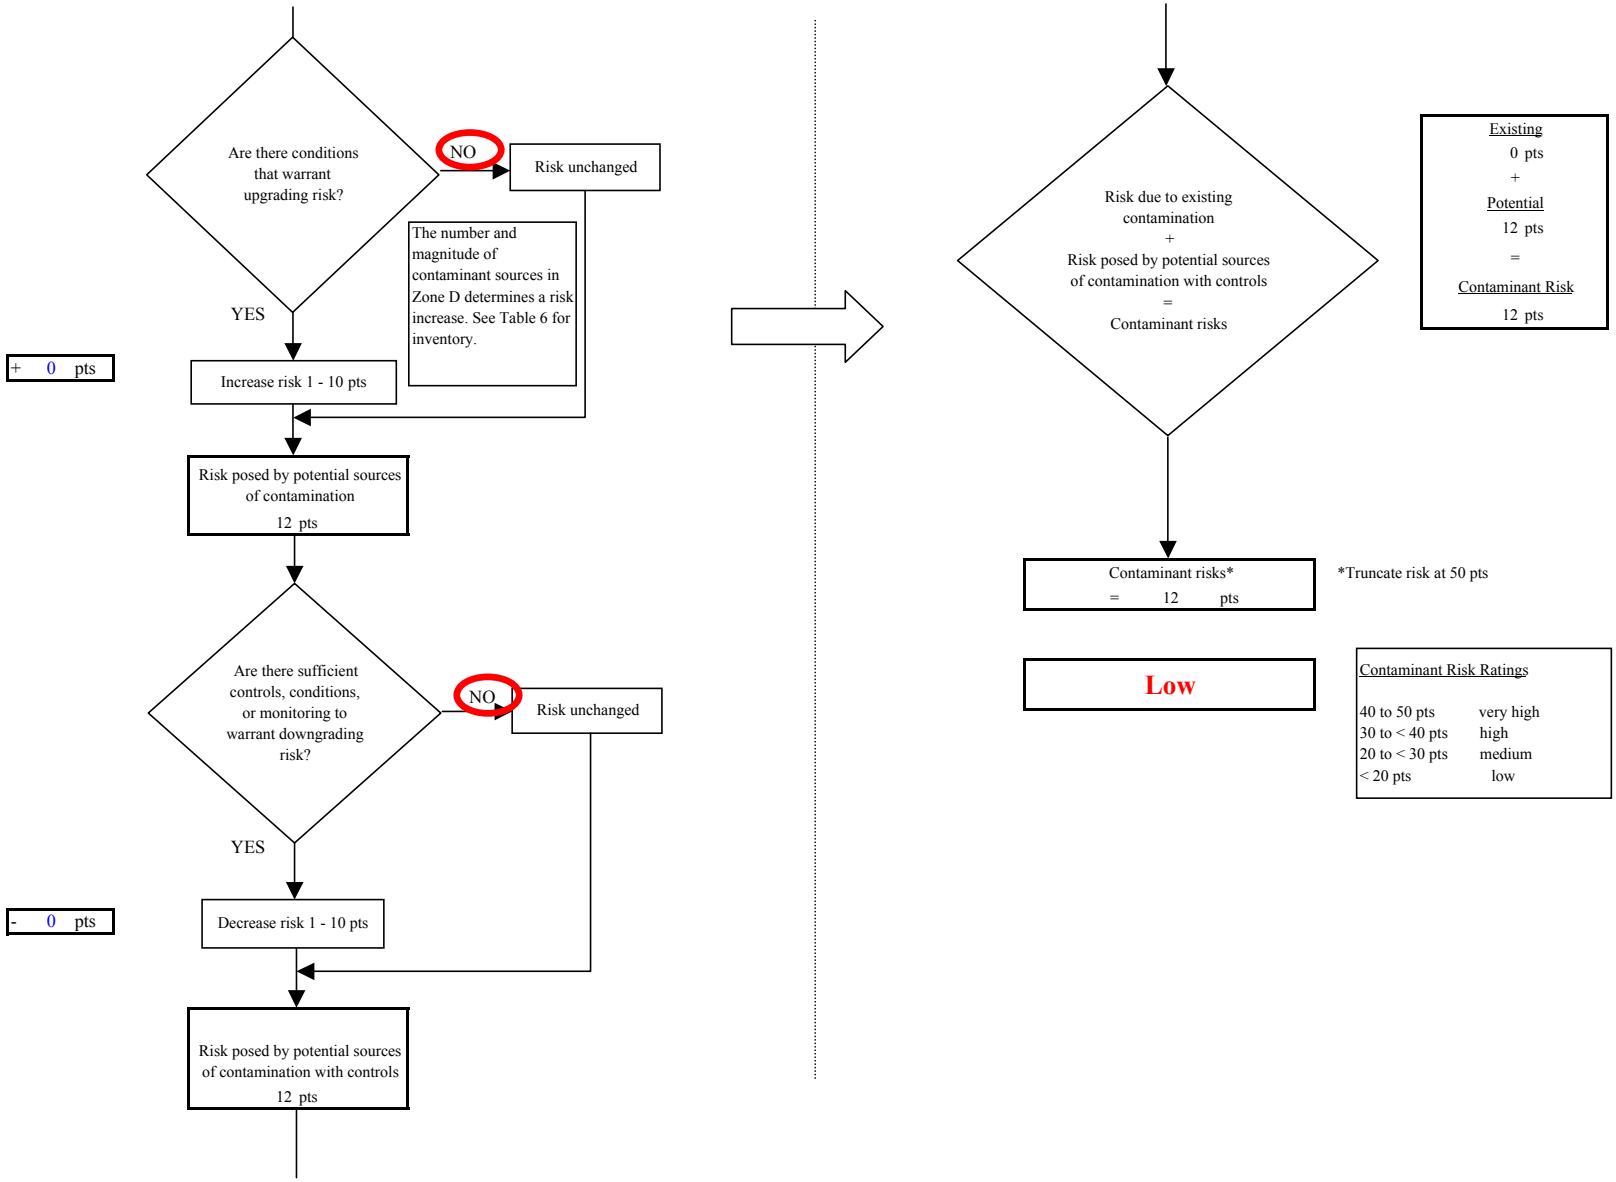
Chart 11. Contaminant risks for Alaska Bible College (PWS No. 292099.001) - Synthetic Organic Chemicals

The contaminant risk for synthetic organic chemicals is **Low**. The risk is primarily attributed to the presence of a domestic wastewater collection system in Zone A. (see Table 6 – Appendix B).

No recent sampling data was available in ADEC records for Alaska Bible College (See Chart 11 – Contaminant Risks for Synthetic Organic Chemicals in Appendix D).

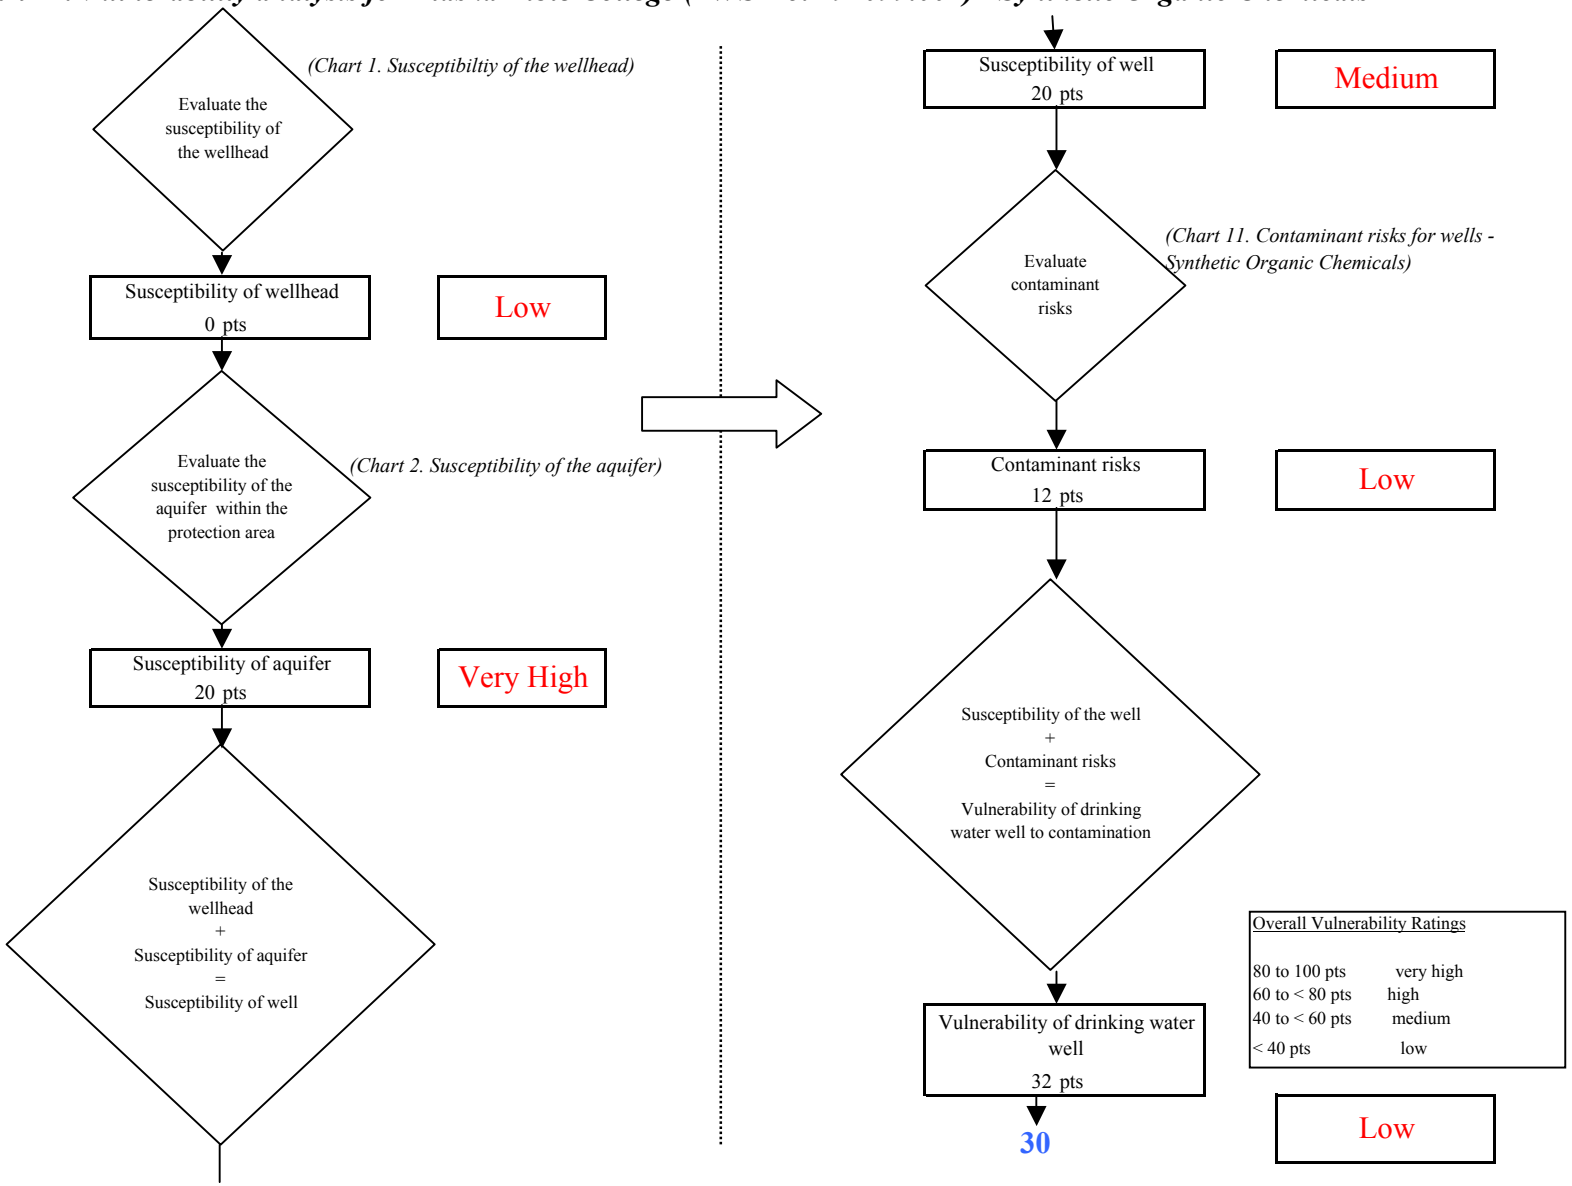
Chart 12. Vulnerability analysis for Alaska Bible College (PWS No. 292099.001) - Synthetic Organic Chemicals

After combining the contaminant risk for synthetic organic chemicals with the natural susceptibility of the well, the overall vulnerability of the well to contamination is **Low**.
