Source Water Assessment

A Hydrogeologic Susceptibility and Vulnerability Assessment for Homeshore Cafe Public Drinking Water System, Gustavus, Alaska PWSID # 111560.001

DRINKING WATER PROTECTION REPORT 1605

Alaska Department of Environmental Conservation

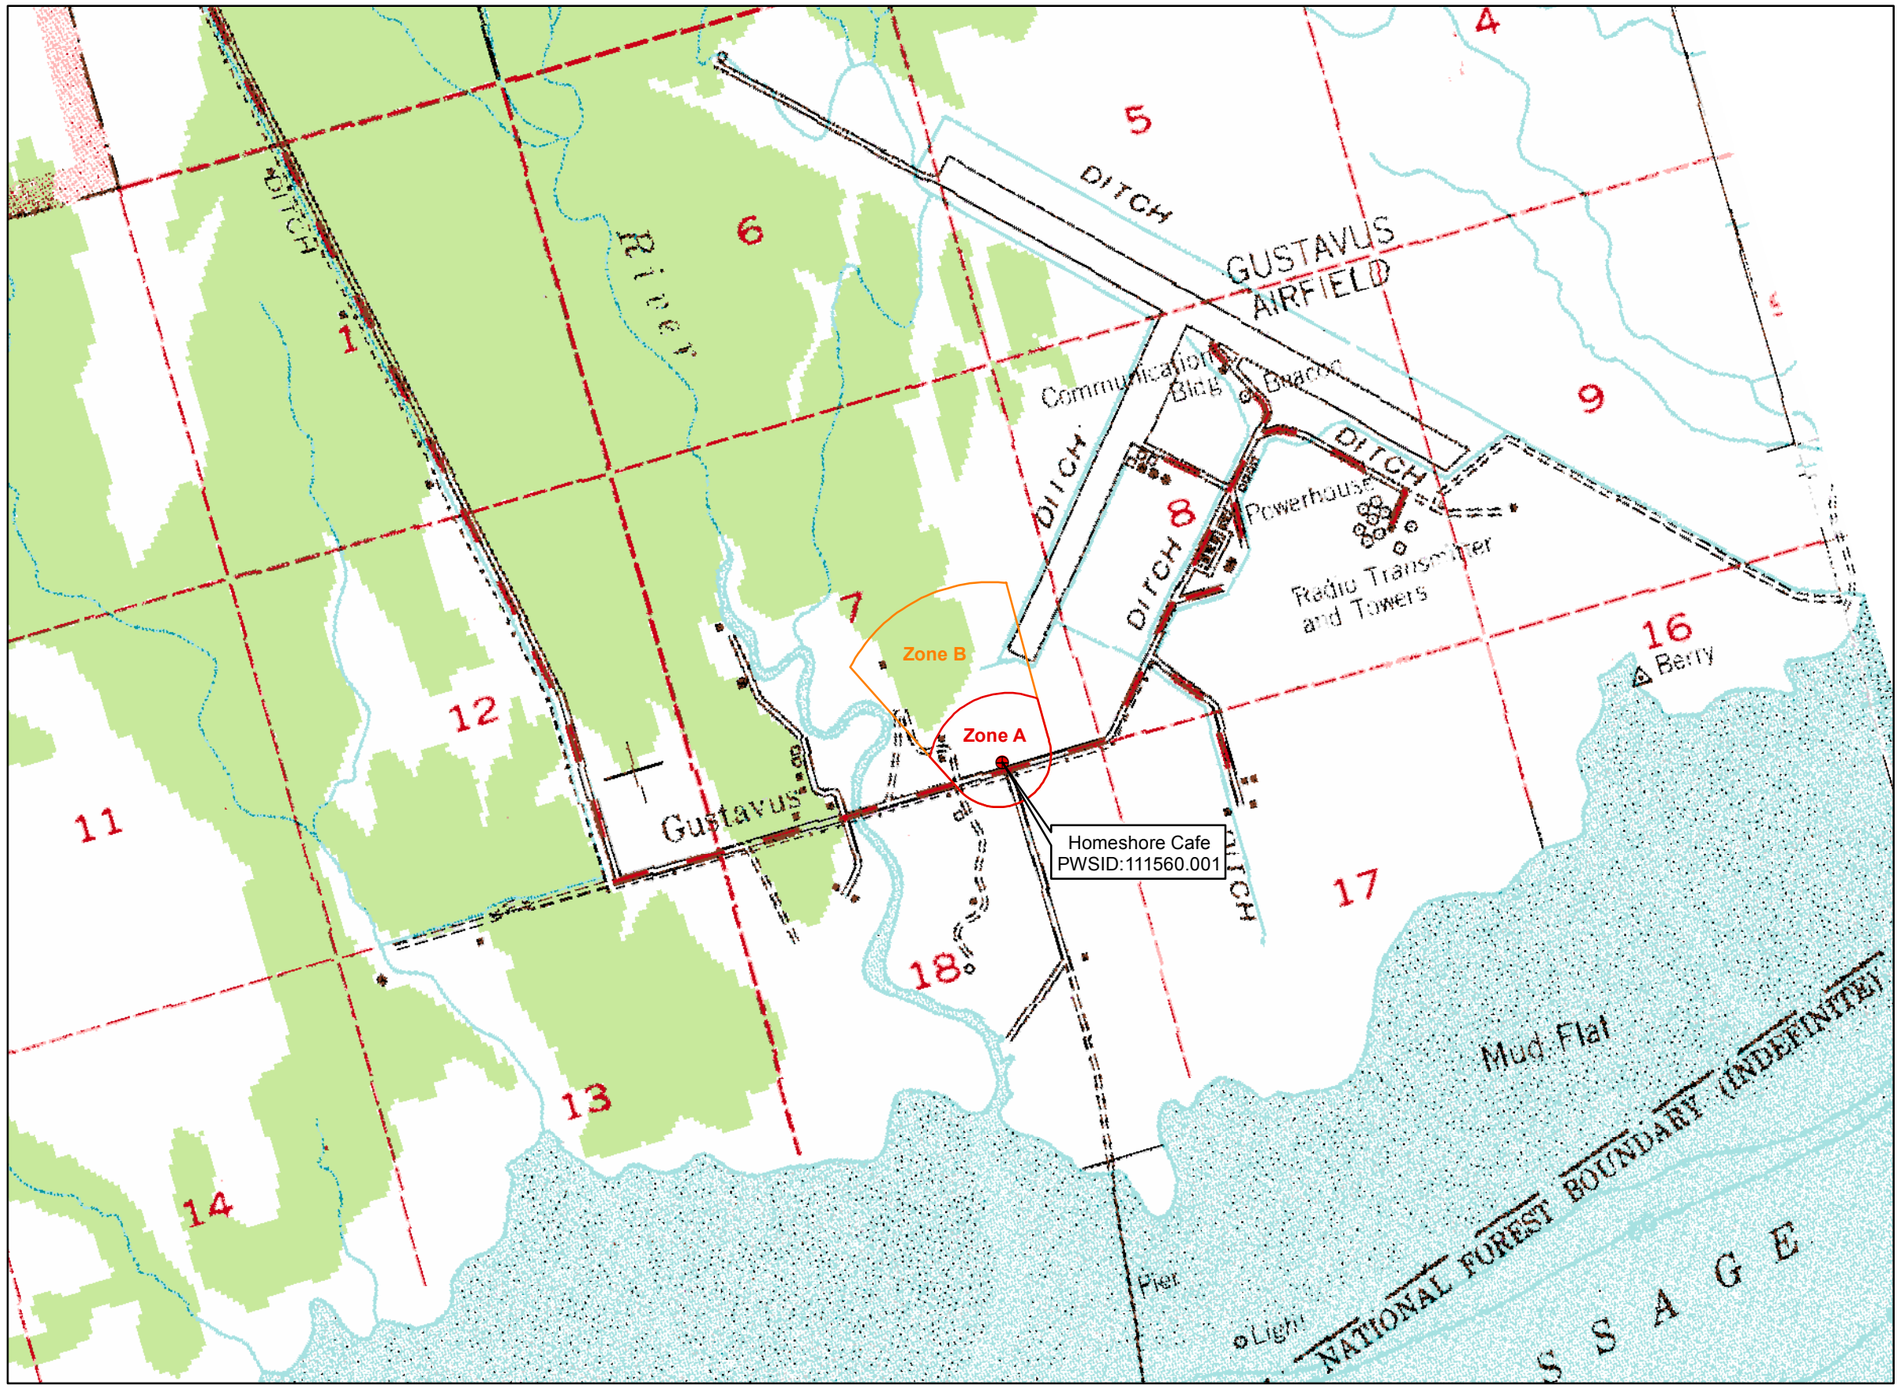
Appendix A Map A

The drinking water protection area for Homeshore Cafe was determined using an analytical calculation and includes Zones A and B (see Map A of Appendix A).

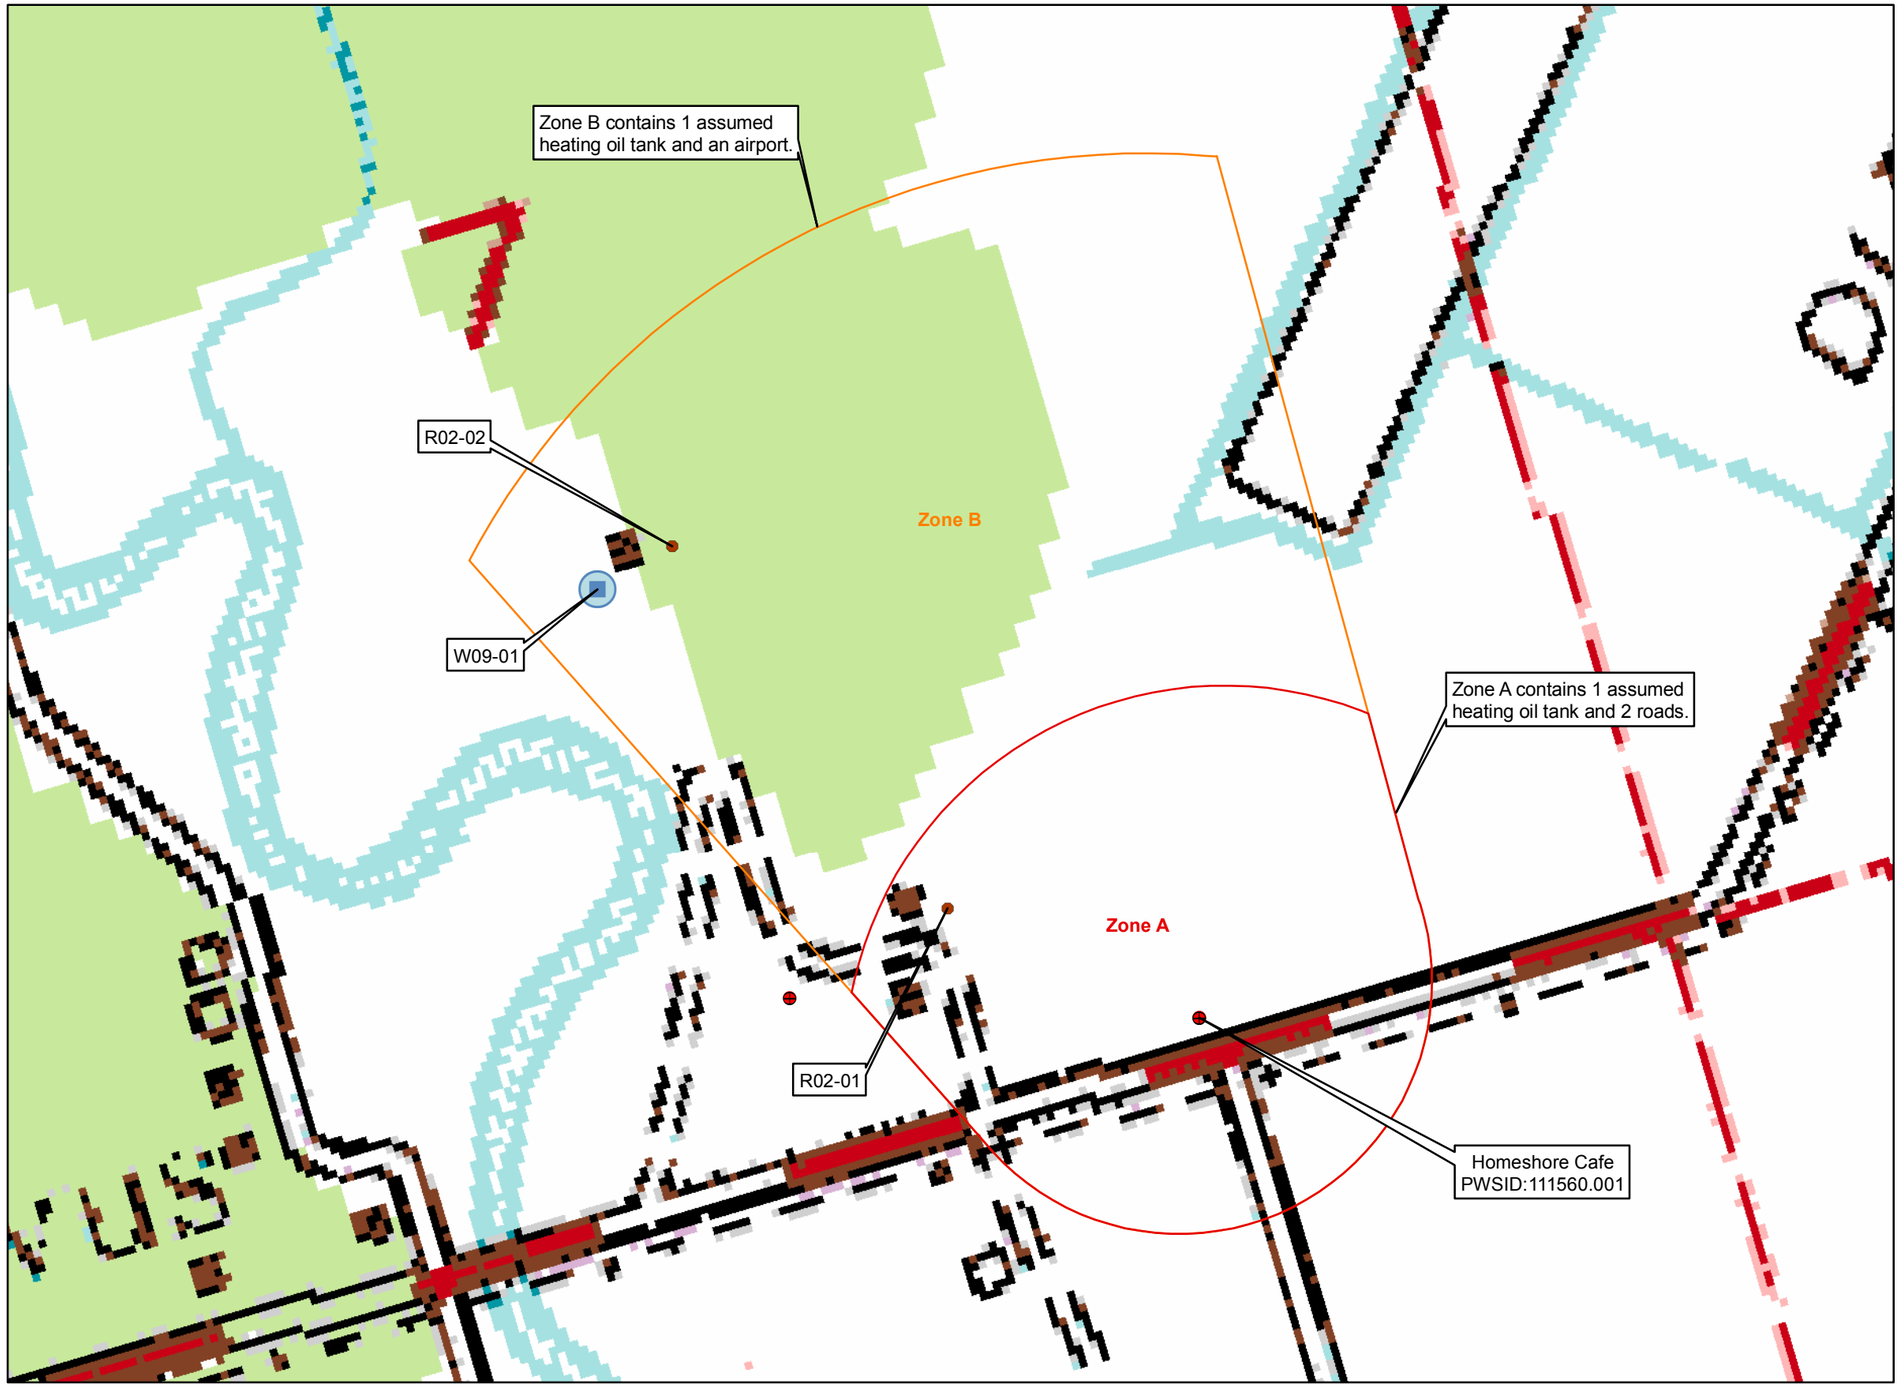
Appendix C Map C

The sources are displayed on Map C of Appendix C and summarized in Table 1 of Appendix B.

The contaminant risk for volatile organic chemicals is **High** with the septic systems, heating oil tanks, roads, and airport contributing to the risk to the drinking water well.
