A Hydrogeologic Susceptibility and Vulnerability Assessment for Stampede Lodge Drinking Water System, Healy, Alaska PWSID # 391118

DRINKING WATER PROTECTION PROGRAM REPORT # 316
Alaska Department of Environmental Conservation

By Ecology & Environment, Inc.

August 2002

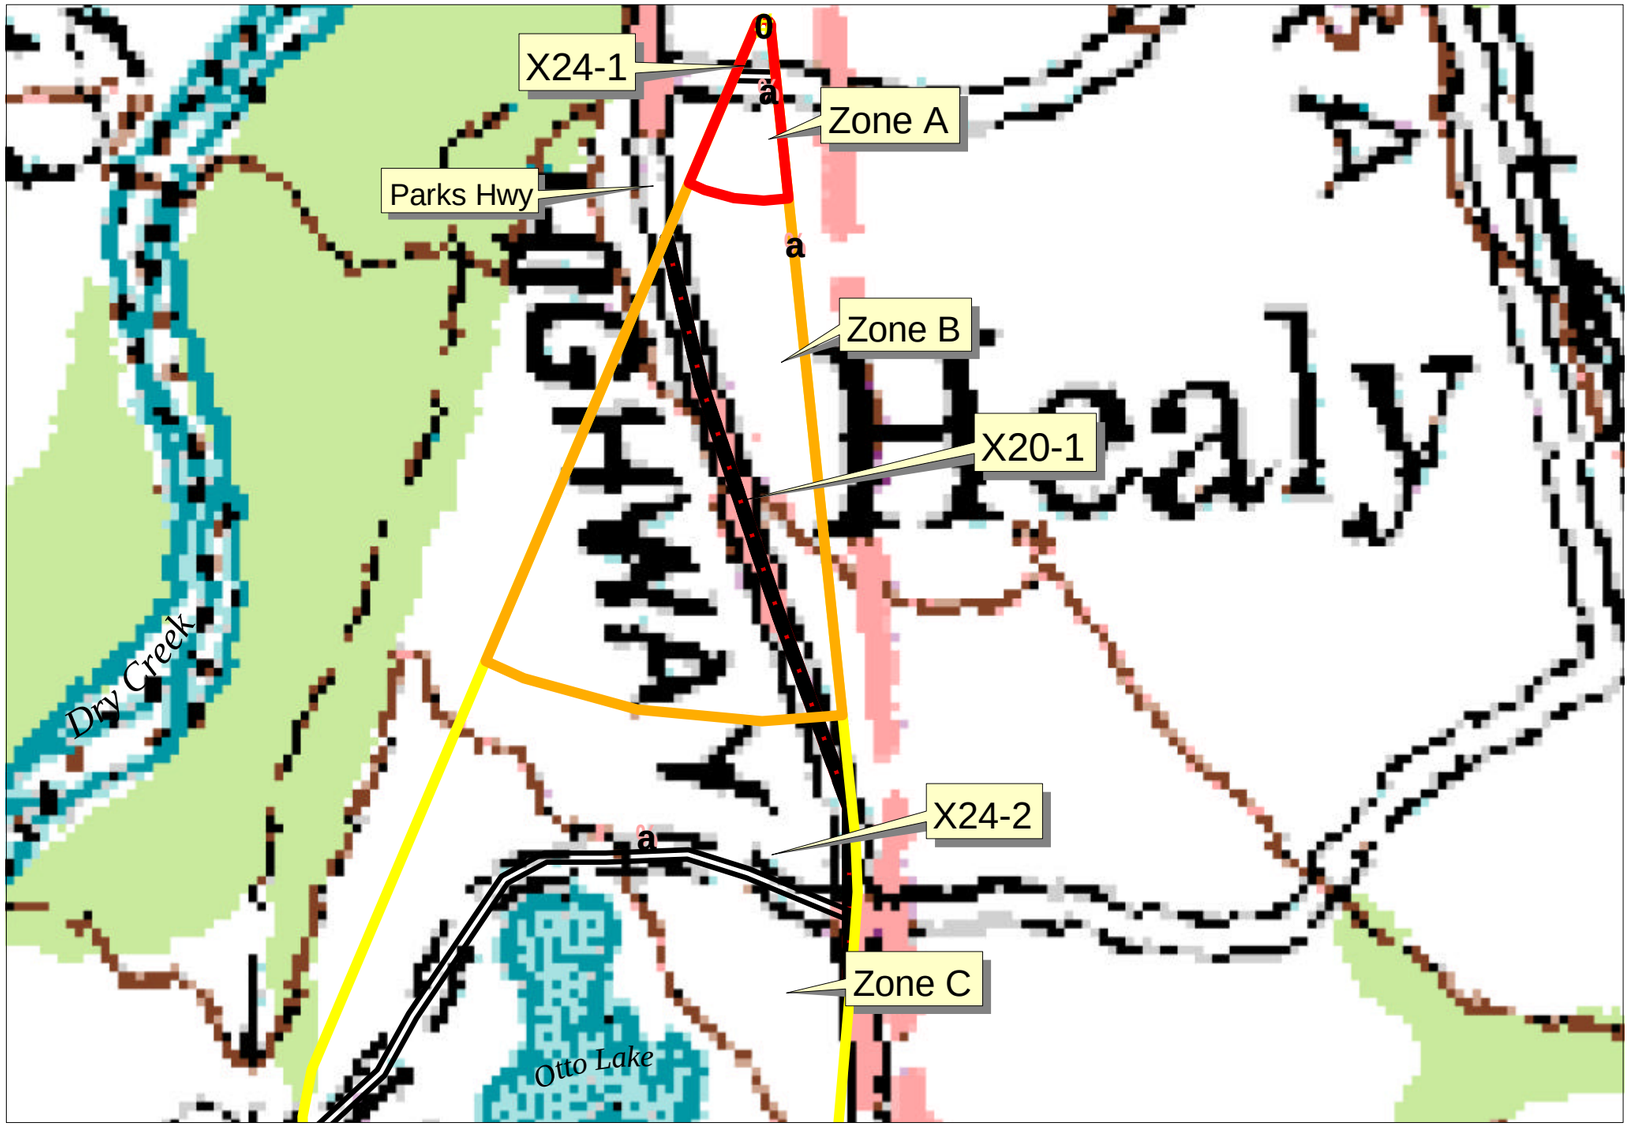
Map 2

Stampede Lodge is a Class B (transient/non-community) water system consisting of one well in Healy, Alaska. Identified potential and current sources of contaminants for Stampede Lodge public drinking water source include: paved and gravel roads. These identified potential and existing sources of contamination are considered sources of bacteria and viruses, nitrates and/or nitrites, and volatile organic chemicals. Overall, the public water sources for Stampede Lodge received a vulnerability rating of **Medium** for bacteria and viruses, **Medium** fornitrates and nitrites, and **Medium** for volatile organic chemicals.

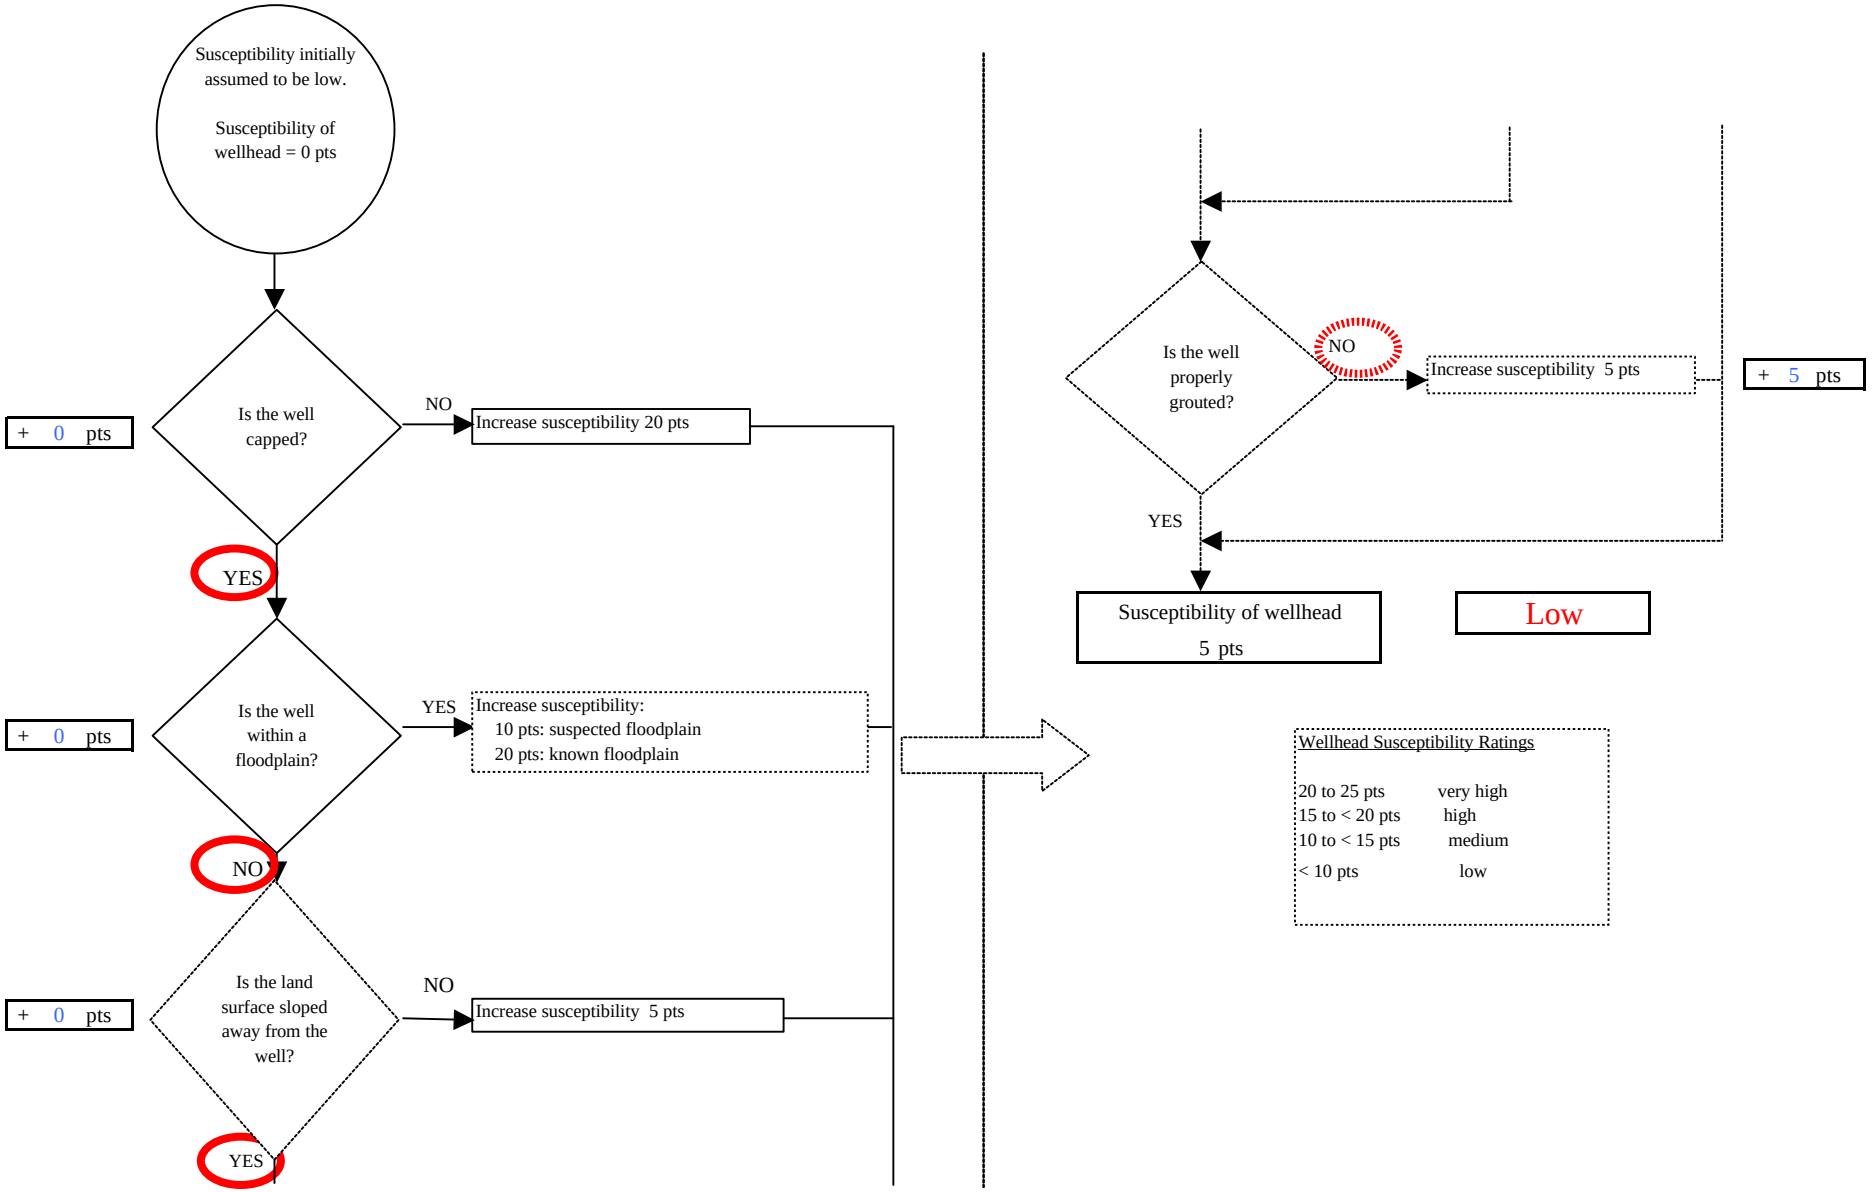
Chart 1. Susceptibility of the wellhead - Stampede Lodge

Score	Rating
Susceptibility of the Wellhead	5	Low
Susceptibility of the Aquifer	25	Very High
Natural Susceptibility	30	High

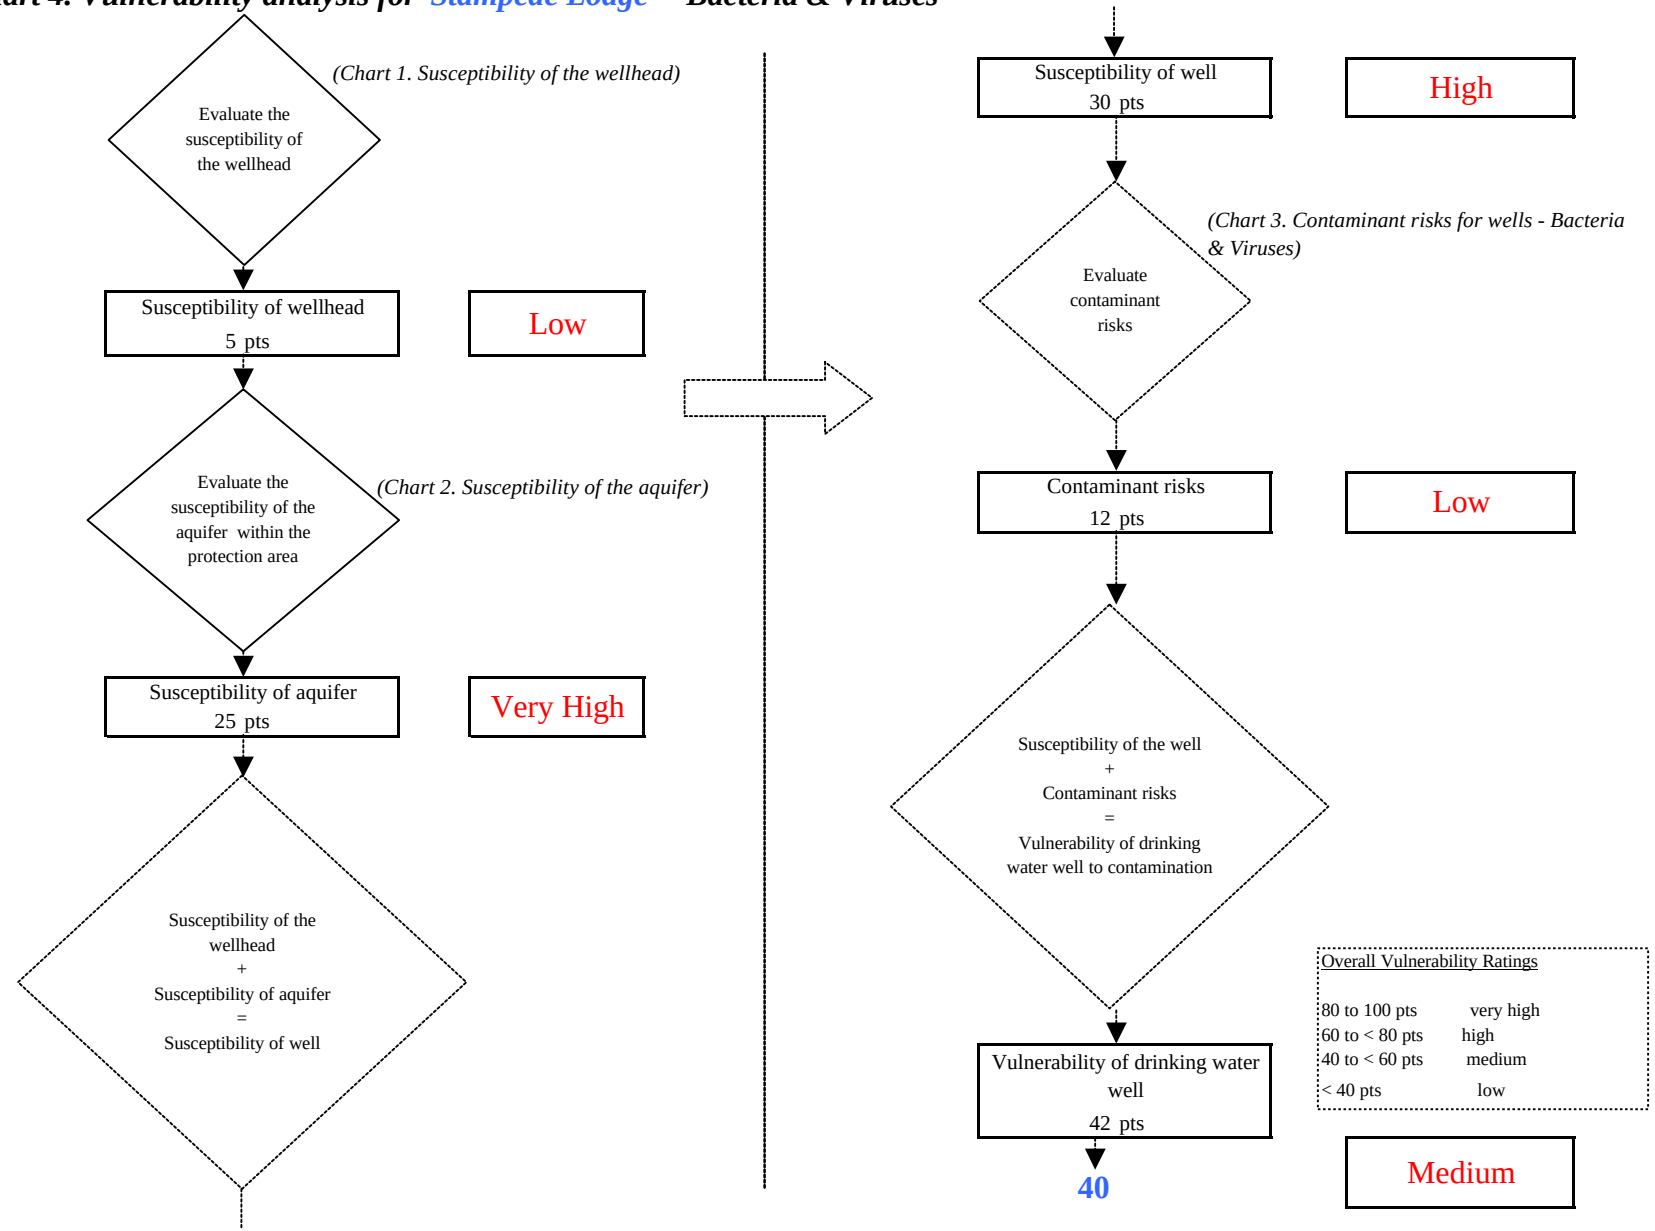
Chart 4. Vulnerability analysis for Stampede Lodge - Bacteria & Viruses

Category	Score	Rating
Bacteria and Viruses	40	Medium
Nitrates and Nitrites	45	Medium
Volatile Organic Chemicals	40	Medium

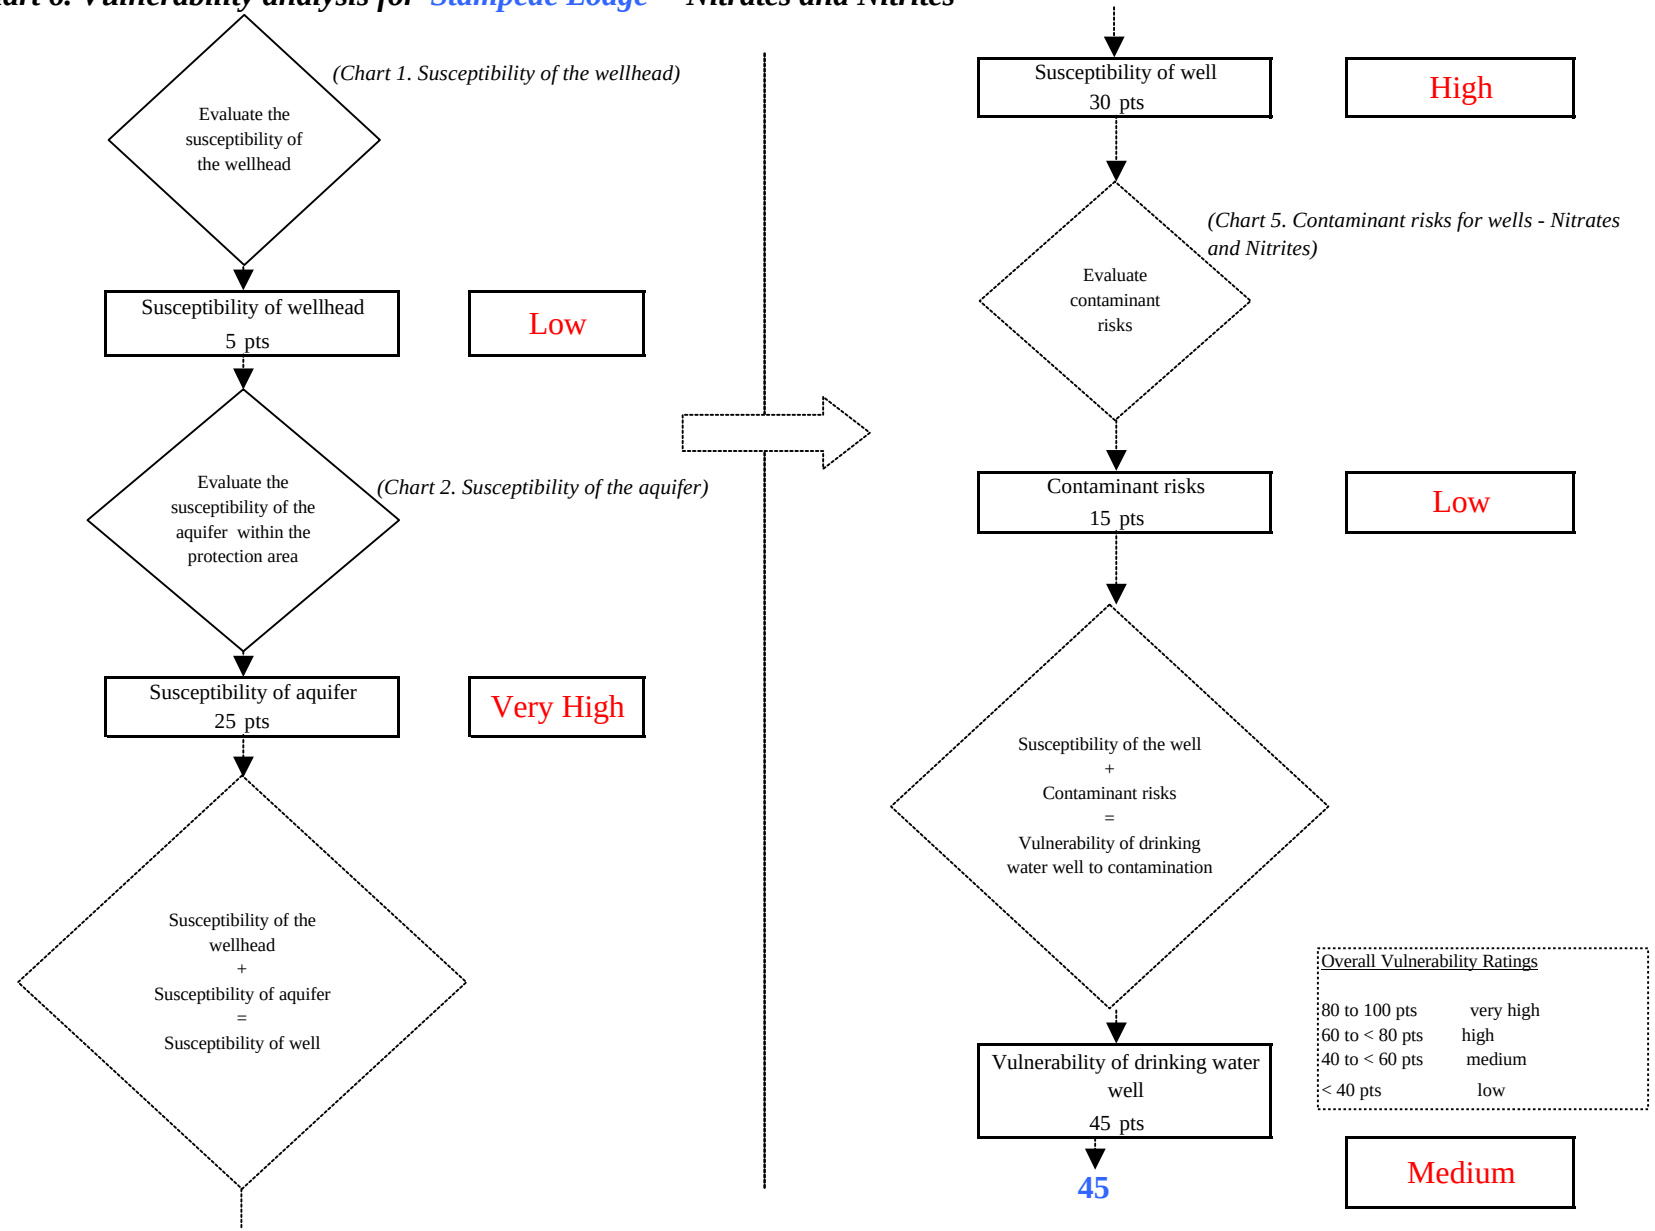
Chart 6. Vulnerability analysis for Stampede Lodge - Nitrates and Nitrites

The sampling history for Stampede Lodge well indicates that nitrates and/or nitrites are found in natural background concentration at this site, as elsewhere throughout Alaska. Nitrate concentrations in uncontaminated groundwater are typically less than 2 milligrams per liter (mg/L) and are derived primarily from the decomposition of organic matter in soils [Wang, Strelakos, Jokela, 2000]. Existing nitrate concentration in Stampede Lodge well is approximately 0.6 mg/L or 6% of the Maximum Contaminant Level (MCL) of 10mg/L. The MCL is the maximum level of contaminant that is allowed to exist in drinking water and still be consumed by humans without harmful health effects. Due to the high solubility and weak retention by soil, nitrates are very mobile, moving at approximately the same rate as water. Though existing nitrate contamination was detected at the site, concentrations remain at safe levels with respect to human health (See Chart 5 - Contaminant Risks for Nitrates and/or Nitrites in Appendix D).
