Source Water Assessment

A Hydrogeologic Susceptibility and Vulnerability Assessment for Kennicott Glacier Lodge - Well #2 Public Drinking Water System, McCarthy Area, Alaska PWSID # 292241.003

DRINKING WATER PROTECTION REPORT 1768

Alaska Department of Environmental Conservation

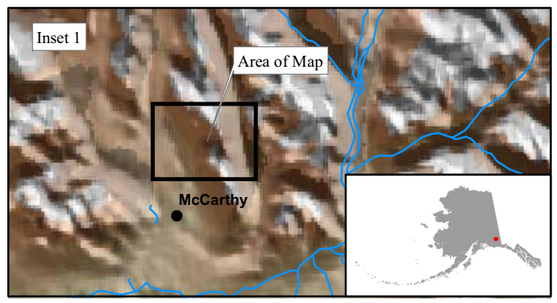
Appendix A Map A

The drinking water protection area for Kennicott Glacier Lodge - Well #2 was determined using an analytical calculation and includes Zones A and B (see Map A in Appendix A).

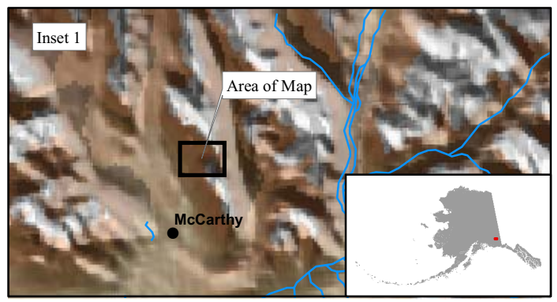
Appendix C Map C

The sources are displayed on Map C of Appendix C and summarized in Table 1 of Appendix B.

Contaminant Source Type	*Contaminant Source ID*	*CS ID tag*	*Zone*	*Map Number*	*Comments*
Municipal or city parks (with green areas)	X04	X04	A	C	Wrangell - St Elias National Park
