Source Water Assessment

A Hydrogeologic Susceptibility and Vulnerability Assessment for Leader Creek Inn Public Drinking Water System, Naknek, Alaska PWSID # 261402.001

DRINKING WATER PROTECTION REPORT 1756

January, 2009

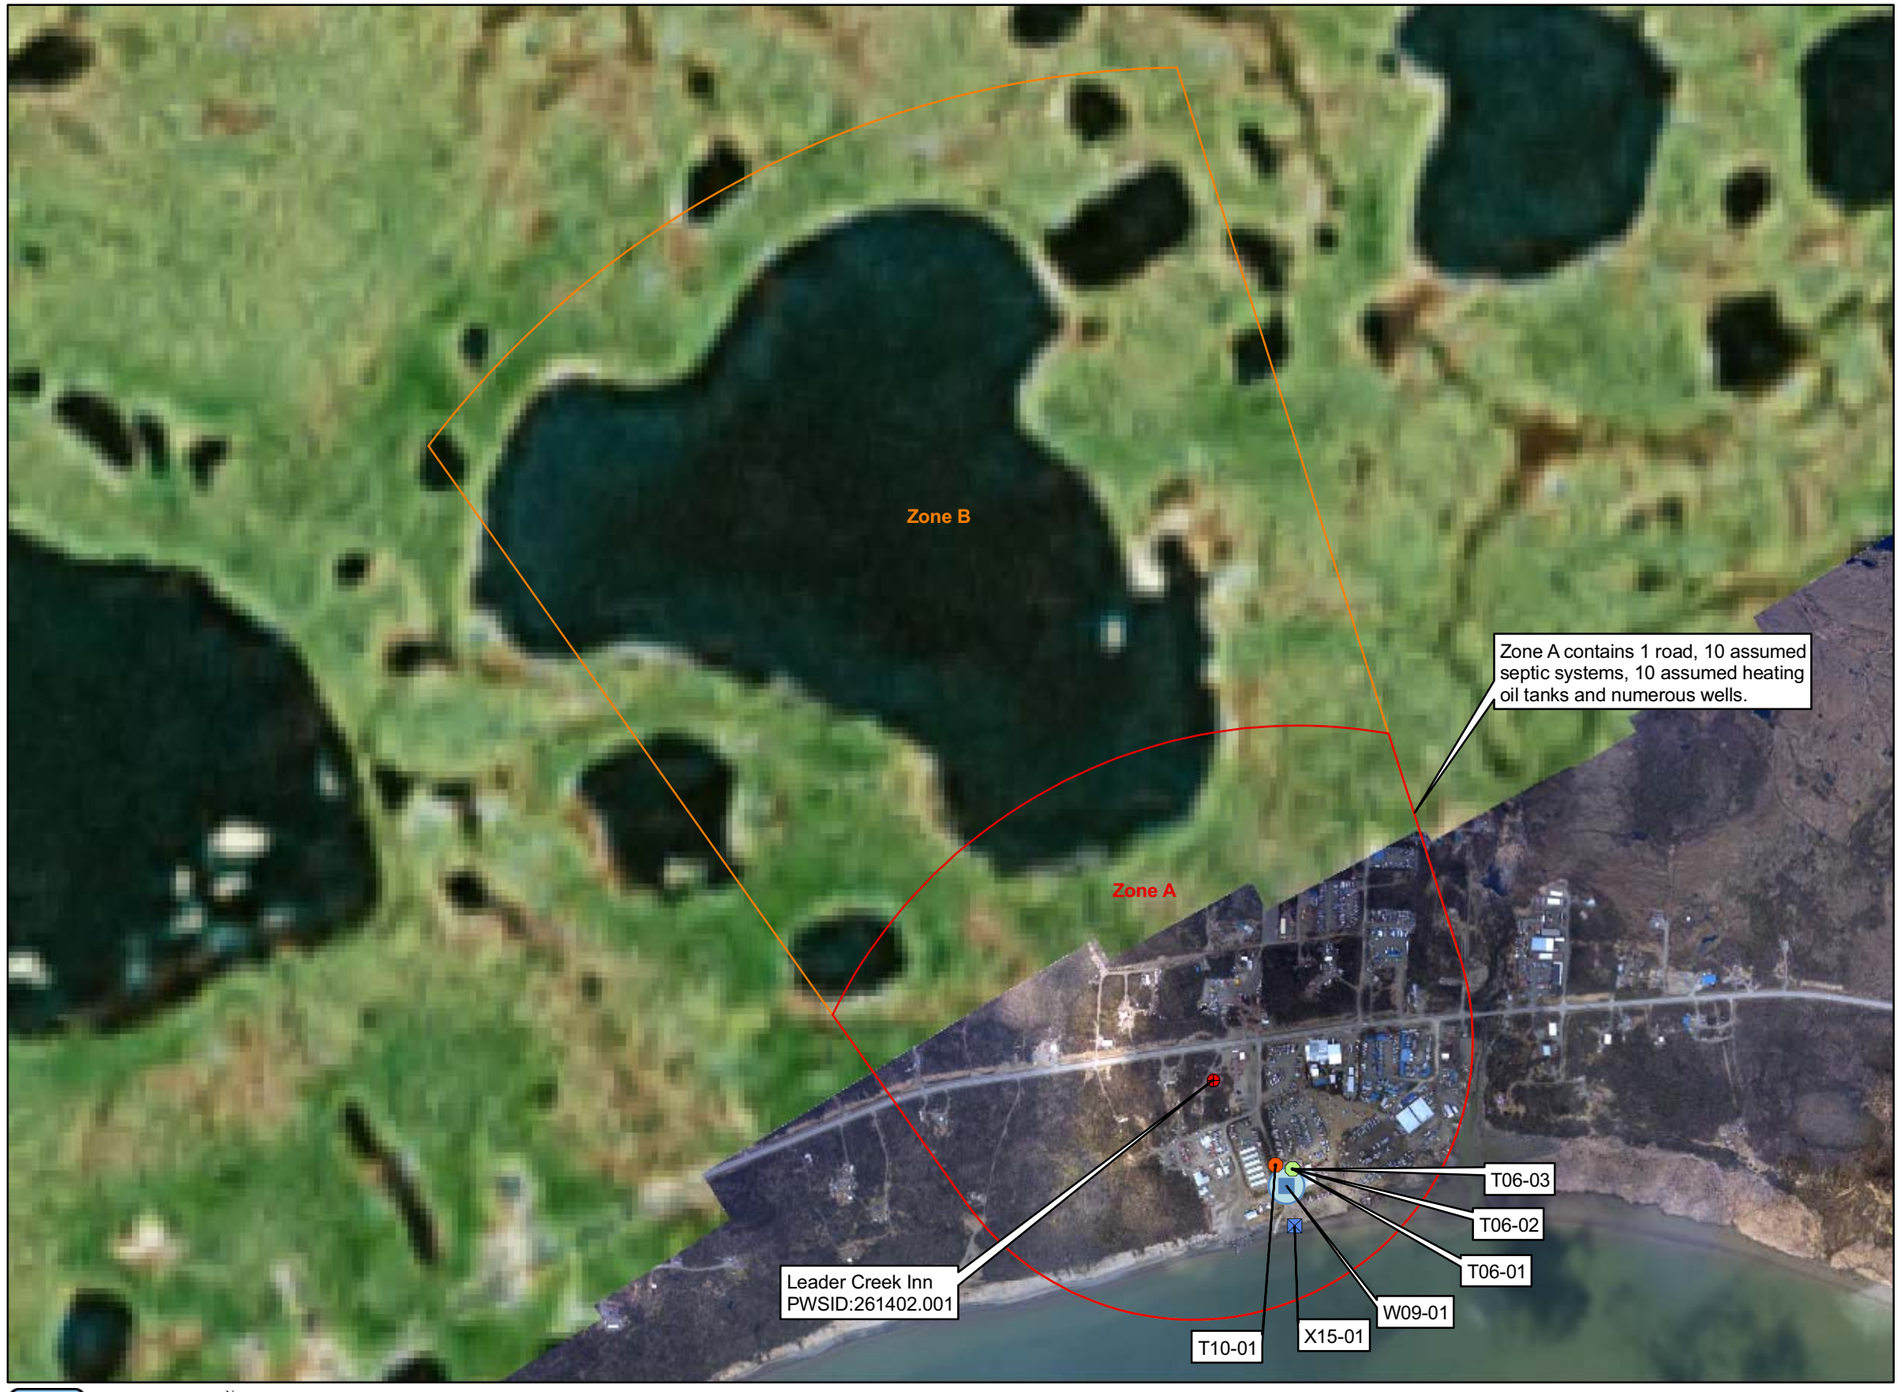
Appendix C Map C

The sources are displayed on Map C of Appendix C and summarized in Table 1 of Appendix B.

The contaminant risk for volatile organic chemicals is **High** with septic systems, heating oil tanks, a road, gasoline and diesel tanks, and a boat yard contributing to the risk to the drinking water well.
