Source Water Assessment for Best View RV and Trailer Park

A Hydrogeologic Susceptibility and Vulnerability Assessment

DRINKING WATER PROTECTION PROGRAM REPORT 404
PWSID 222246.001

March 2002

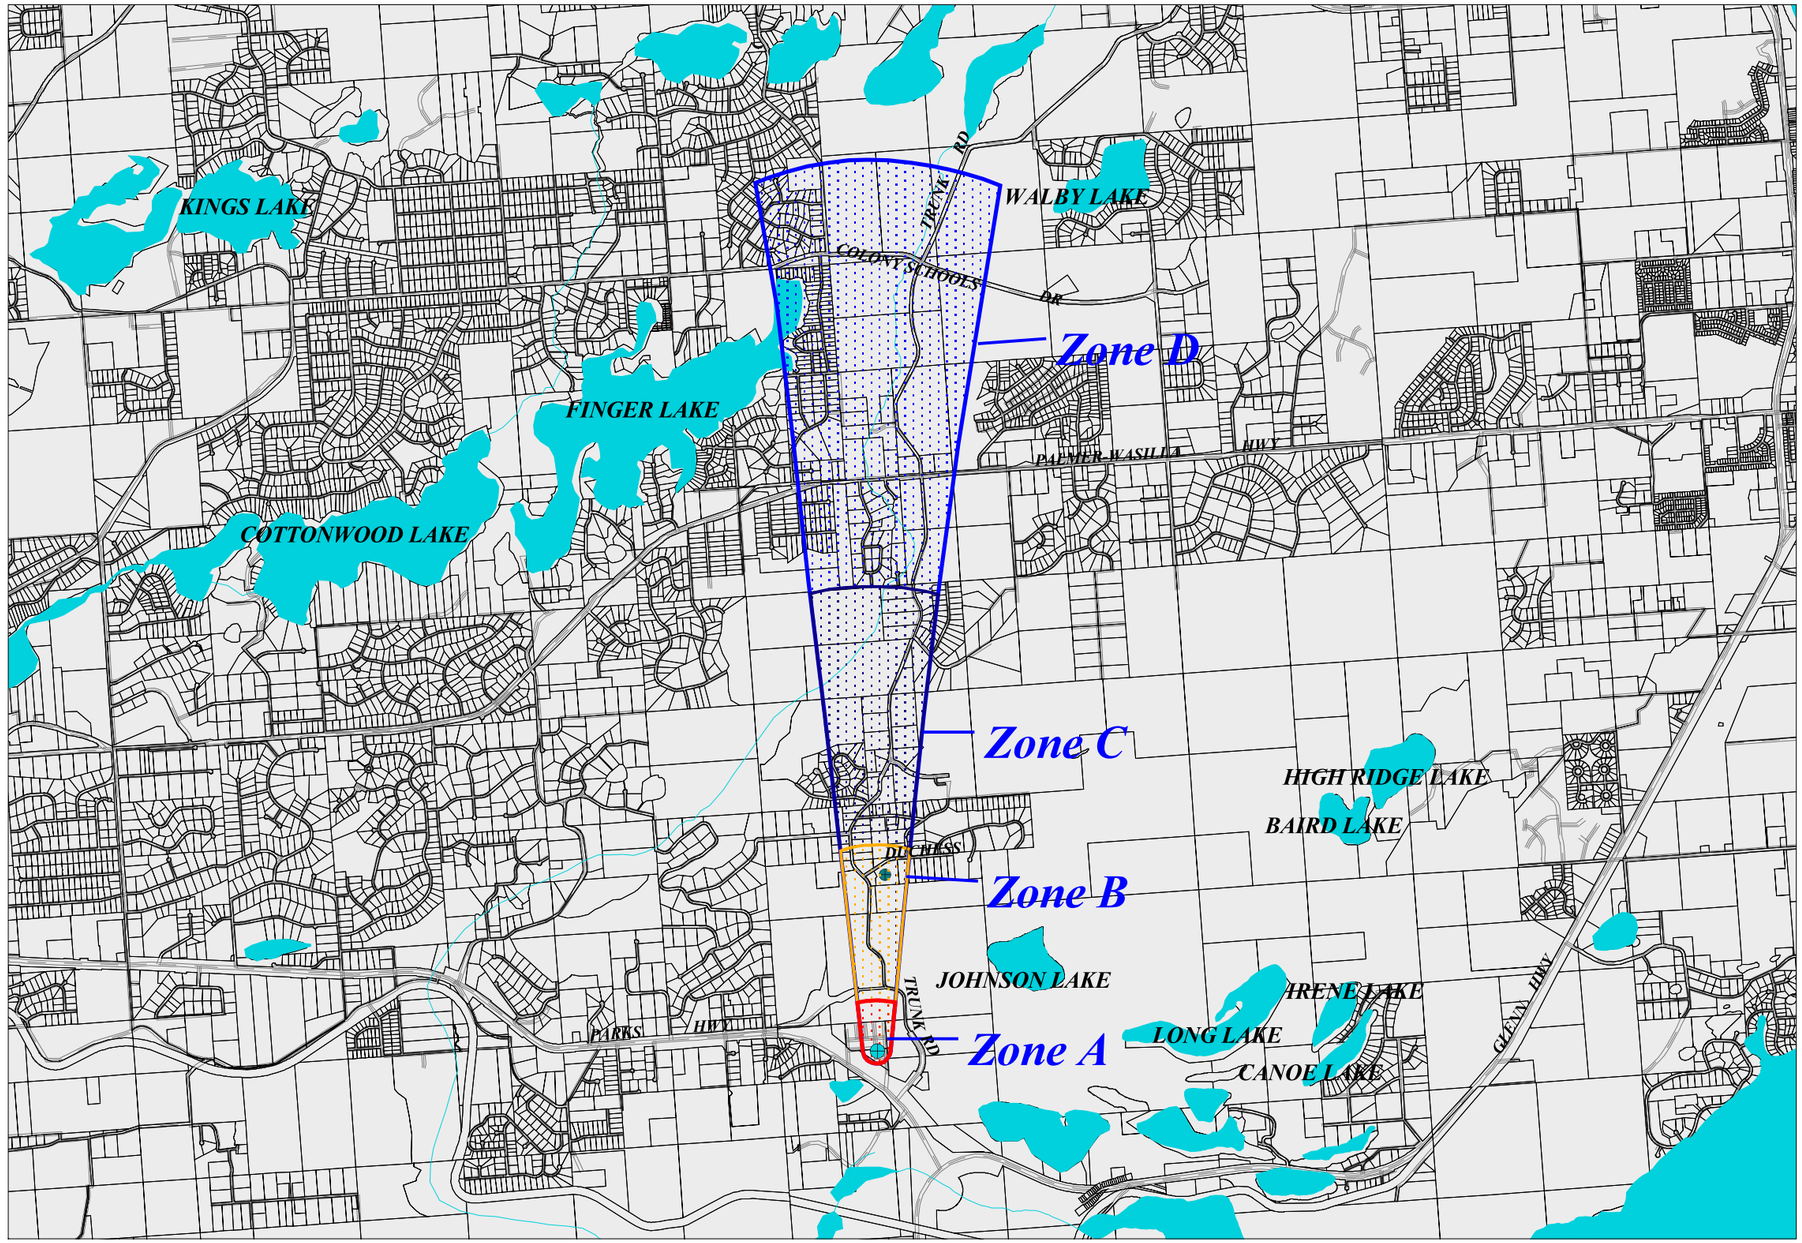
Map 1

B, Zone C and Zone D (Map 1, Appendix A). Zone A corresponds to the area between the well and the distance equal to ¼ of the distance of the 2-year time-of-travel. Depending on where a contaminant source is located within Zone A, travel time for a contaminant to the well may be on the order of several days to several hours. Zone A also extends down gradient from the well to take into account the area of the aquifer that is influenced by pumping of the well. The Zone B protection area for Best View RV and Trailer Park corresponds to a time-of-travel of less than two years and extends toward base of the Talkeetna Mountains. Zone C protection area corresponds to a time-of-travel of greater than 2 years and less than 5 years. Zone D corresponds to a time-of-travel of greater than 5 years and less than 10 years.

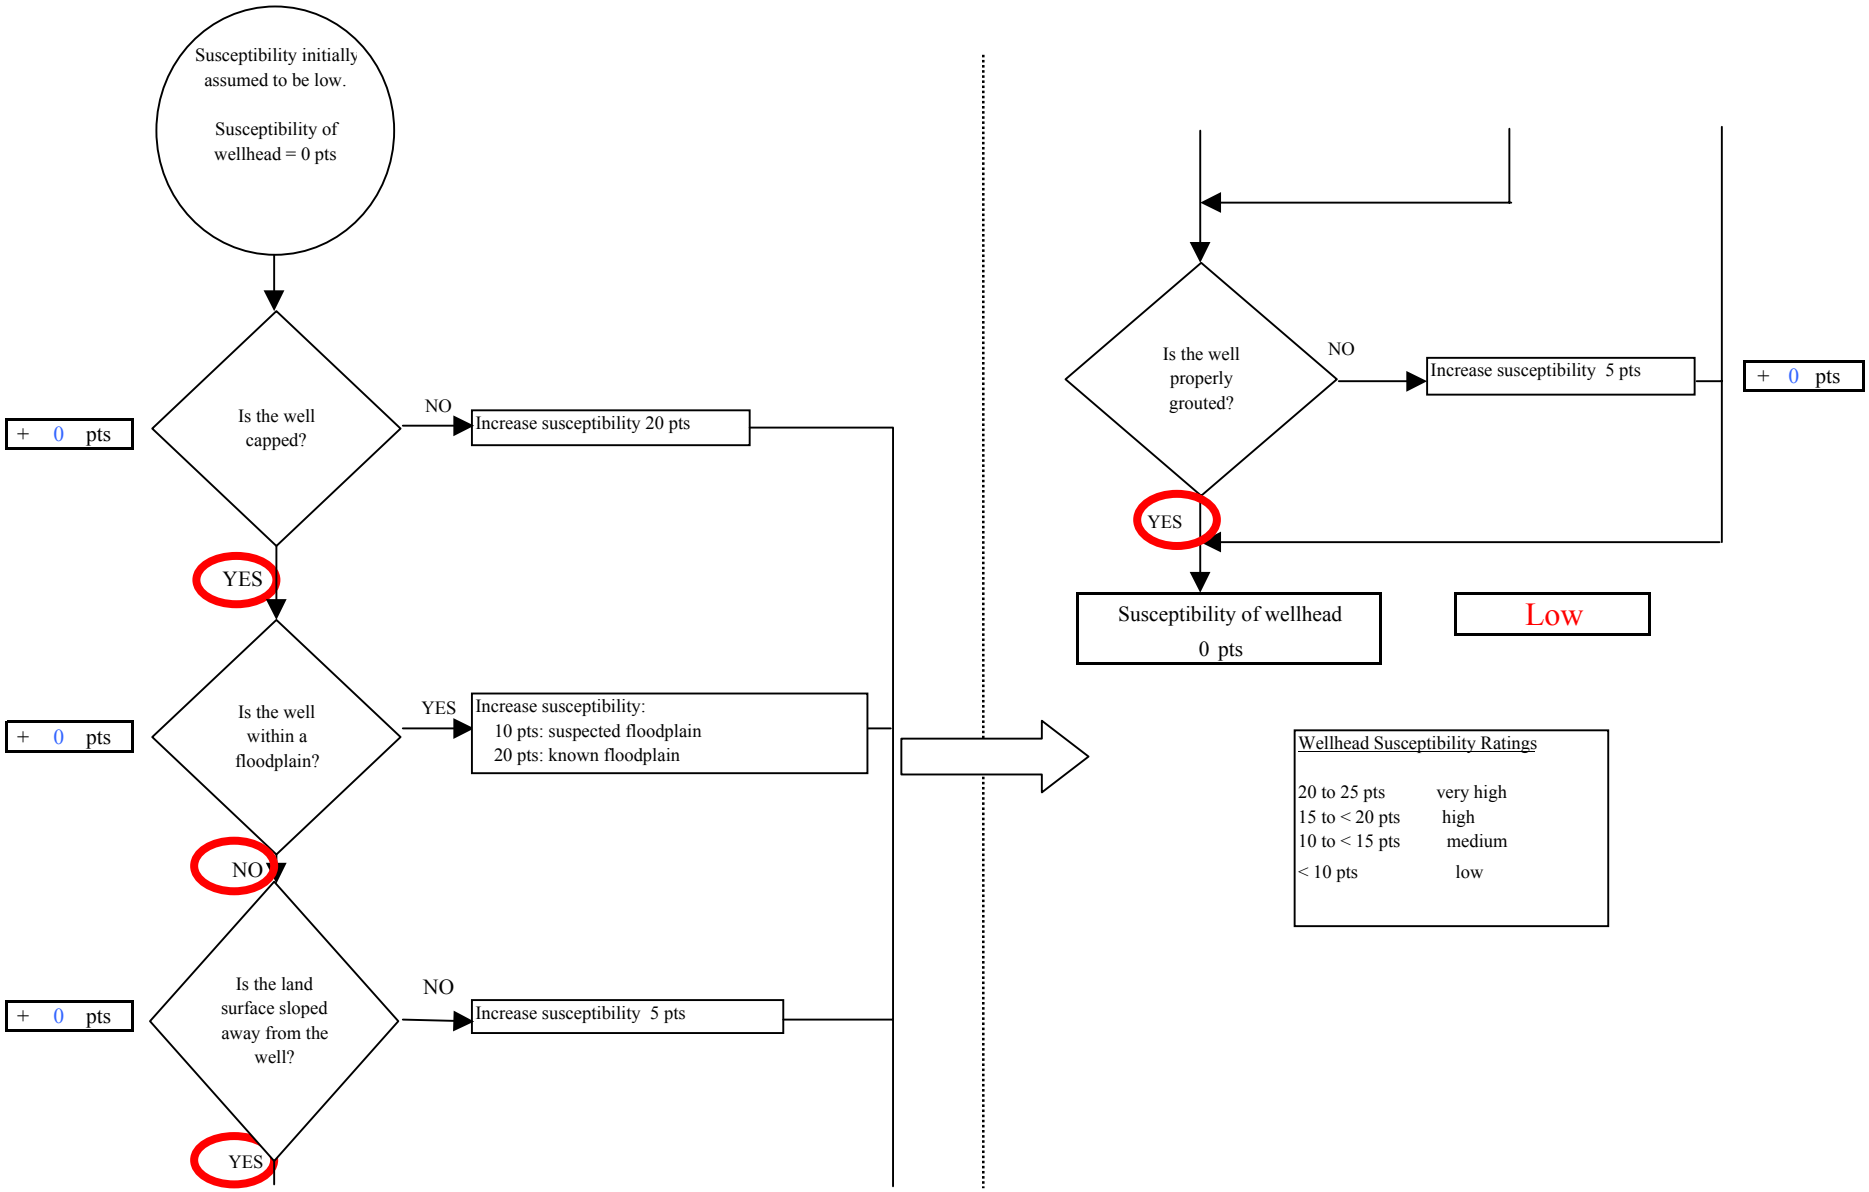
Chart 1. Susceptibility of the wellhead - Best View RV and Trailer Park

Score	Rating
Susceptibility of the Wellheads	0	Low
Susceptibility of the Aquifer	25	Very High
Natural Susceptibility	25	Medium

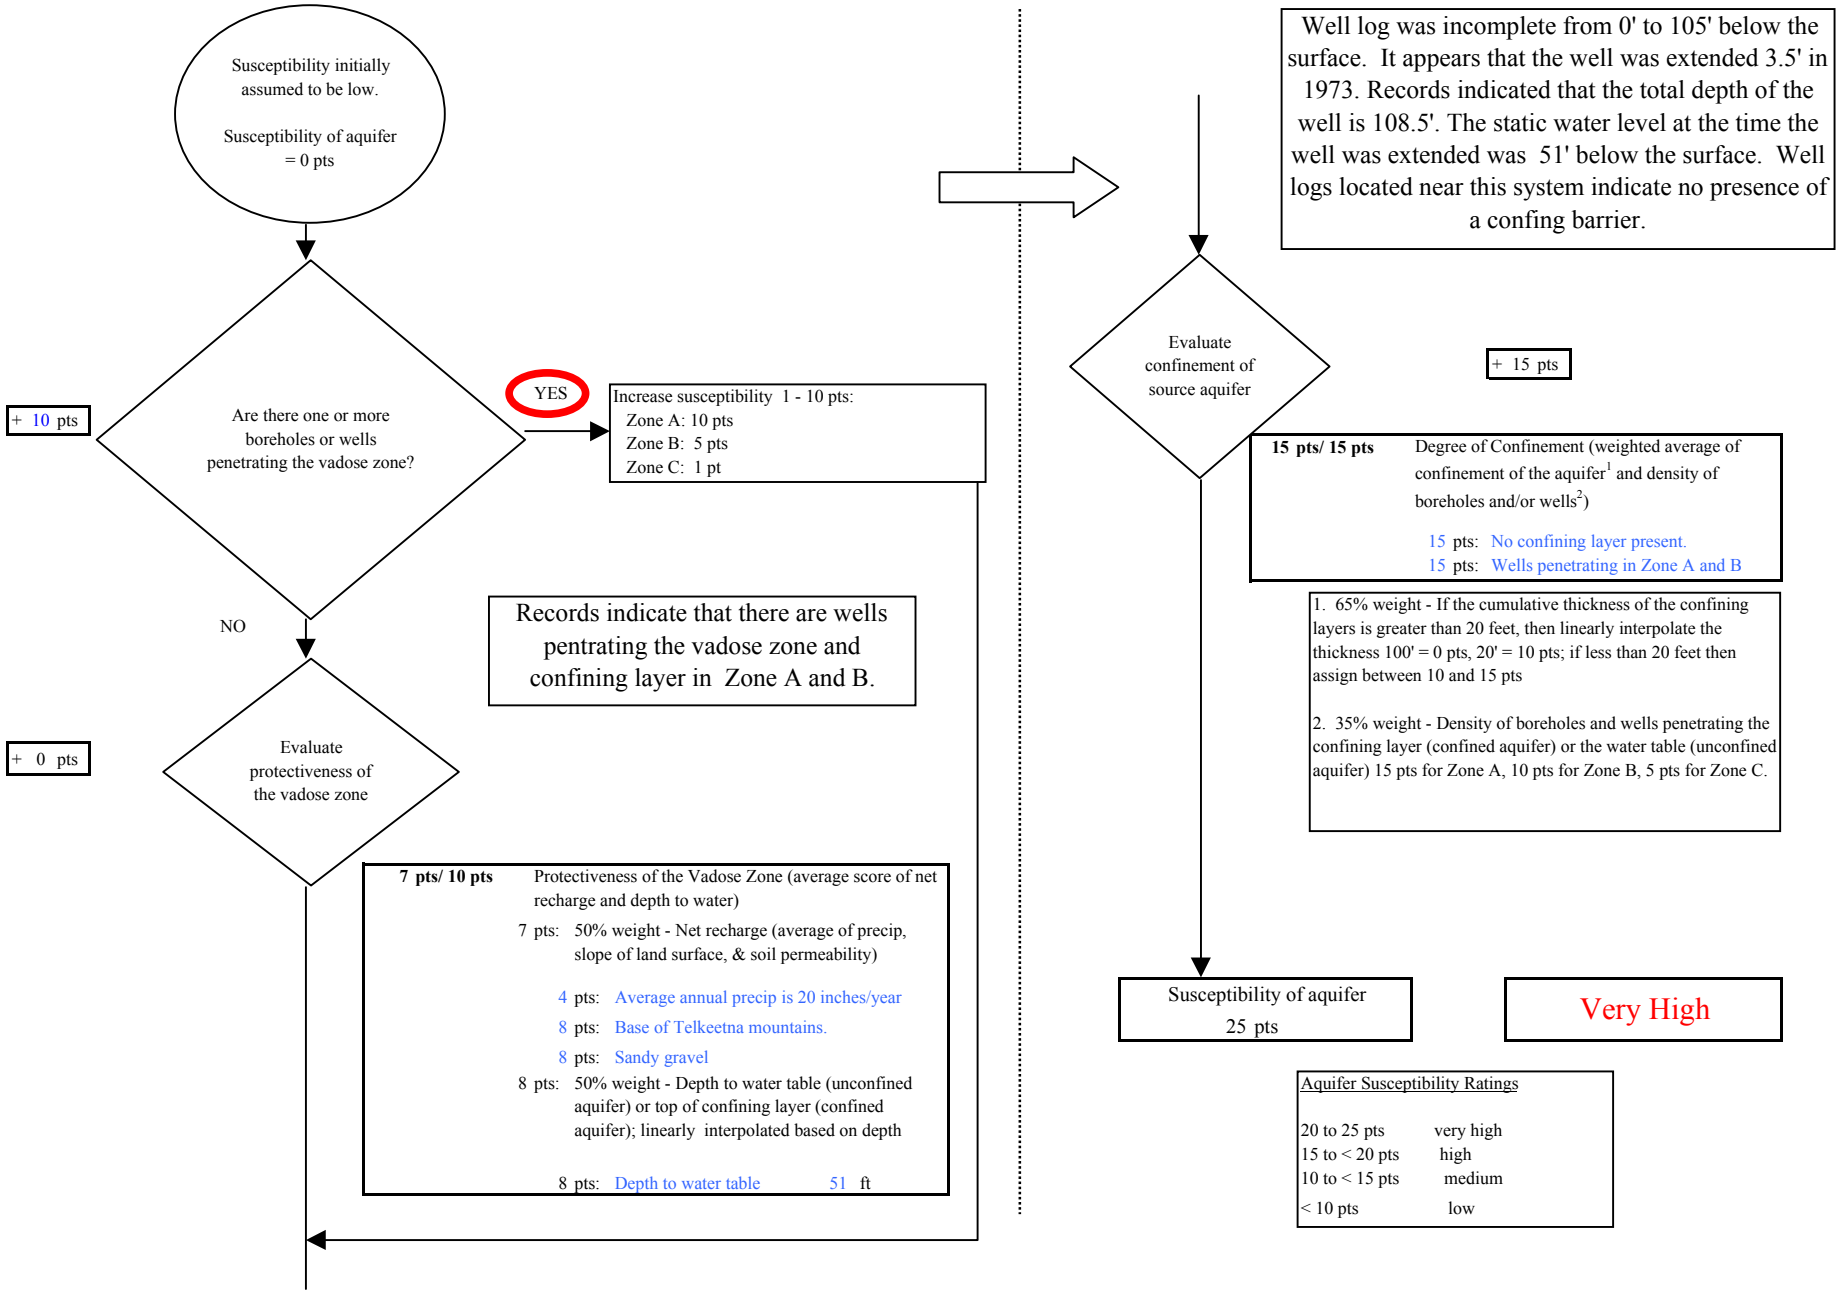
Chart 2. Susceptibility of the aquifer - Best View RV and Trailer Park

The Best View RV and Trailer Park well is completed in an unconfined aquifer setting. Nearby well logs indicate that no confining layers are encountered from the surface to the depth of this well. A confining layer is present at a substantially greater depth. The lack of a confining layer increases the chances that contaminants that enter the subsurface may enter the aquifer.

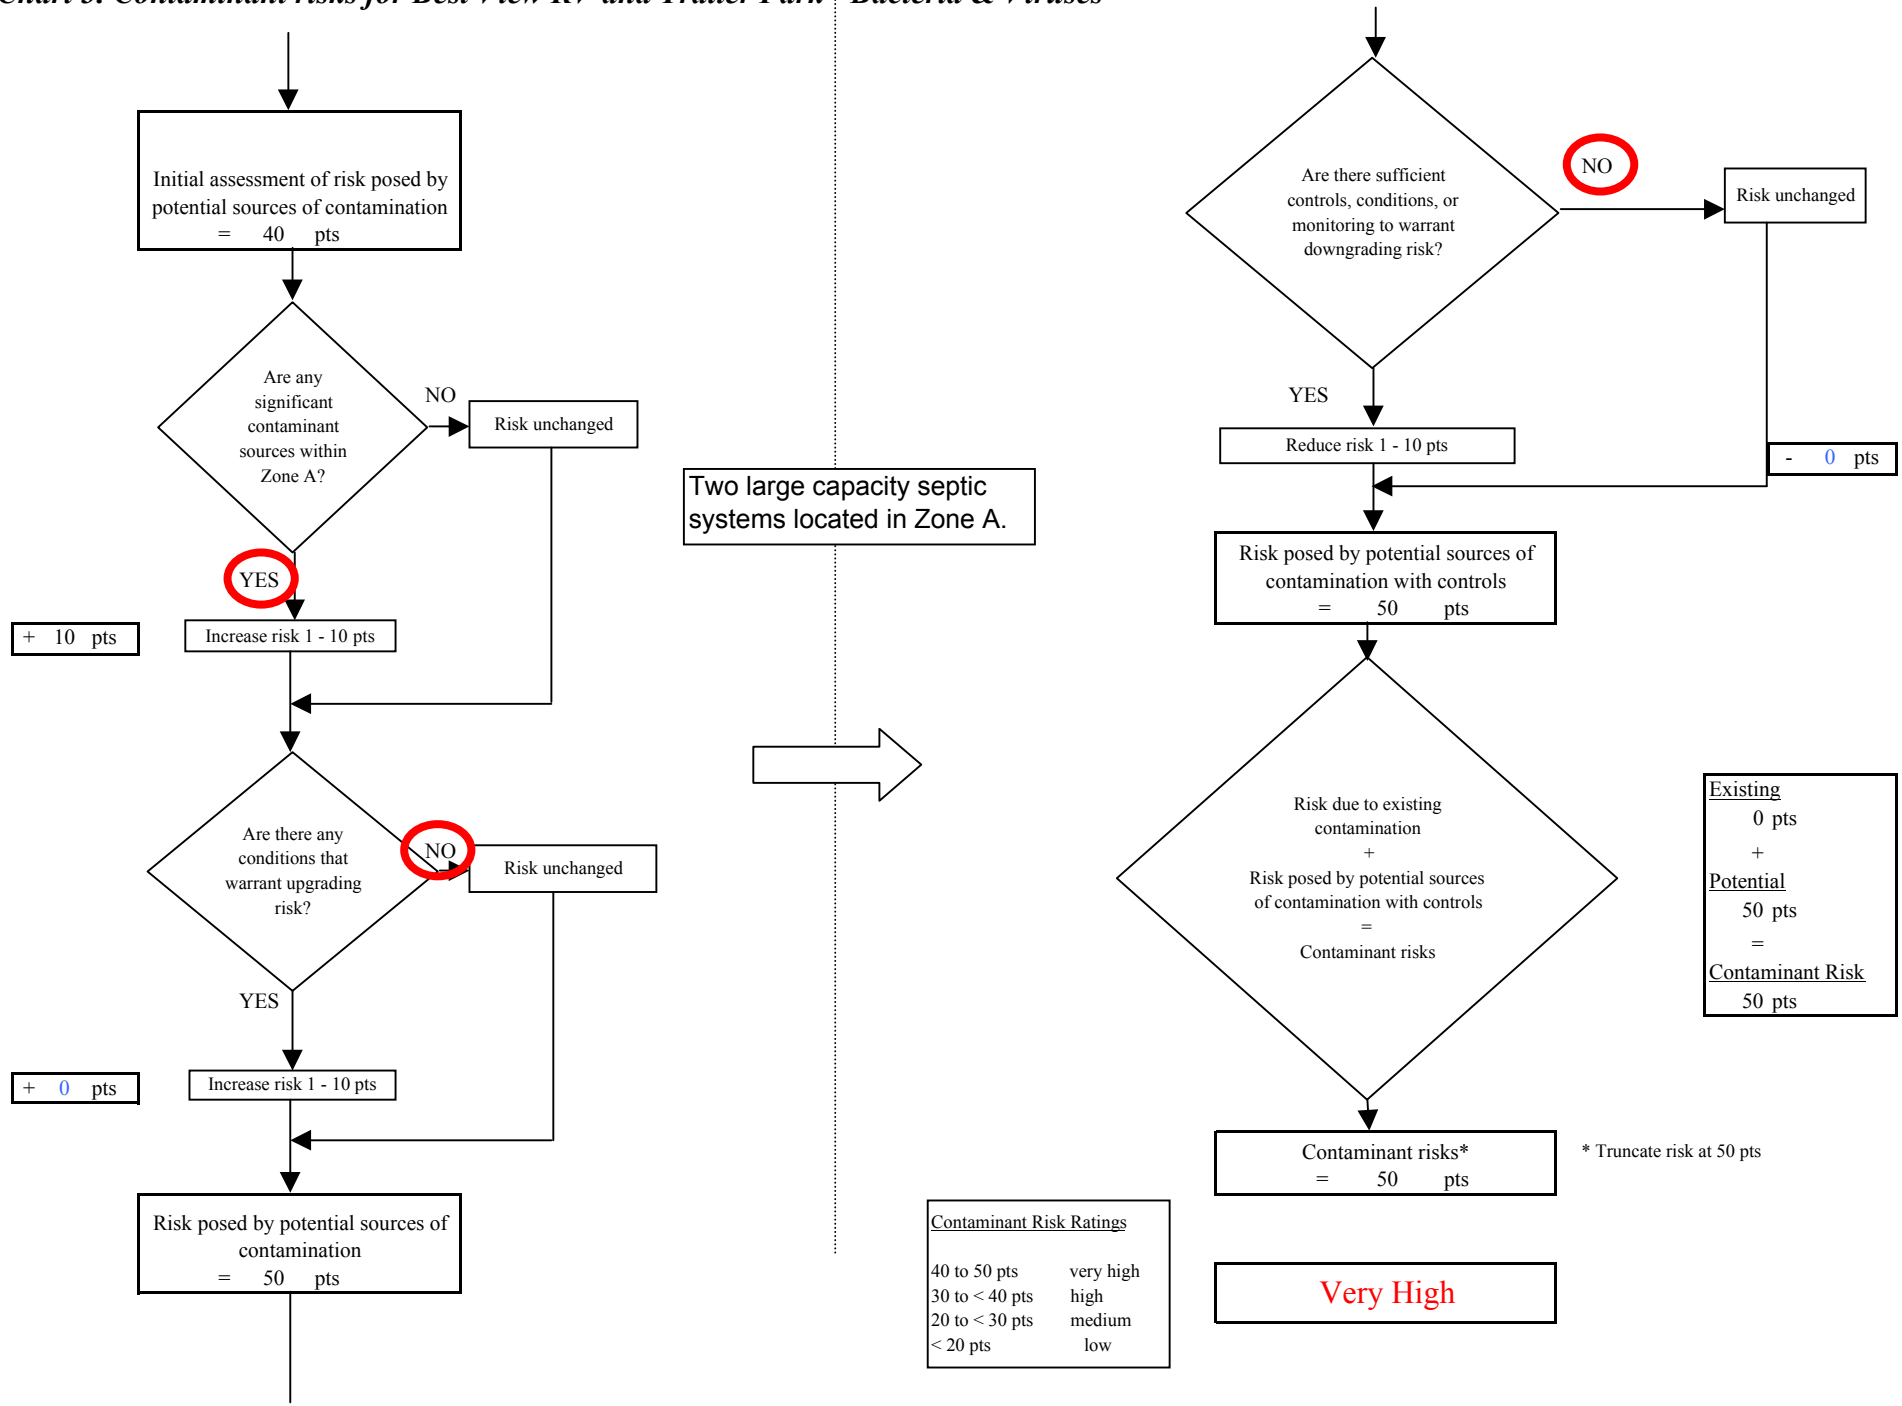
Chart 3. Contaminant risks for Best View RV and Trailer Park - Bacteria & Viruses

The contamination risk for the bacteria/viruses is driven by the potential risk associated with large capacity septic systems, residential septic systems, residential areas, an orchard/nursery and a gravel pit. No detection of Bacteria and Viruses has occurred in recent sampling history. Combining the contamination risk with the natural susceptibility of the well leads to an overall vulnerability to bacteria and virus contamination of very high.

The very high risk ranking for bacteria and viruses and nitrates/nitrites is largely attributed to the presence of a large capacity of septic system (LCSS's) in Zone A. For purposes of this study, LCSS are defined as septic systems serving more then one single family home. The United States Environmental Protection Agency's (USEPA) Underground Injection Control Program (UICP) is responsible for regulating large capacity septic systems (LCSS's) serving 20 or more individuals (USEPA, 1999). It is unknown how many individuals are served by the LCSS's located in Zone A.

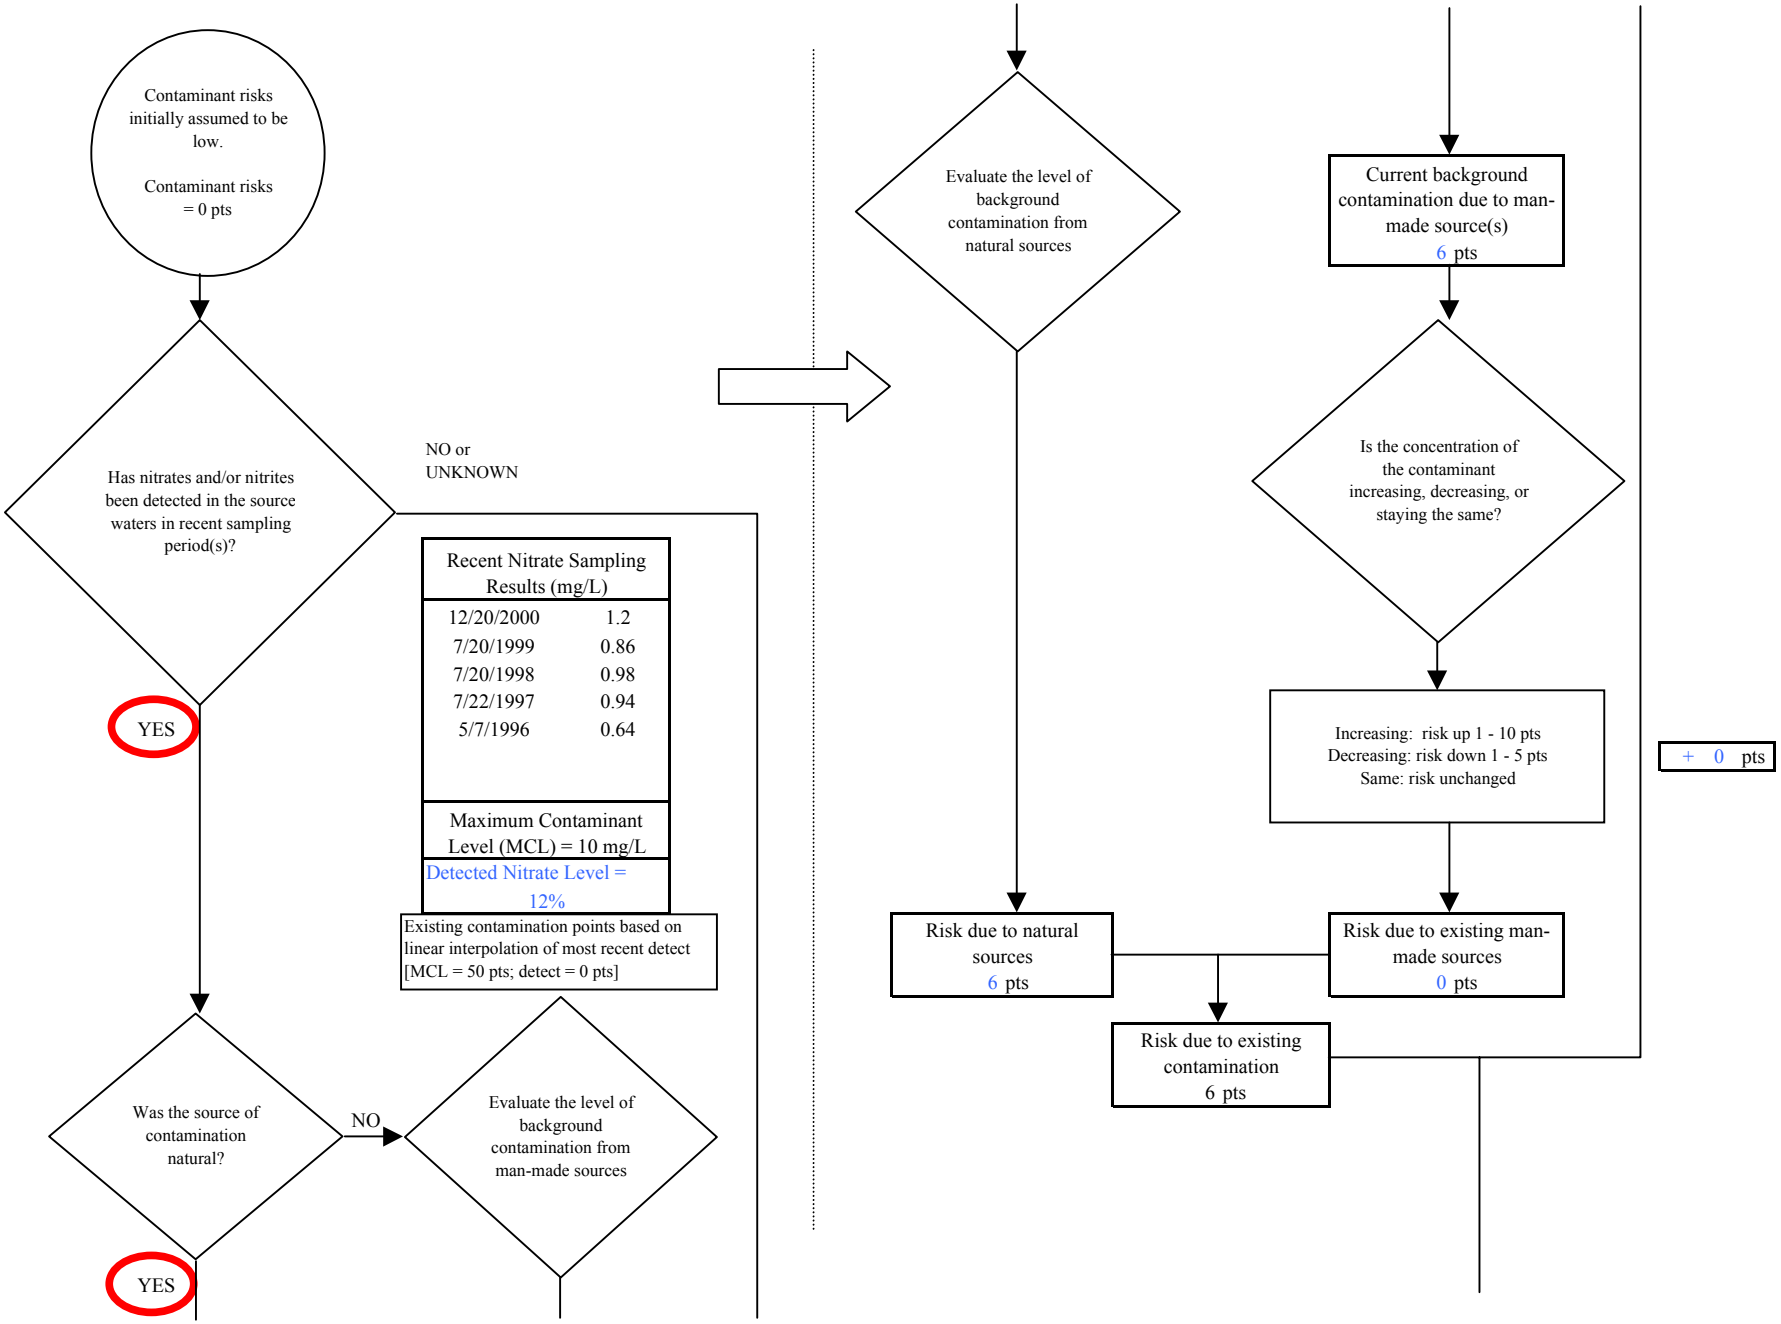
Chart 5. Contaminant risks for Best View RV and Trailer Park - Nitrates and Nitrites

The contamination risk for nitrate/nitrites is driven by the potential risk associated with large capacity septic systems, residential septic systems, and residential areas.

Exisitng risk was determined by reviewing recent historical sampling data. The most recent detection indicates that nitrates were detected at 12% the maximum contaminant level (MCL) of 10 mg/l on 12/20/00. (See Chart 5 – Contaminant Risks for nitrates and/or nitrites in Appendix D.) The MCL is the maximum level of contaminant that is allowed to exist in drinking water and still be consumed by humans without harmful effects. Combining the contamination risk with the natural susceptibility of the well leads to an overall vulnerability to nitrate/nitrite contamination of very high.

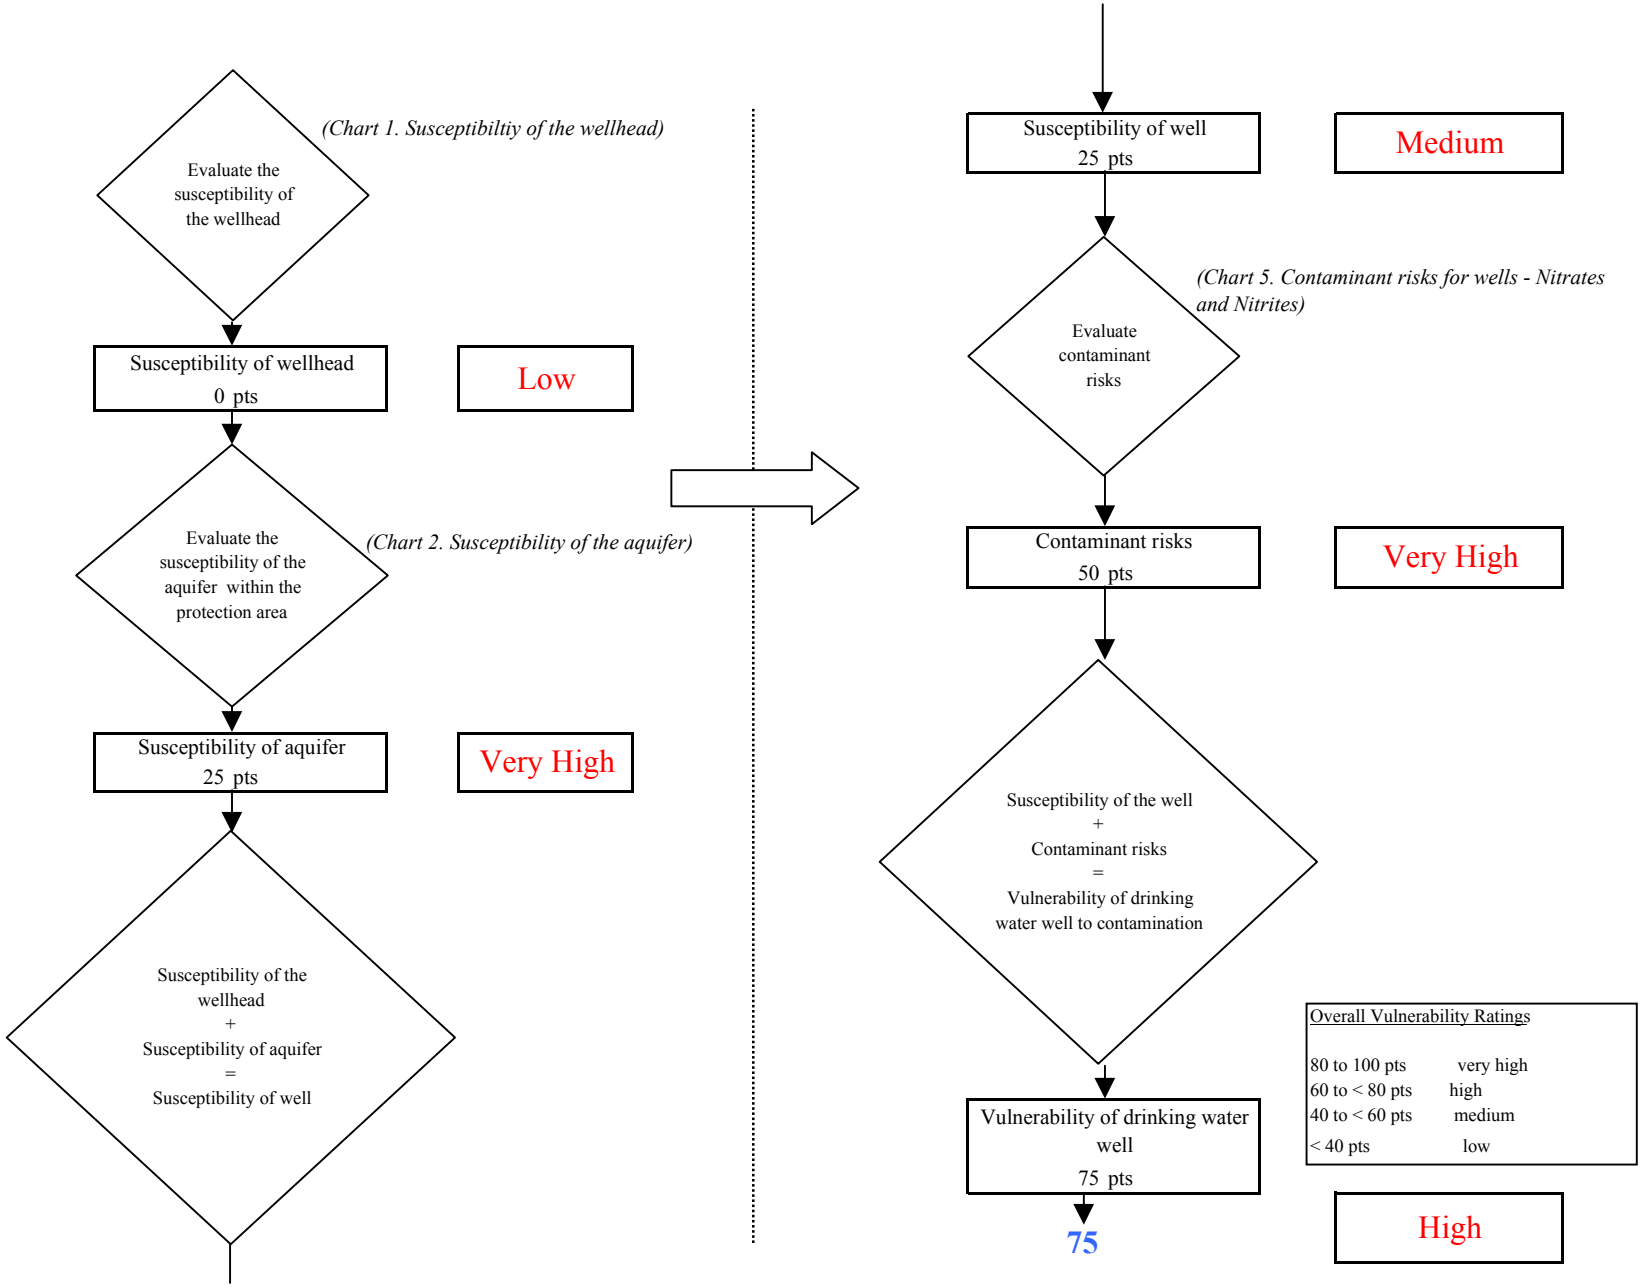
Chart 6. Vulnerability analysis for Best View RV and Trailer Park - Nitrates and Nitrites

Because naturally occurring nitrate levels are typically less than 2 mg/l (or 20% the MCL), it is suspected that the nitrate levels detected are naturally occurring (Wang, Strelakos, Jokela, 2000).

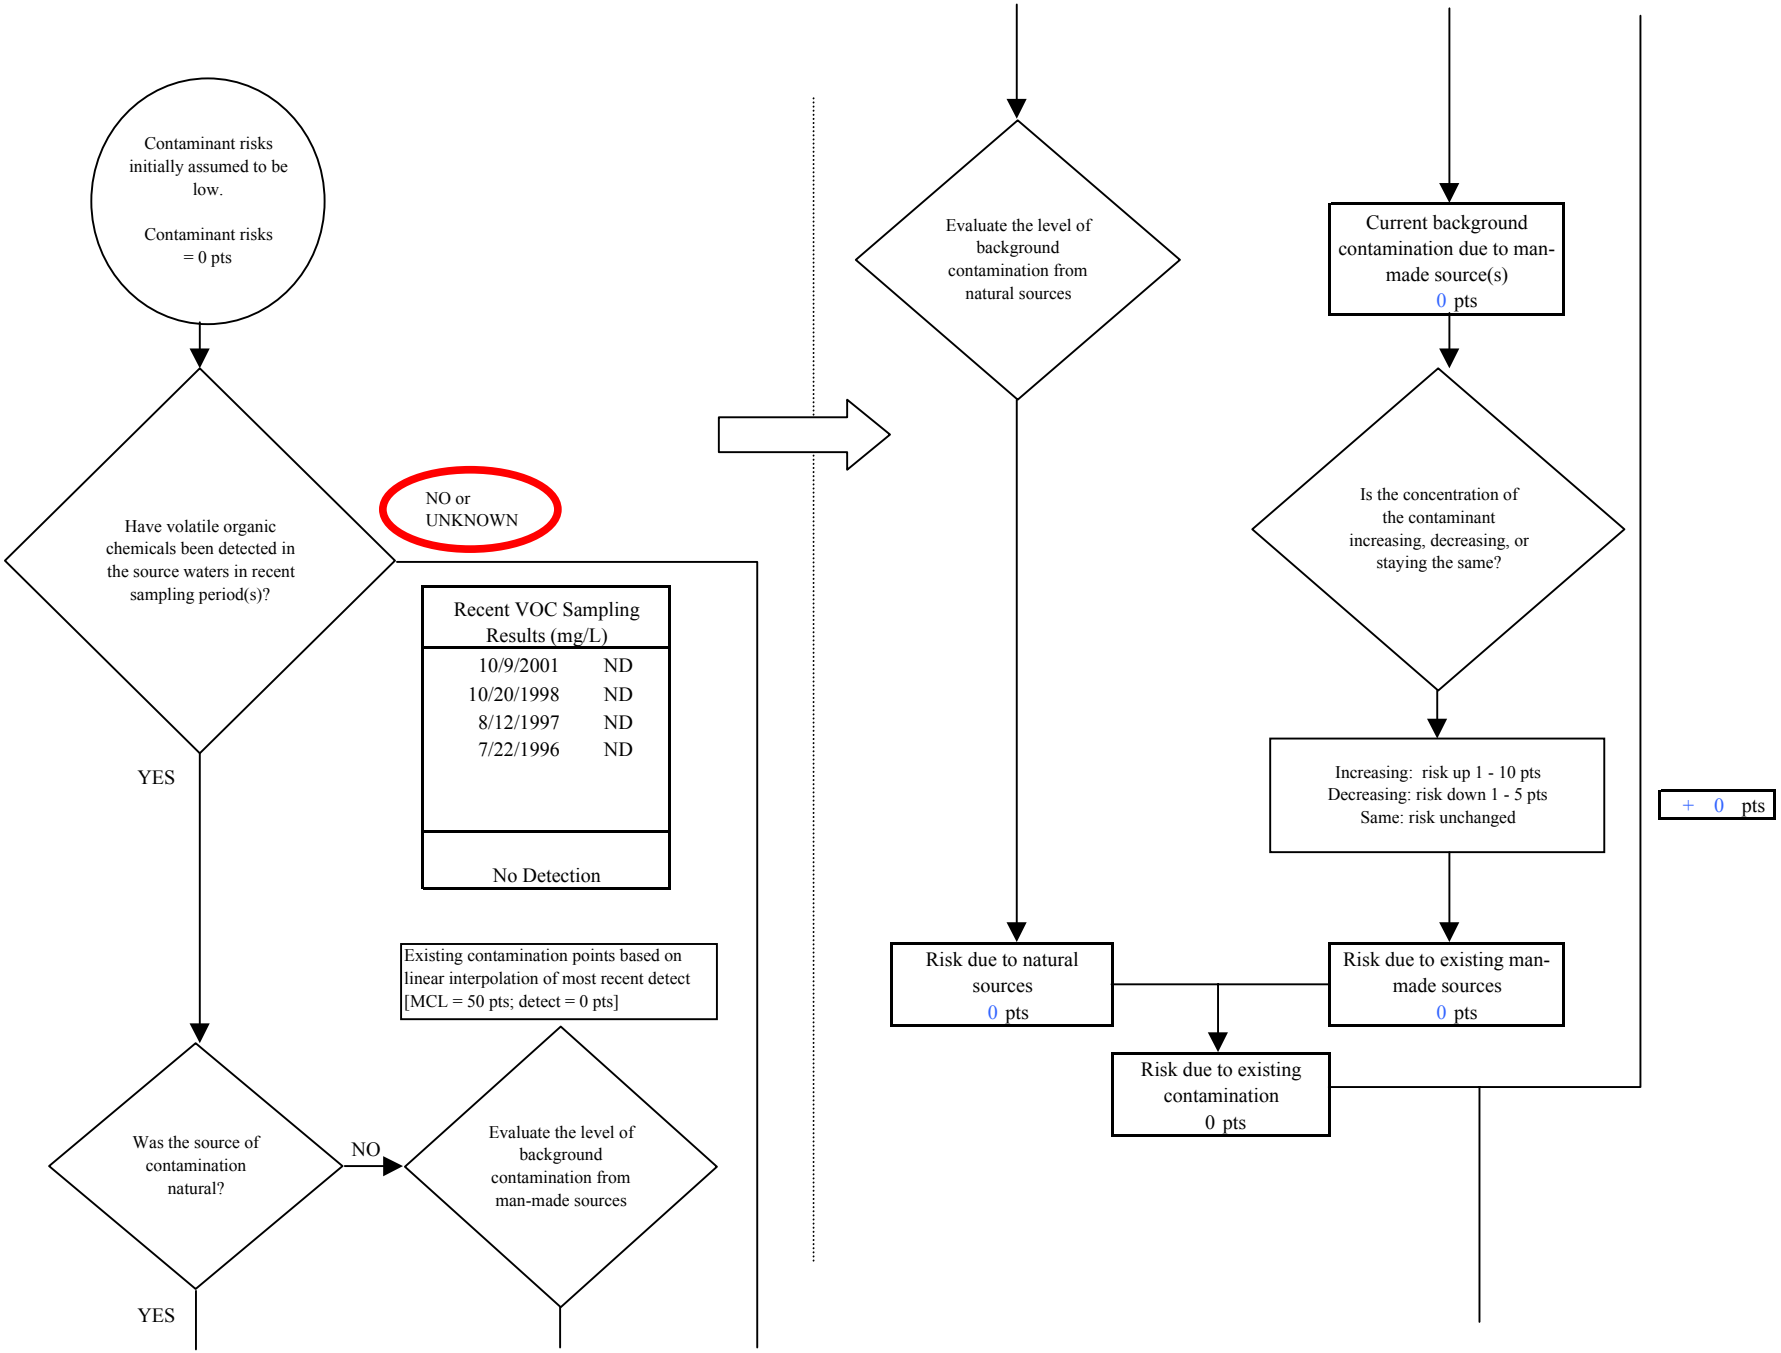
Chart 7. Contaminant risks for Best View RV and Trailer Park - Volatile Organic Chemicals

The contaminant risks for volatile organic chemicals are driven by the potential risk associated with roads, residential areas, large capacity septic systems (LCSS's), residential septic systems, a quarry/gravel pit, motor vehicle waste disposal wells and an airport.

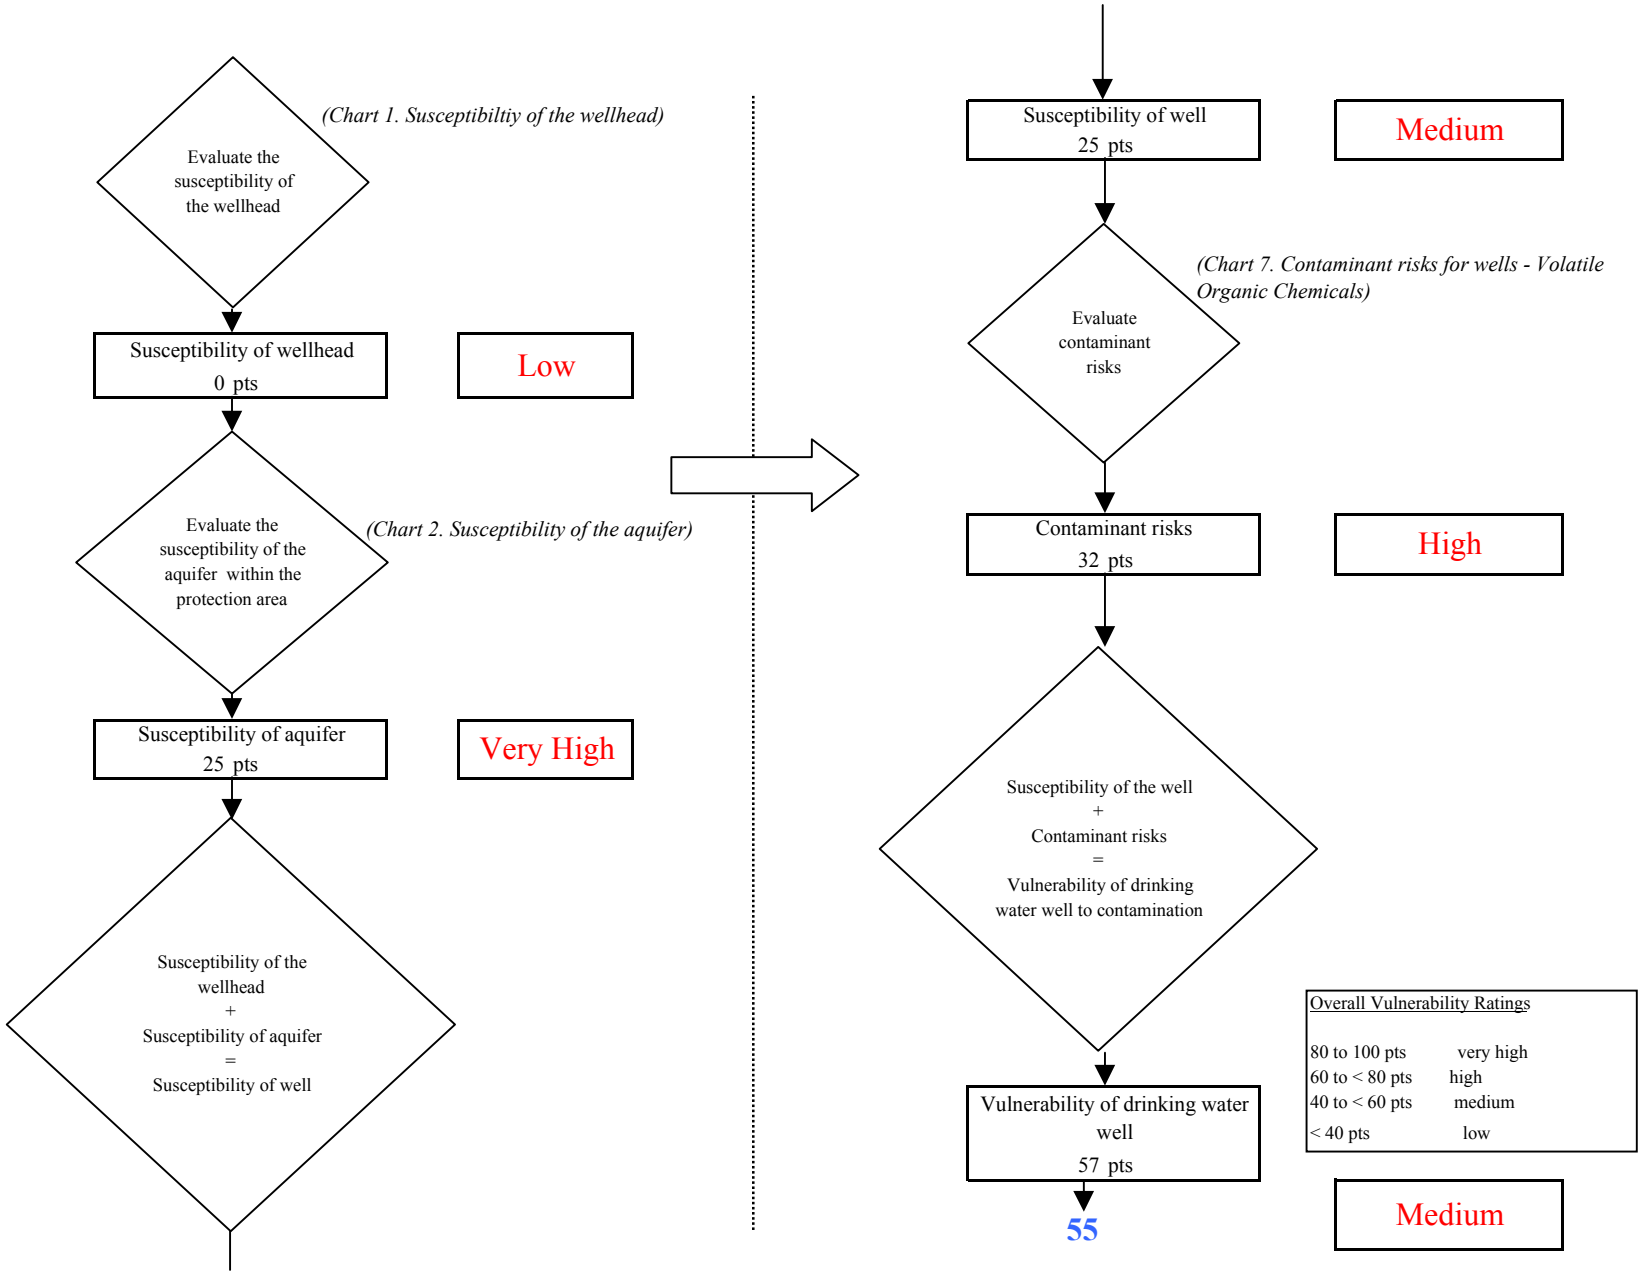
Chart 8. Vulnerability analysis for Best View RV and Trailer Park - Volatile Organic Chemicals

Recent historical sampling indicate no detection of volatile organic chemicals. Combining the contaminant risk with the natural susceptibility of the well leads to an overall vulnerability to volatile organic chemical contamination of low.

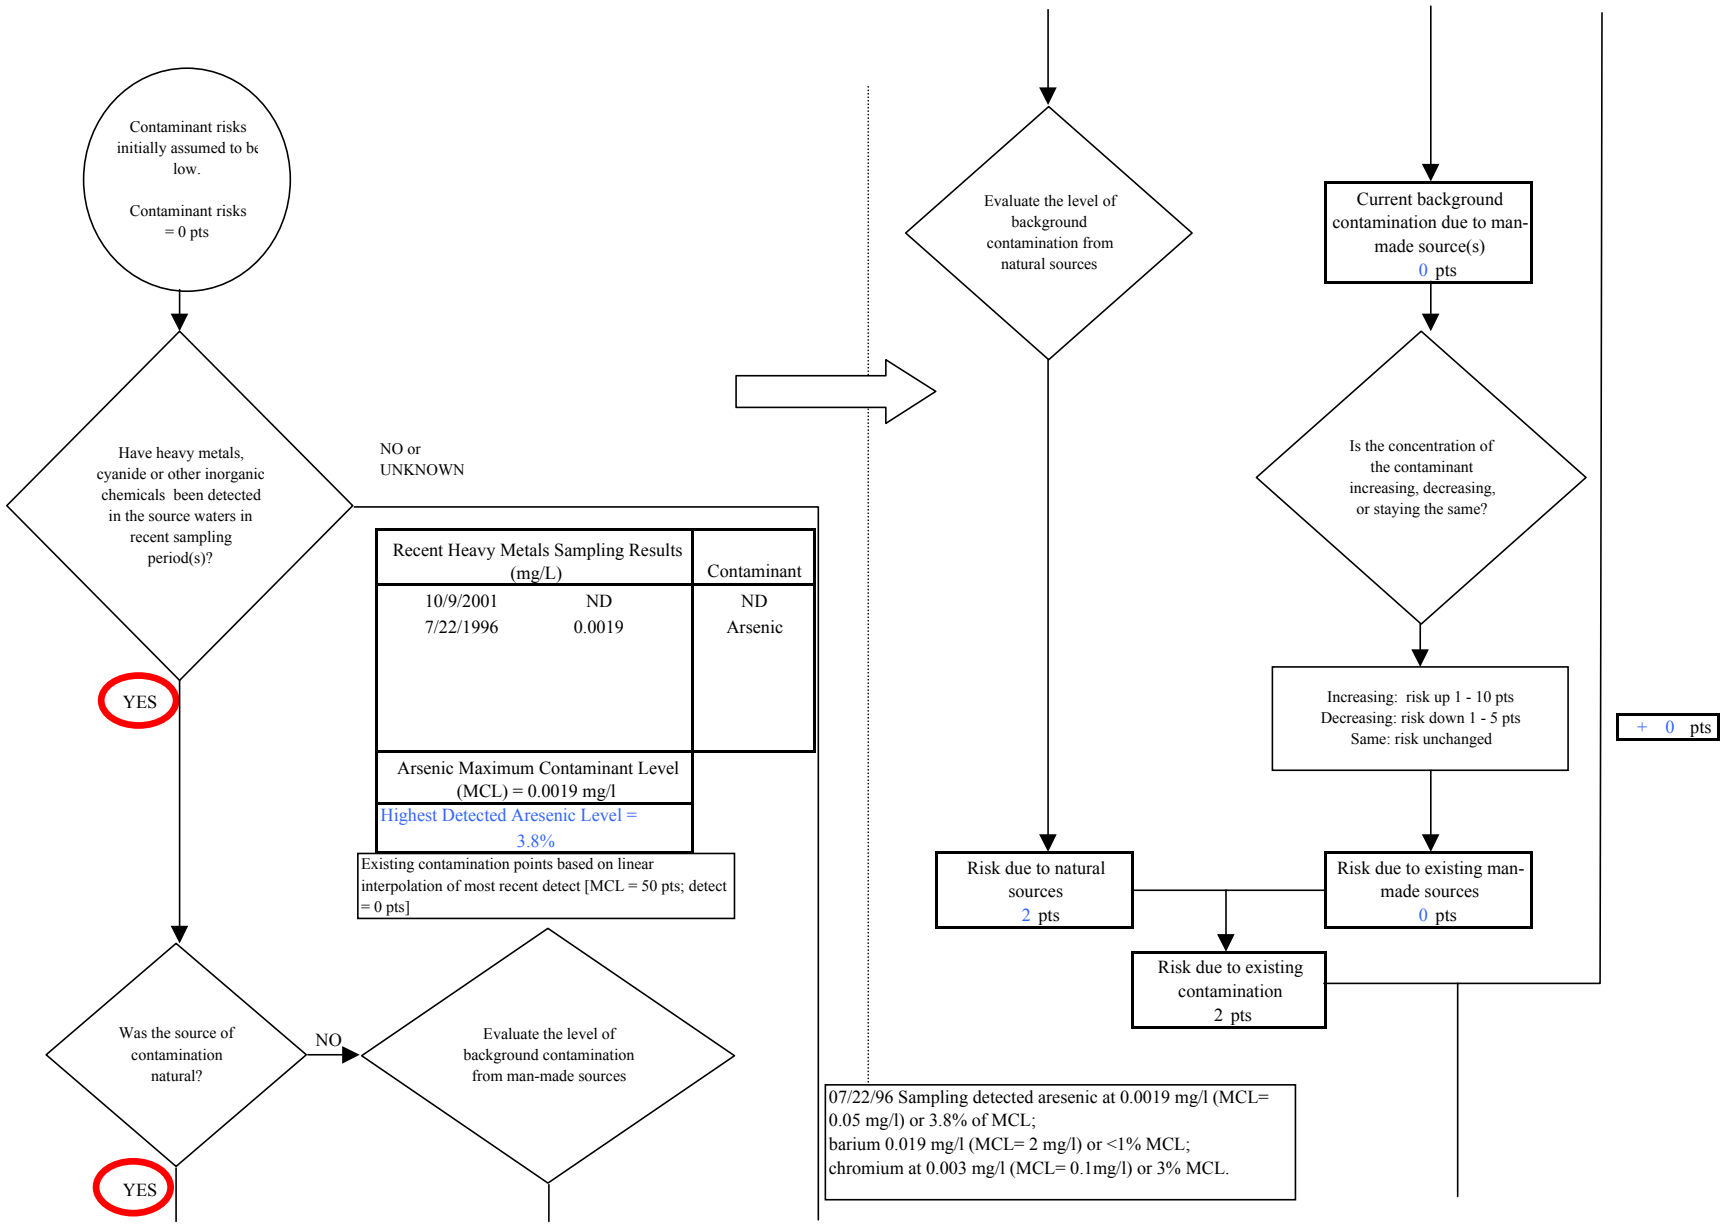
Chart 9. Contaminant risks for Best View RV and Trailer Park - Heavy Metals, Cyanide and Other Inorganic Chemicals

The contaminant risks for heavy metals and inorganic are driven by the potential risks associated with roads, residential areas, large capacity septic systems (LCSS's), residential septic systems, motor vehicle waste disposal wells and an airport.
