Source Water Assessment for Best View RV and Trailer Park

A Hydrogeologic Susceptibility and Vulnerability Assessment

DRINKING WATER PROTECTION PROGRAM REPORT 404
PWSID 222246.001

March 2002

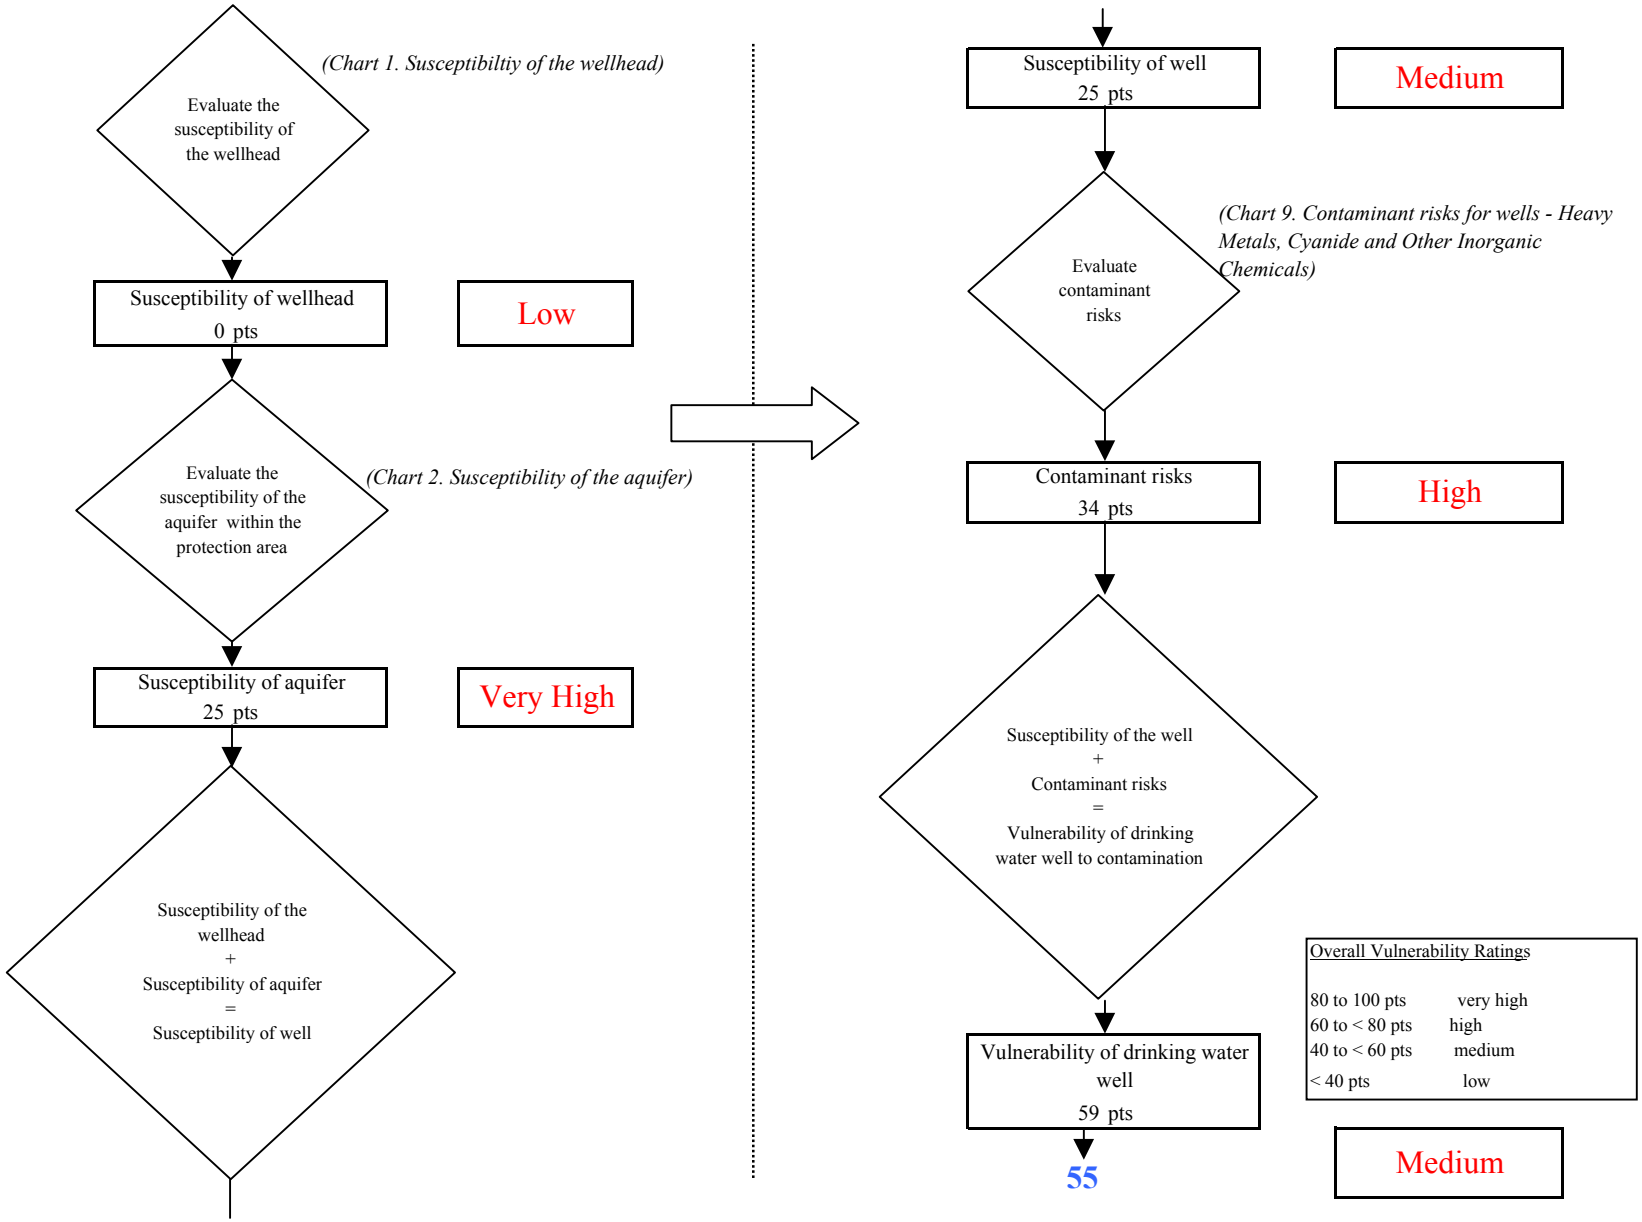
Chart 10. Vulnerability analysis for Best View RV and Trailer Park - Heavy Metals, Cyanide and Other Inorganic Chemicals

The presence of existing contamination also contributes to the overall risk. Recent historical sampling indicates that arsenic was detected at very low levels. Sampling done on 7/22/1996 detected arsenic at 0.0019 mg/l or 3.8% of the MCL of 0.05 mg/l; barium at 0.019mg/l or <1% MCL; chromium at 0.003 mg/l or 3% of the MCL of 0.1 mg/l. Combining the contaminant risk with the natural susceptibility of the well leads to an overall vulnerability to heavy metals and inorganic chemical contamination of medium.

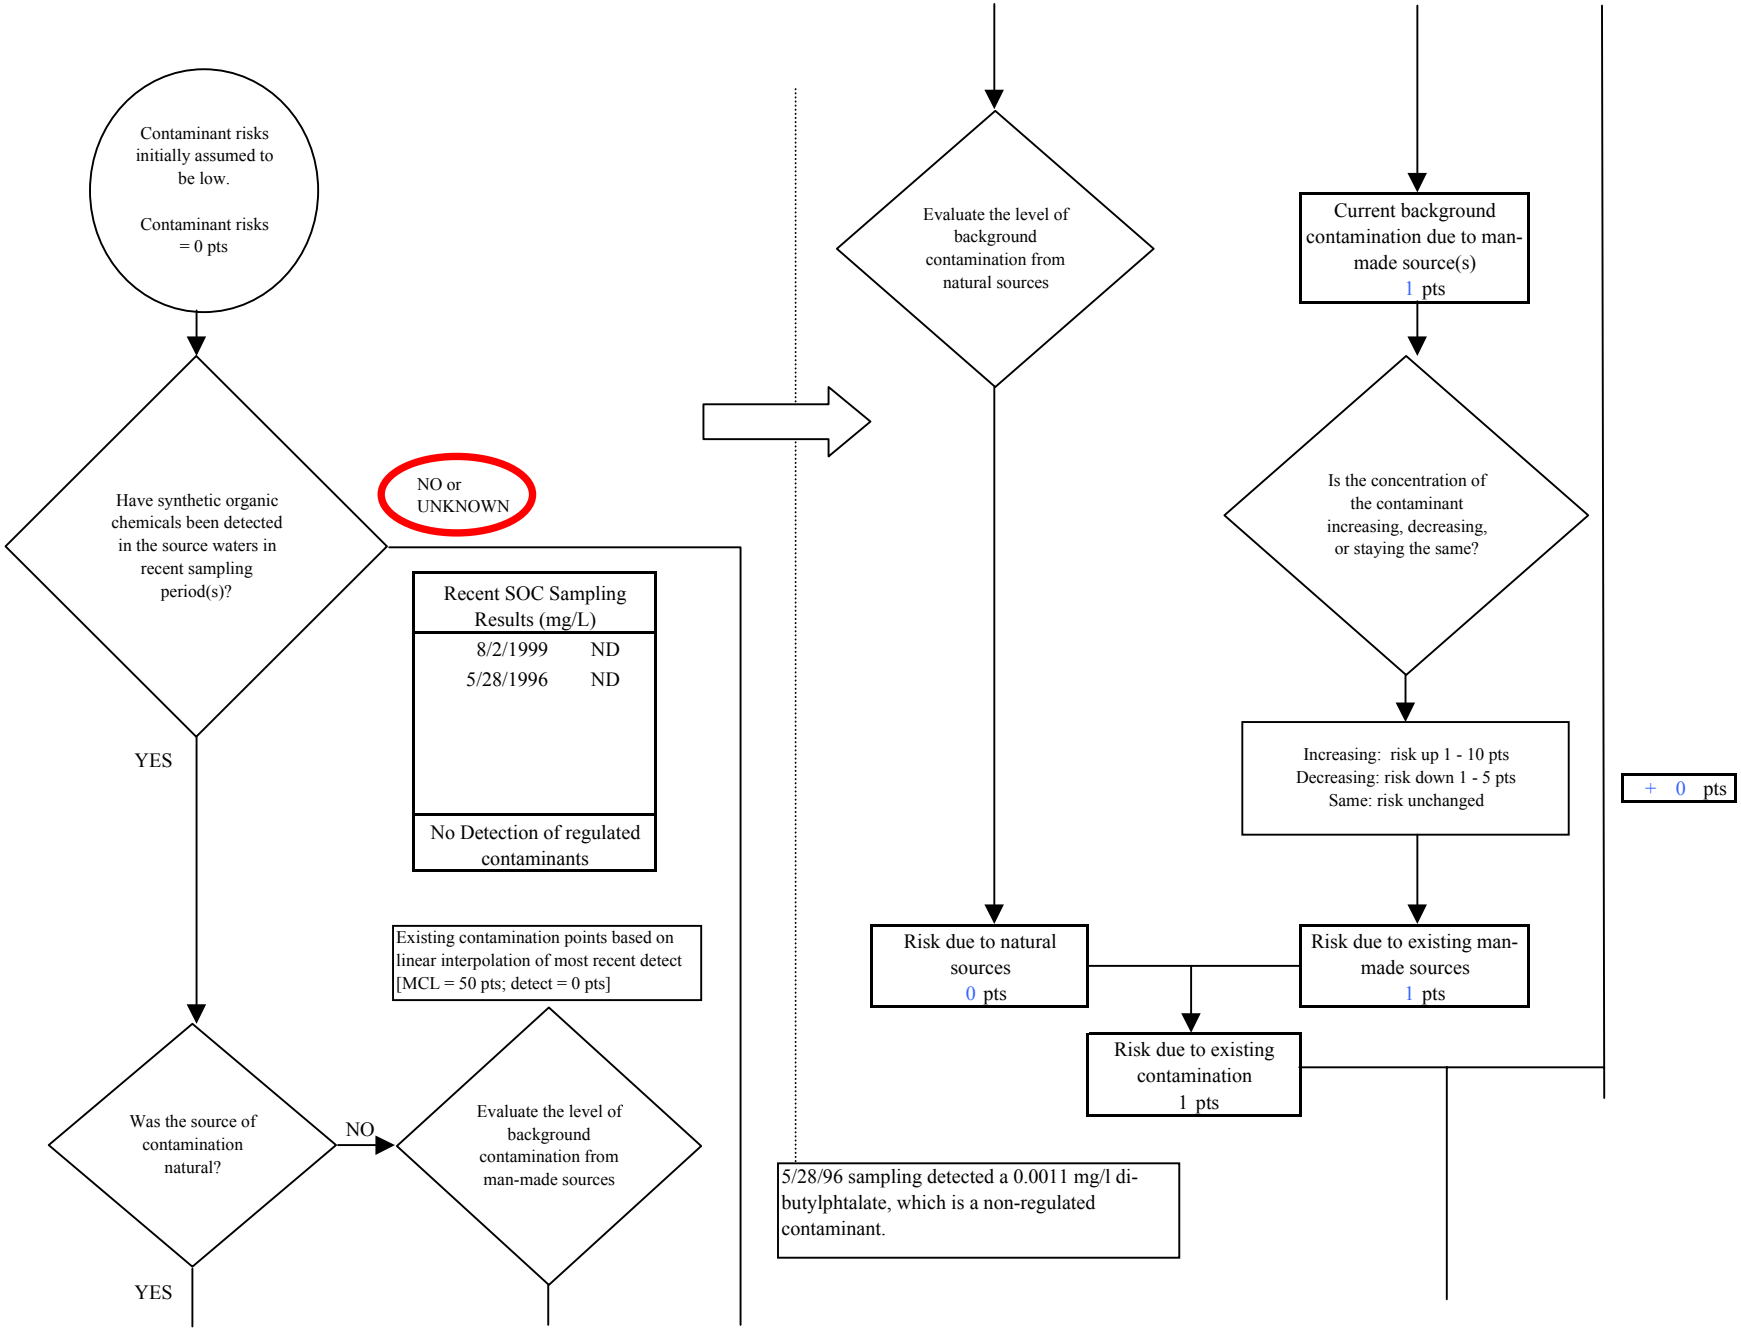
Chart 11. Contaminant risks for Best View RV and Trailer Park - Synthetic Organic Chemicals

The contaminant risk for synthetic organic chemicals is driven by the potential risk associated with residential areas, large capacity septic systems (LCSS's), residential septic systems, motor vehicle waste disposal wells and an orchard or nursery.

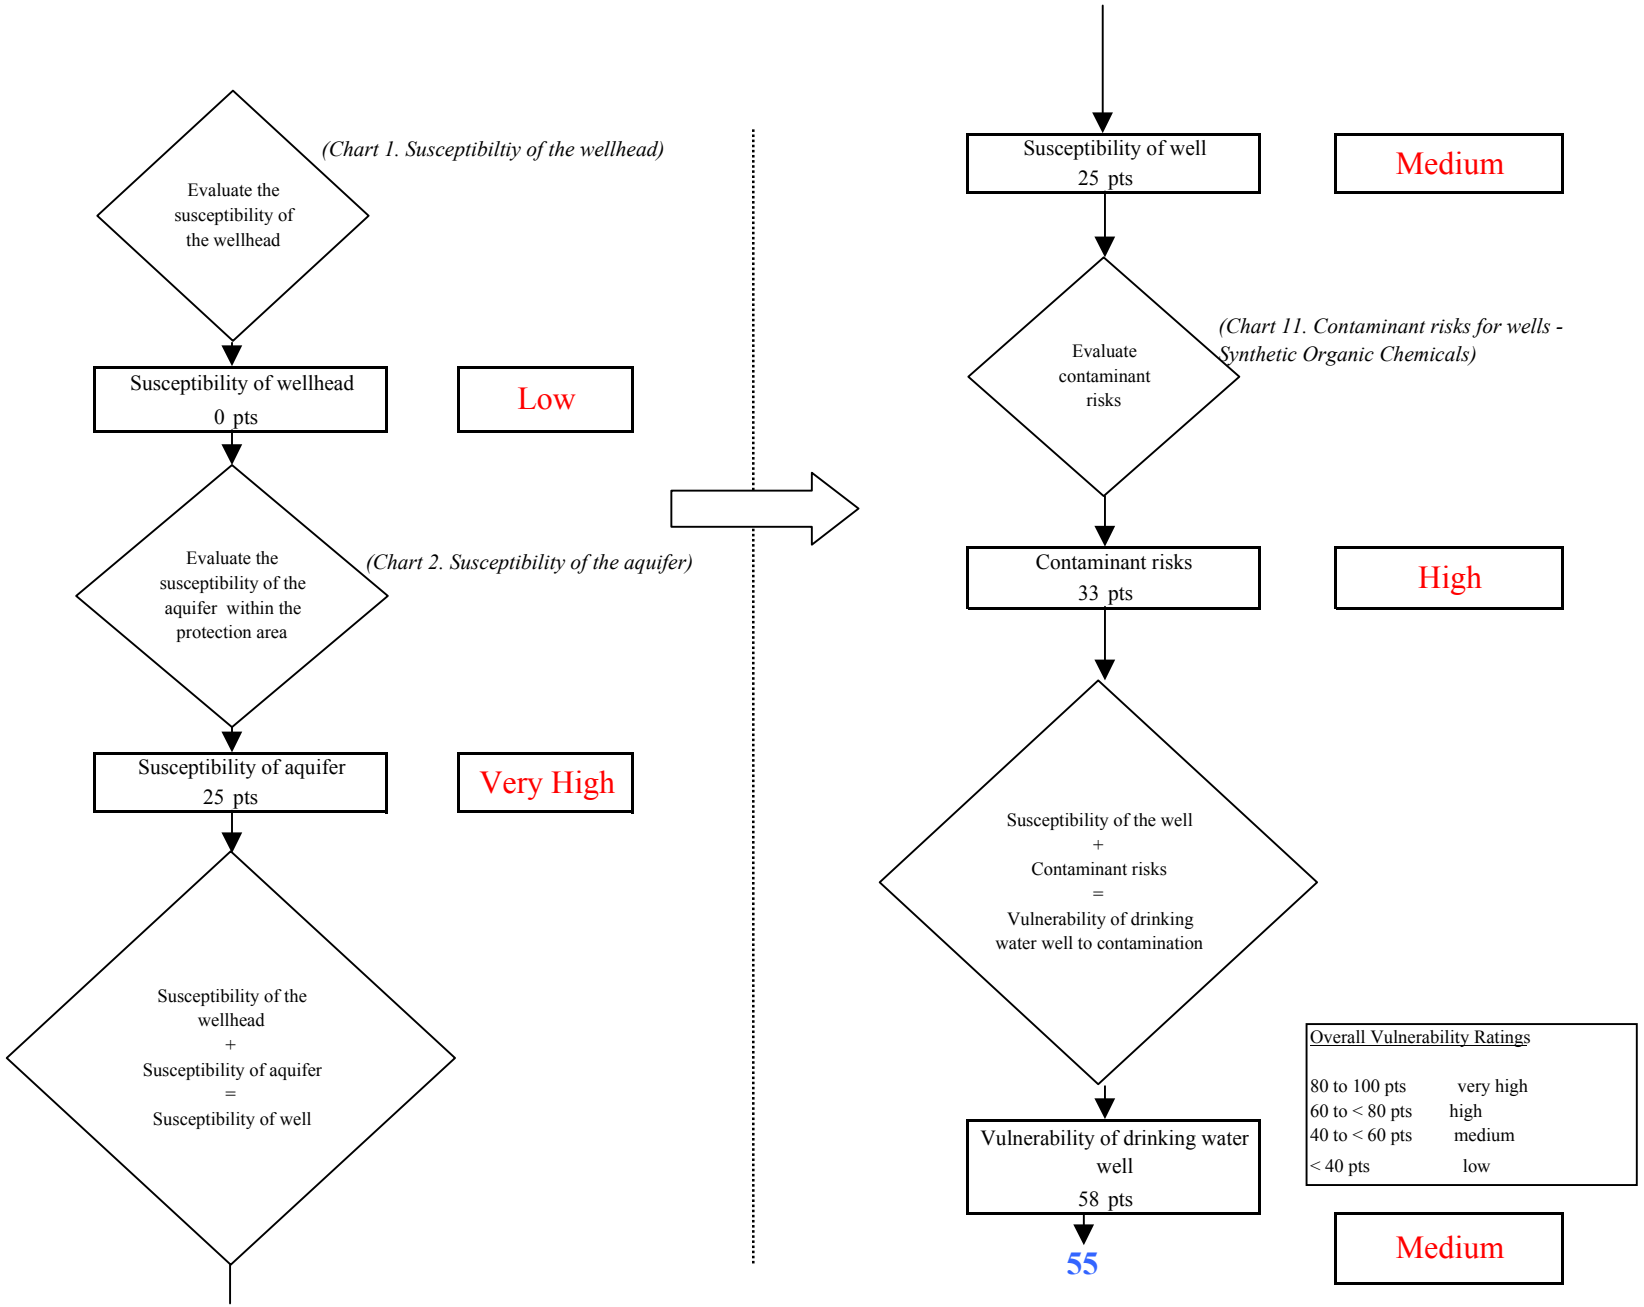
Chart 12. Vulnerability analysis for Best View RV and Trailer Park - Synthetic Organic Chemicals

Recent sampling history indicates that no regulated synthetic organic contamination has been detected. However, sampling done on 5/28/96 detected a di-n-butyl phthalate at 0.0011 mg/l. Di-n-butyl phthalate is a non-regulated contaminant and the USEPA has not established a MCL for it. Di-n-butyl phthalate is a man-made chemical that is added to plastics and other chemical products. Di-n-butyl phthalate does not dissolve easily in water, but can get into water by attaching to dirt particles. The Agency for Toxic Substances and Disease Registry mentions that some public water systems have detected Di-n-butyl phthalate usually at levels of 0.0001-0.0002 mg/l. Di-n-butyl phthalate appears to have relatively low toxicity, and large amounts are needed to cause injury. Adverse effects on humans from exposure to di-n-butyl phthalate have not been reported. (ATSDR, 2001).

Combining the contaminant risk with the natural susceptibility of the well leads to an overall vulnerability to synthetic chemical contamination of medium.
