Source Water Assessment

A Hydrogeologic Susceptibility and Vulnerability Assessment for Ruby Washeteria & Laundromat Drinking Water System, Ruby, Alaska

PWSID # 360264.001

June 2004

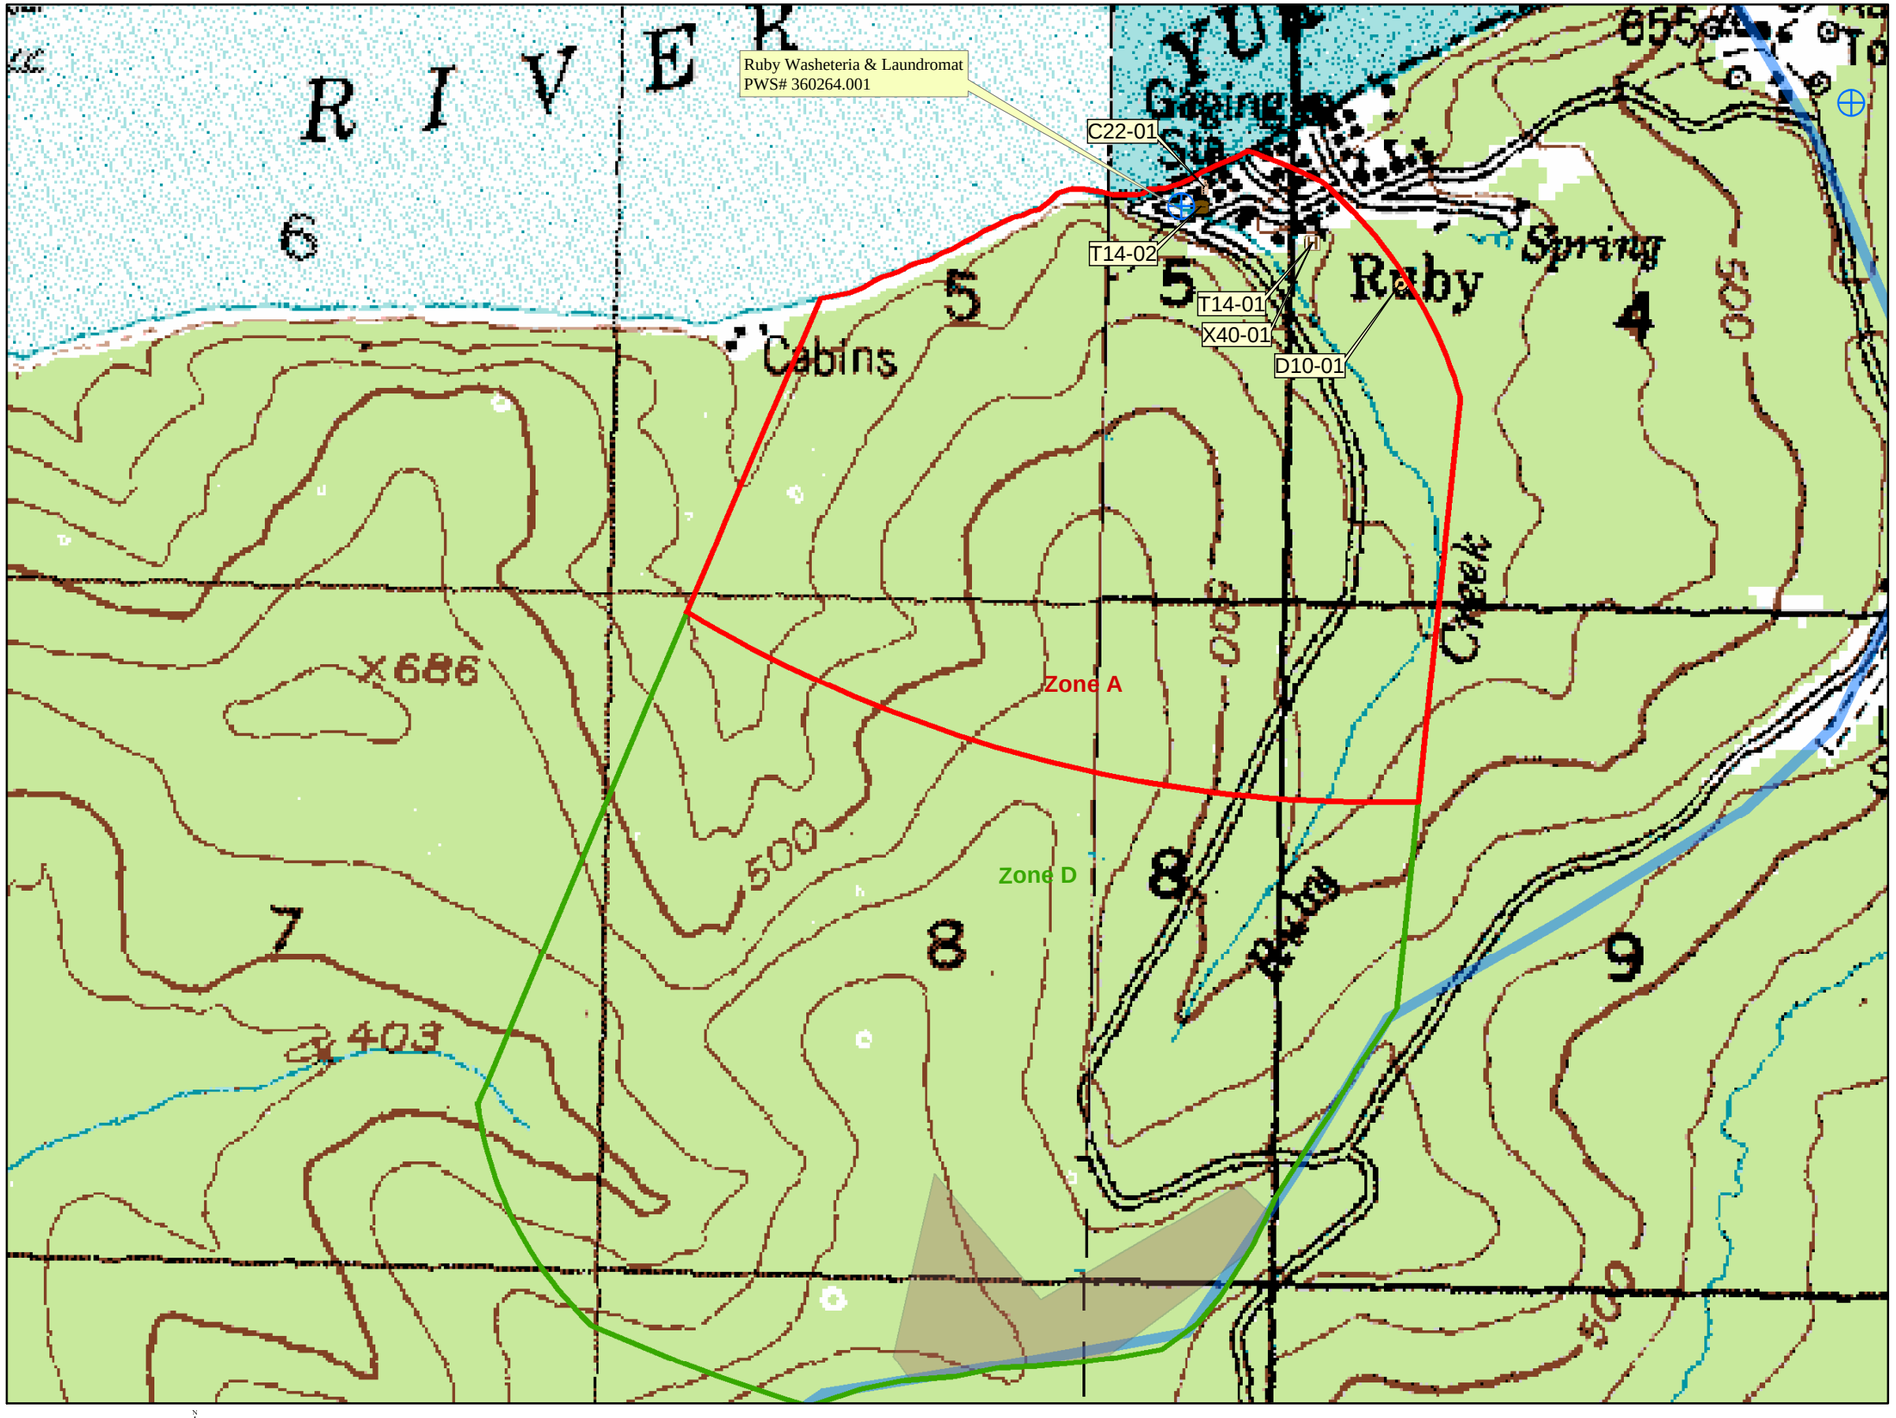
Drinking Water Protection Area
and Potential and Existing Contaminant Sources
(Map C)

Identified potential and current sources of contaminants for the public drinking water source include pit toilets, a large capacity septic system, a landfill and aboveground fuel storage tanks. An inventory of potential or existing contamination sources can be found in Appendix B, Table 1. These identified potential and existing sources of contamination are considered as sources of bacteria and viruses, nitrates and/or nitrites, volatile organic chemicals, heavy metals, cyanide and other inorganic chemicals, synthetic organic chemicals, and other organic chemicals contaminant categories.

The sources are displayed on Map C of Appendix C and summarized in Table 1 of Appendix B.

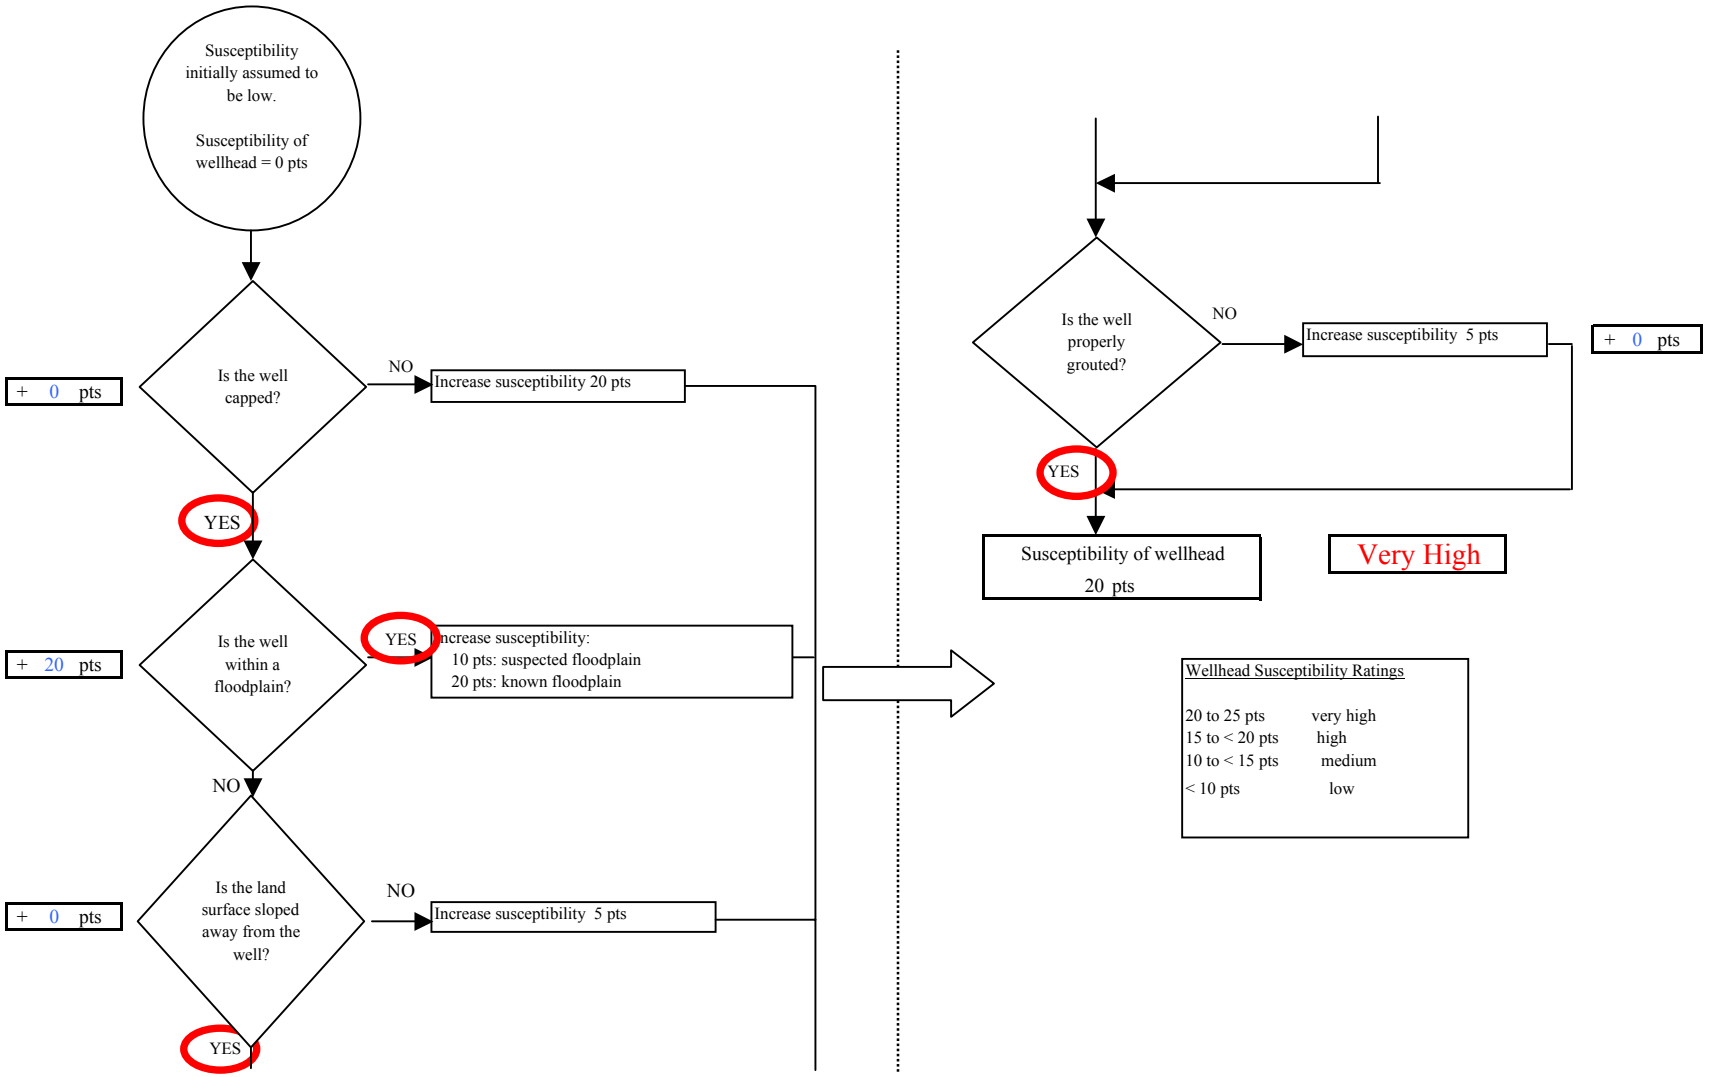
Chart 1. Susceptibility of the wellhead - Ruby Washeteria & Laundromat (PWS No 360264.001)

Score	Rating
Susceptibility of the Wellhead	20	Very High
Susceptibility of the Aquifer	22	Very High
Natural Susceptibility	42	Very High

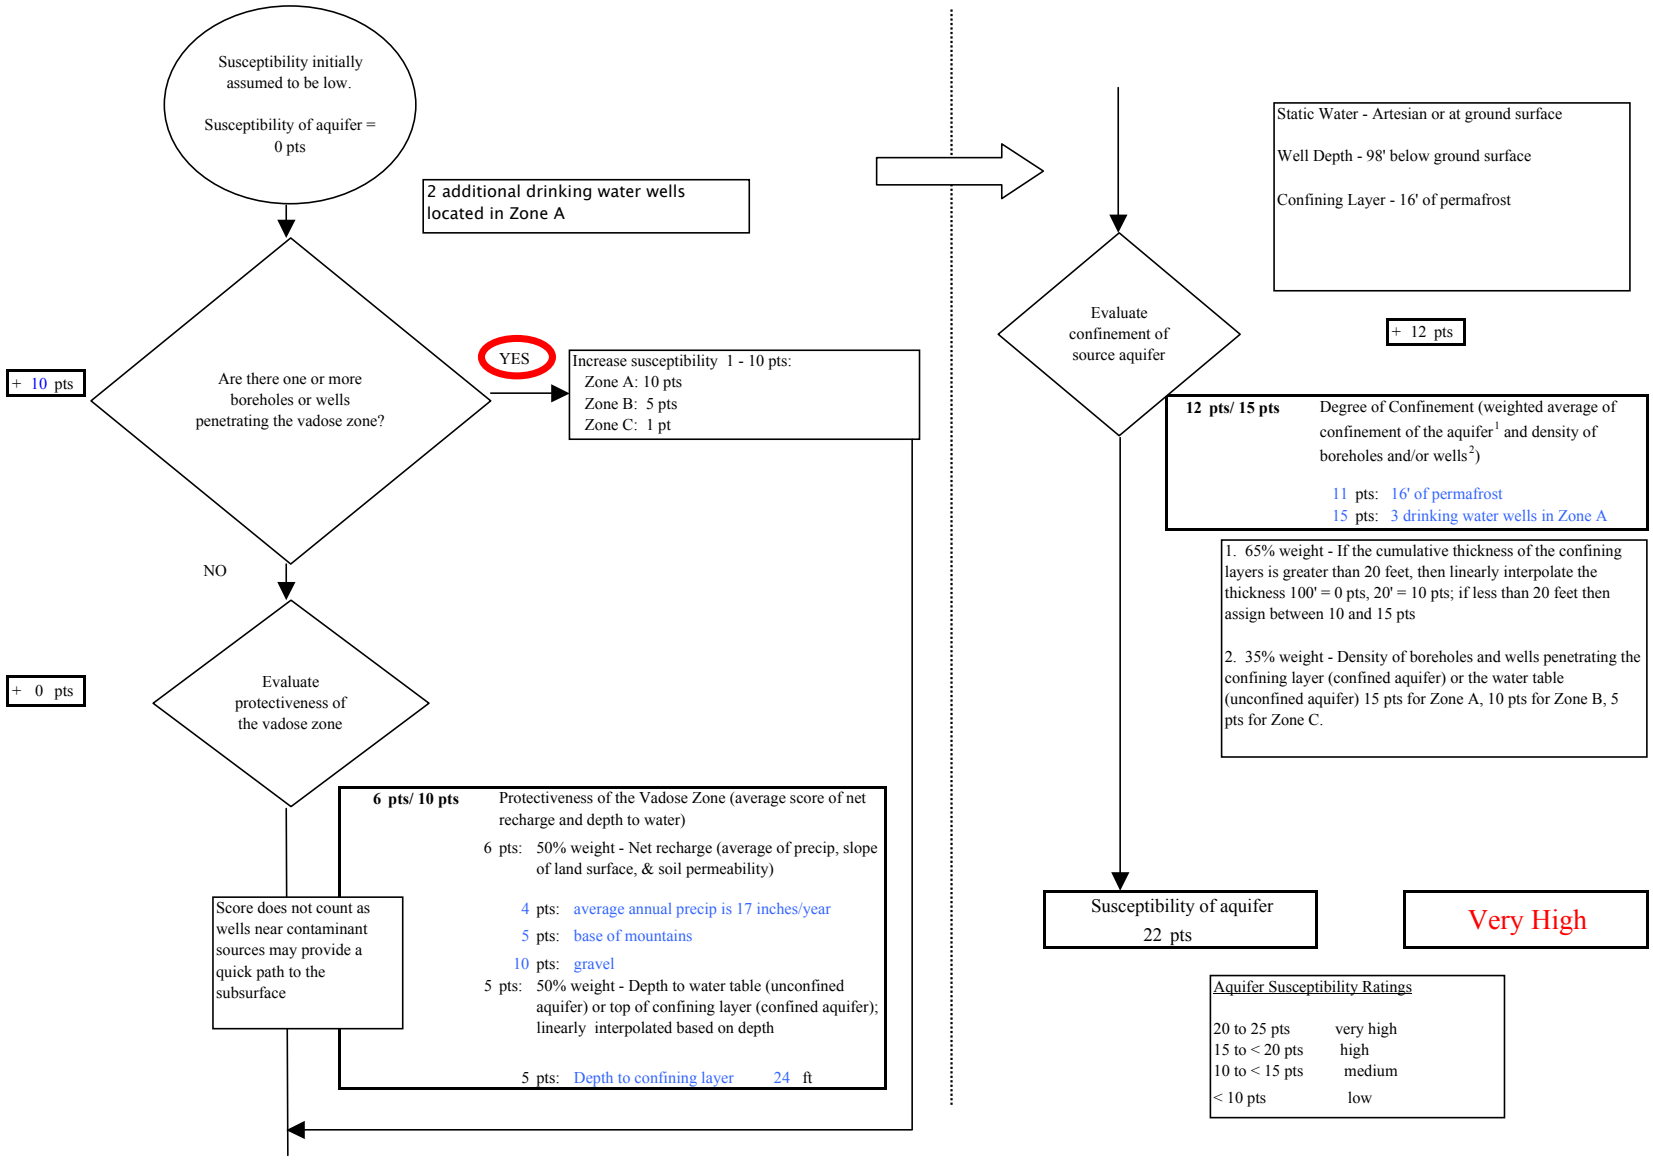
Chart 2. Susceptibility of the aquifer Ruby Washeteria & Laundromat (PWS No 360264.001)

The Ruby Washeteria & Laundromat's water well is in a confined aquifer. Confined aquifers are less susceptible to potential groundwater quality impacts posed by the migration of surface water contaminants downward from the surface. Table 2 shows the susceptibility scores and ratings for this PWS.

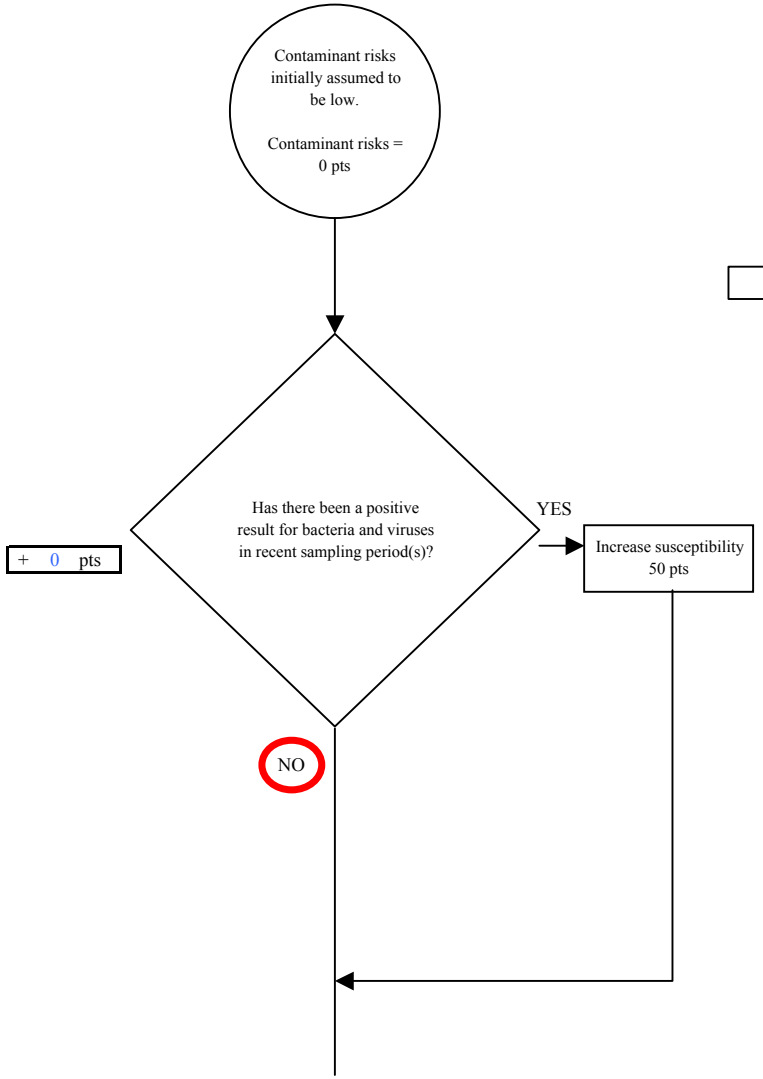
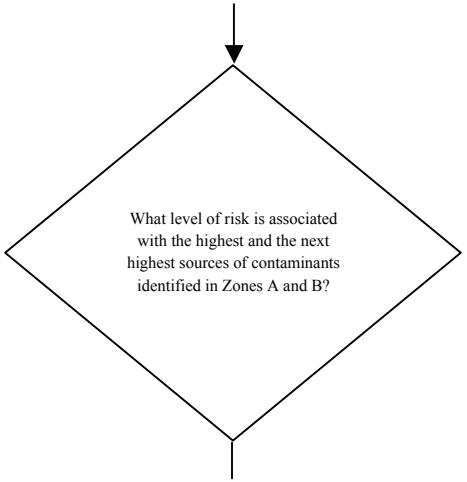
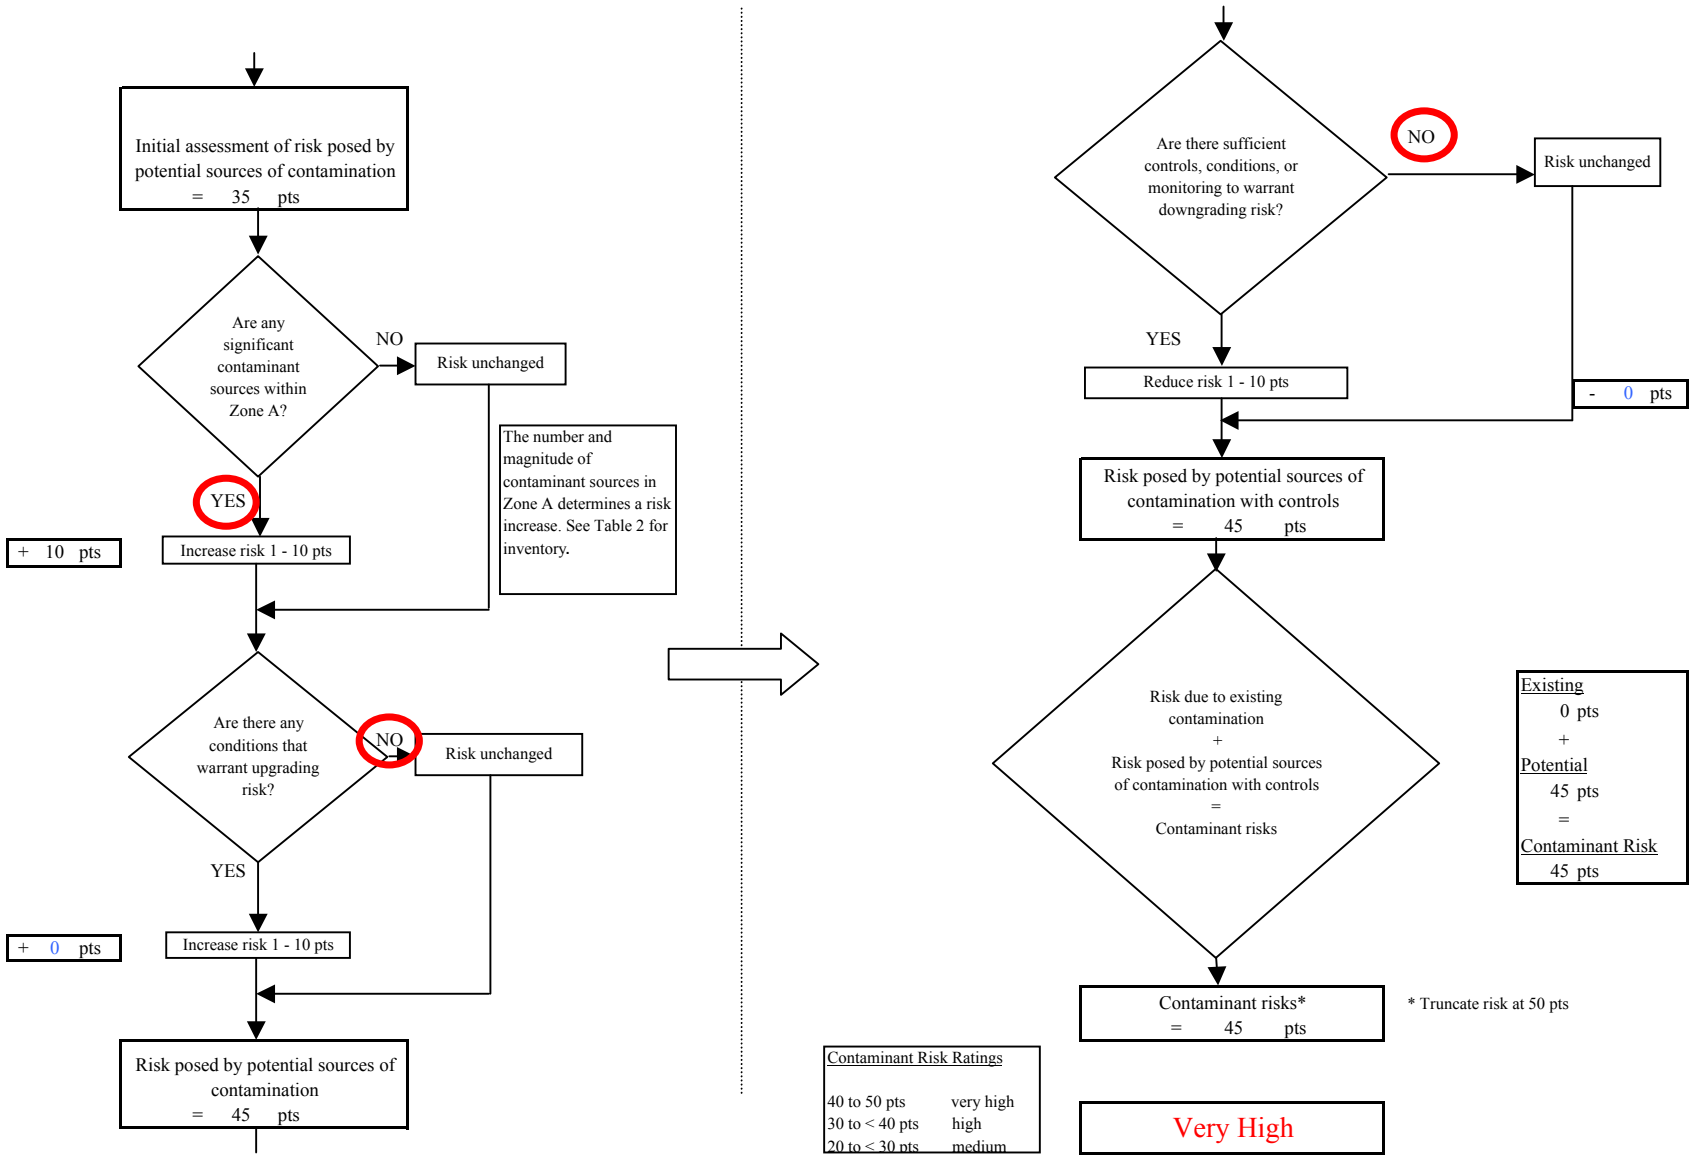
Chart 3. Contaminant risks for Ruby Washeteria & Laundromat (PWS No 360264.001) - Bacteria & Viruses

The contaminant risk for bacteria and viruses is **Very High**. The risk is primarily attributed to the presence of a large capacity septic system located in Zone A and a landfill in Zone D (see Table 2 – Appendix B). Other potential contaminant sources are also found within the protection area (see Table 2 – Appendix B).

No positive bacteria counts have been reported in recent (within five years) sampling events (See Chart 3 – Contaminant Risks for Bacteria and Viruses in Appendix D). Only a small amount of bacteria and viruses are required to endanger public health.

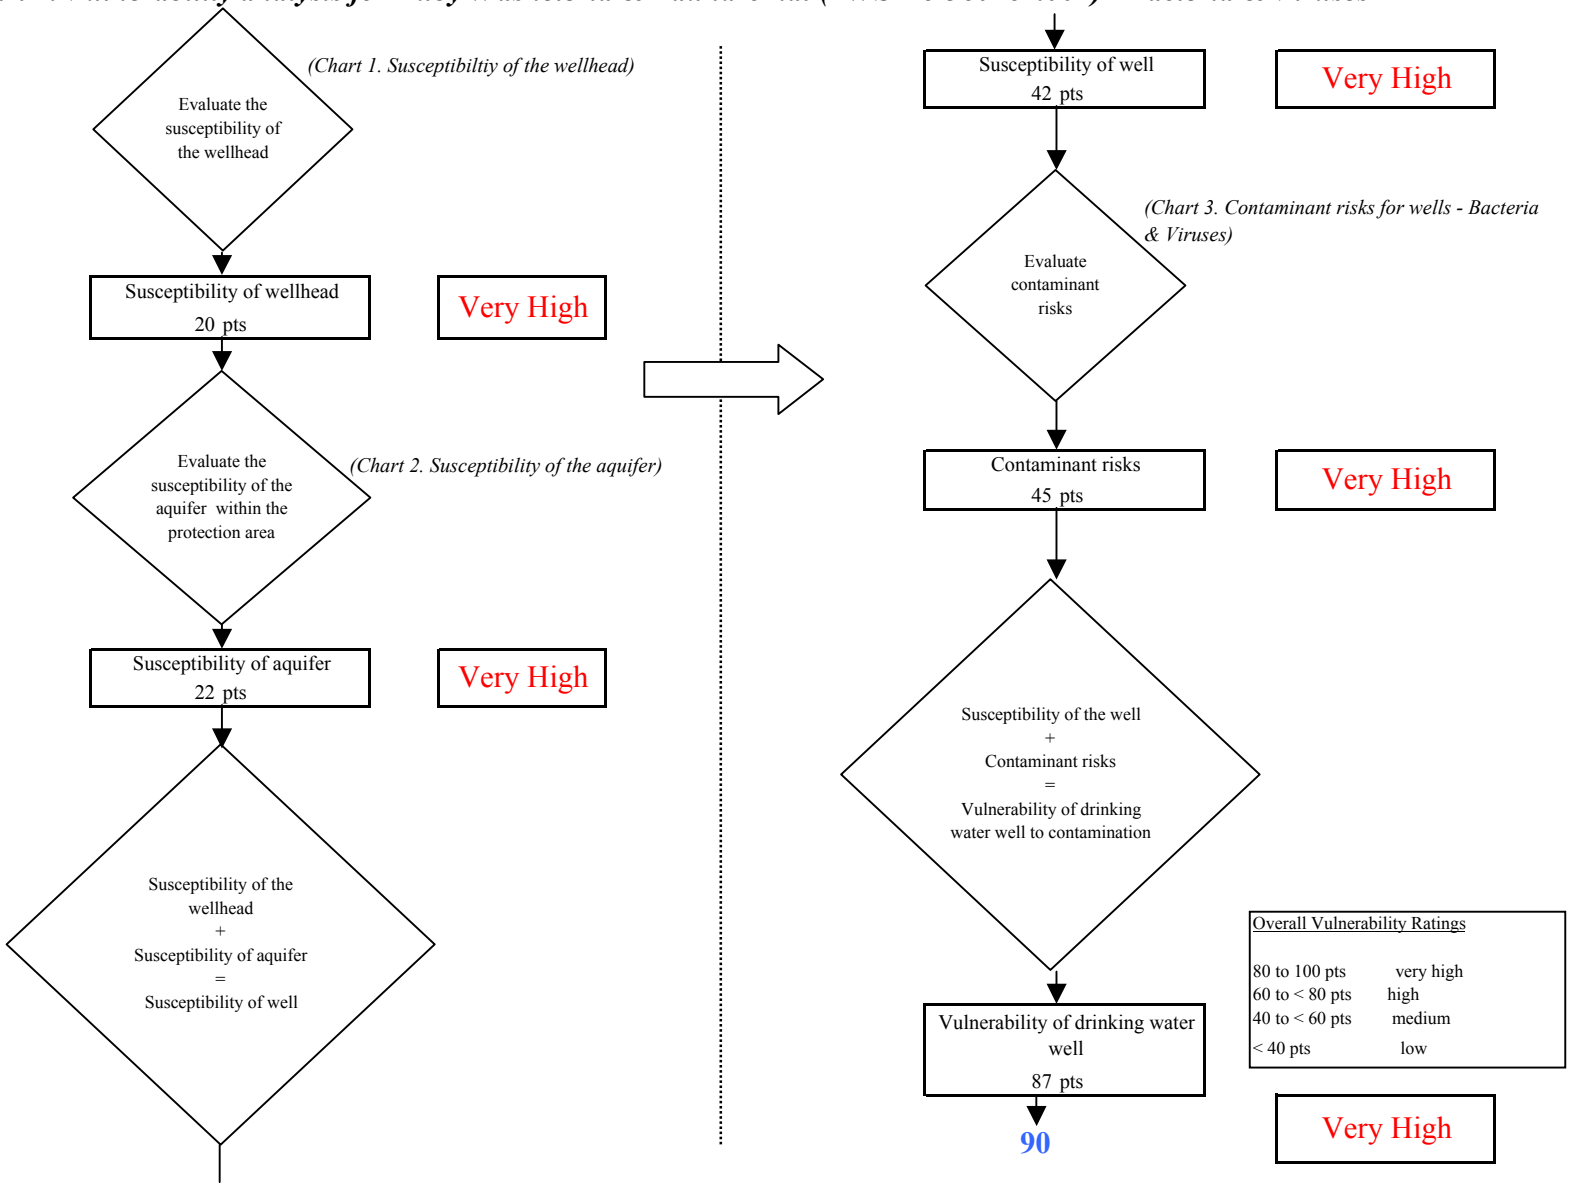
Chart 4. Vulnerability analysis for Ruby Washeteria & Laundromat (PWS No 360264.001) - Bacteria & Viruses

After combining the contaminant risk for bacteria and viruses with the natural susceptibility of the well, the overall vulnerability of the well to contamination is **Very High**.

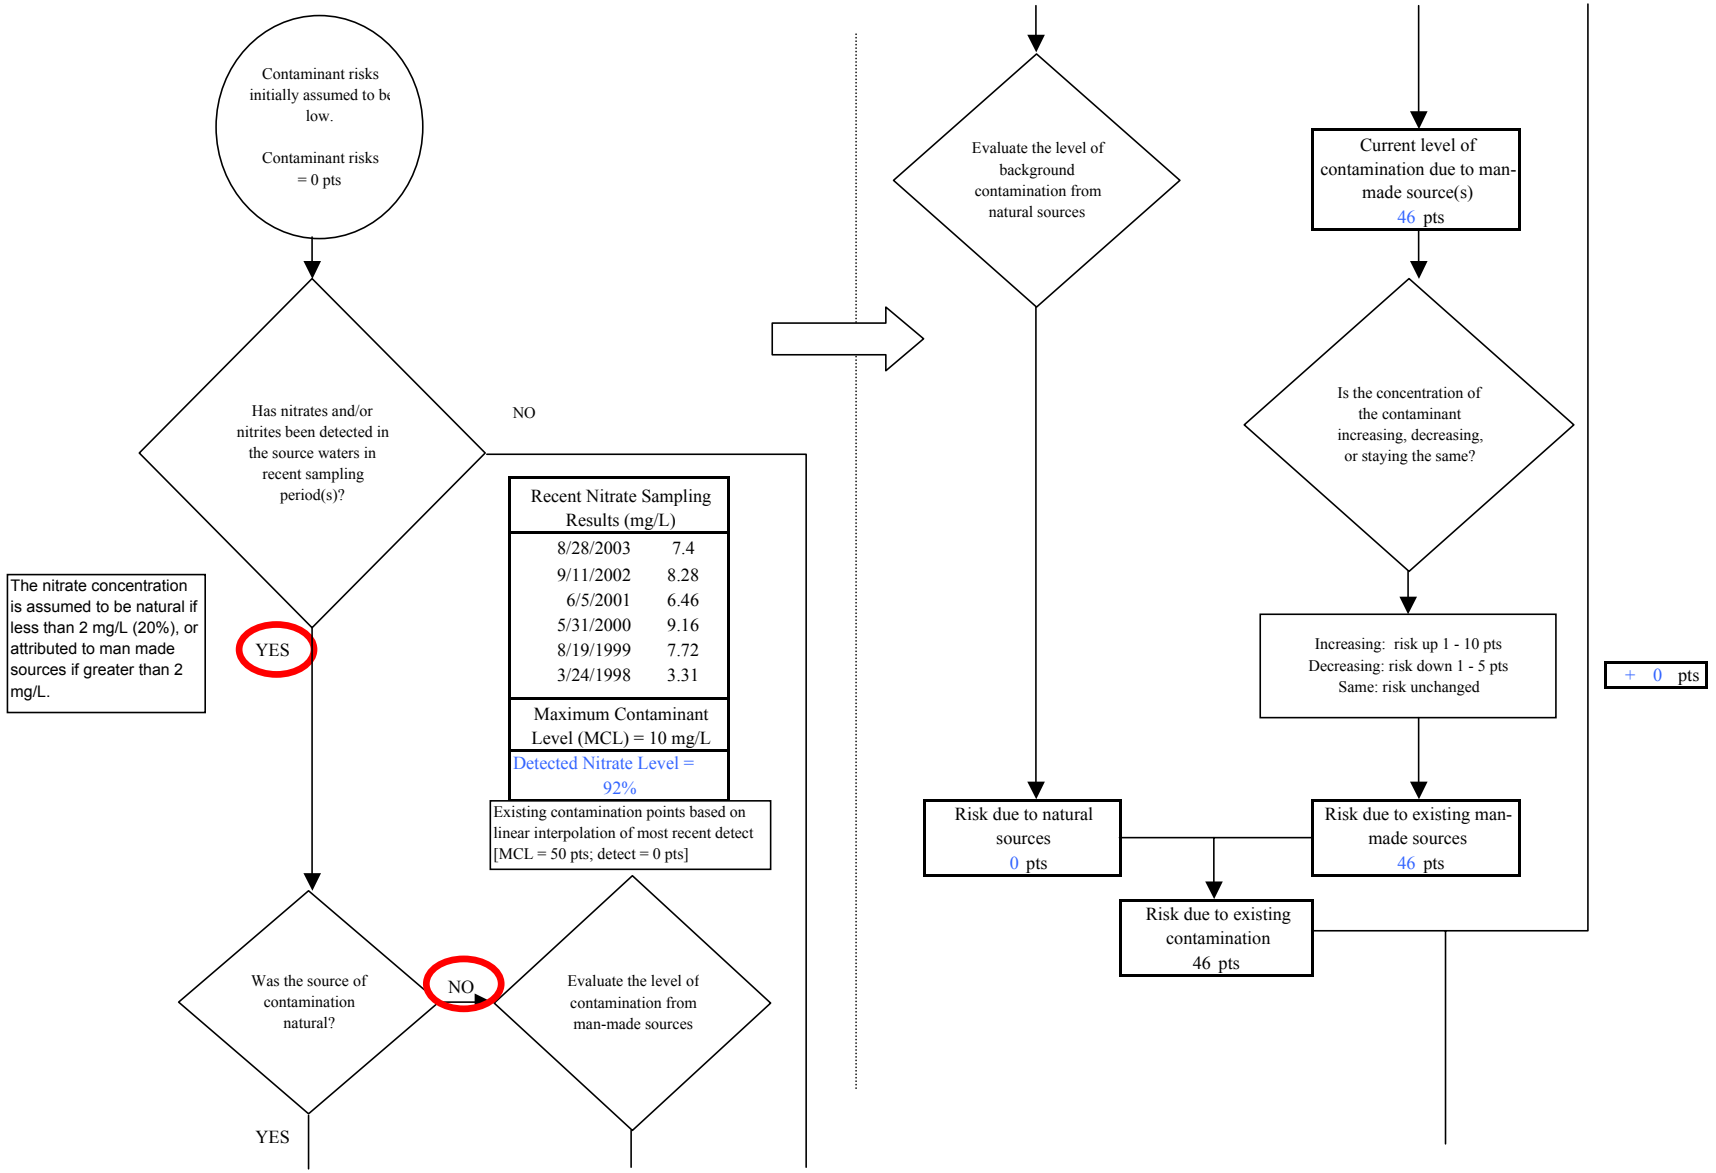
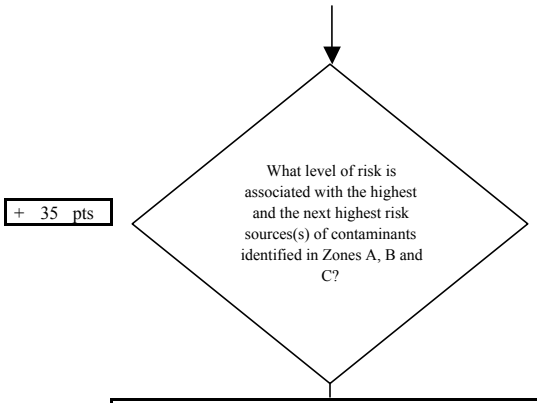
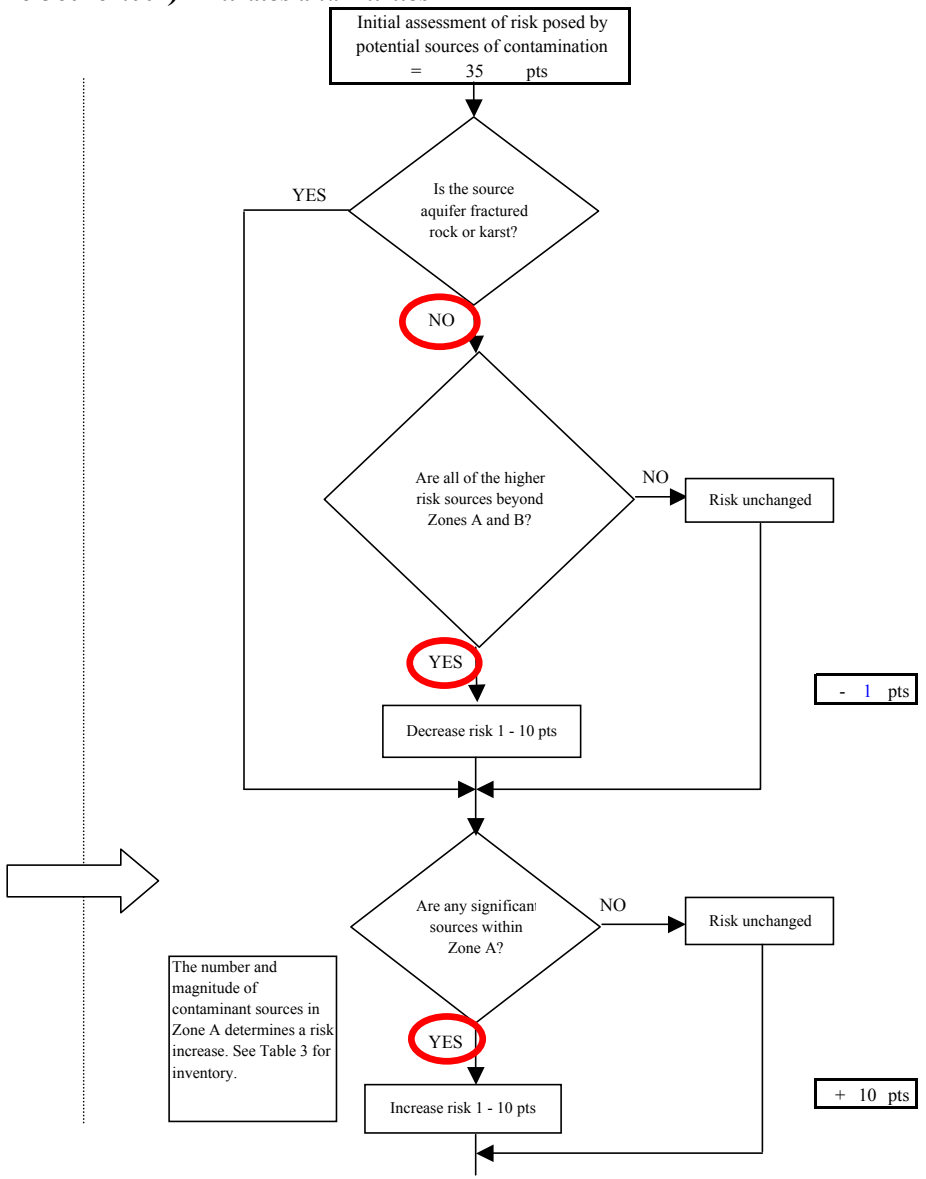
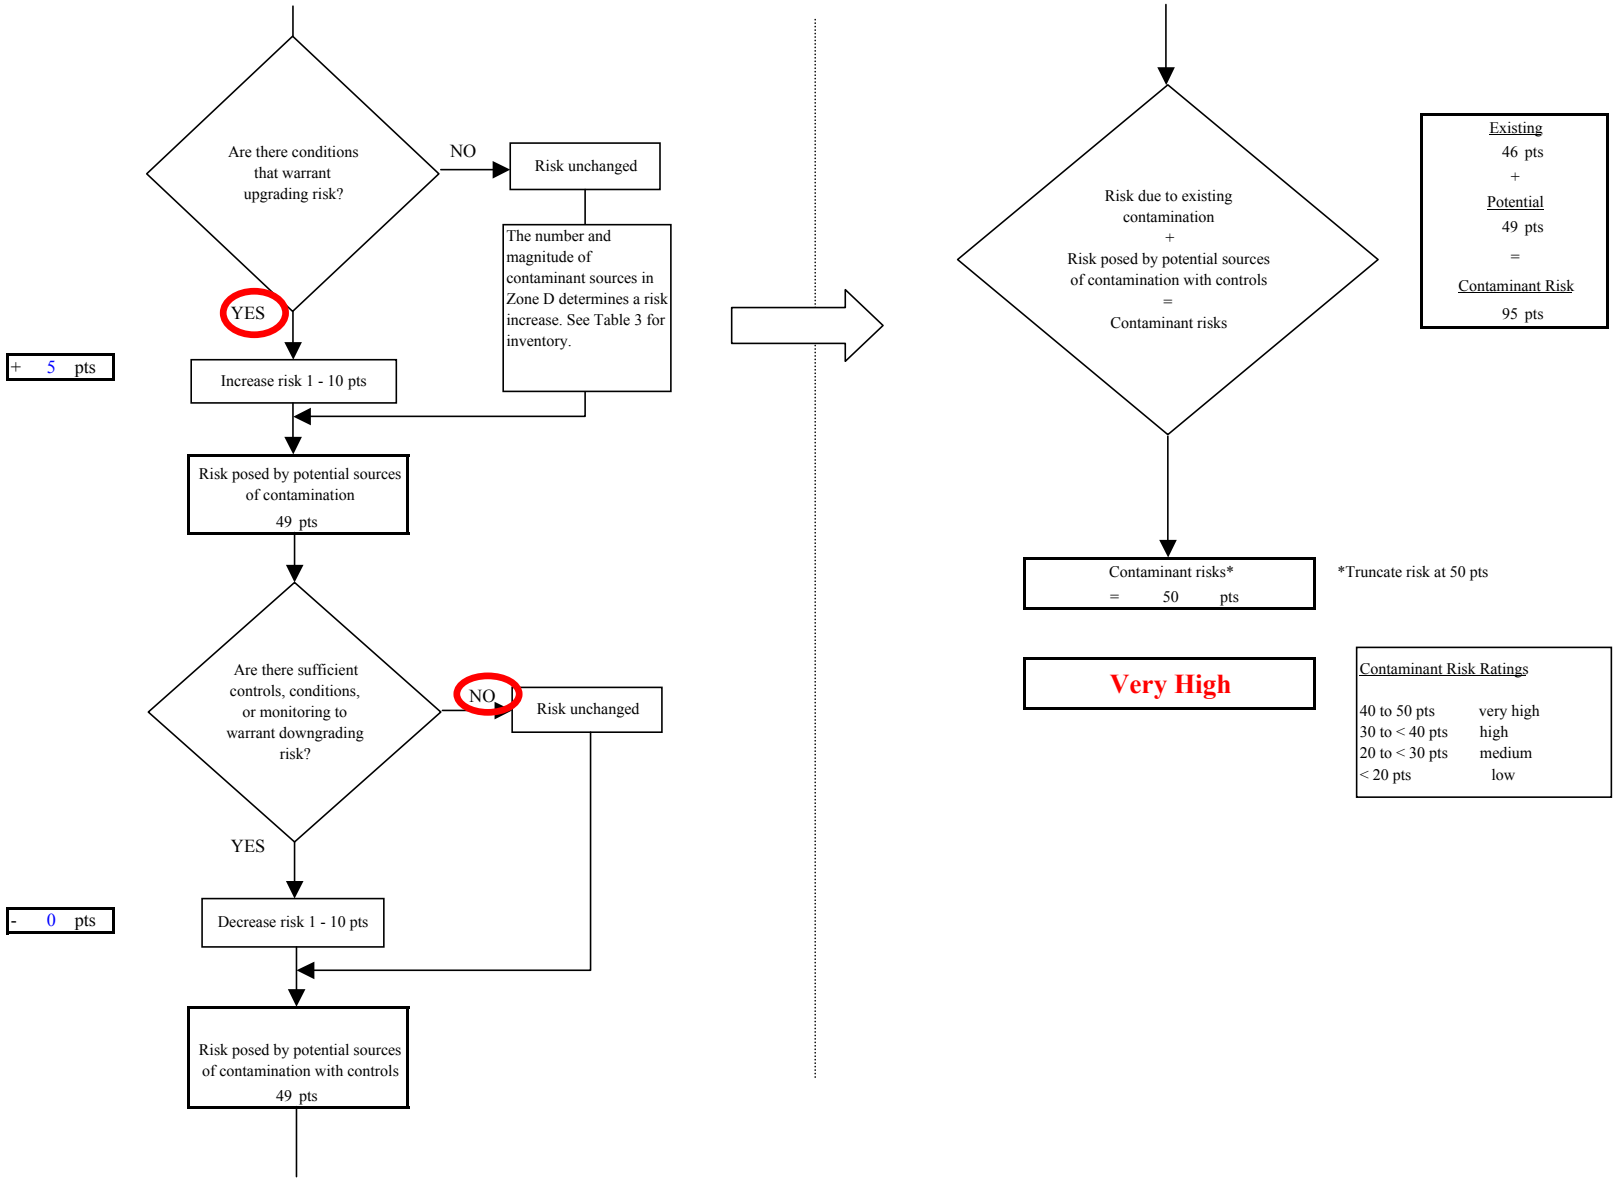
Chart 5. Contaminant risks for Ruby Washeteria & Laundromat (PWS No 360264.001) - Nitrates and Nitrites

The contaminant risk for nitrates and nitrites is **Very High.** The risk to this source of public drinking water is primarily attributed to the presence of a large capacity septic system located in Zone A and a landfill in Zone D (see Table 3 – Appendix B). Other potential contaminant sources are also found within

Nitrates are very mobile, moving at approximately the same rate as water. The sampling history for this well indicates that significant levels nitrates have been detected in recent sampling events, however they did not exceed the MCL of 10mg/L. Nitrate concentrations in uncontaminated groundwater are typically less than 2 mg/L; therefore, nitrate concentrations above 2 mg/L may be indicative of man-made sources (See Chart 5 - Contaminant Risks for Nitrates and/or Nitrites in Appendix D).

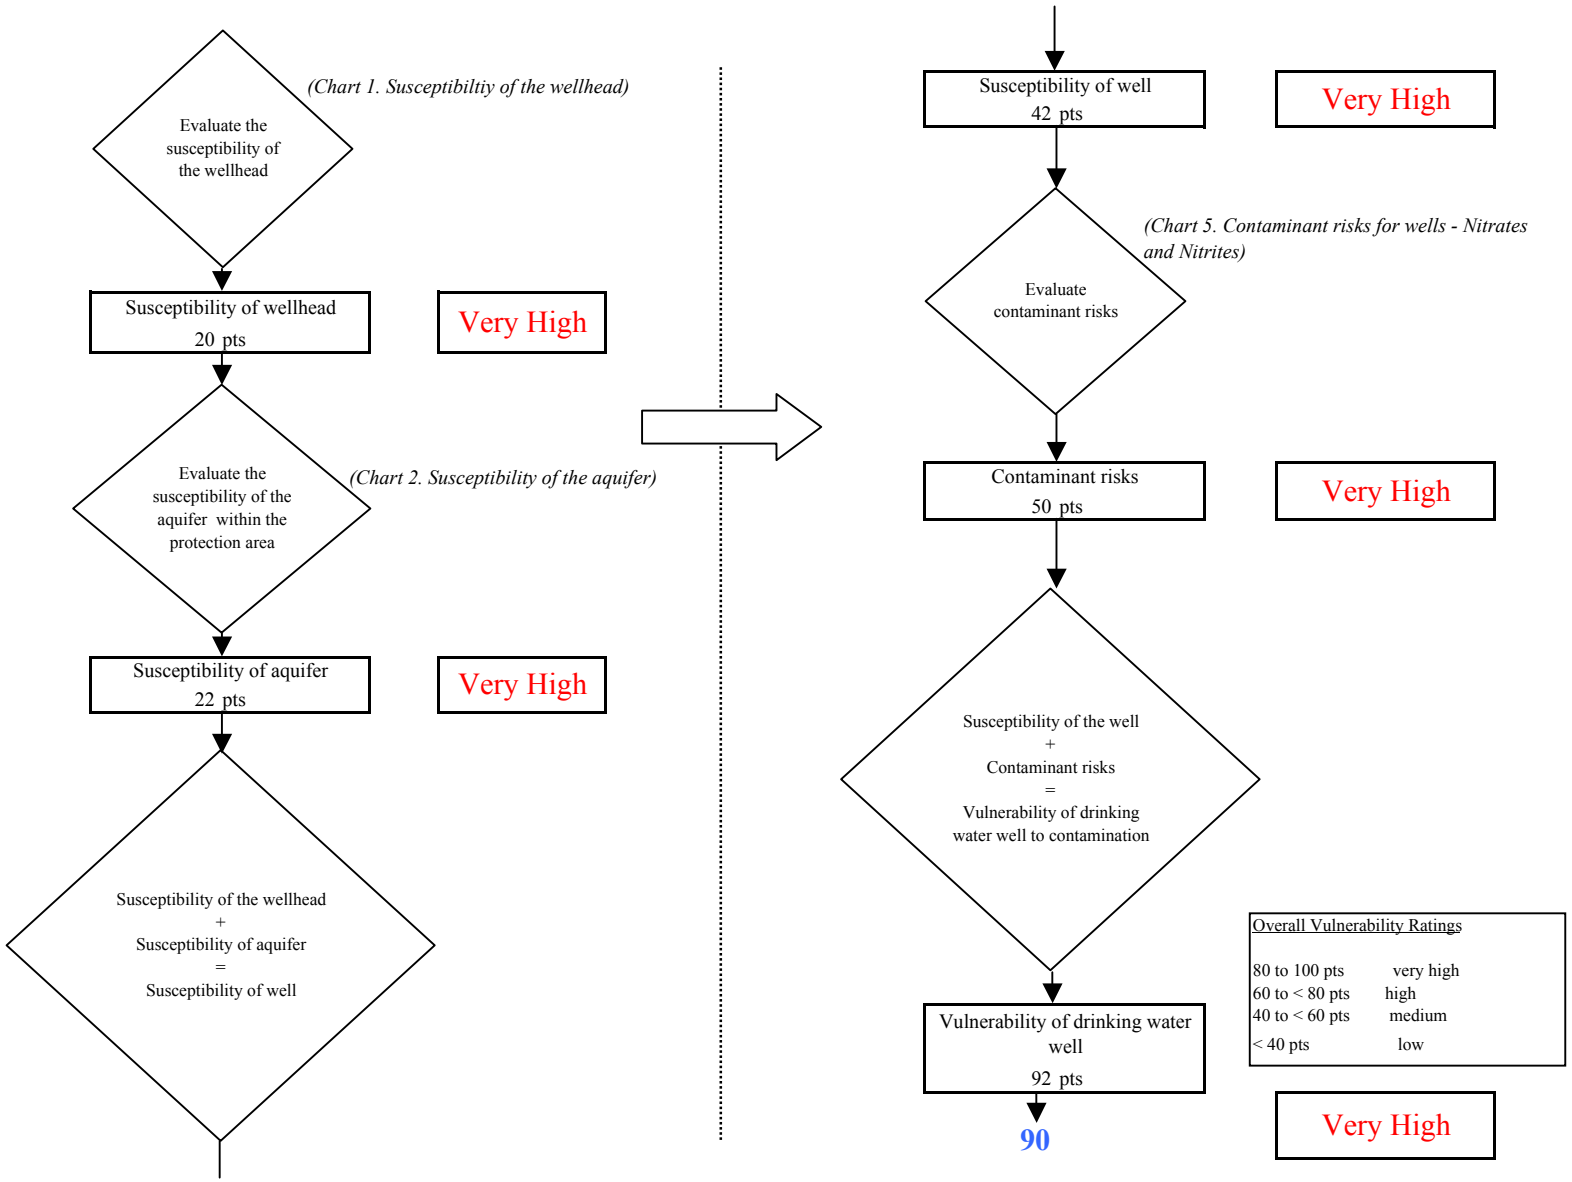
Chart 6. Vulnerability analysis for Ruby Washeteria & Laundromat (PWS No 360264.001) - Nitrates and Nitrites

Nitrate levels are often derived from the decomposition of organic matter in soils. Although the nitrate source is unknown, such occurrences may be attributed to septic systems or other sources. After combining the contaminant risk for nitrates and nitrites with the natural susceptibility of the well, the overall vulnerability of the well to nitrate and nitrite contamination is **Very High**.
