Source Water Assessment

A Hydrogeologic Susceptibility and Vulnerability Assessment for Ruby Washeteria & Laundromat Drinking Water System, Ruby, Alaska

PWSID # 360264.001

June 2004

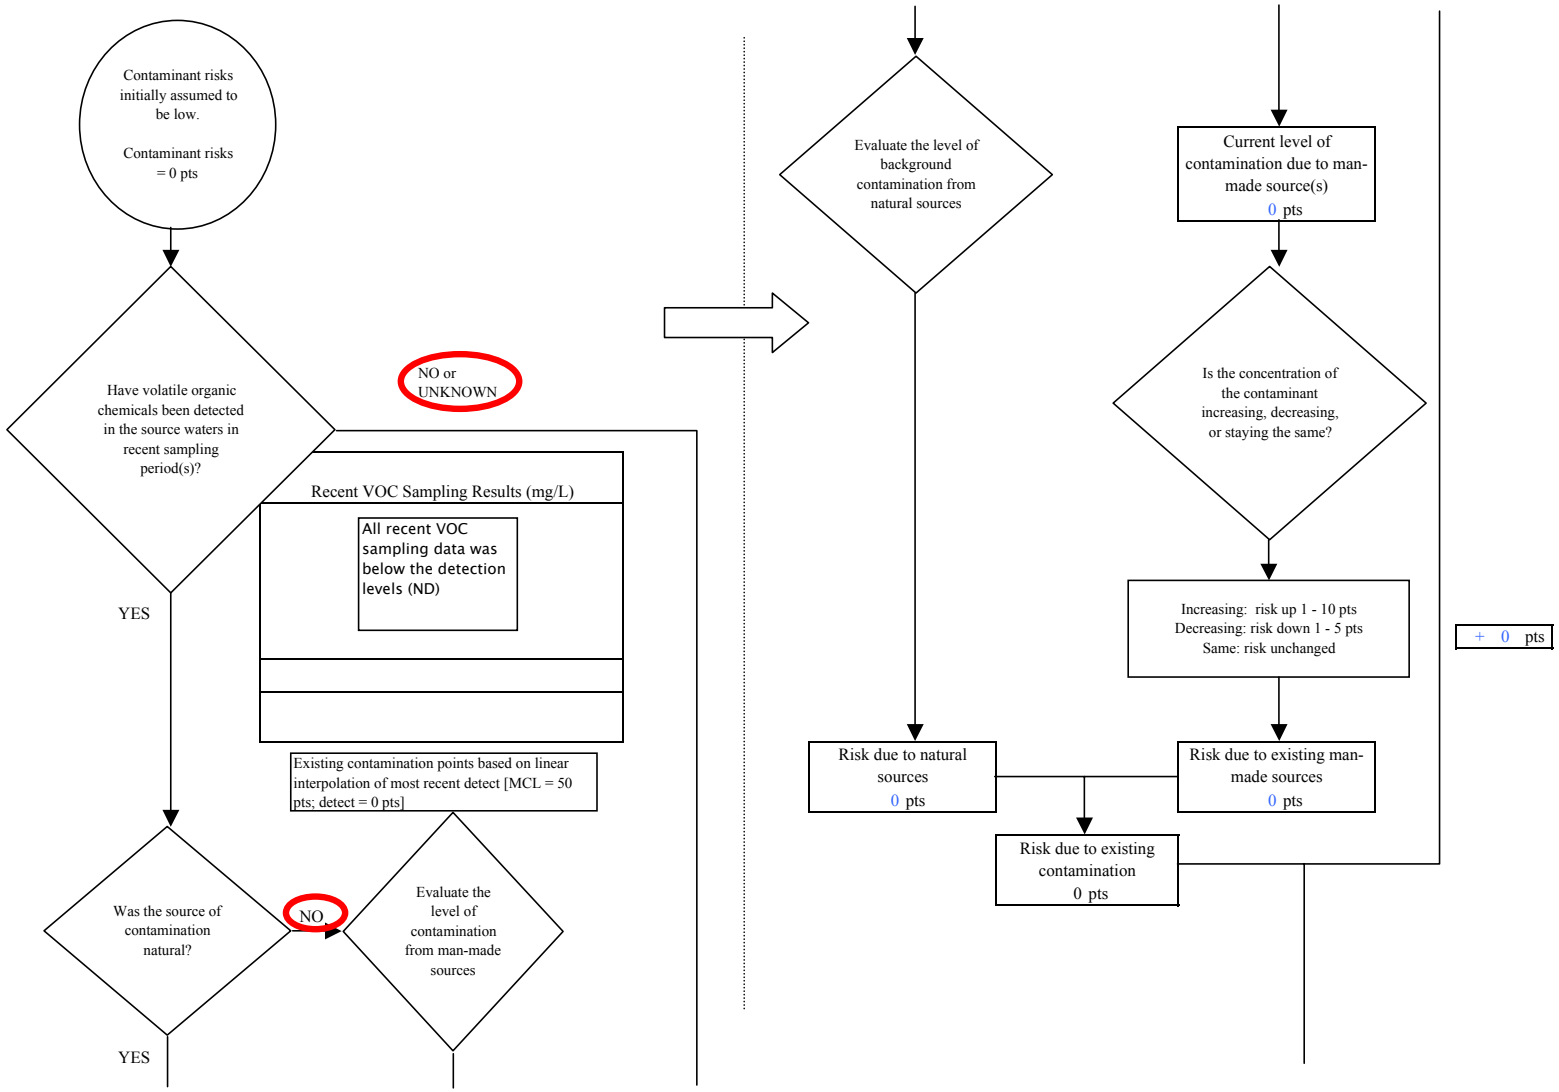
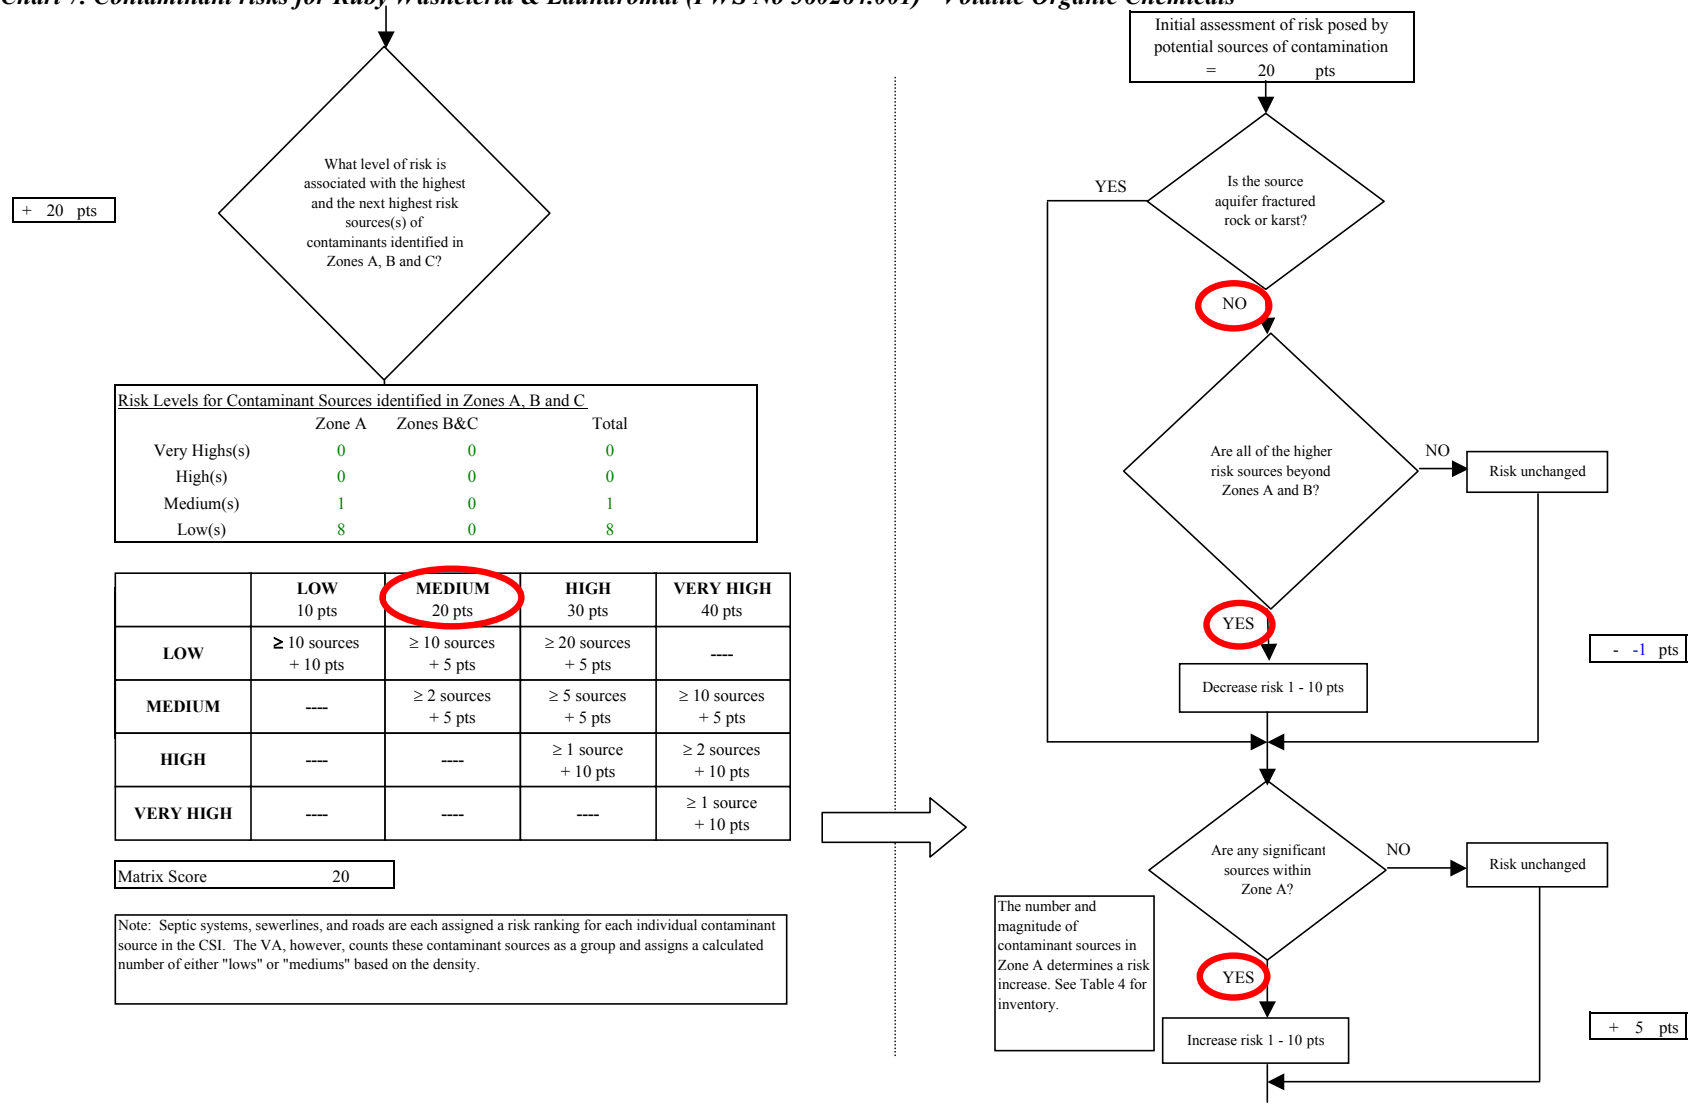
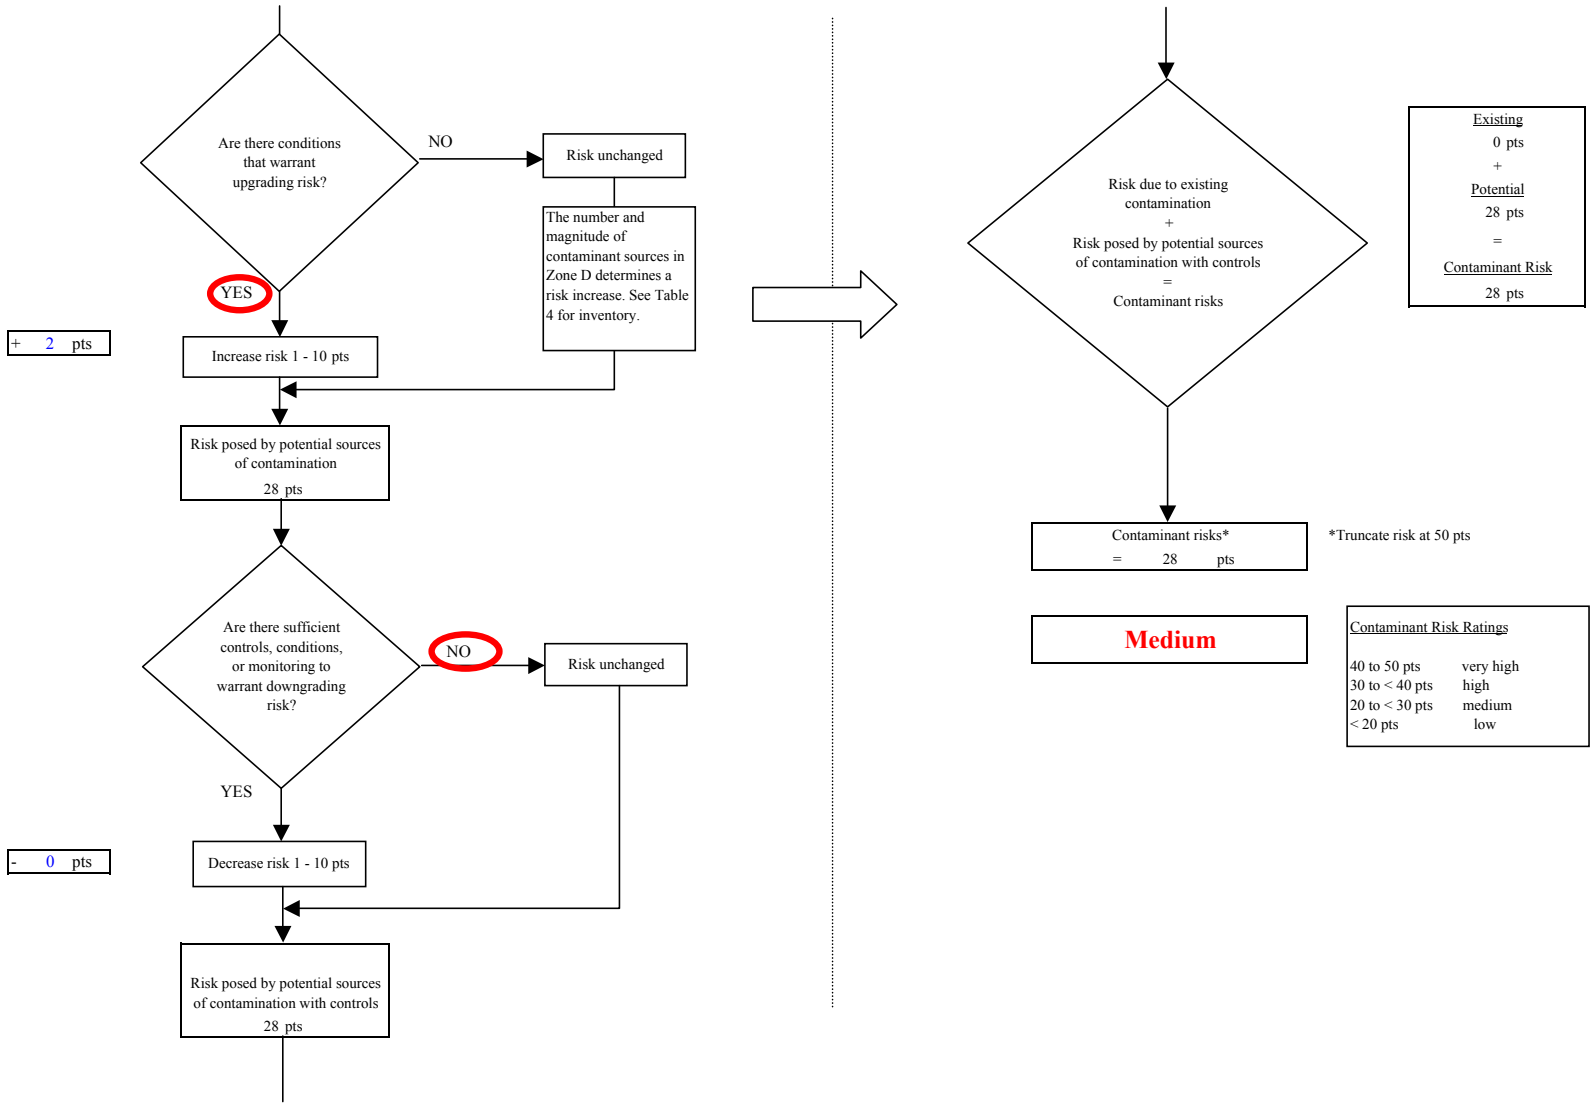
Chart 7. Contaminant risks for Ruby Washeteria & Laundromat (PWS No 360264.001) - Volatile Organic Chemicals

The contaminant risk for volatile organic chemicals is **Medium**. The risk is primarily attributed to the presence of aboveground fuel storage tanks located in Zone A and a landfill in Zone D (see Table 4 – Appendix B).

All recent volatile organic sampling data was reported to be below detection levels (See Chart 7 – Contaminant Risks for Volatile Organic Chemicals in Appendix D).

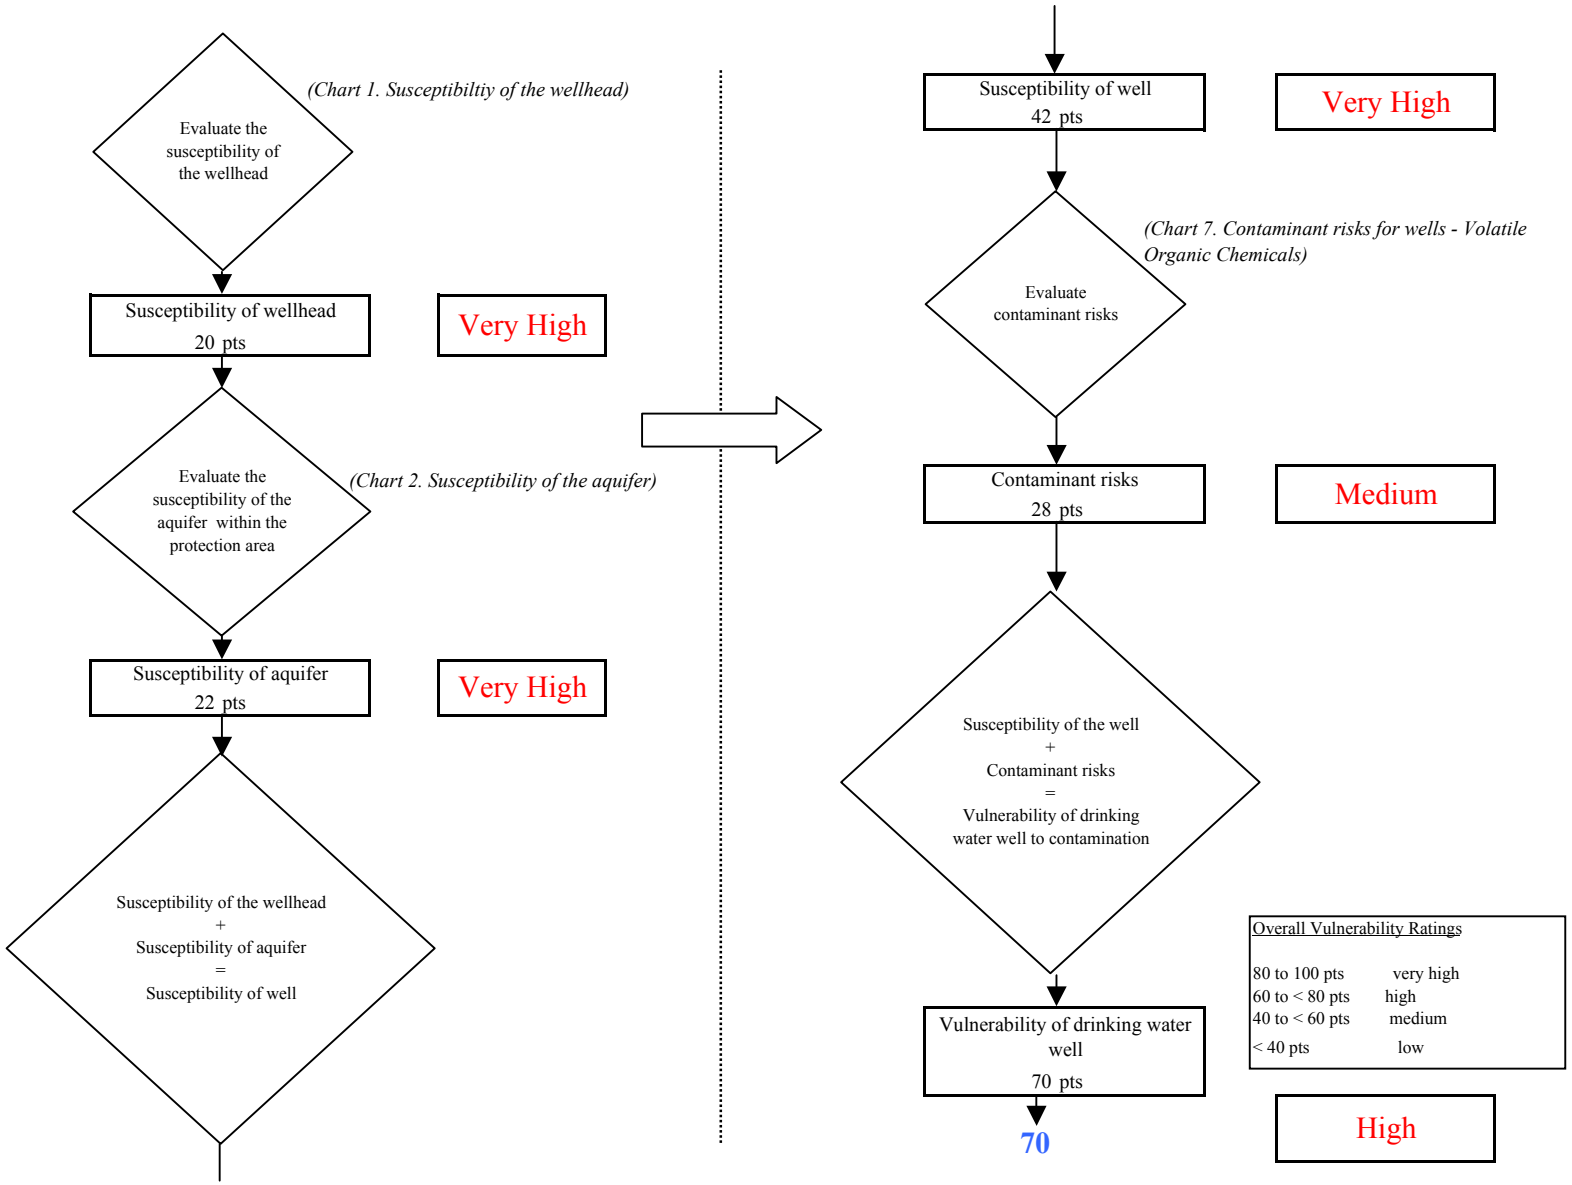
Chart 8. Vulnerability analysis for Ruby Washeteria & Laundromat (PWS No 360264.001) - Volatile Organic Chemicals

After combining the contaminant risk for volatile organic chemicals with the natural susceptibility of the well, the overall vulnerability of the well to contamination is **High**.

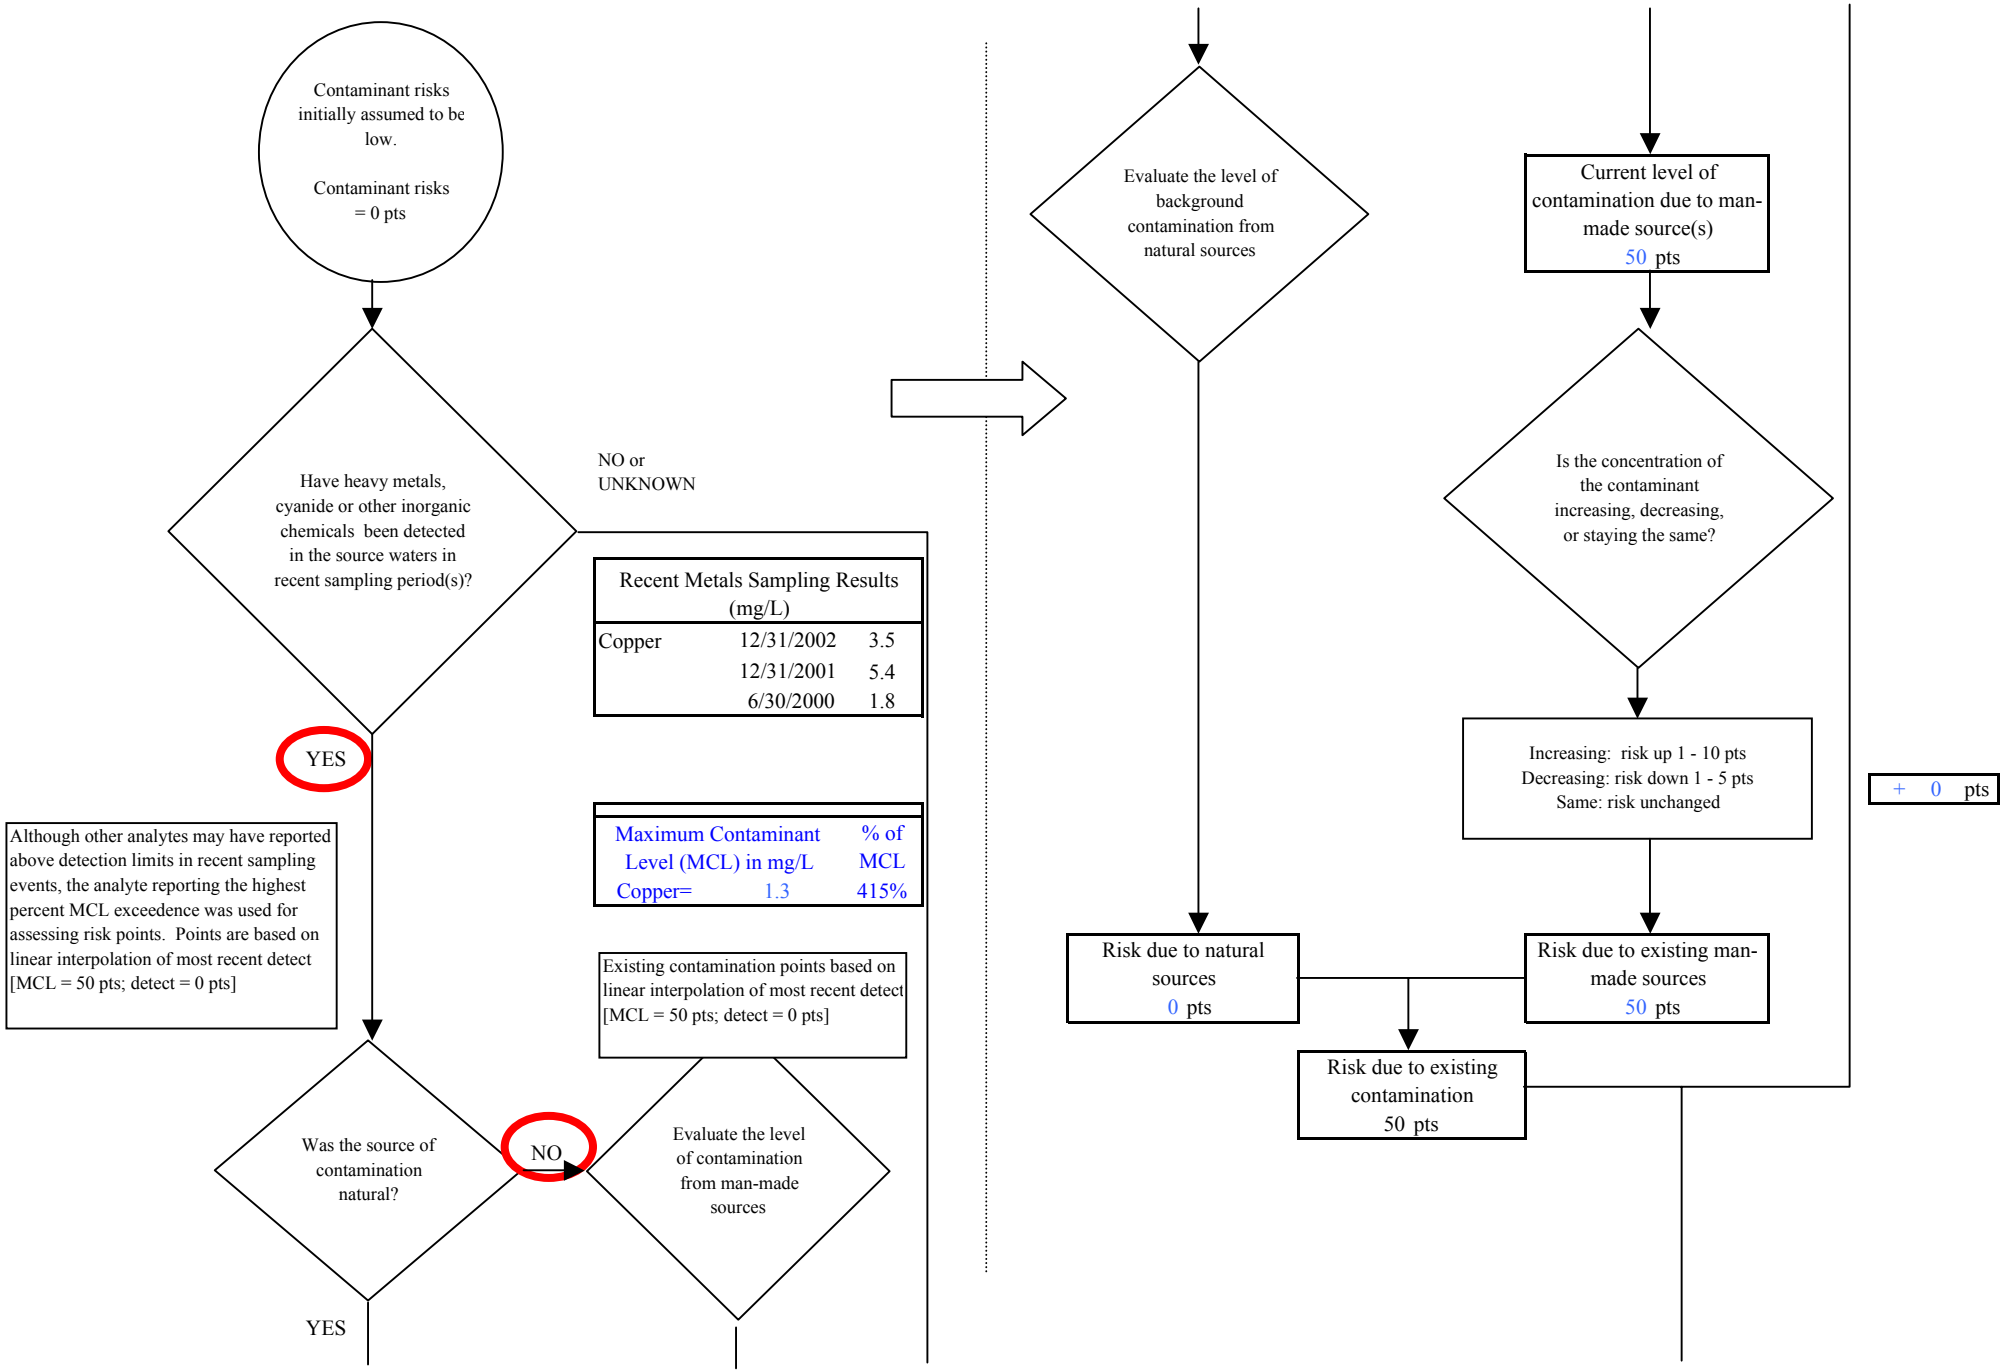
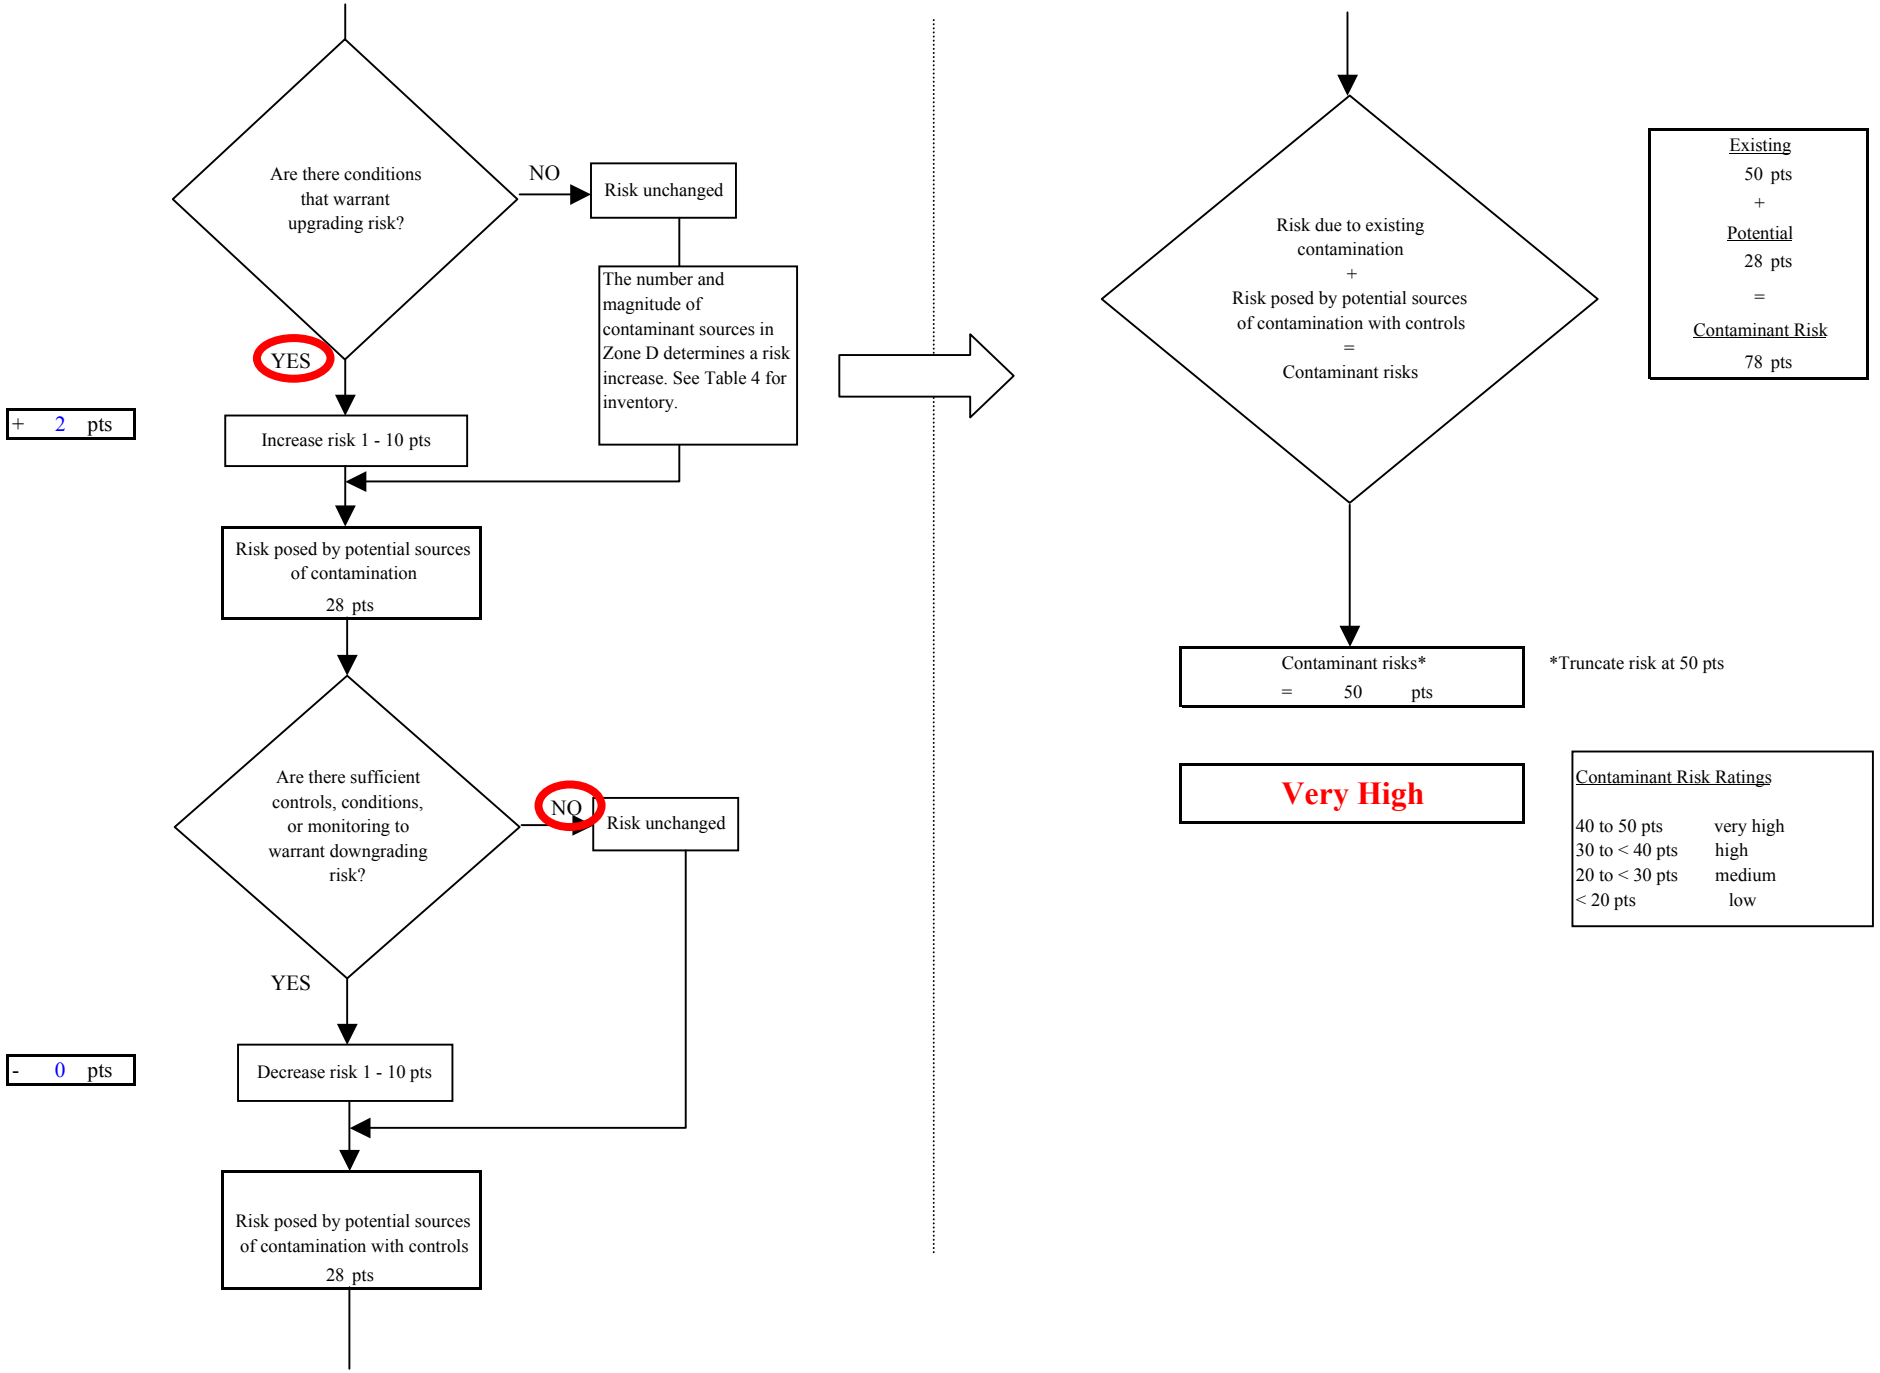
Chart 9. Contaminant risks for Ruby Washeteria & Laundromat (PWS No 360264.001) - Heavy Metals, Cyanide and Other Inorganic Chemicals

The contaminant risk for heavy metals, cyanide and other inorganic chemicals is **Very High.** The risk is primarily attributed to the high levels of copper recorded in recent sampling events as well as the presence of a landfill in Zone D (see Table 5 – Appendix B).

Based on review of recent sampling records for this public water system, high levels of copper have been detected in recent sampling history, and have exceeded the MCL of 1.3 mg/L (see Chart 9 – Contaminant Risks for Heavy Metals, Cyanide, and Other Inorganic Chemicals in Appendix D).

The reported concentrations of copper in recent sampling events are likely representative of source water conditions or an indication of recent maintenance to the distribution system. Risk points were assigned based on the exceedence of the lead MCL.

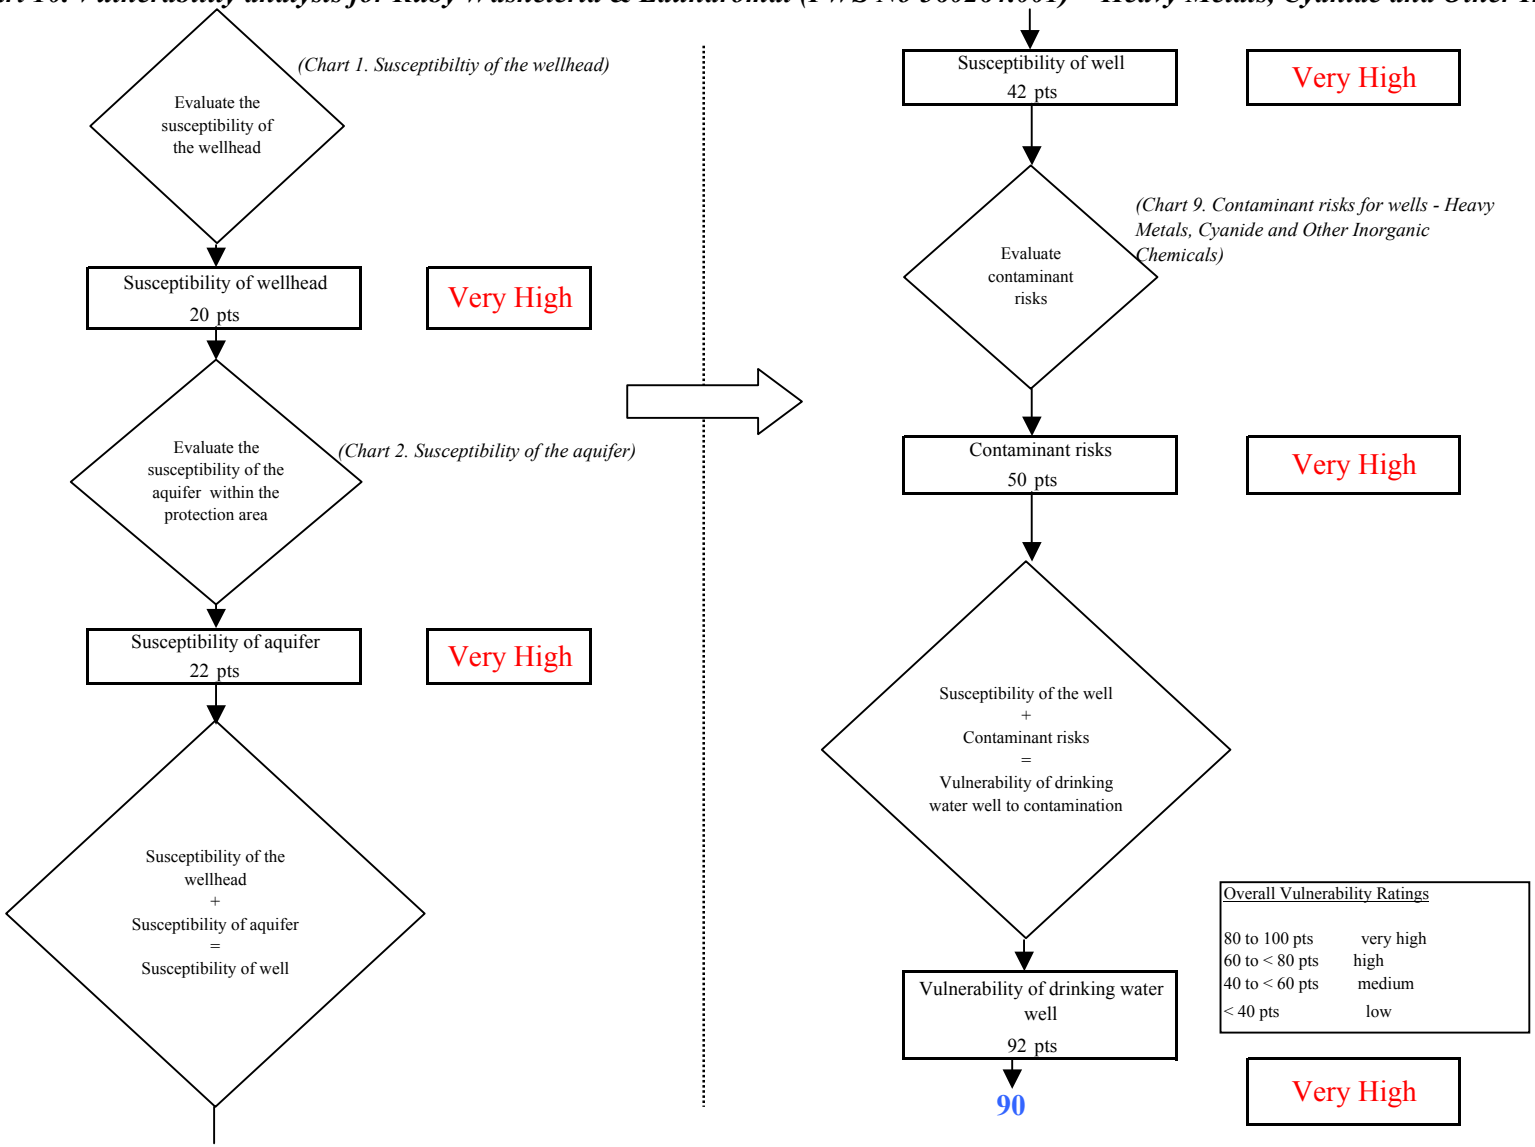
Chart 10. Vulnerability analysis for Ruby Washeteria & Laundromat (PWS No 360264.001) - Heavy Metals, Cyanide and Other Inorganic Chemicals

After combining the contaminant risk for heavy metals, cyanide and other inorganic chemicals with the natural susceptibility of the well, the overall vulnerability of the well to contamination is **Very High.**

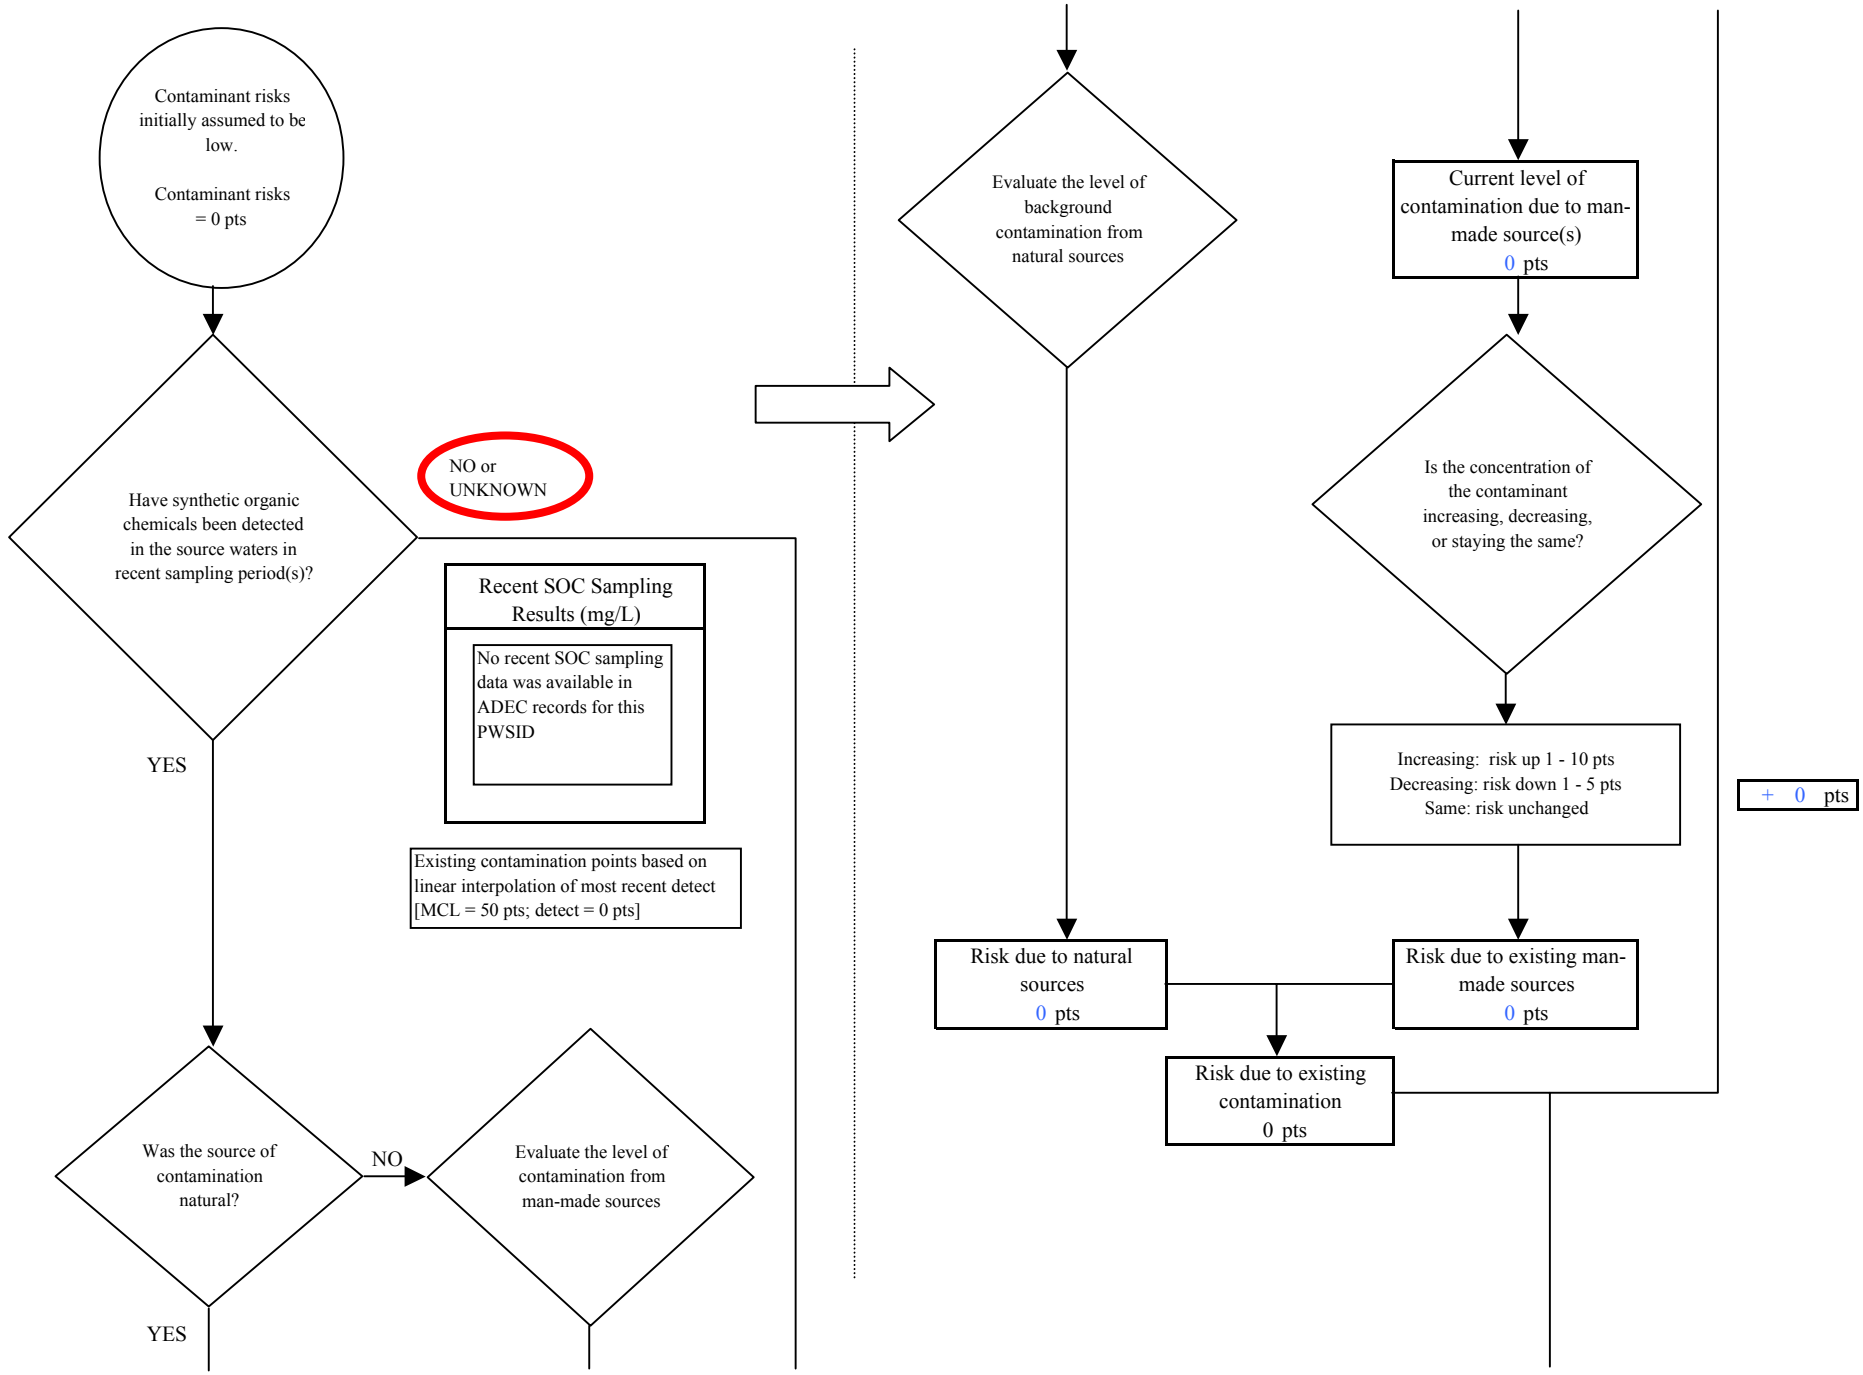
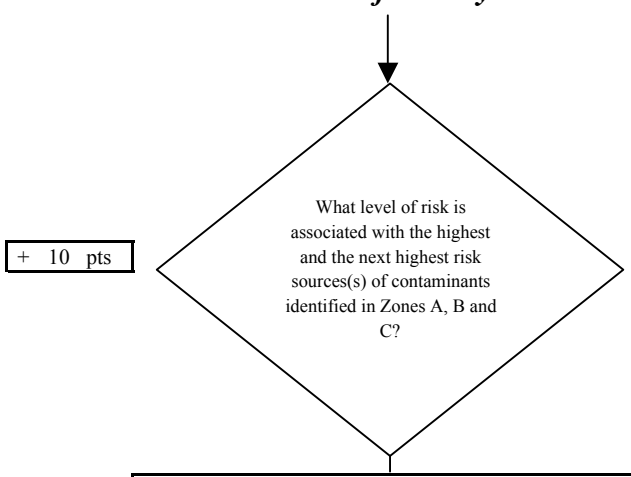
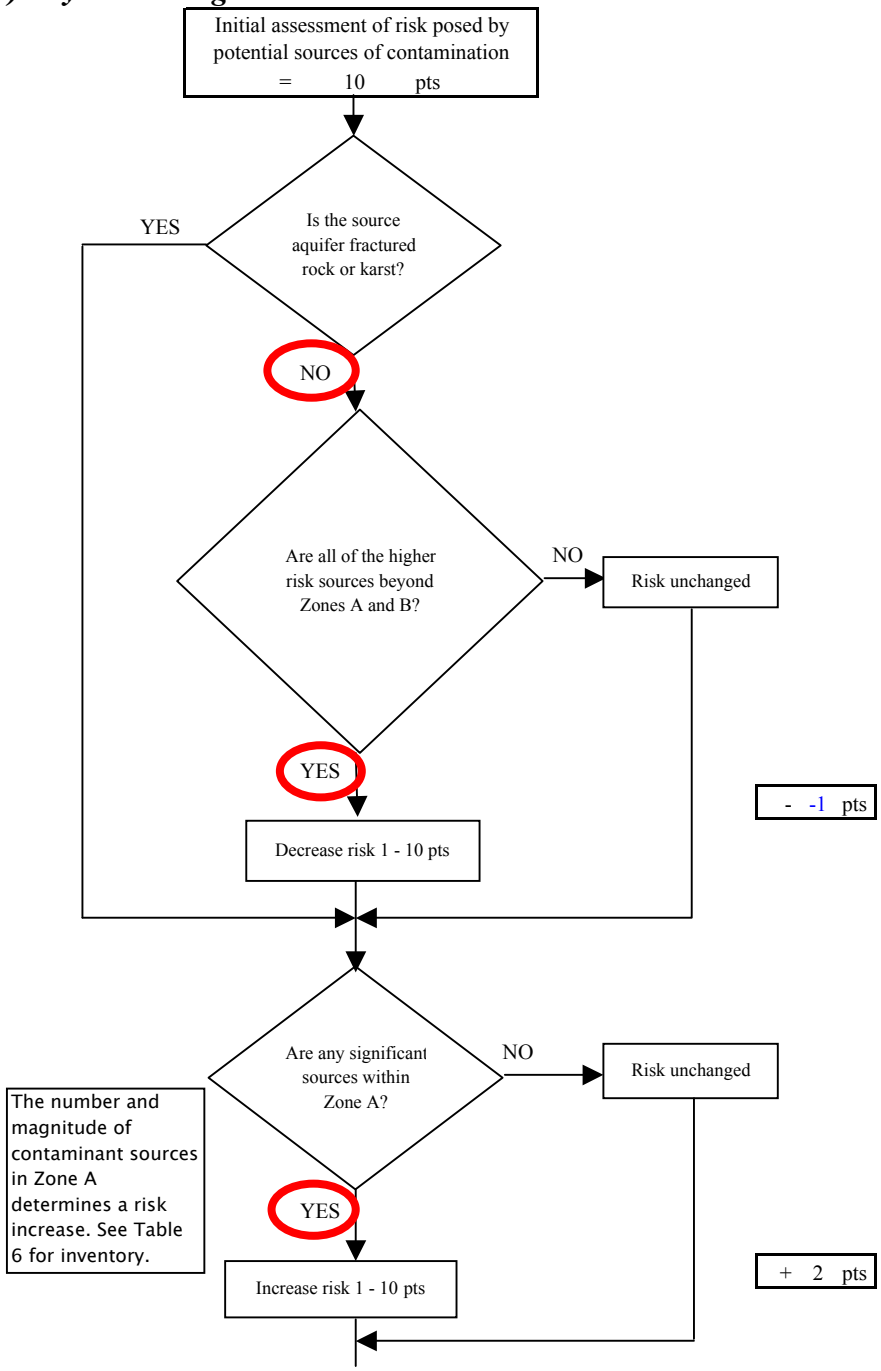
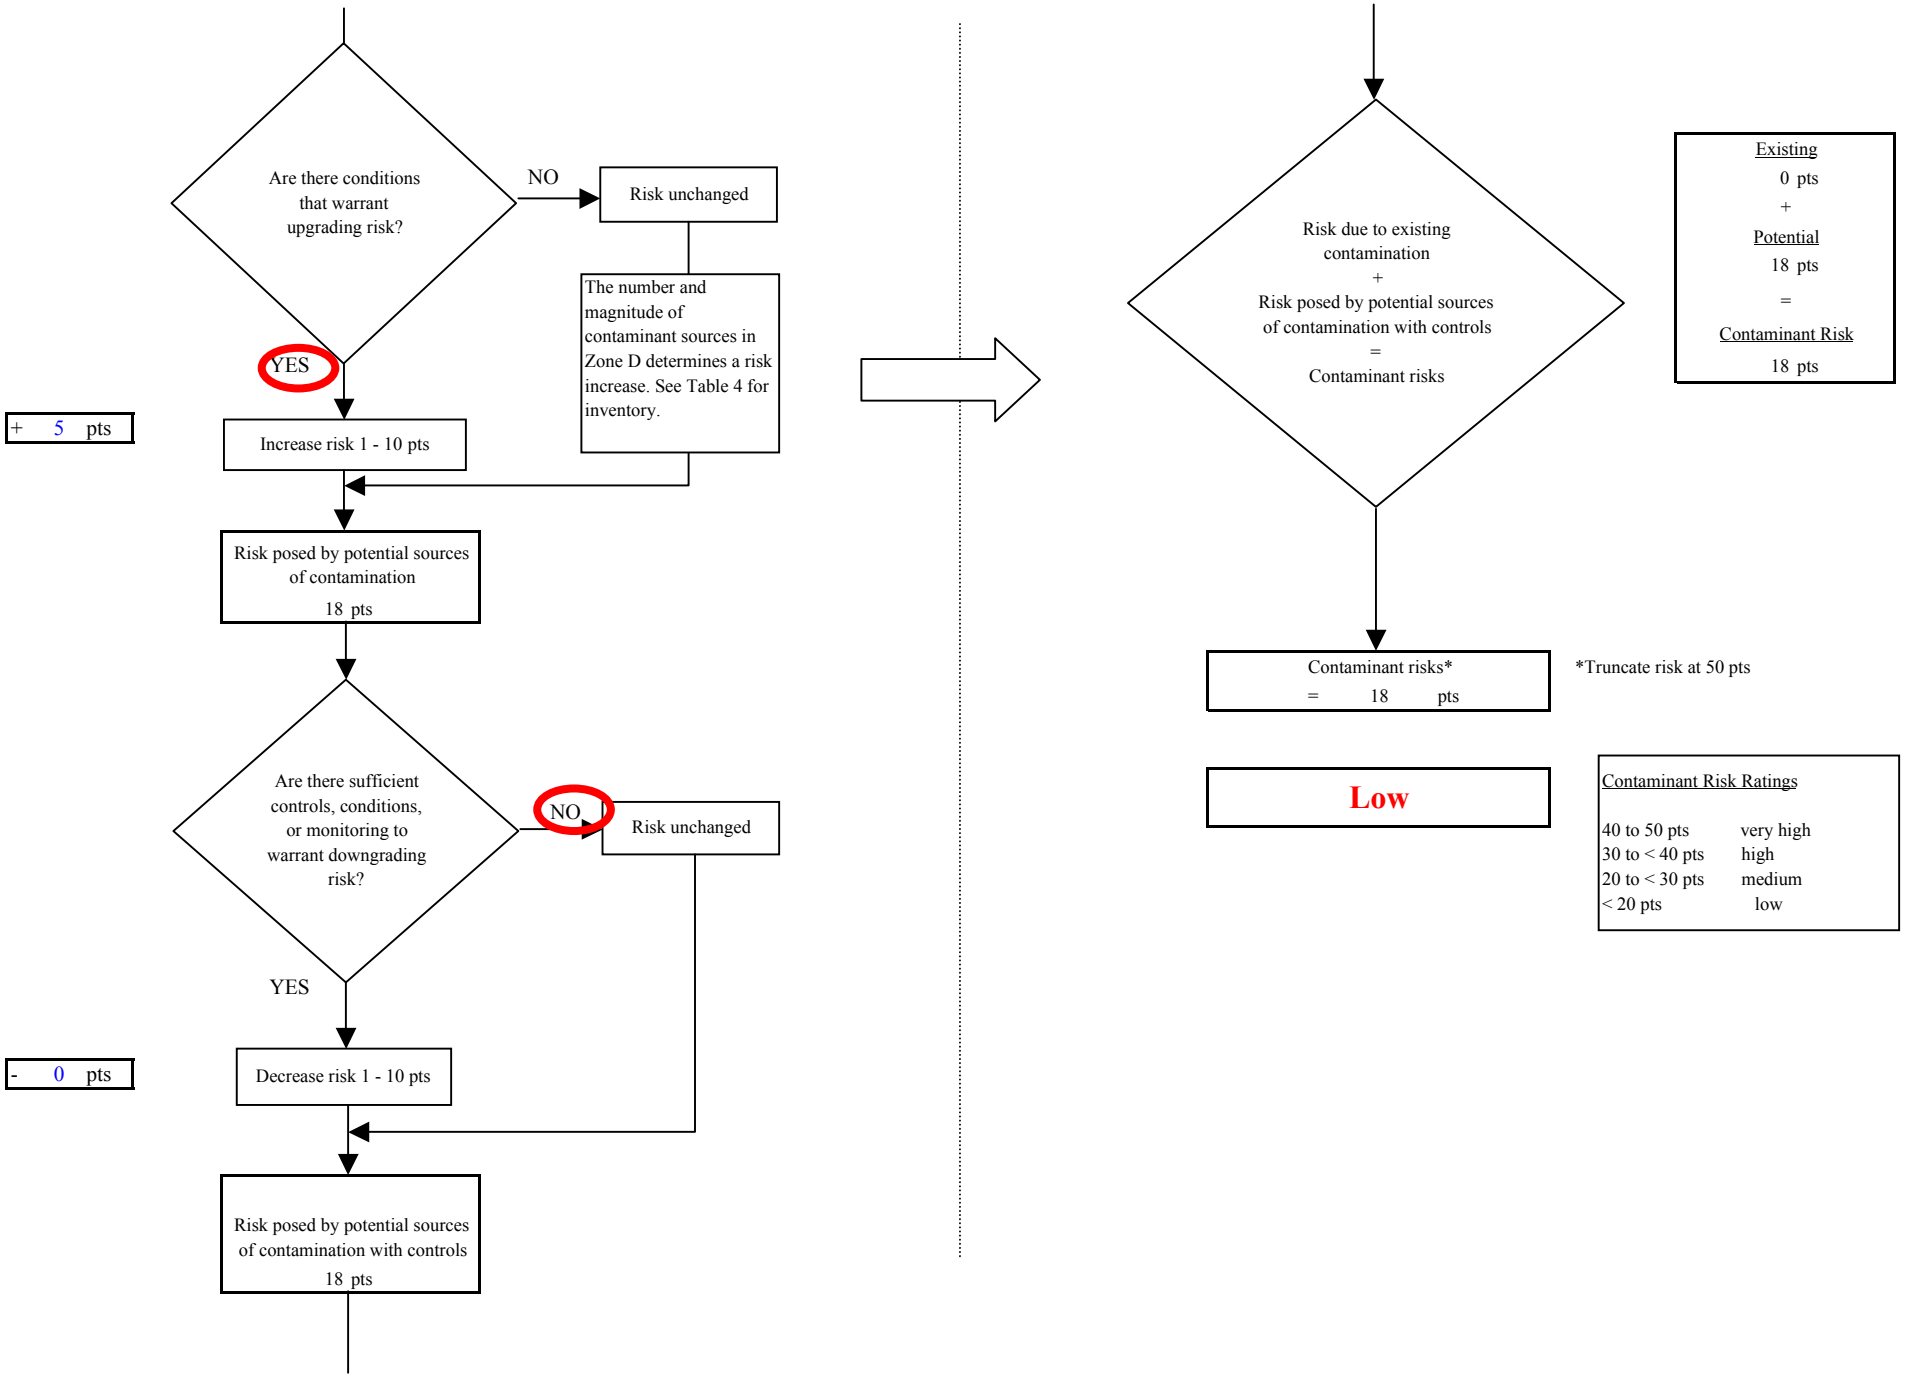
Chart 11. Contaminant risks for Ruby Washeteria & Laundromat (PWS No 360264.001) - Synthetic Organic Chemicals

The contaminant risk for synthetic organic chemicals is **Low**. The risk is primarily attributed to the presence of a landfill located in Zone D (see Table 6 – Appendix B).

No recent sampling data was available in ADEC records for the Ruby Washeteria & Laundromat (See Chart 11 – Contaminant Risks for Synthetic Organic Chemicals in Appendix D).
