Source Water Assessment

A Hydrogeologic Susceptibility and Vulnerability Assessment for Ruby Washeteria & Laundromat Drinking Water System, Ruby, Alaska

PWSID # 360264.001

June 2004

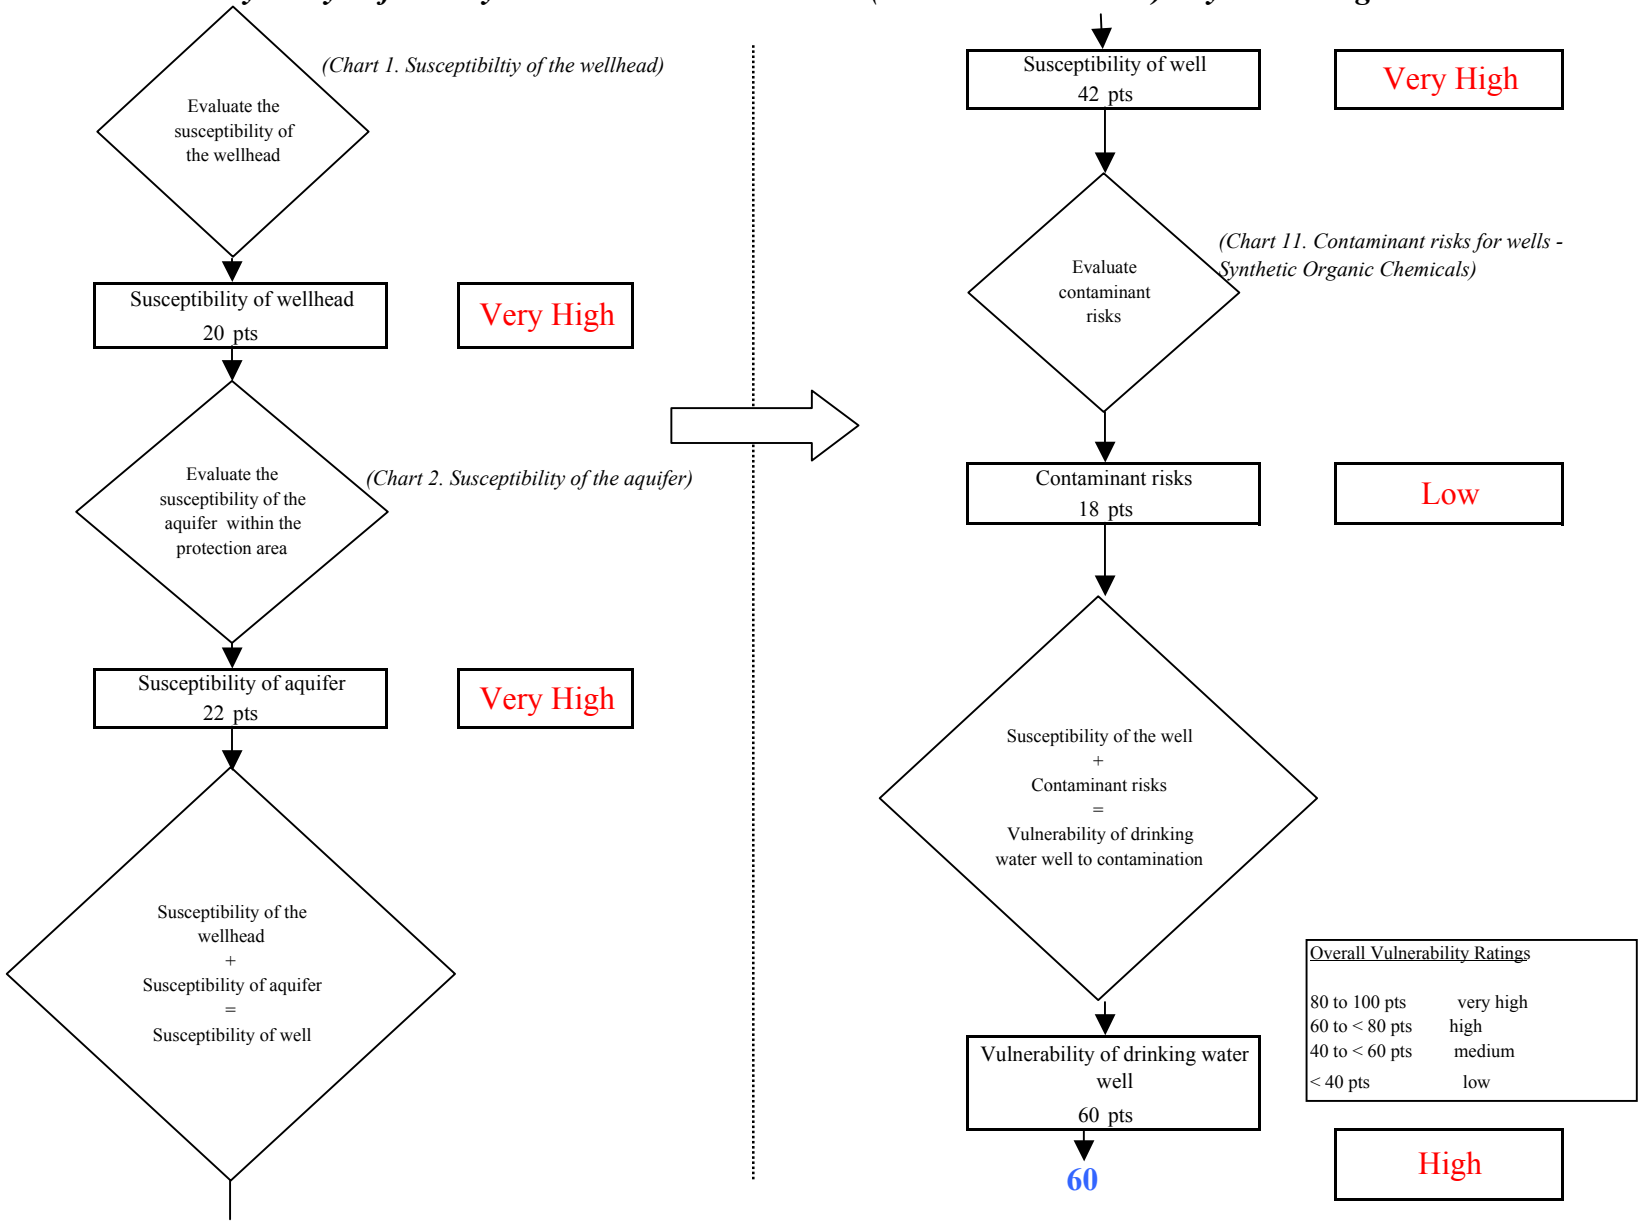
Chart 12. Vulnerability analysis for Ruby Washeteria & Laundromat (PWS No 360264.001) - Synthetic Organic Chemicals

After combining the contaminant risk for synthetic organic chemicals with the natural susceptibility of the well, the overall vulnerability of the well to contamination is **High.**

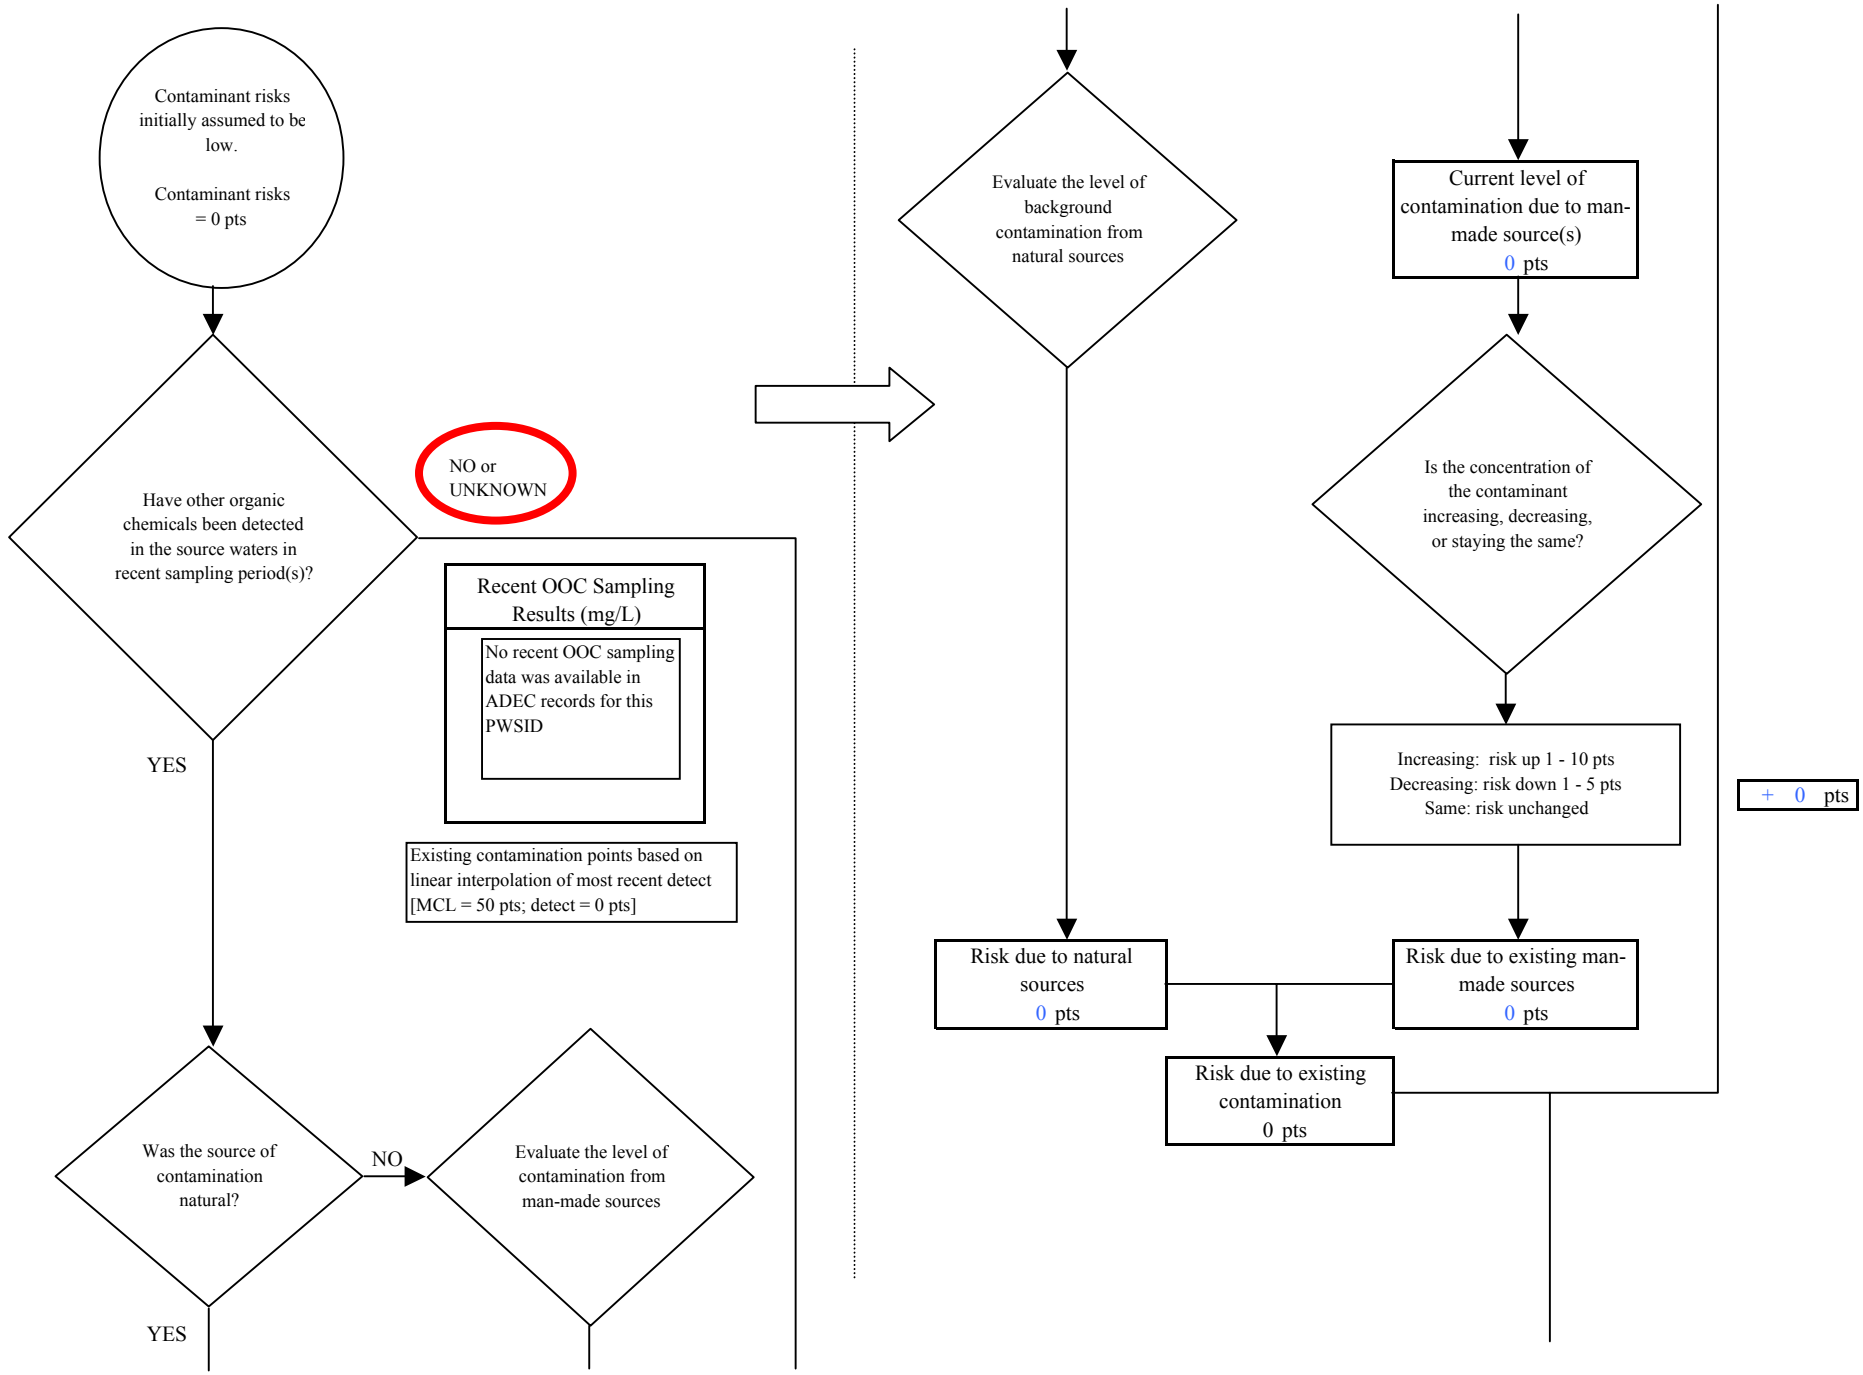
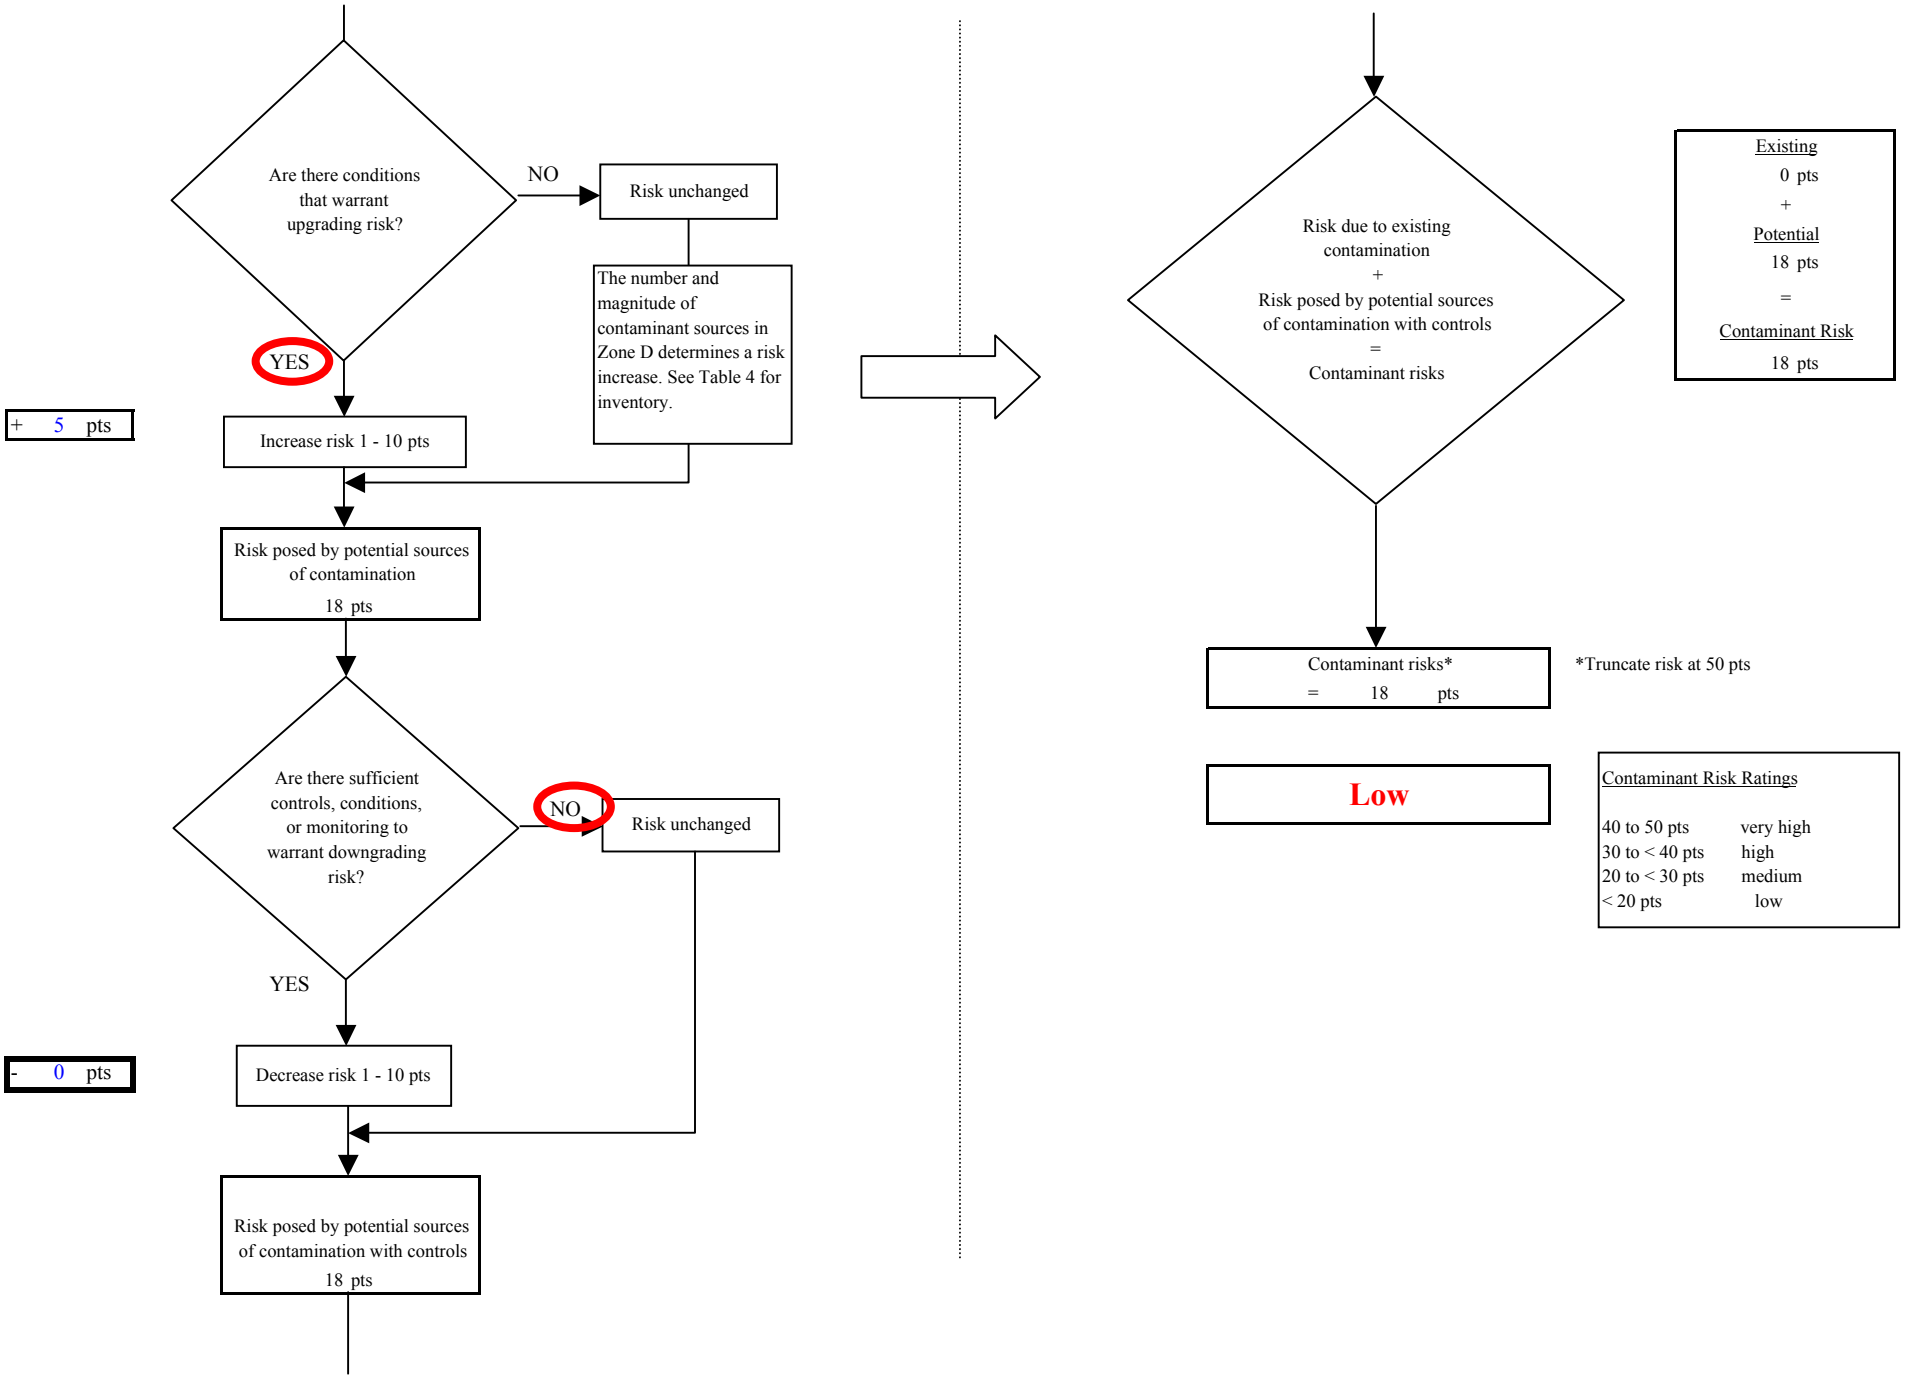
Chart 13. Contaminant risks for Ruby Washeteria & Laundromat (PWS No 360264.001) - Other Organic Chemicals

The contaminant risk for other organic chemicals is **Low**. The risk is primarily attributed to the presence of a landfill in Zone D (see Table 7 – Appendix B).

No recent sampling data was available in ADEC records for the Ruby Washeteria & Laundromat (See Chart 13 – Contaminant Risks for Other Organic Chemicals in Appendix D).
