Source Water Assessment

A Hydrogeologic Susceptibility and Vulnerability Assessment for Lost Lake Boy Scout Camp Public Drinking Water System, Salcha Area, Alaska PWSID # 370277.002

DRINKING WATER PROTECTION REPORT 1813

February, 2009

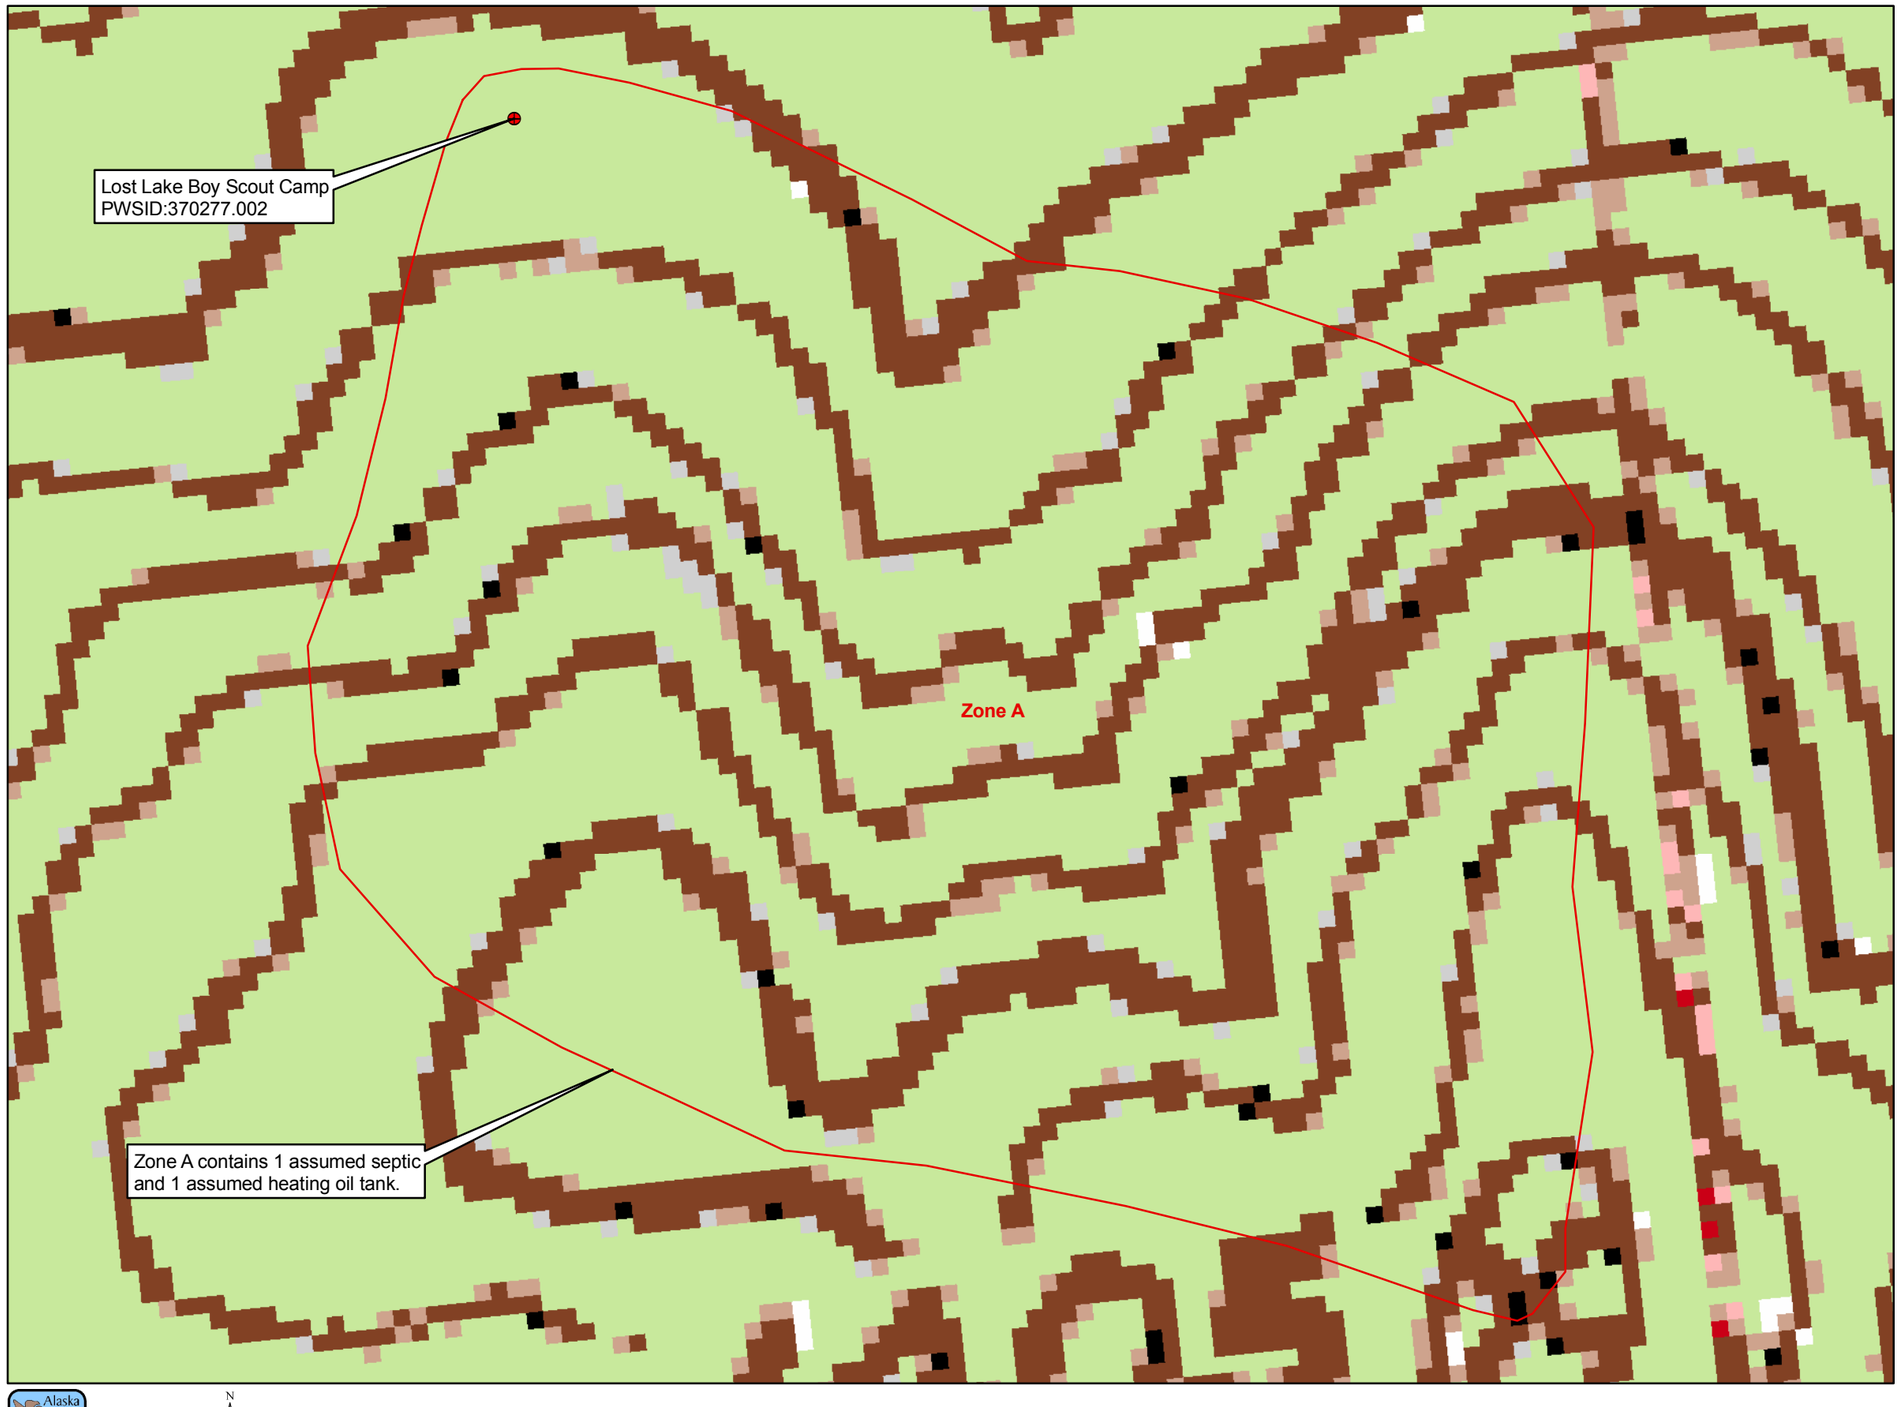
Appendix C Map C

The contaminant risk for volatile organic chemicals is **Medium** with a septic system and a heating oil tank contributing to the risk to the drinking water well.

Contaminant Source Type	***Contaminant Source ID***	***CS ID tag***	***Zone***	***Risk Ranking for Analysis***	***Map Number***	***Comments***
Septic systems (serves one single-family home)	R02	R02	A	Low	C	1 assumed septic system
Tanks, heating oil, residential (above ground)	R08	R08	A	Medium	C	1 assumed heating oil tank
