Source Water Assessment

A Hydrogeologic Susceptibility and Vulnerability Assessment for the Copper River School District Slana School Drinking Water System, Slana, Alaska

PWSID # 381503.001

June 2004

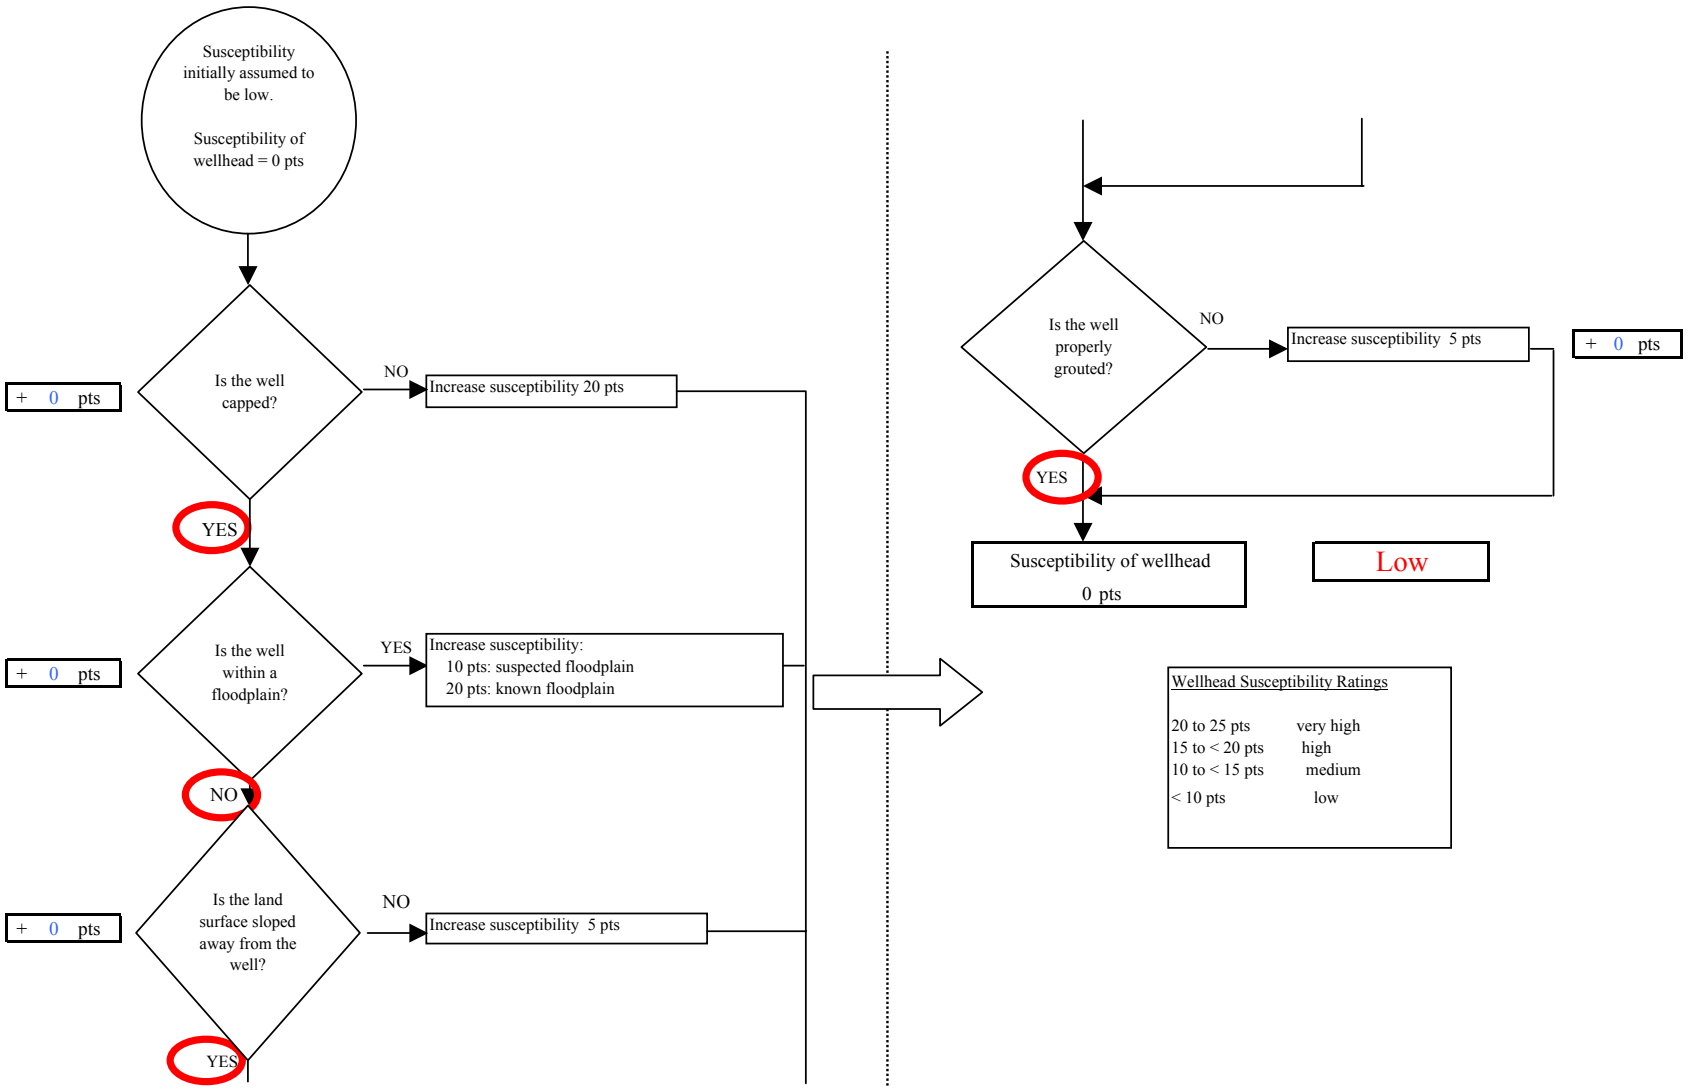
Chart 1. Susceptibility of the wellhead - Copper River School District - Slana School (PWS No.381503.001)

Score	**Rating**
Susceptibility of the Wellhead	0	Low
Susceptibility of the Aquifer	13	Medium
Natural Susceptibility	13	Low

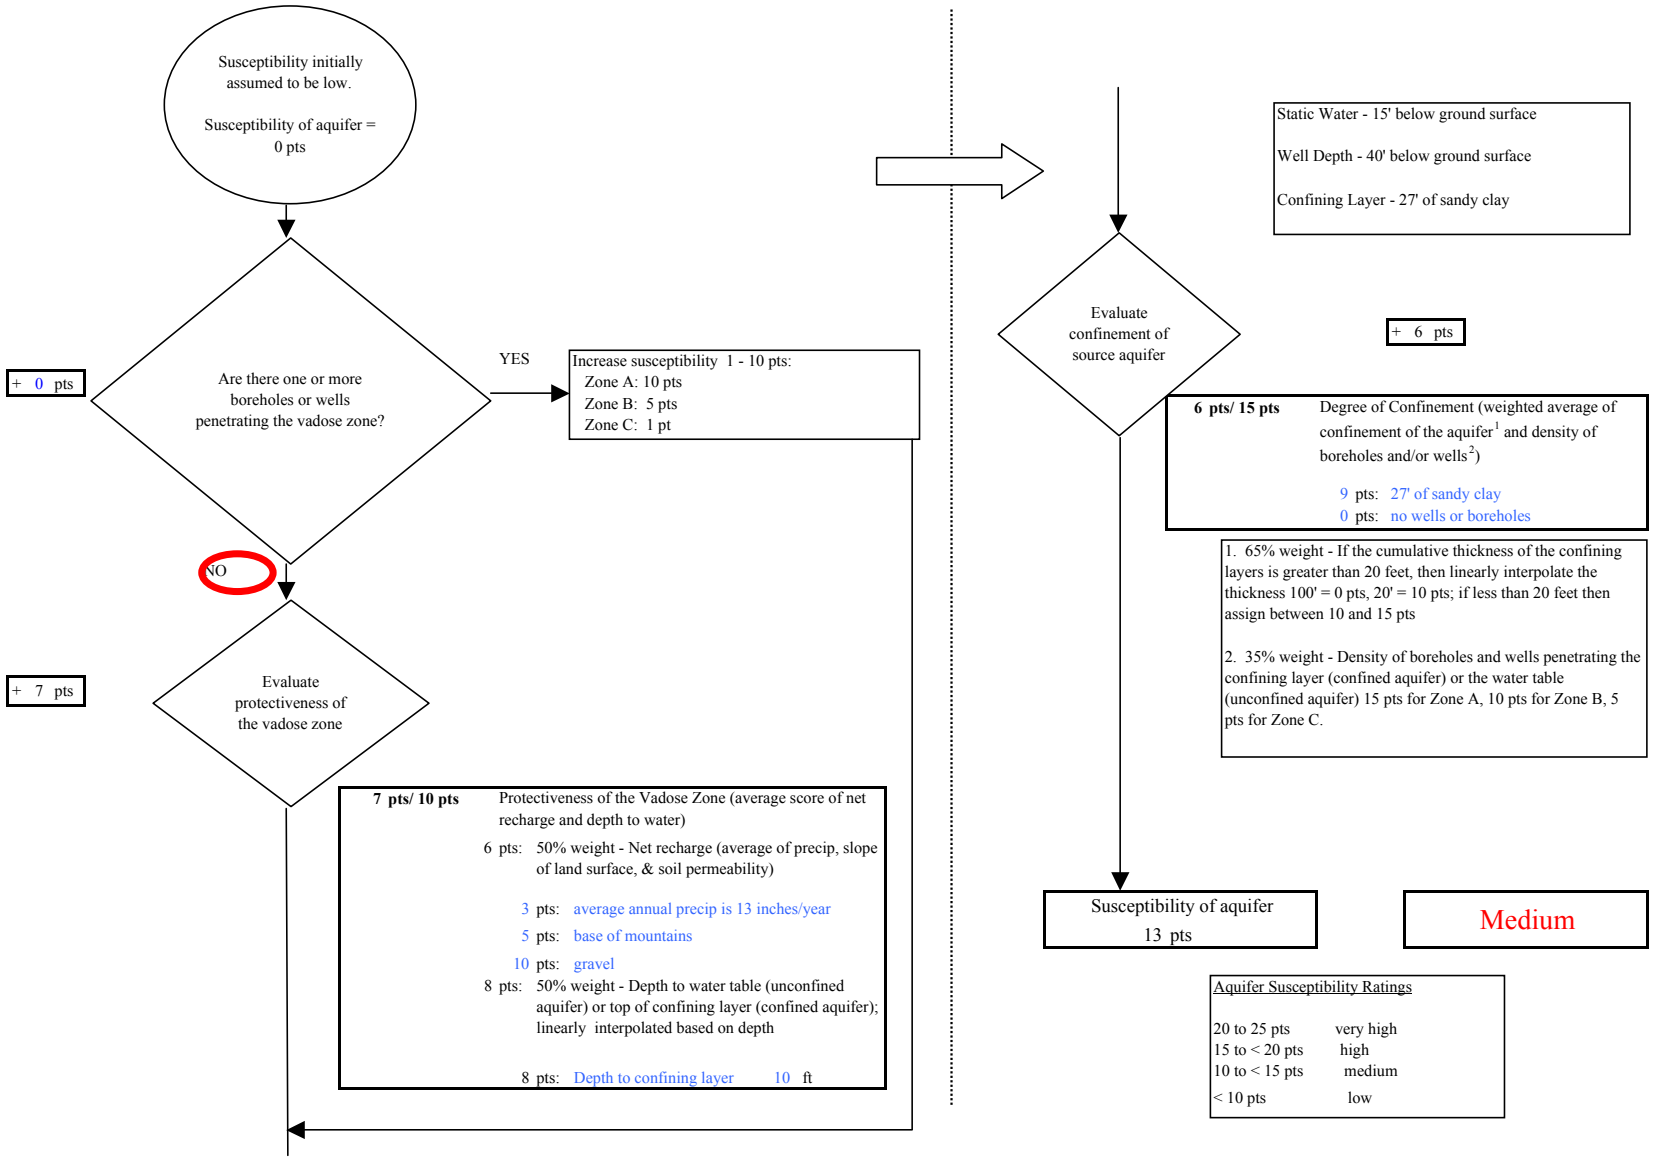
Chart 2. Susceptibility of the aquifer Copper River School District - Slana School (PWS No.381503.001)

The CRSD Slana School PWS's water well is completed in a confined aquifer. Confined aquifers are less susceptible to potential groundwater quality impacts posed by the migration of surface water contaminants downward from the surface. Table 2 shows the susceptibility scores and ratings for this PWS.

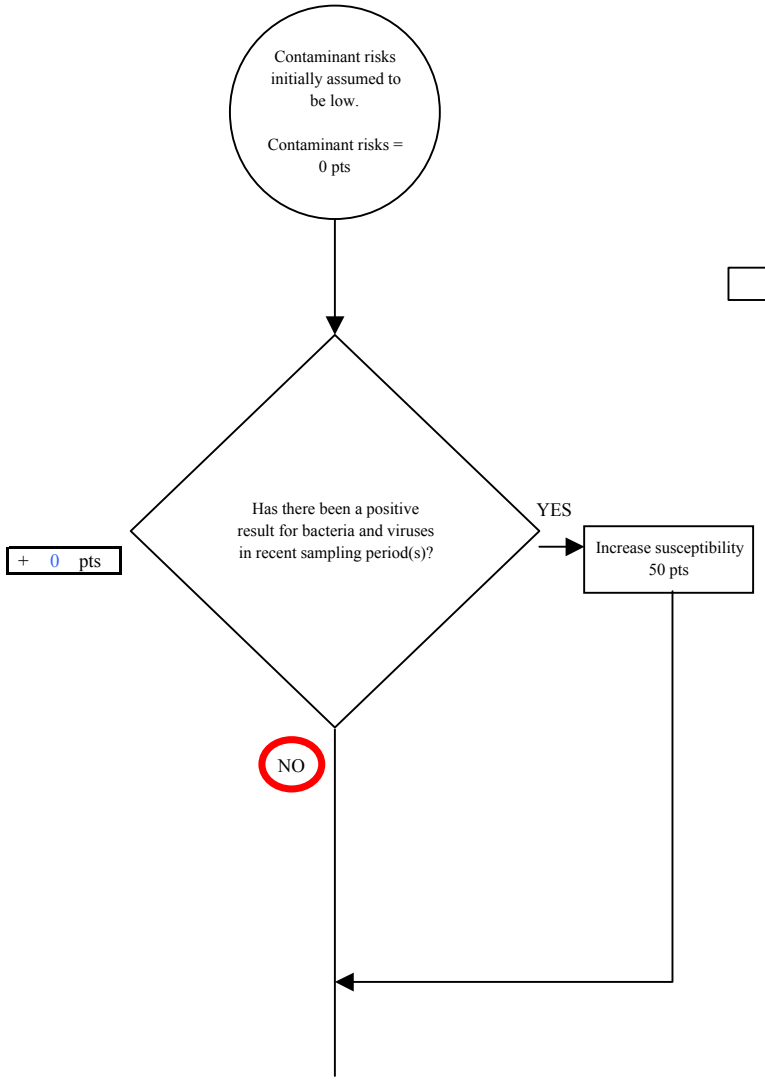
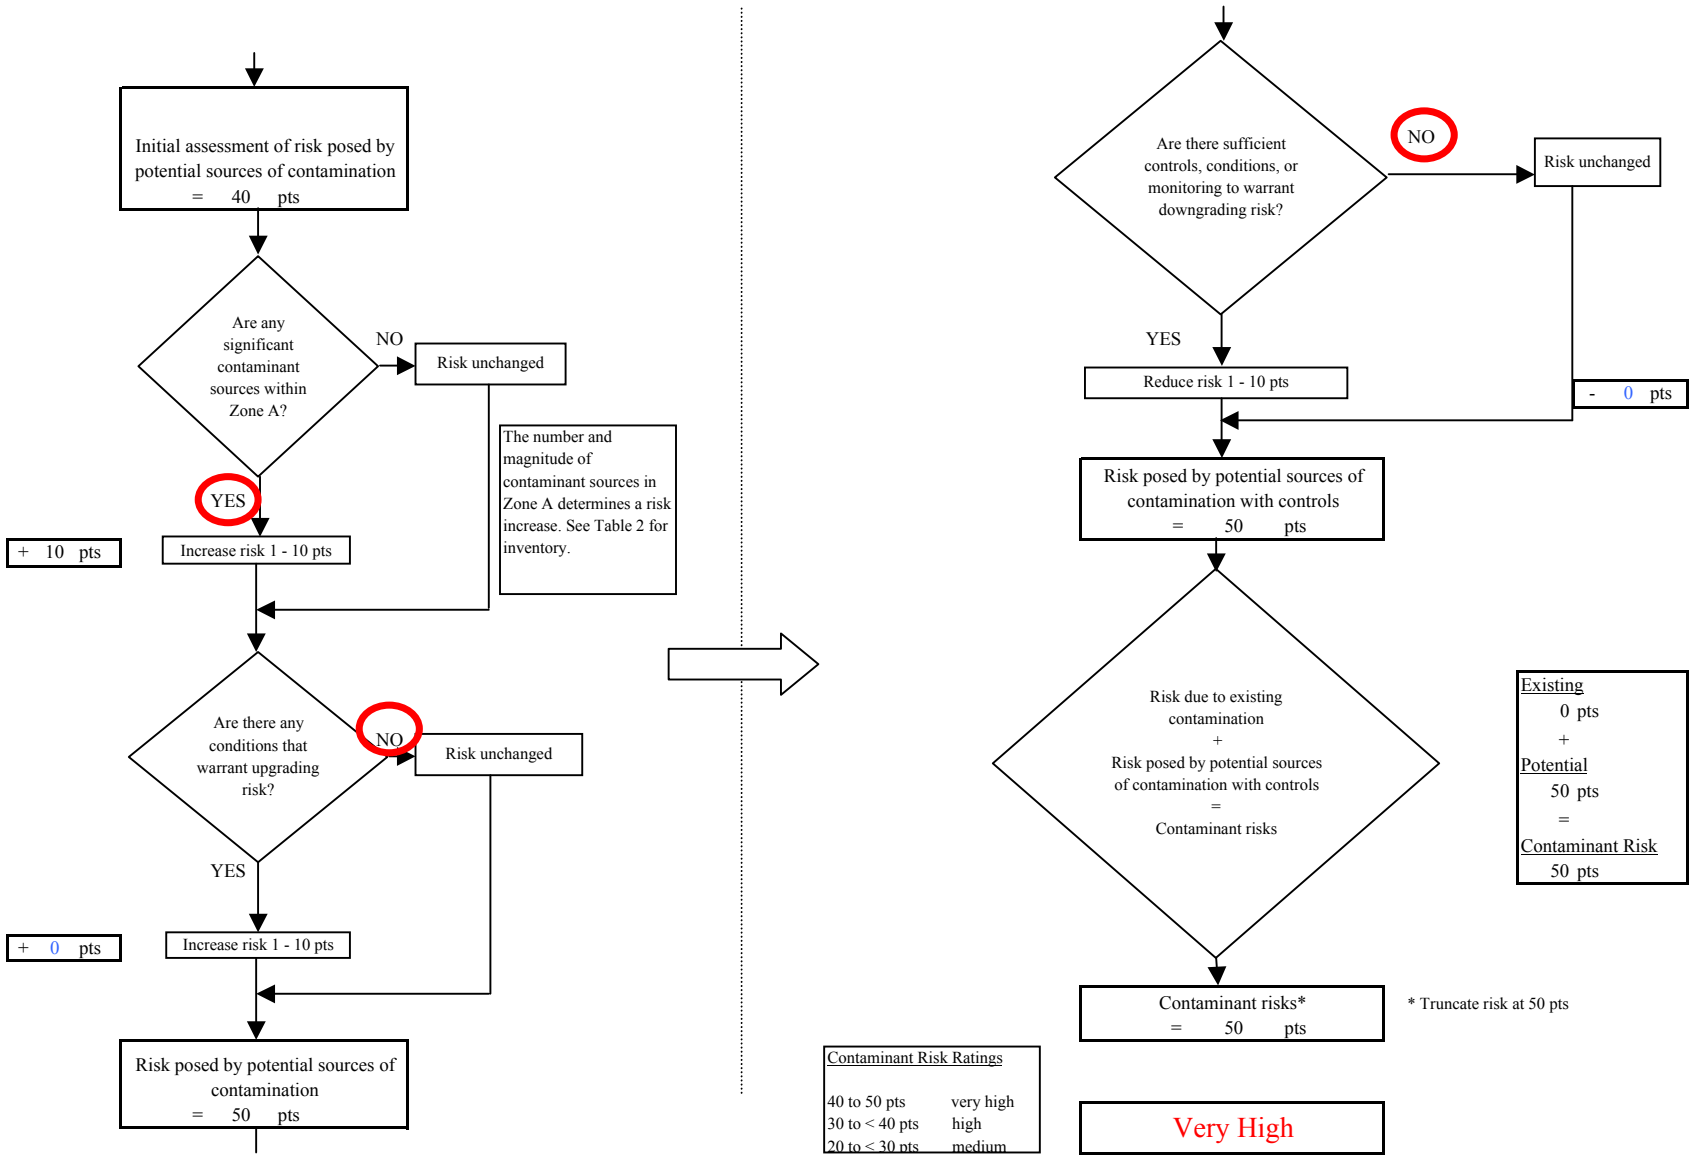
Chart 3. Contaminant risks for Copper River School District - Slana School (PWS No.381503.001) - Bacteria & Viruses

The contaminant risk for bacteria and viruses is **Very High**. The risk is primarily attributed to the presence of a large capacity septic system located in Zone A. Numerous other potential contaminant sources are also found within the protection area (see Table 2 – Appendix B).

No positive bacteria counts have been reported in recent (within five years) sampling events (See Chart 3 – Contaminant Risks for Bacteria and Viruses in Appendix D). Only a small amount of bacteria and viruses are required to endanger public health.

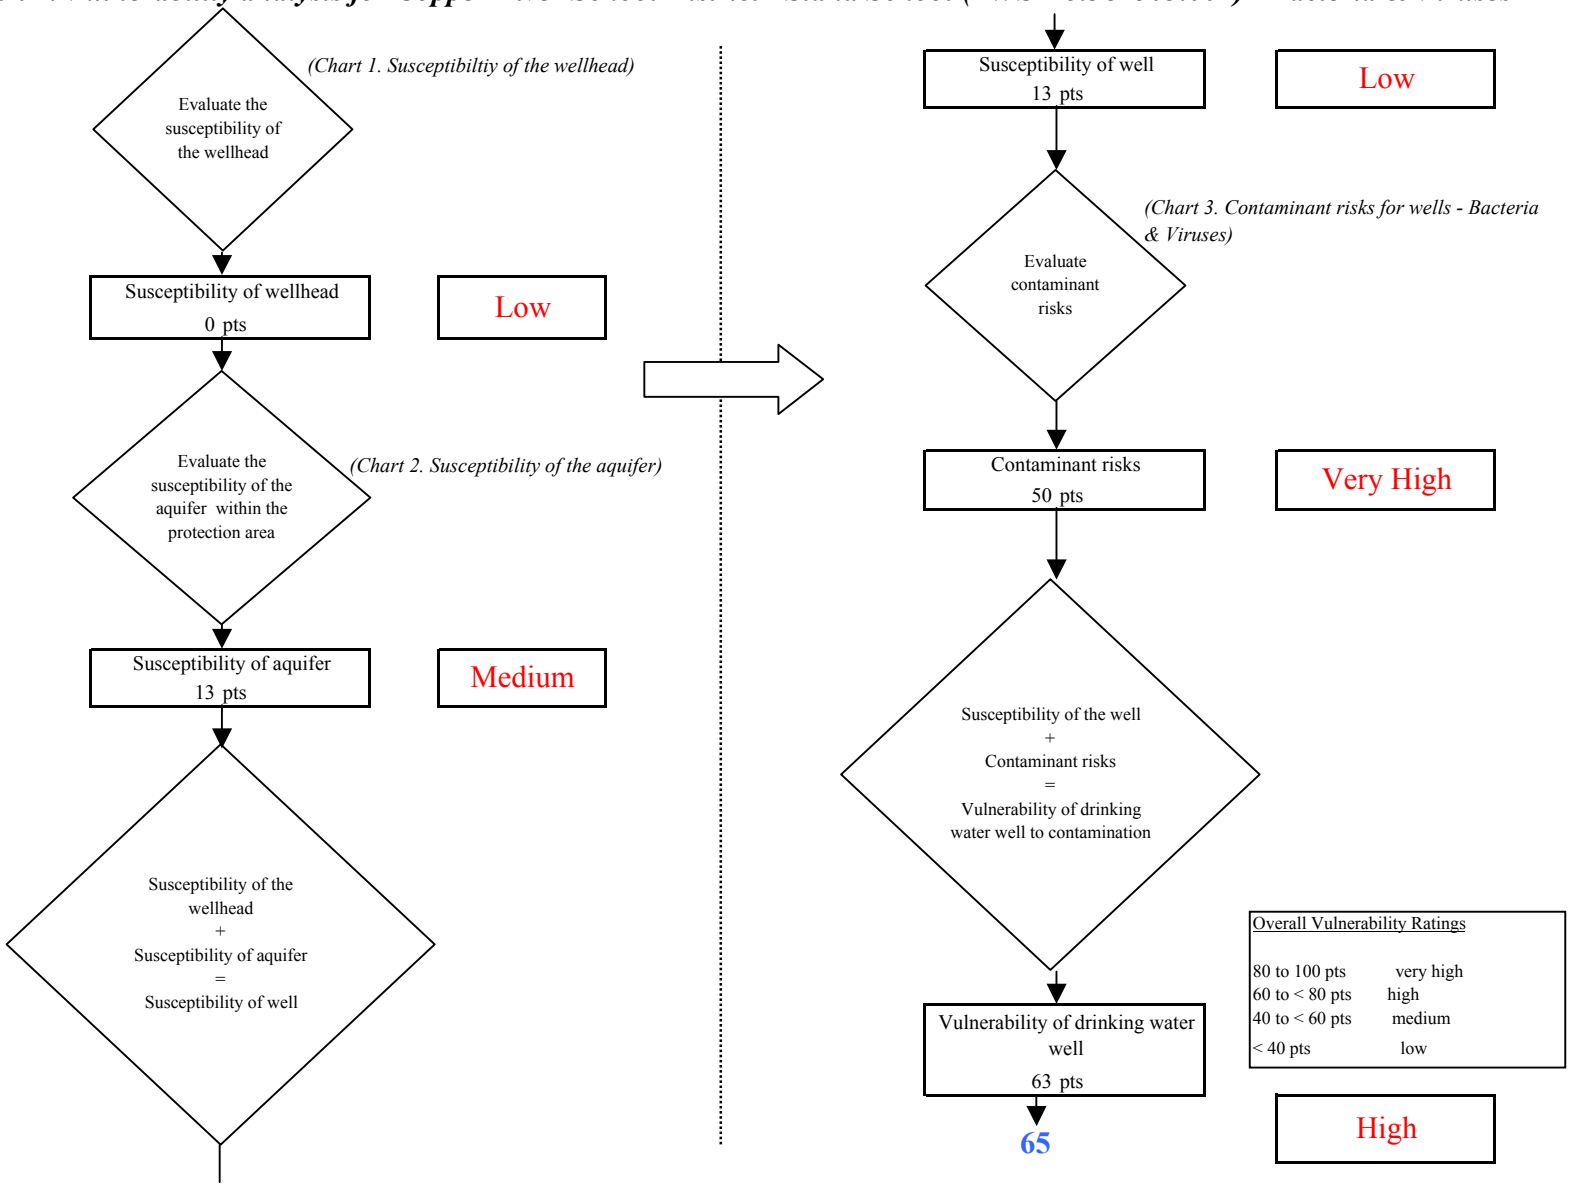
Chart 4. Vulnerability analysis for Copper River School District - Slana School (PWS No.381503.001) - Bacteria & Viruses

After combining the contaminant risk for bacteria and viruses with the natural susceptibility of the well, the overall vulnerability of the well to contamination is **High**.

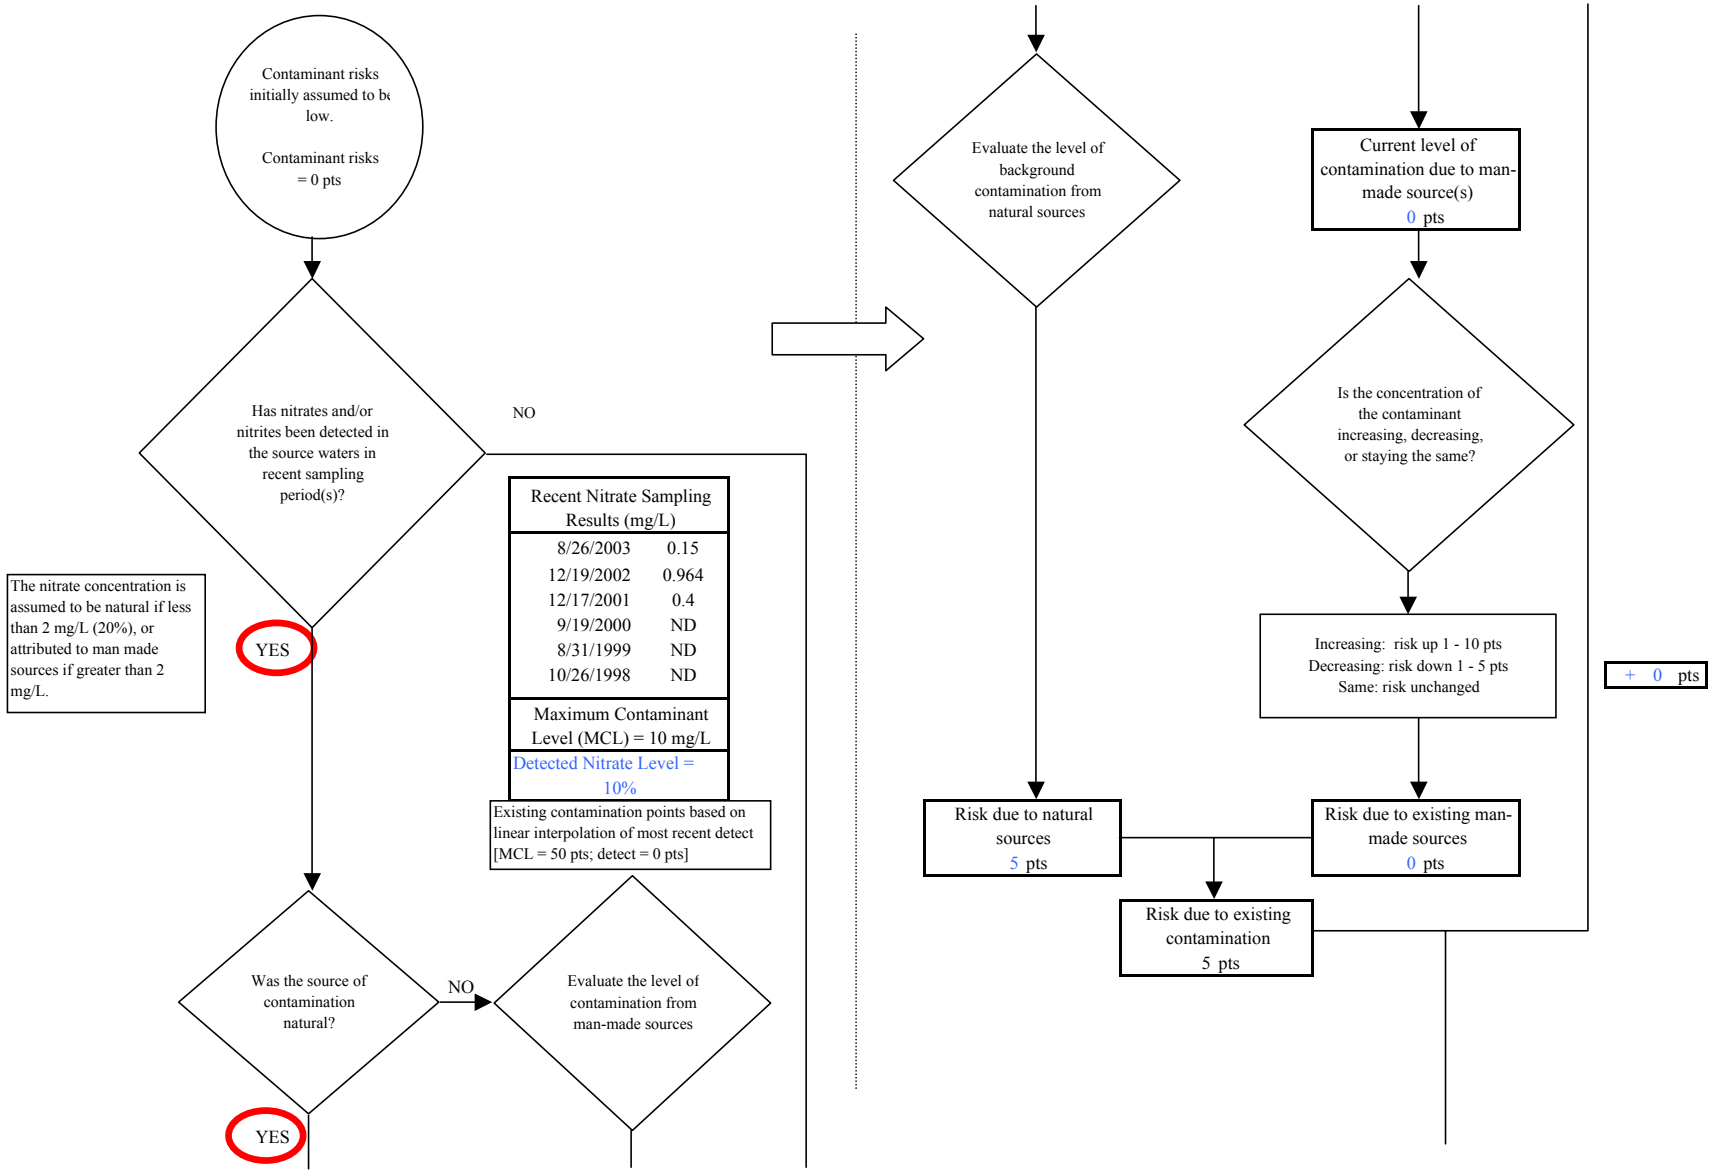
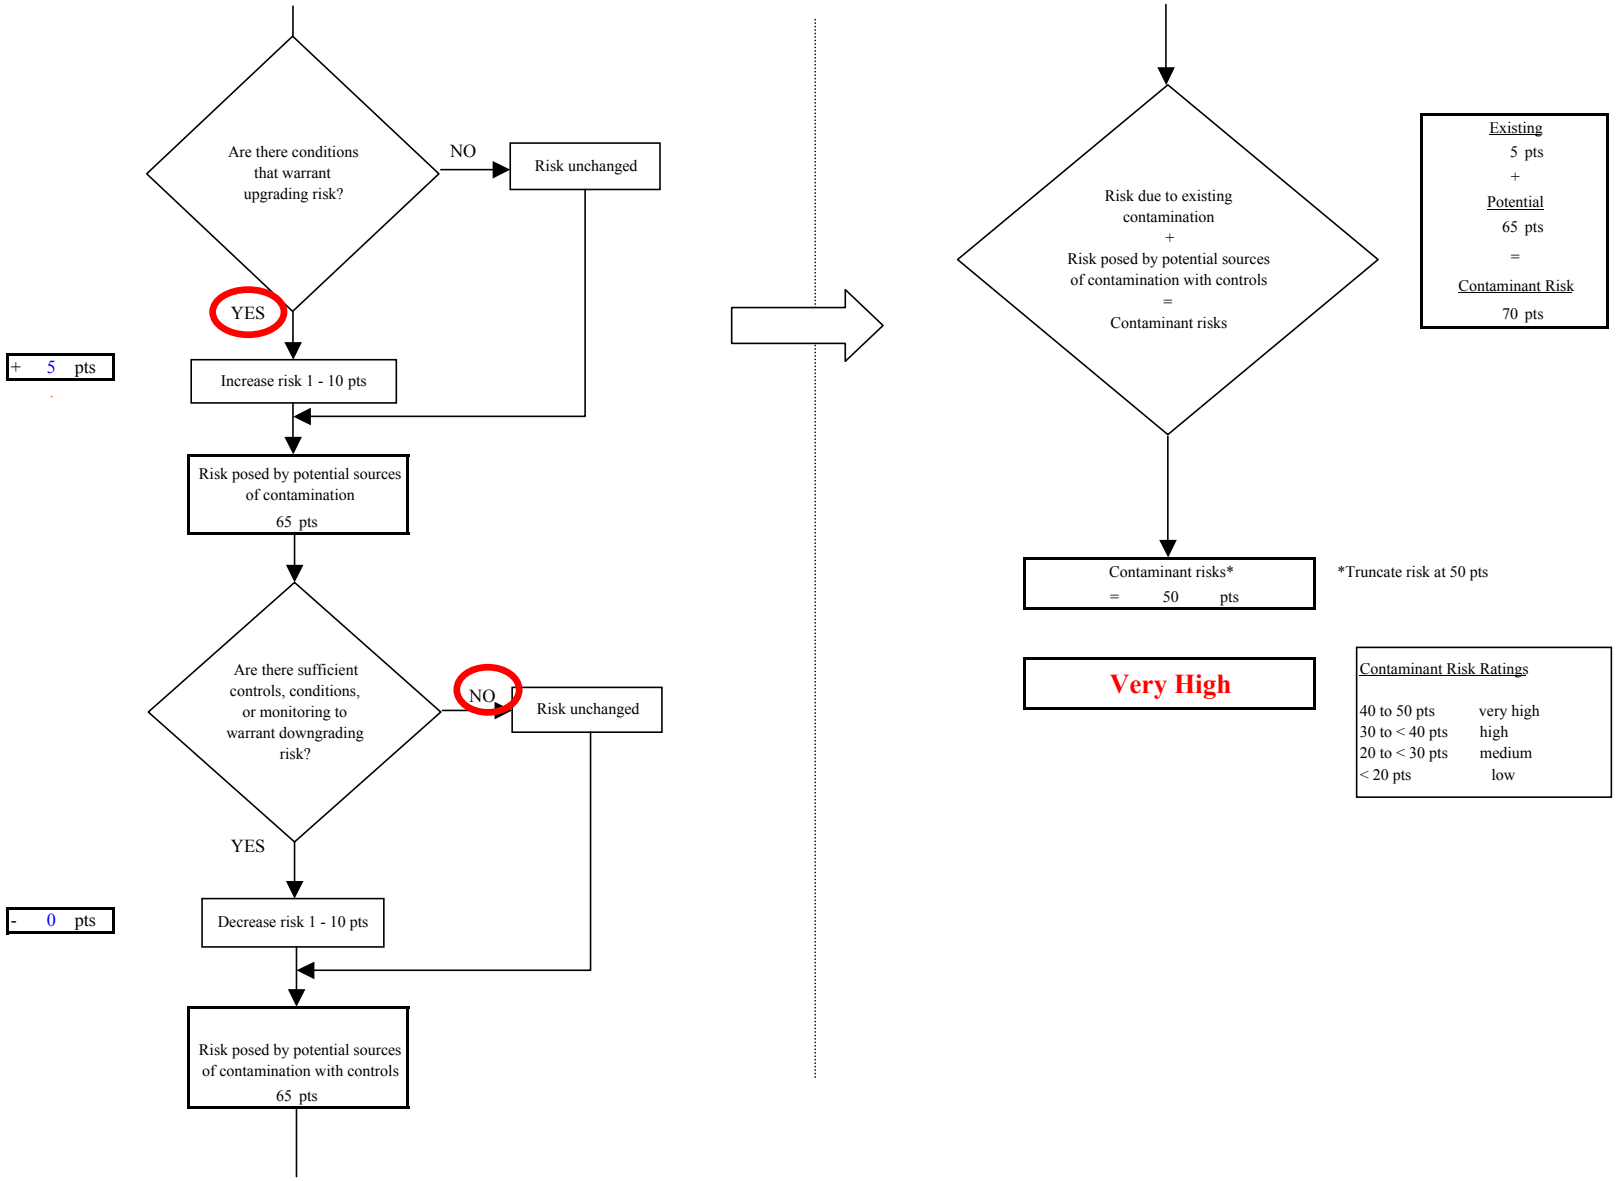
Chart 5. Contaminant risks for Copper River School District - Slana School (PWS No.381503.001) - Nitrates and Nitrites

The contaminant risk for nitrates and nitrites is **Very High**. The risk to this source of public drinking water is primarily attributed to the presence of a large capacity septic system in Zone A and a landfill in Zone B. Numerous other potential contaminant sources are also found within the protection area (see Table 3 – Appendix B).

the MCL of 10mg/L. Nitrate concentrations in uncontaminated groundwater are typically less than 2 mg/L; therefore, nitrate concentrations above 2 mg/L may be indicative of man-made sources (See Chart 5 - Contaminant Risks for Nitrates and/or Nitrites in Appendix D).

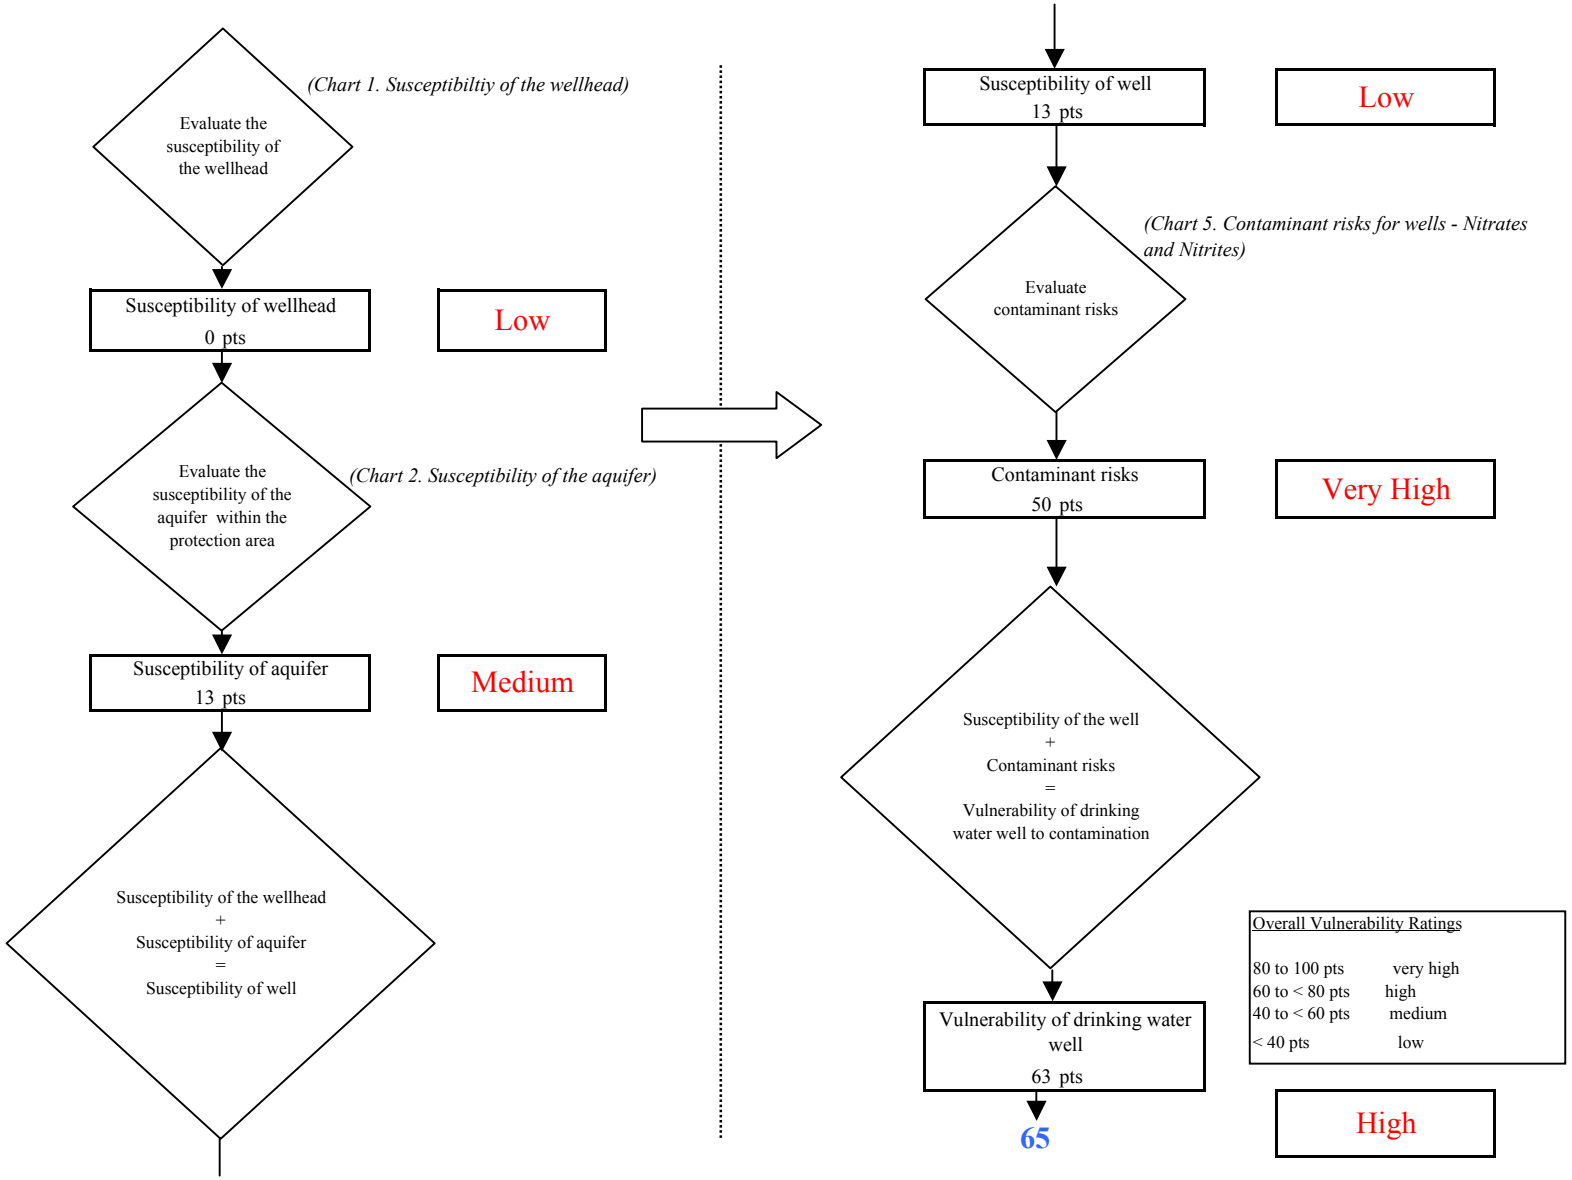
Chart 6. Vulnerability analysis for Copper River School District - Slana School (PWS No.381503.001) - Nitrates and Nitrites

After combining the contaminant risk for nitrates and nitrites with the natural susceptibility of the well, the overall vulnerability of the well to nitrate and nitrite contamination is **High.**

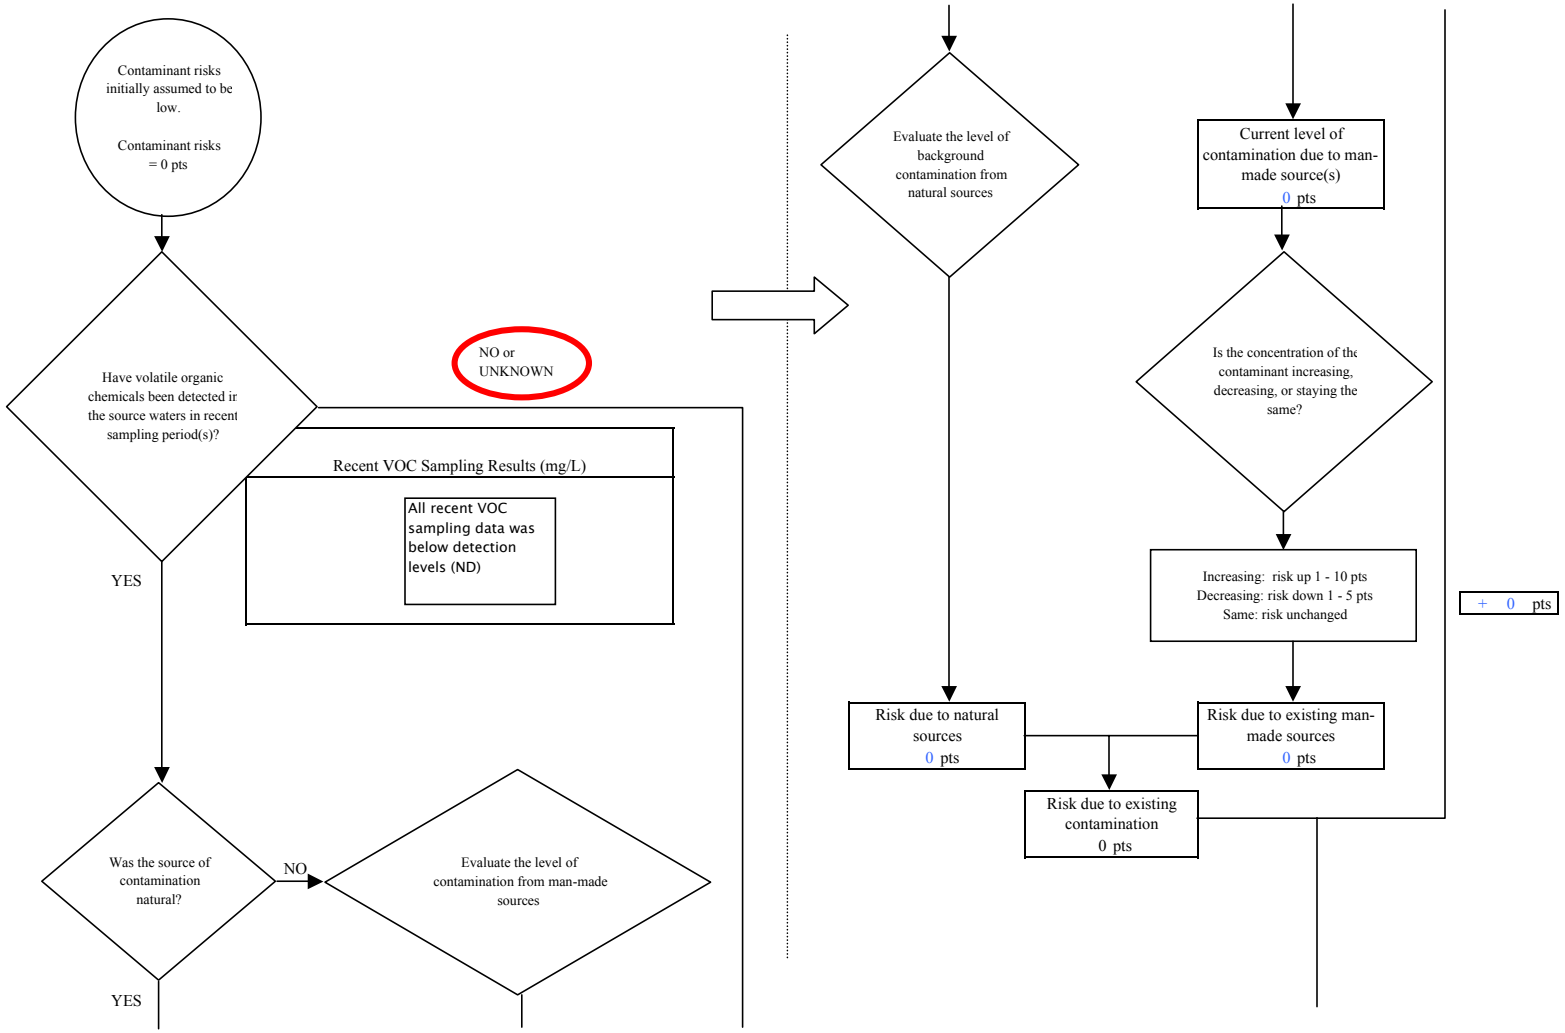
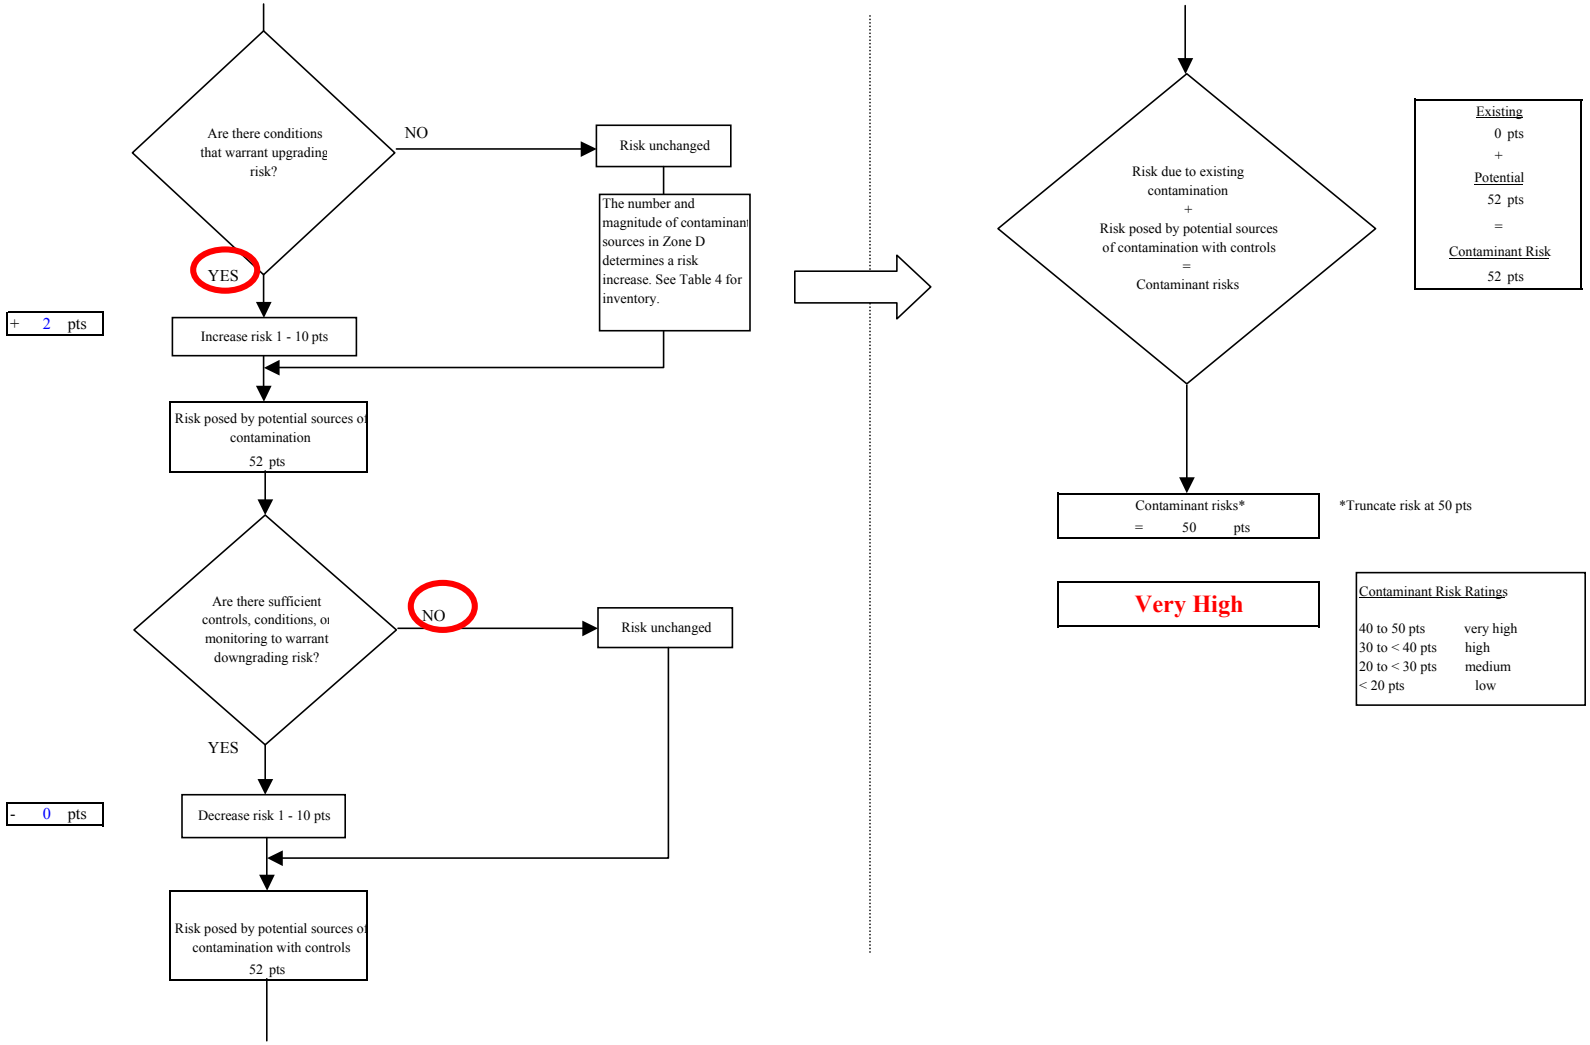
Chart 7. Contaminant risks for Copper River School District - Slana School (PWS No.381503.001) - Volatile Organic Chemicals

The contaminant risk for volatile organic chemicals is **Very High**. The risk is primarily attributed to the presence of underground gasoline fuel tanks and an ADEC recognized contaminated site located in Zone A. Numerous other potential contaminant sources are also found within the protection area (see Table 4 – Appendix B).

No recent sampling data was available in ADEC records for the CRSD Slana School PWS (See Chart 7 – Contaminant Risks for Volatile Organic Chemicals in Appendix D).
