Source Water Assessment

A Hydrogeologic Susceptibility and Vulnerability Assessment for the Copper River School District Slana School Drinking Water System, Slana, Alaska

PWSID # 381503.001

June 2004

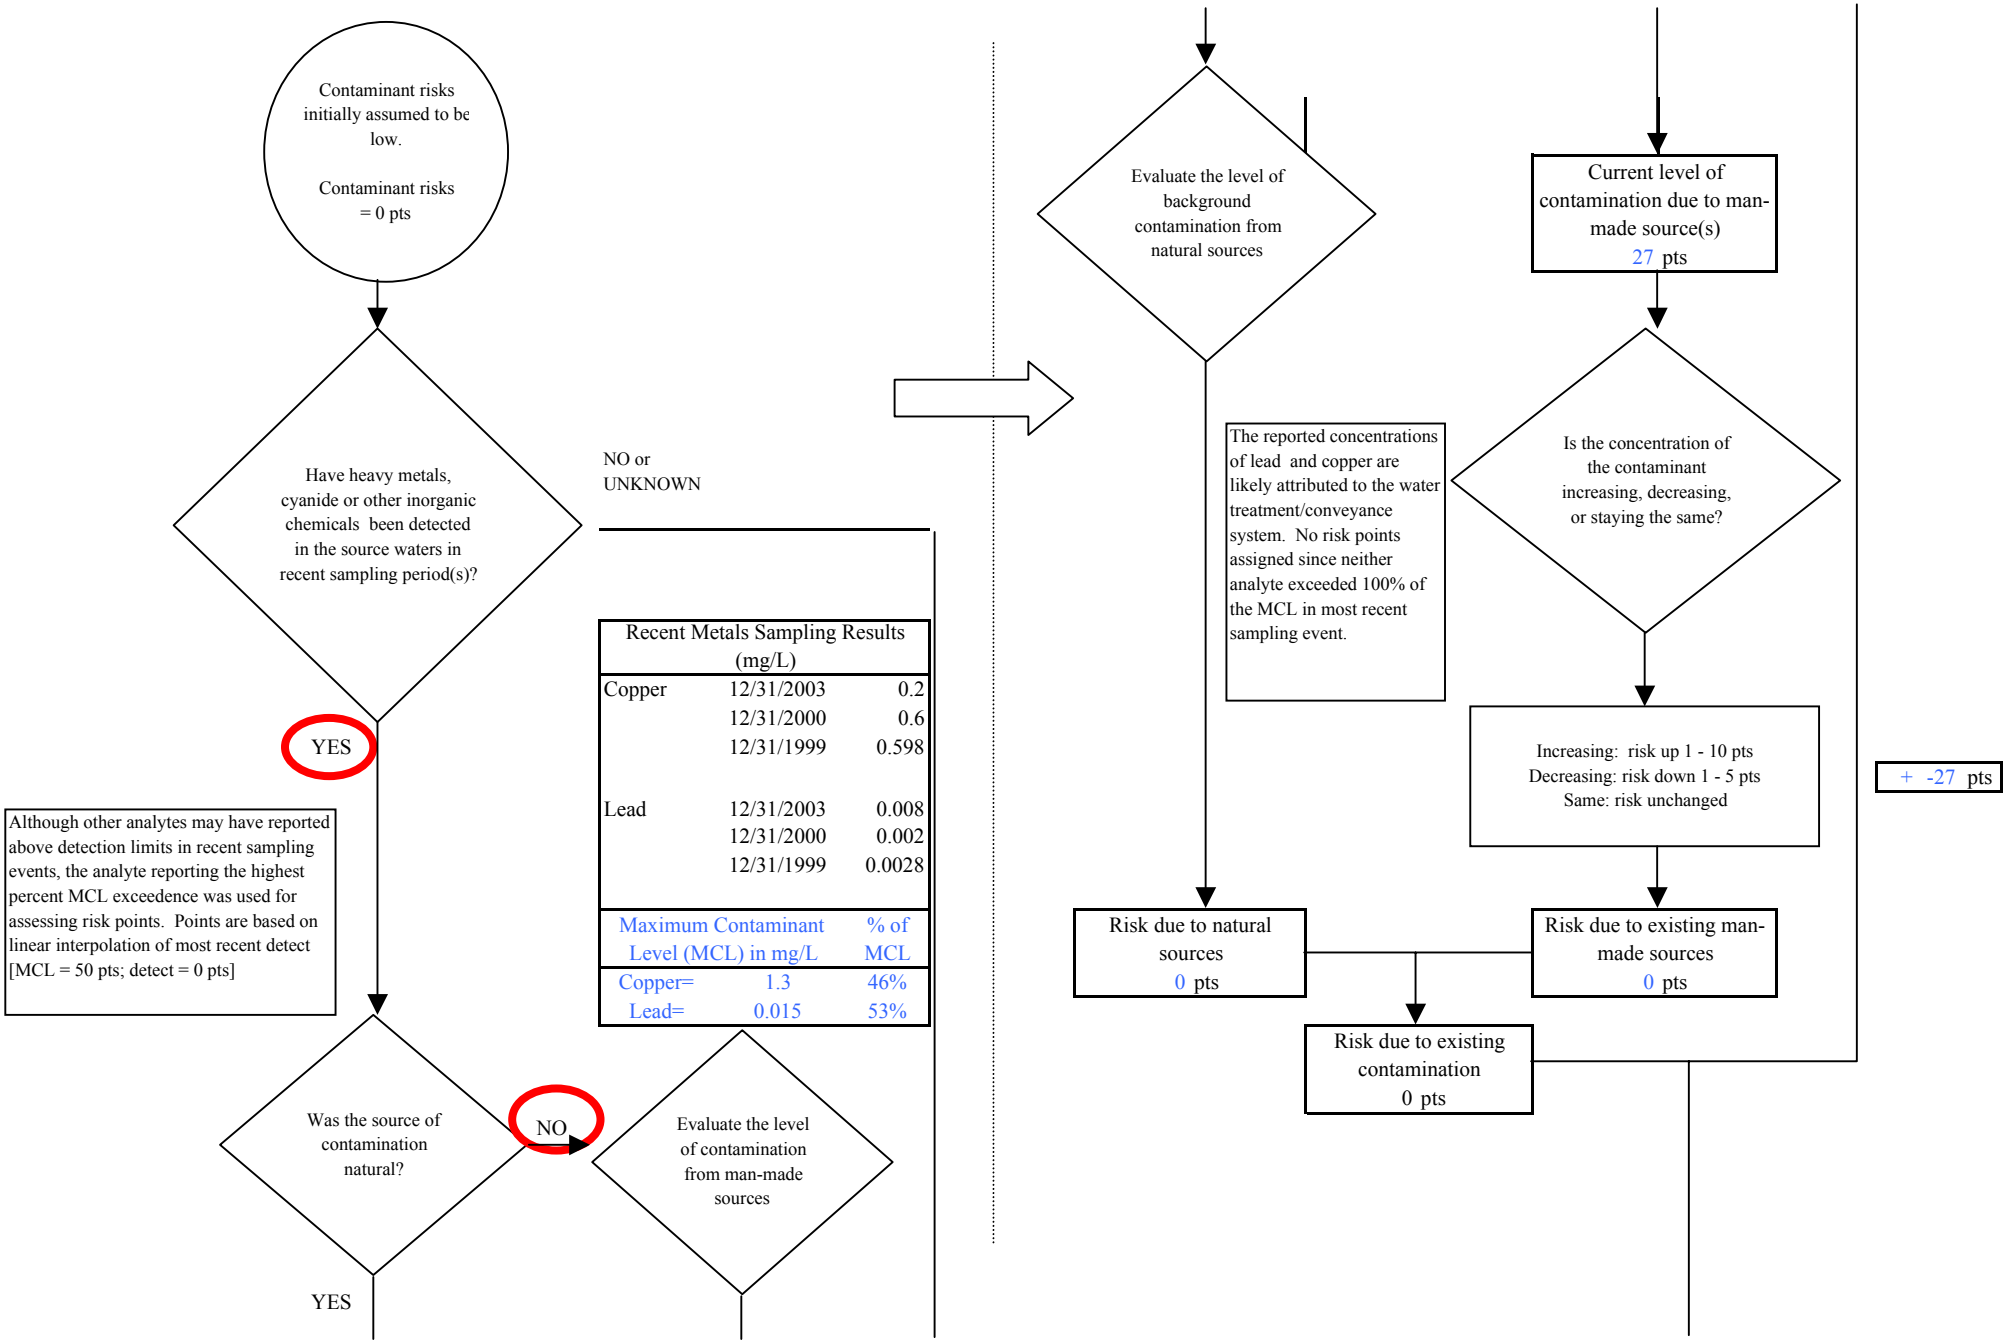
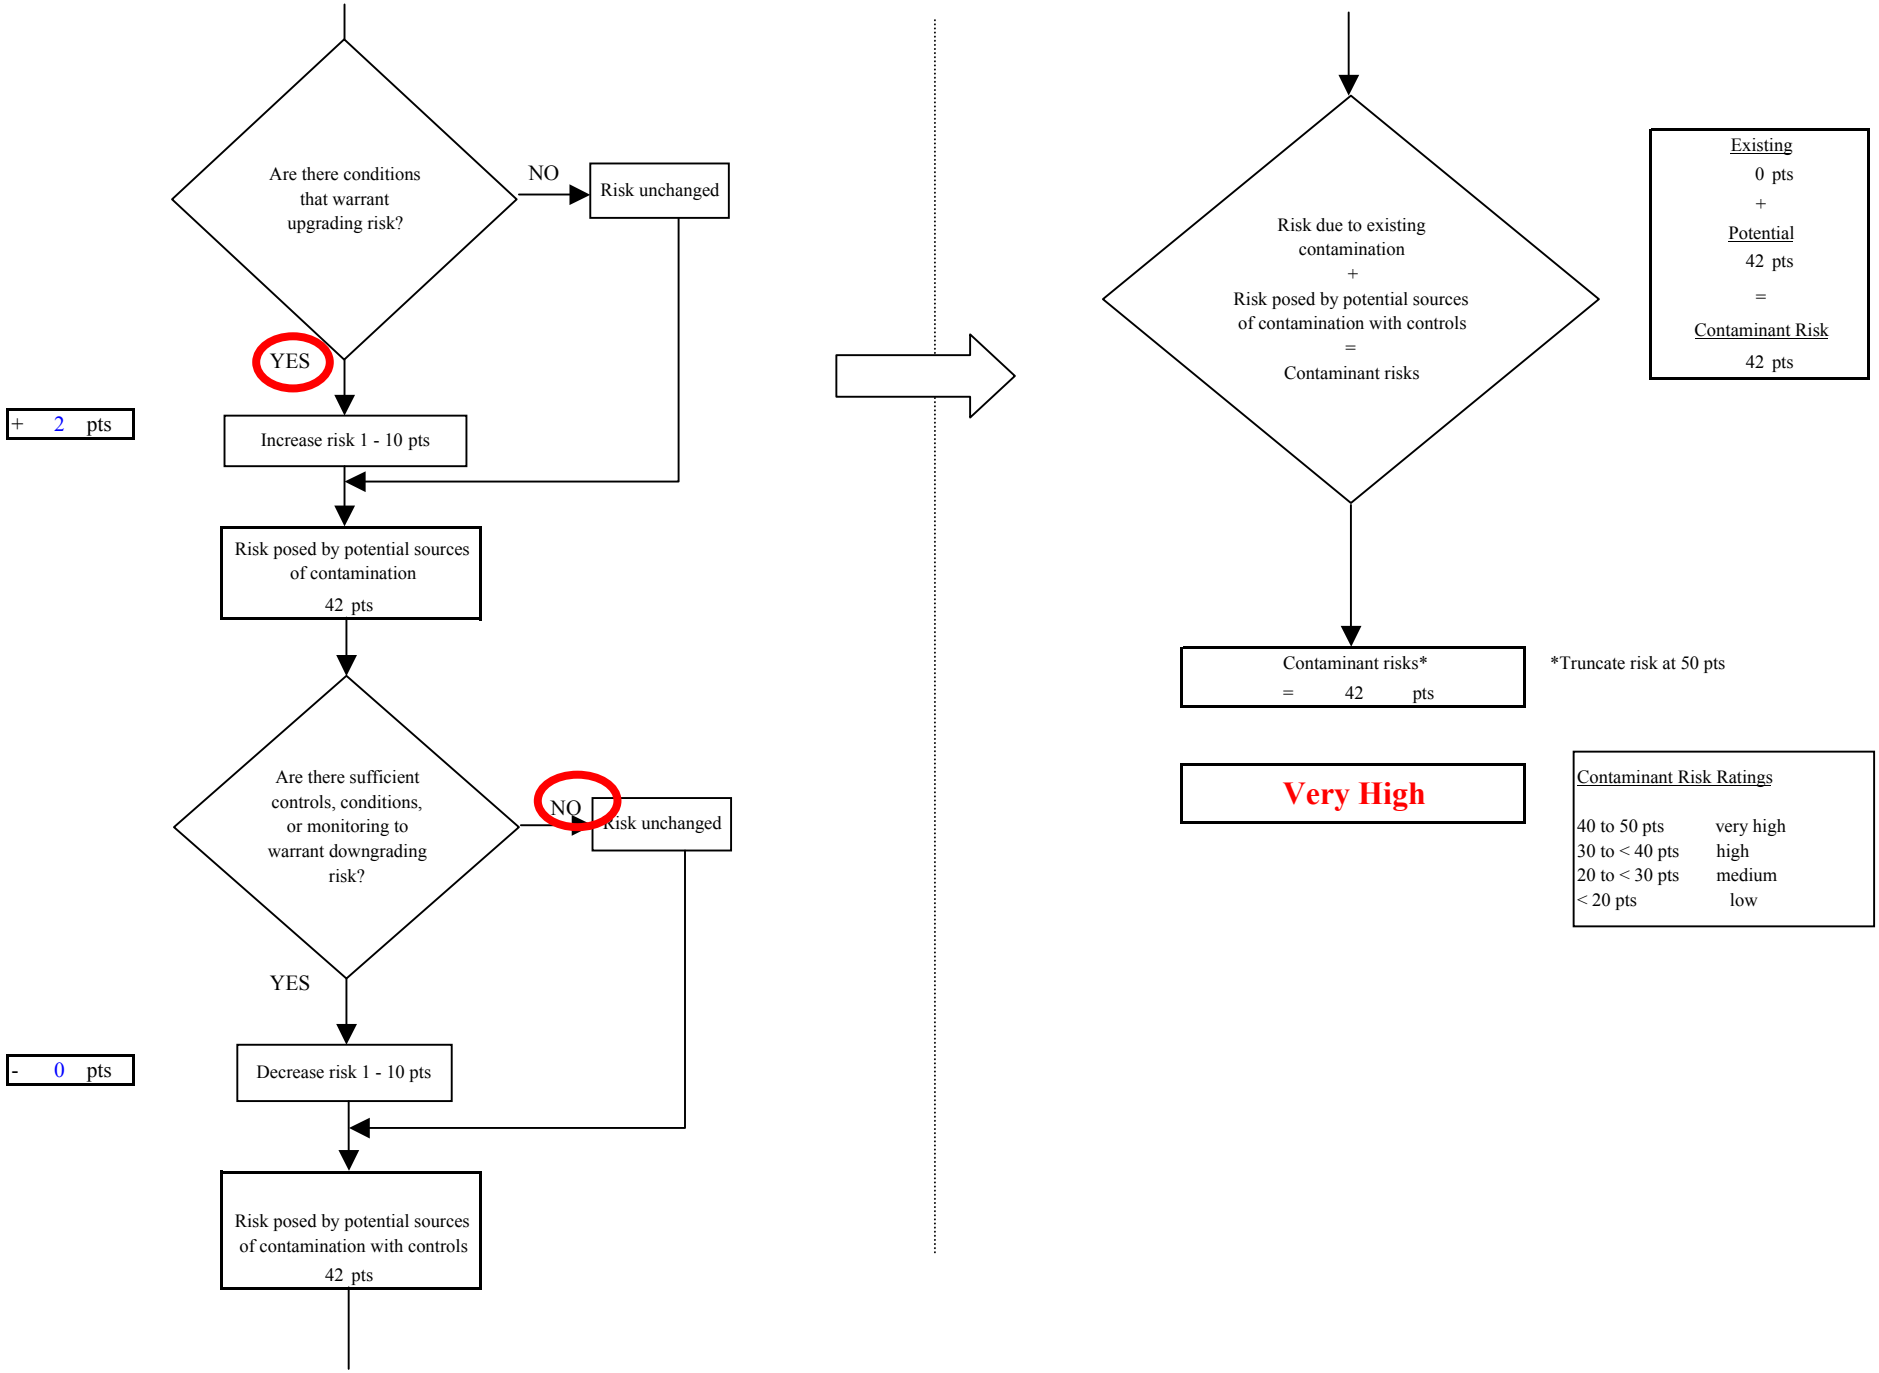
Chart 9. Contaminant risks for Copper River School District - Slana School (PWS No.381503.001) - Heavy Metals, Cyanide and Other Inorganic Chemicals

The contaminant risk for heavy metals, cyanide and other inorganic chemicals is **Very High**. The risk is primarily attributed to the presence of fuel tanks in Zone A and a landfill in Zone B. Numerous other potential contaminant sources are also found within the protection area (see Table 5 – Appendix B).

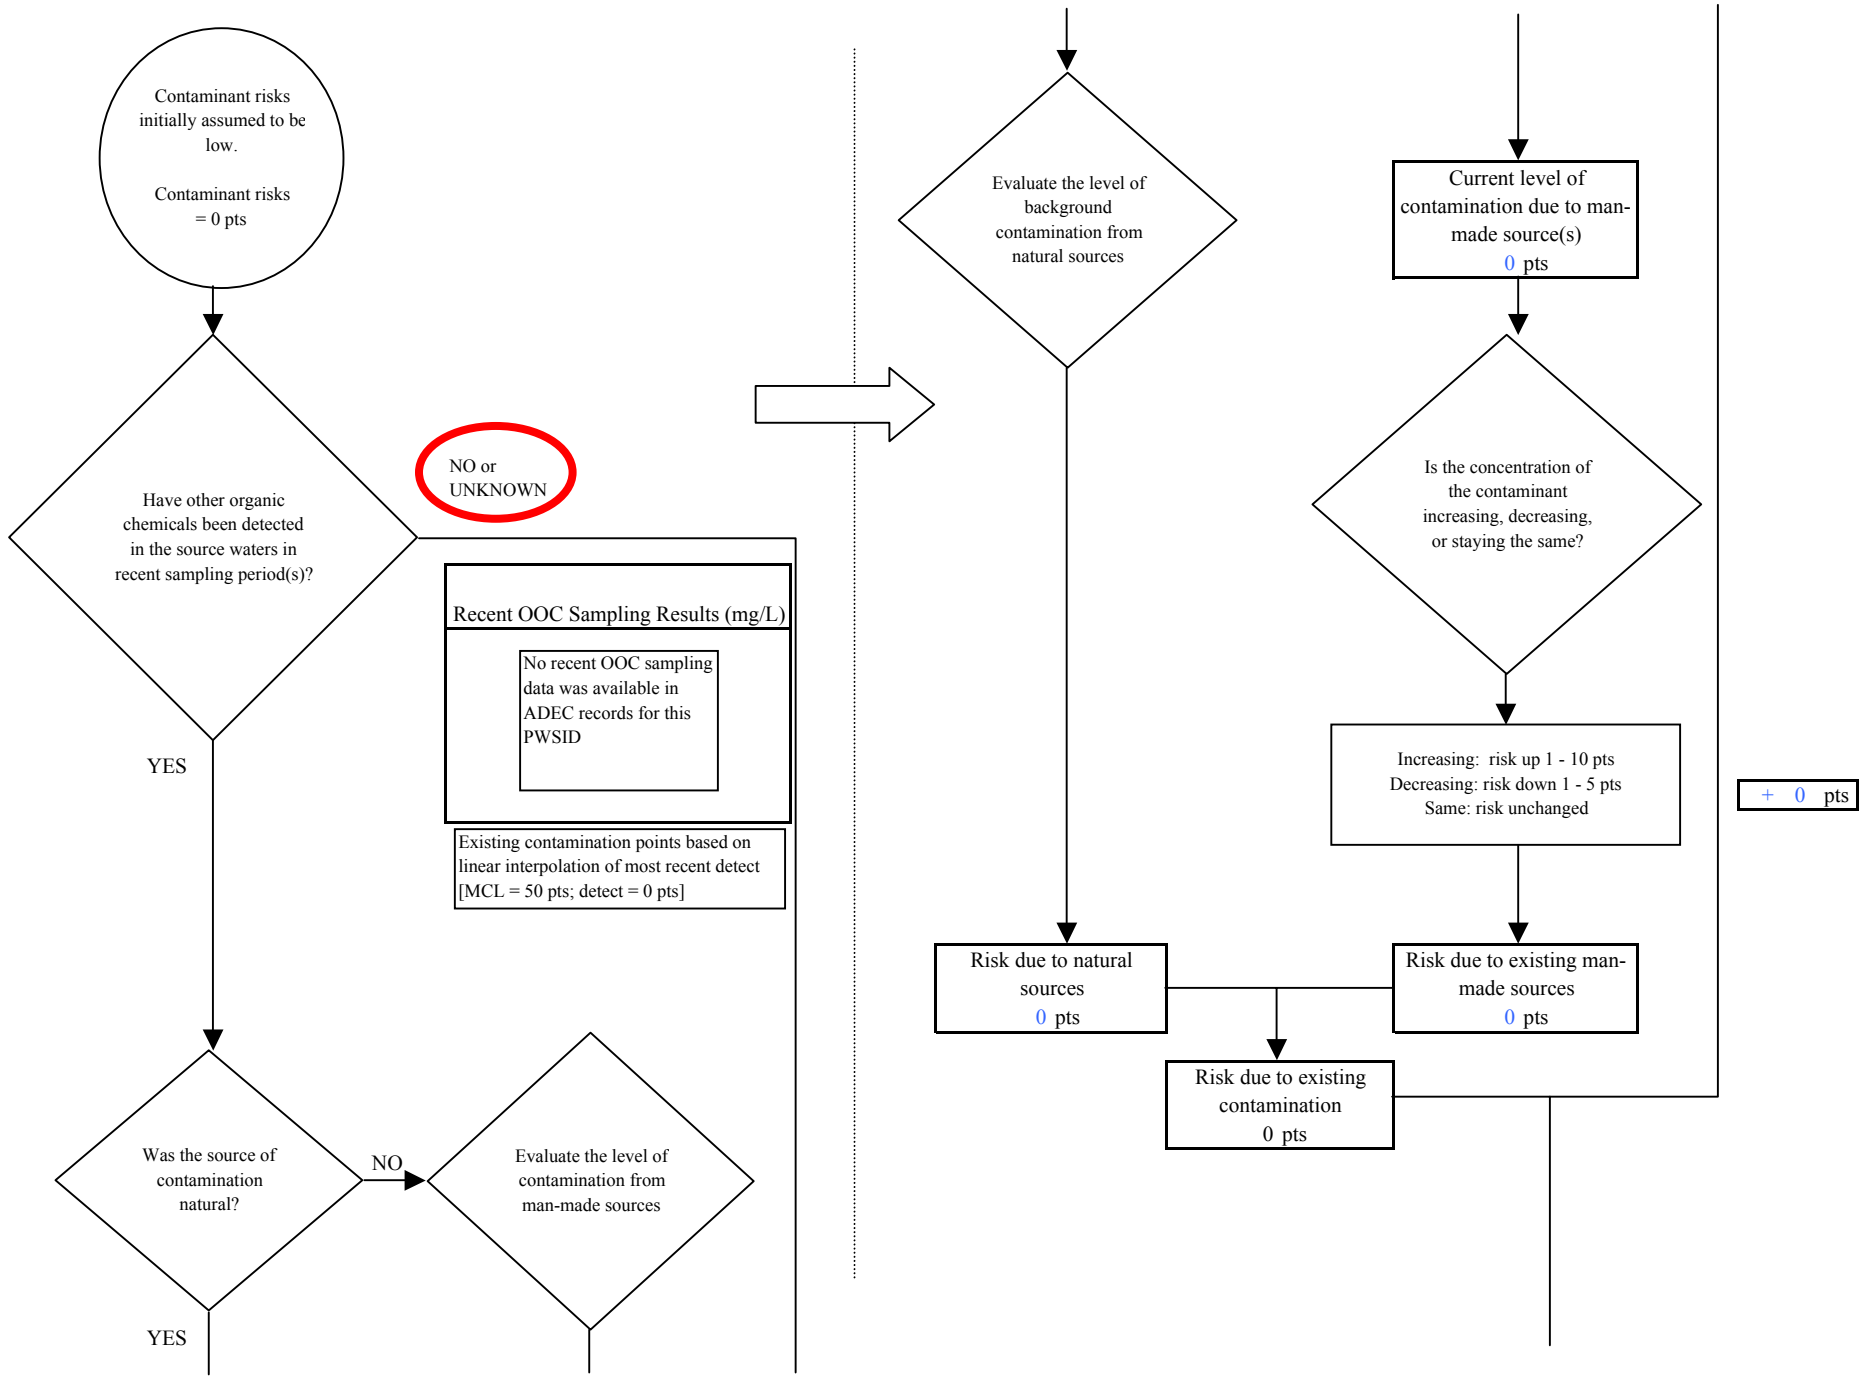
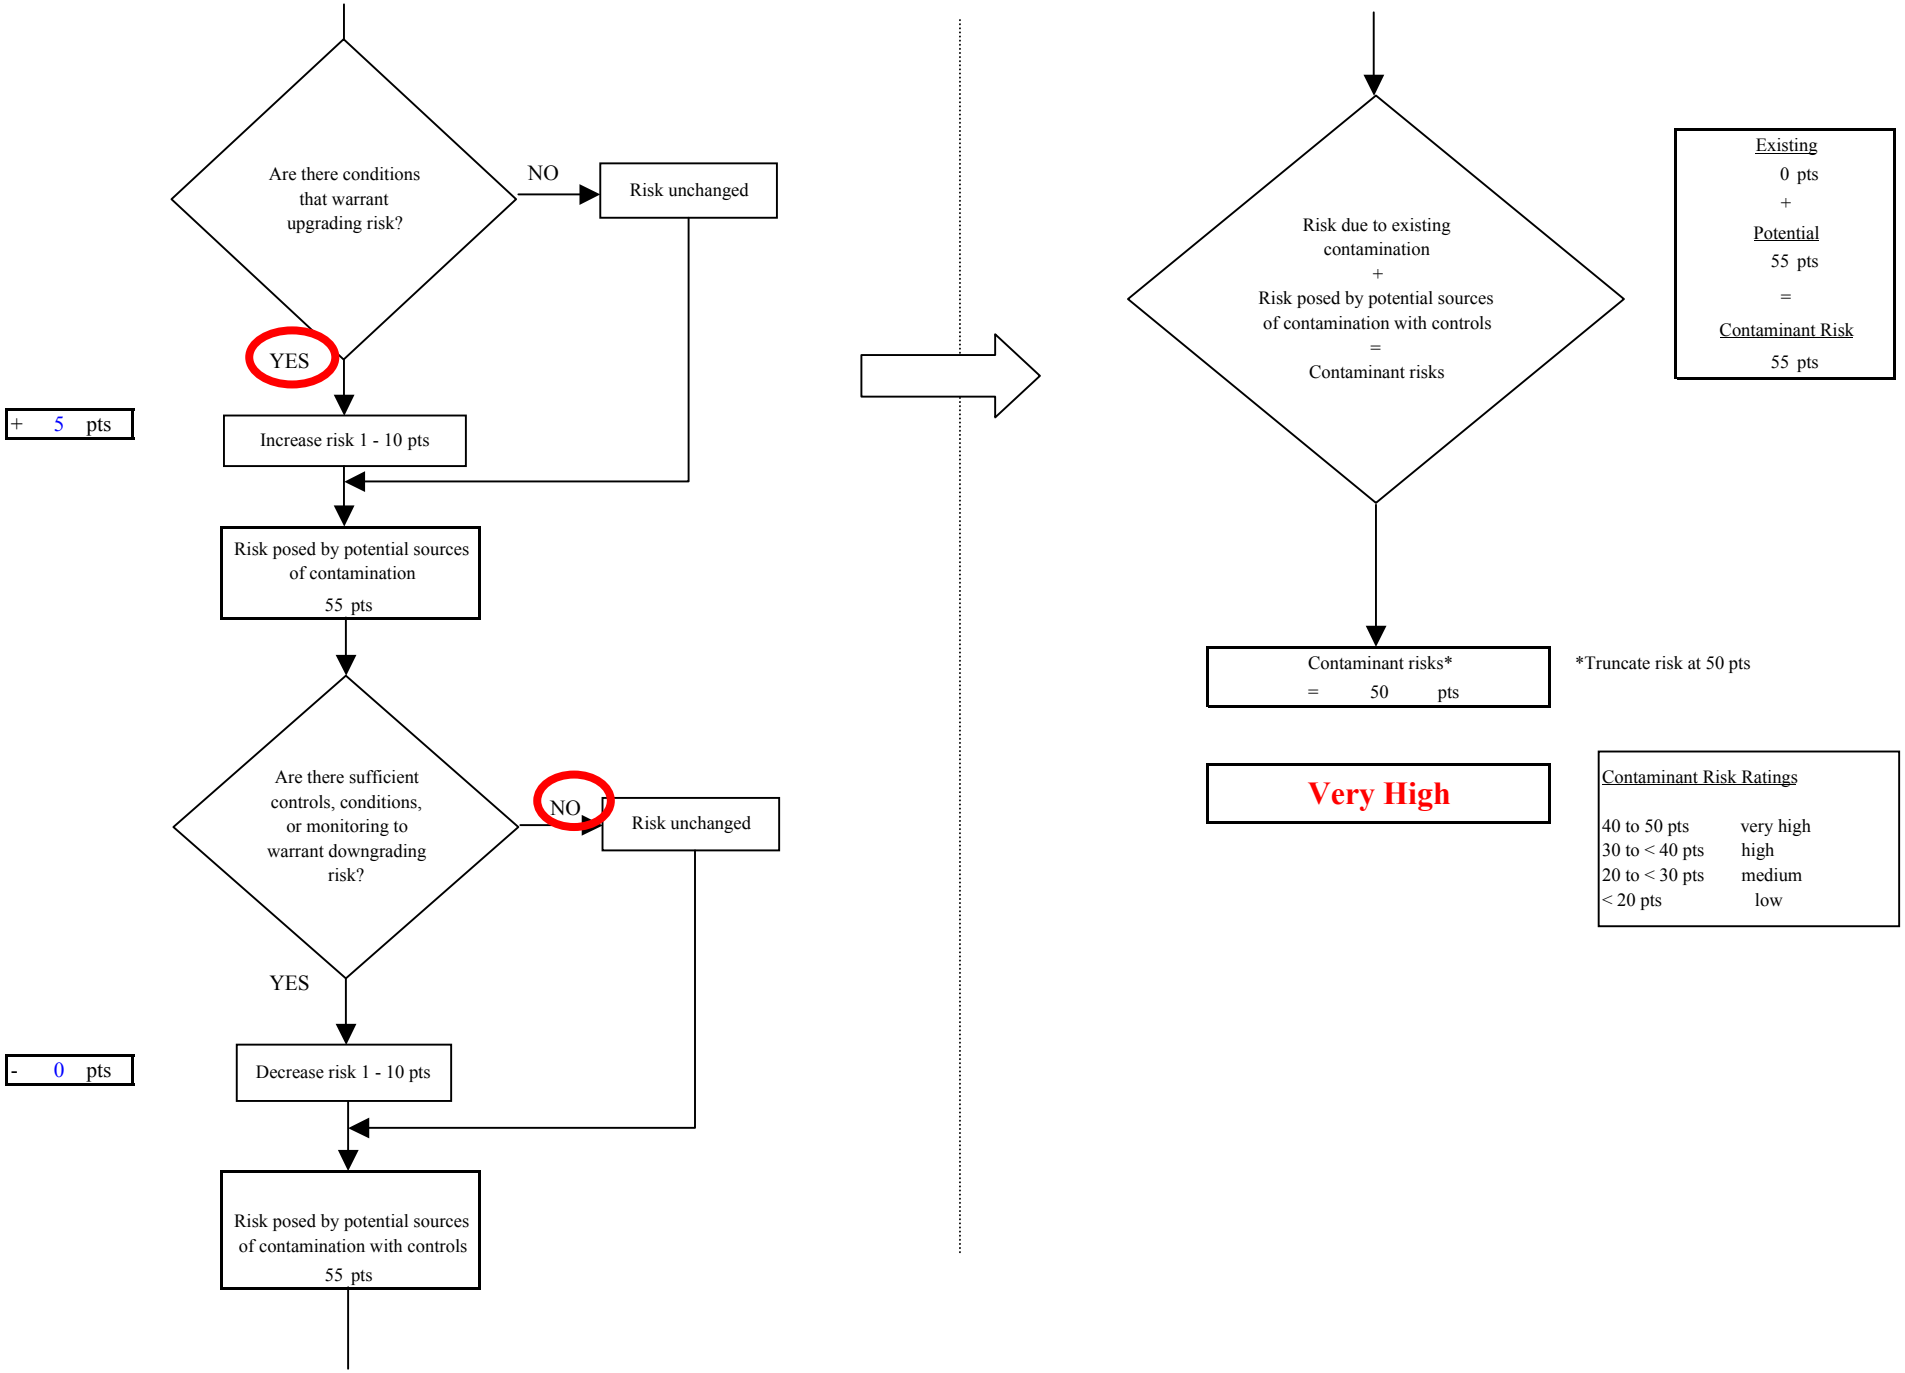
Chart 13. Contaminant risks for Copper River School District - Slana School (PWS No.381503.001) - Other Organic Chemicals

The contaminant risk for other organic chemicals is **Very High**. The risk is primarily attributed to the presence of an electric power generation facility in Zone A and a landfill in Zone B. Several other potential contaminant sources are also found within the protection area (see Table 7 – Appendix B).
