A Hydrogeologic Susceptibility and Vulnerability Assessment for USFWS KNWR Watson Lake Public Drinking Water System, Sterling Area, Alaska PWSID # 249090.001

DRINKING WATER PROTECTION REPORT 1725

Alaska Department of Environmental Conservation

January, 2009

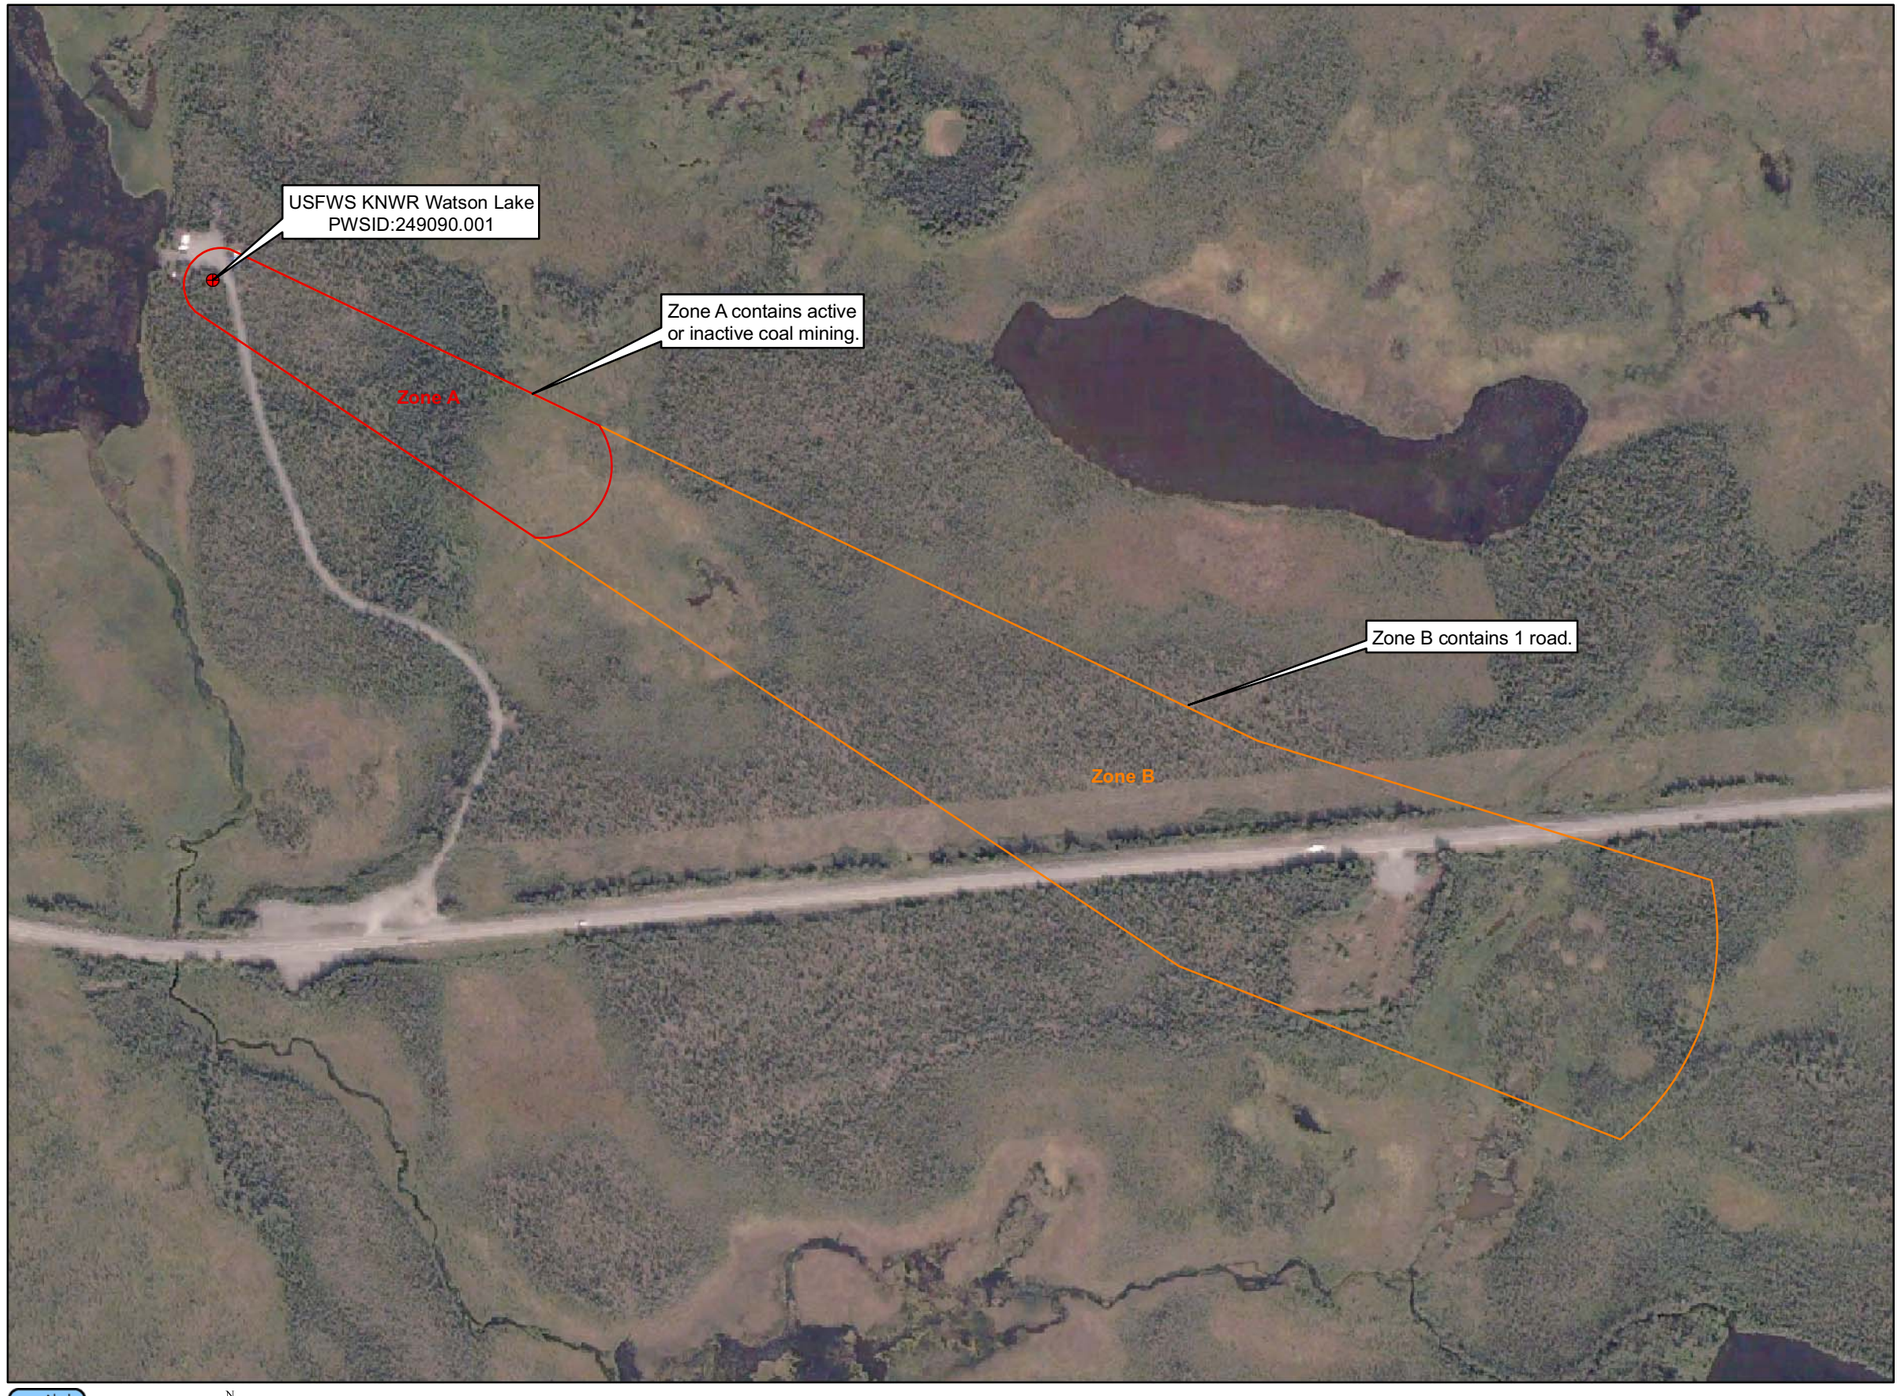
Appendix C Map C

The contaminant risk for volatile organic chemicals is determined to be **Very High**, with coal mining (active or inactive) and a road contributing to the risk to the drinking water well.

Contaminant Source Type	*Contaminant Source ID*	*CS ID tag*	*Zone*	*Risk Ranking for Analysis*	*Map Number*	*Comments*
Coal mining (active or inactive?)	E01	E01	A	High	C	
Highways and roads, paved (cement or asphalt)	X20	X20	B	Low	C	1 road
