Hydrogeologic Susceptibility and Vulnerability Assessment for River's Edge Recreation Park Drinking Water Well, Sutton, Alaska

DRINKING WATER PROTECTION PROGRAM REPORT 103

September 2001

By Catherine Baxter, B.E.S.T. Resource

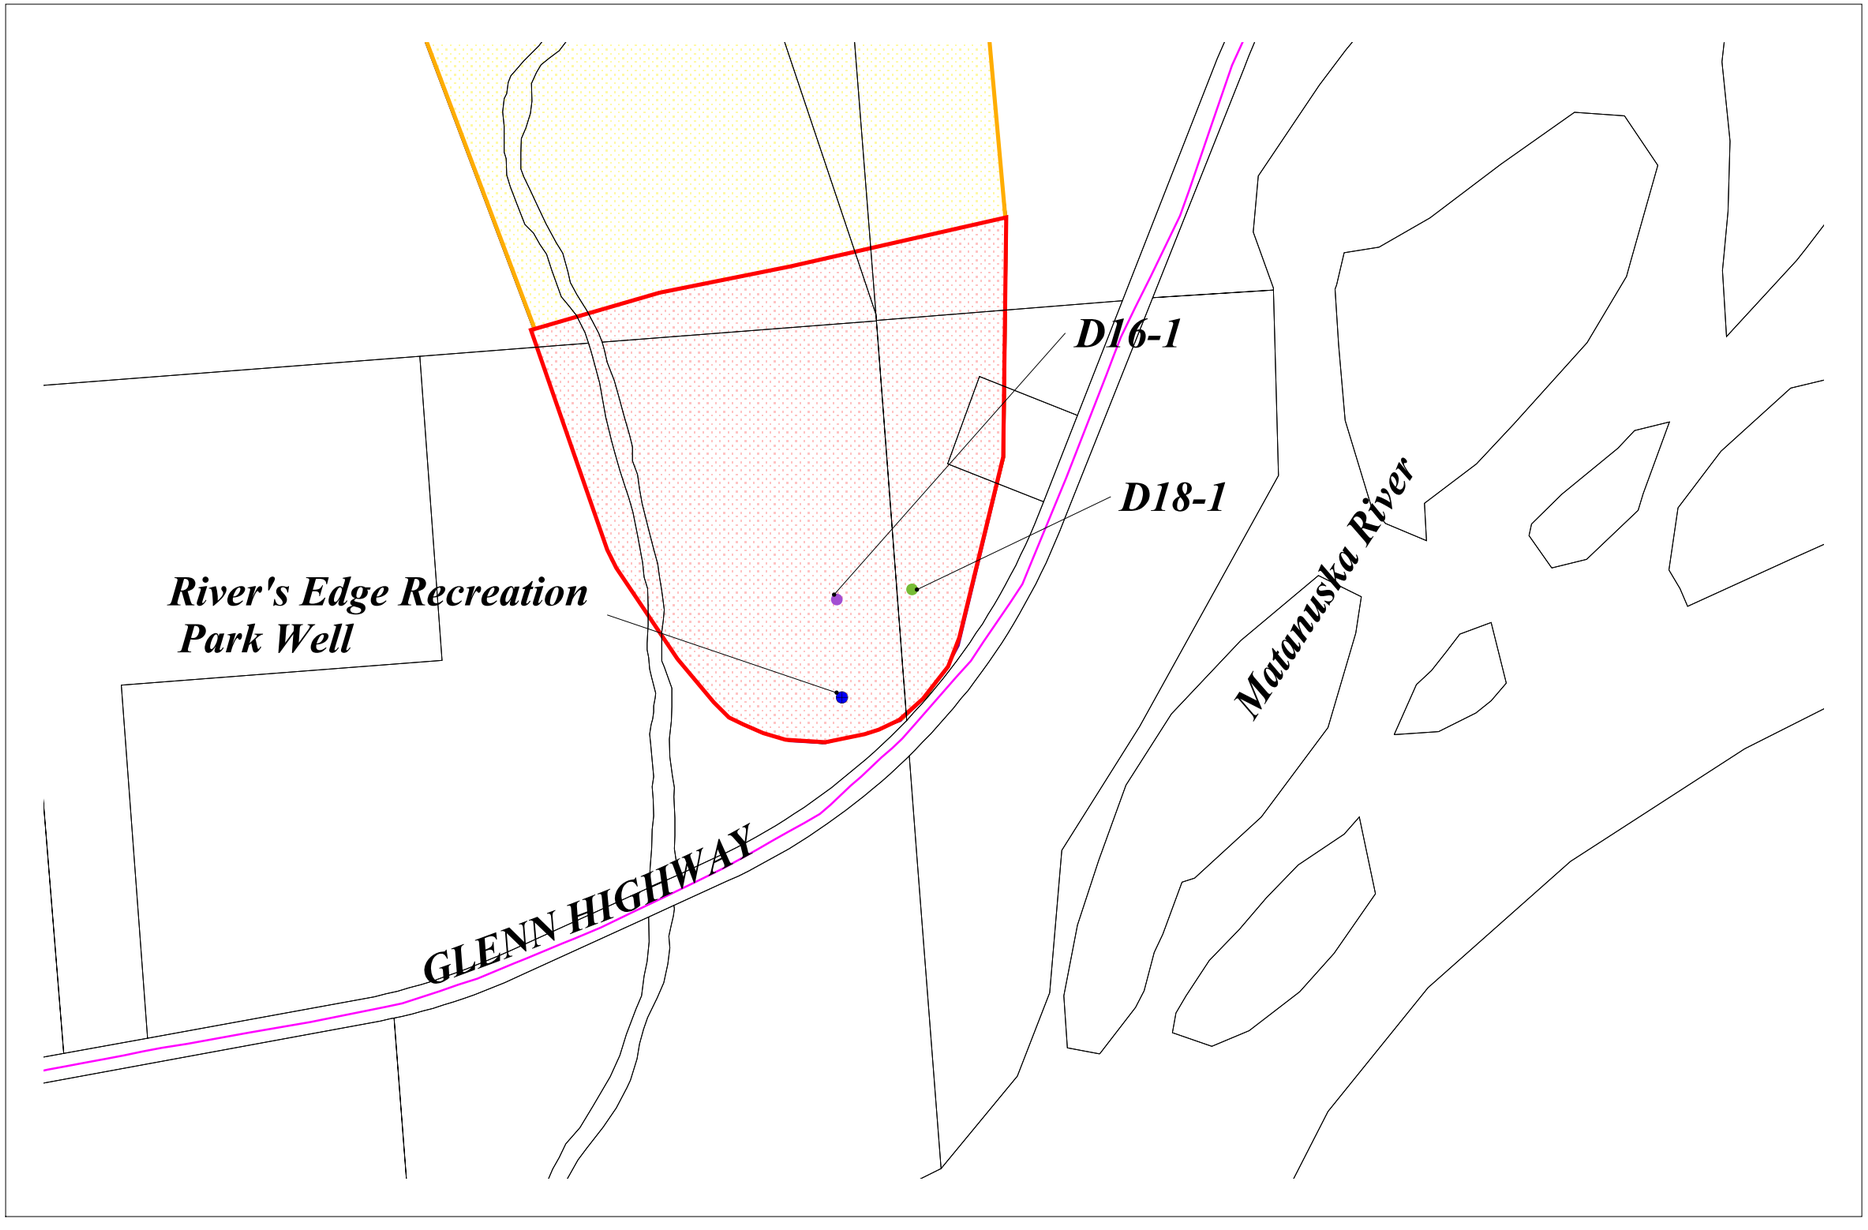
Map 2

Contaminate Source Category	Contaminant Source ID	CS ID Tag	Zone	Location	Map	Comments
Pit Toilet	D16	D16-1	A	Located approx. 225' north of well	2	
RV Dump Station	D18	D18-1	A	Located approx. 325' northeast of well	2

Pit toilet (D16)

RV Dump Station (D18)

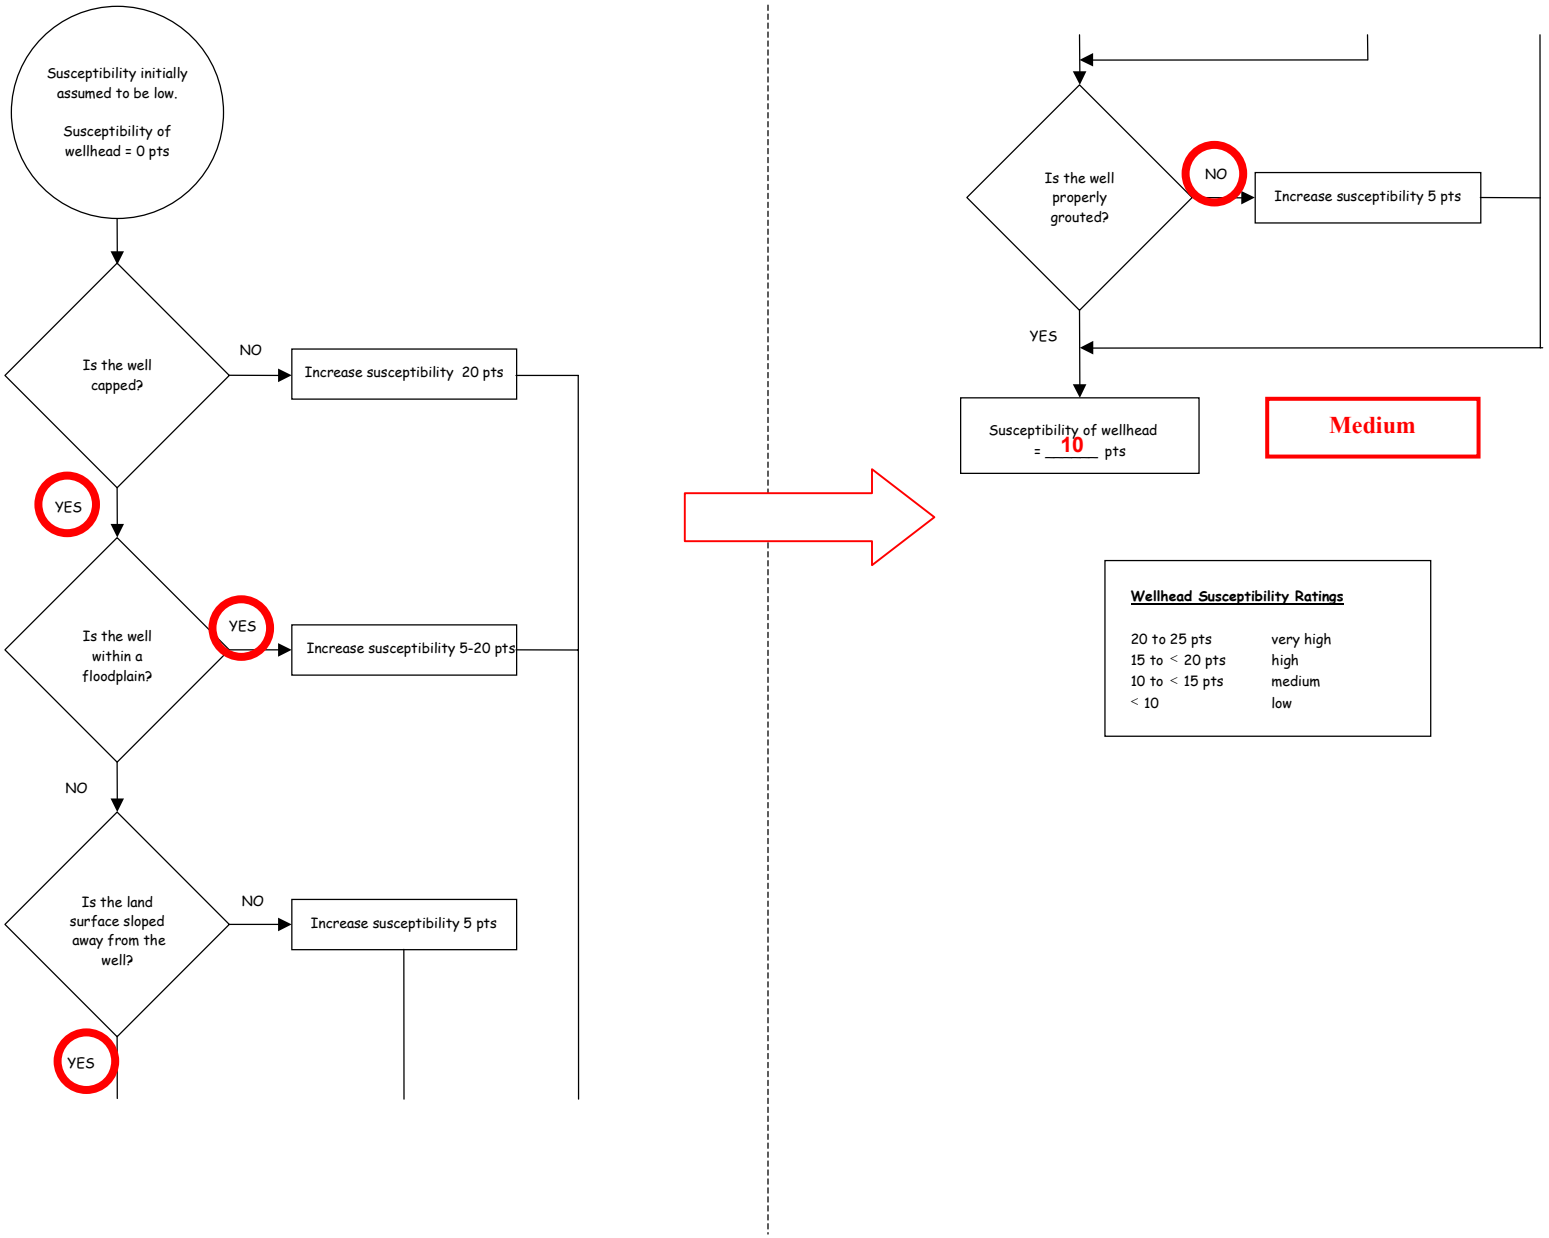
Chart 1. Susceptibility of the wellhead – River's Edge Recreation Park

River's Edge Recreation Park is completed in a confined or semi-confined aquifer setting. The well penetrates 51 feet of sand and gravel with one clay-bearing layer. This 10-foot clay layer, encountered at 30 feet below land surface, may provide a protective barrier for the movement of contaminants in the subsurface. However, near the base of the Talkeetna Mountains, the clay and till layers tend to be discontinuous and thin toward the mountains. Therefore, contaminants that enter the subsurface near the base of the mountains may enter the confined aquifer uninhibited by any protective layer. This well does not appear to be properly grouted as indicated previously from information obtained from ADEC records. The absence of grouting can promote the transport of contaminants along the well casing.

Score	Rating
Susceptibility of the Wellhead	10	Medium
Susceptibility of the Aquifer	23	Very High
Natural Susceptibility	33	High

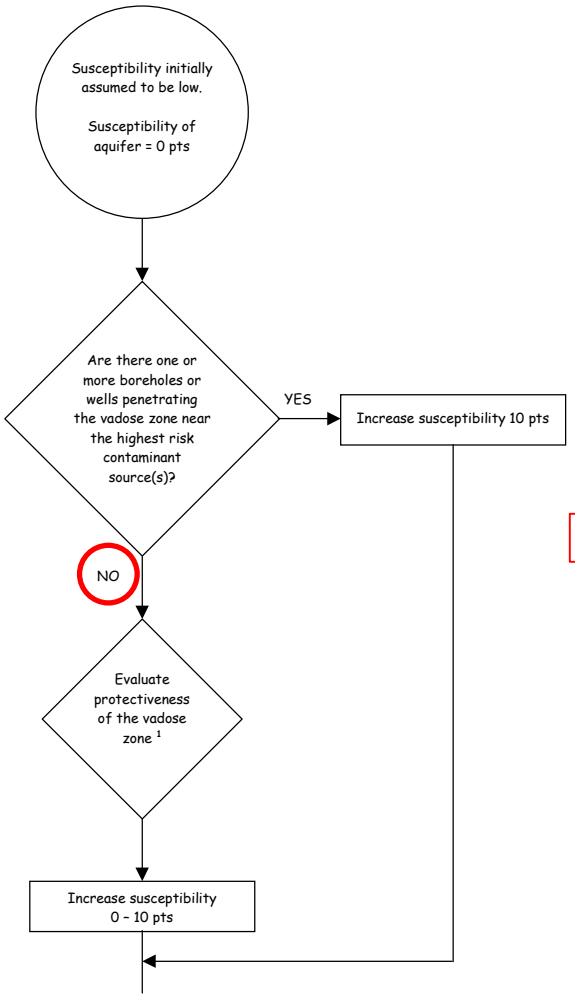
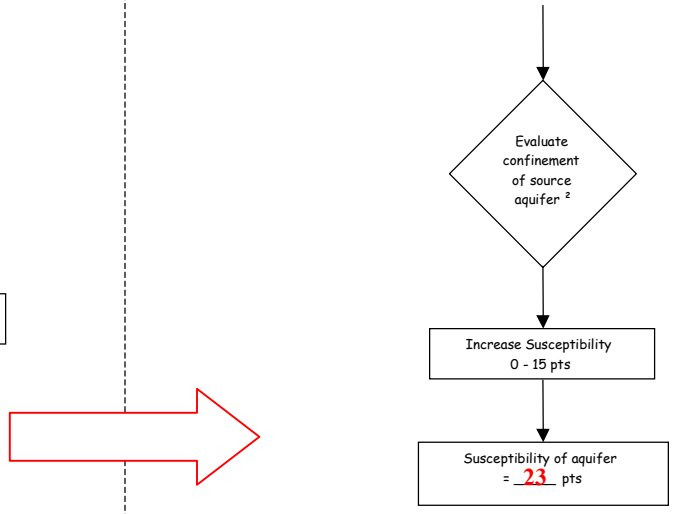
Chart 2. Susceptibility of the aquifer – River's Edge Recreation Park

Recharge (16-20 inches per year, base of Talkeetna Mountains, with silty, gravelly sand)
4/10 = 4 Points
Depth to static water level (30 feet) 4/10 = 4 Points

Protectiveness of the Vadose Zone Total = **8 Points**

Unconfined 15/15 = 10 Points
Density of boreholes/wells 15/15 = 5 Point

Degree of Confinement Total = **15 Points**

Very High

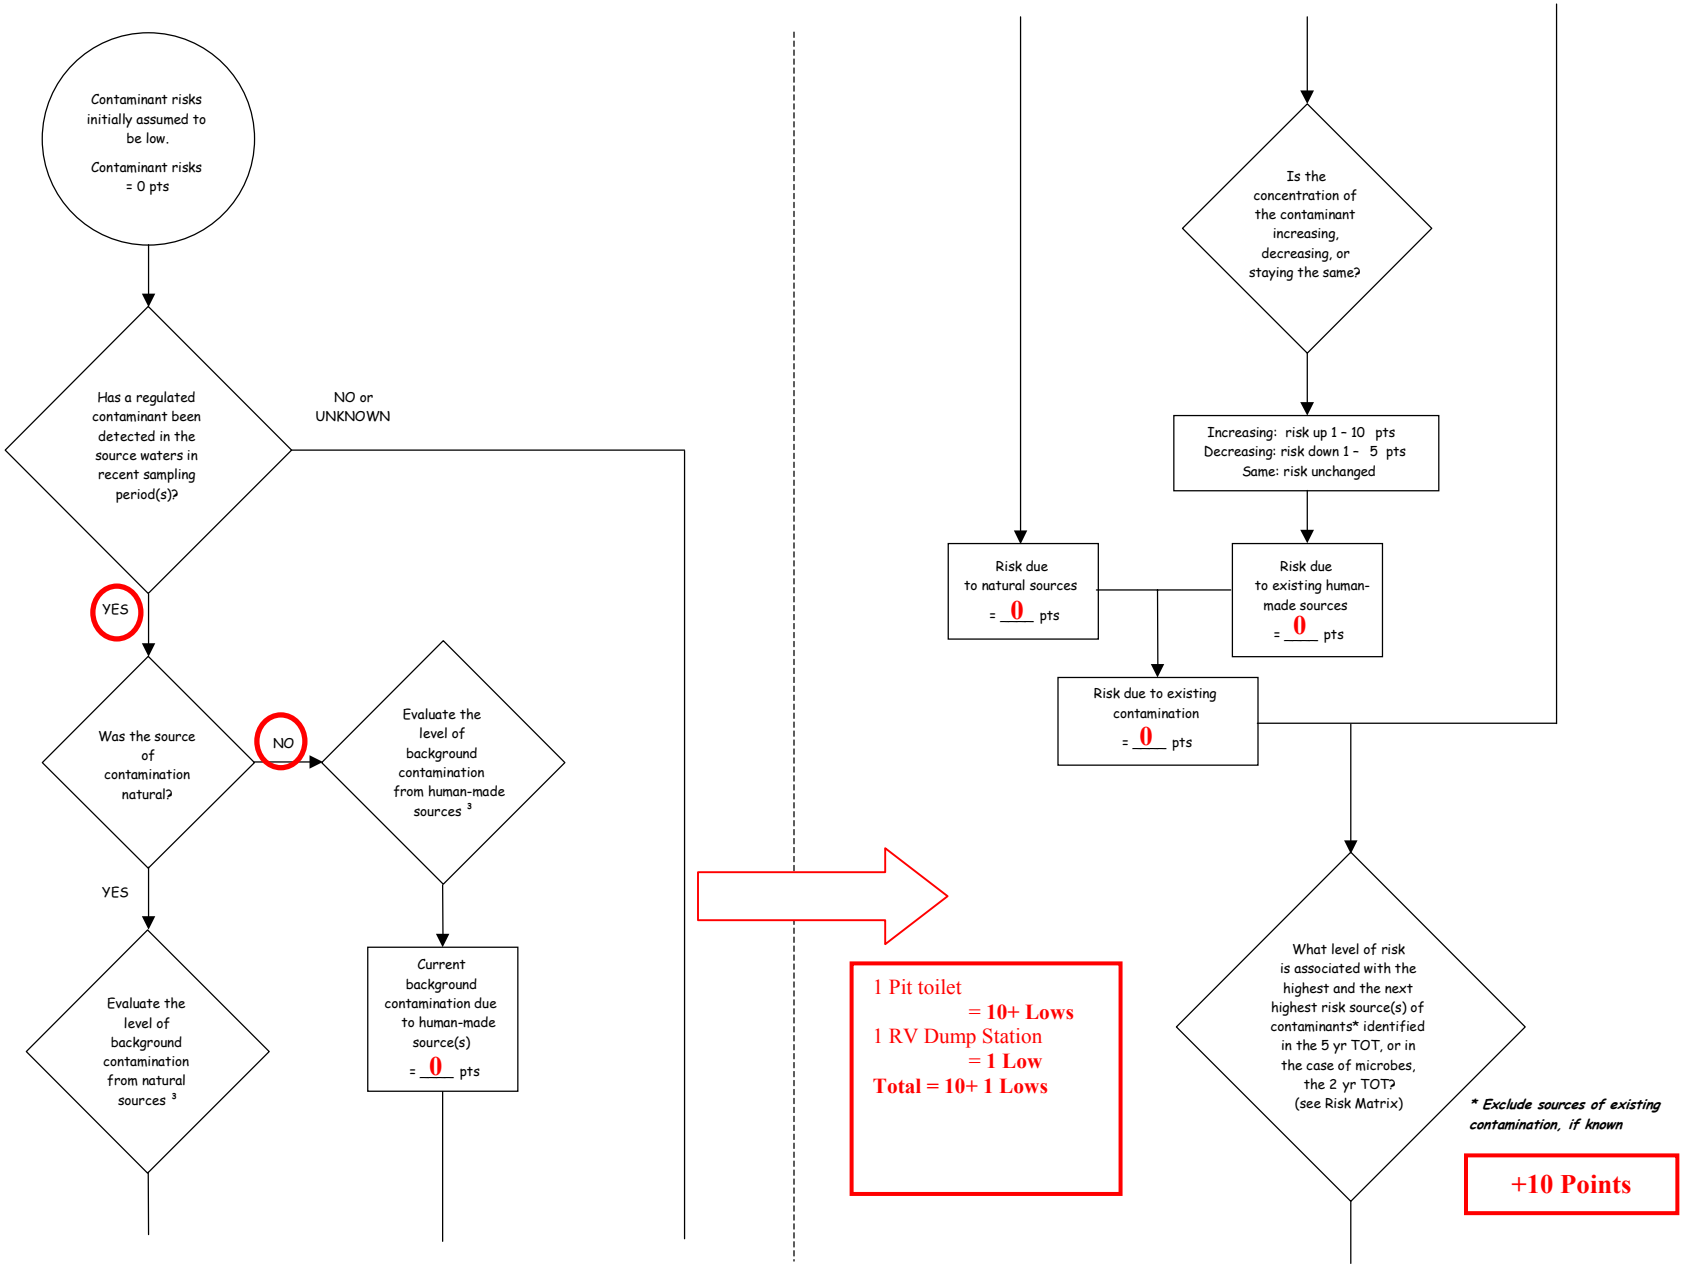
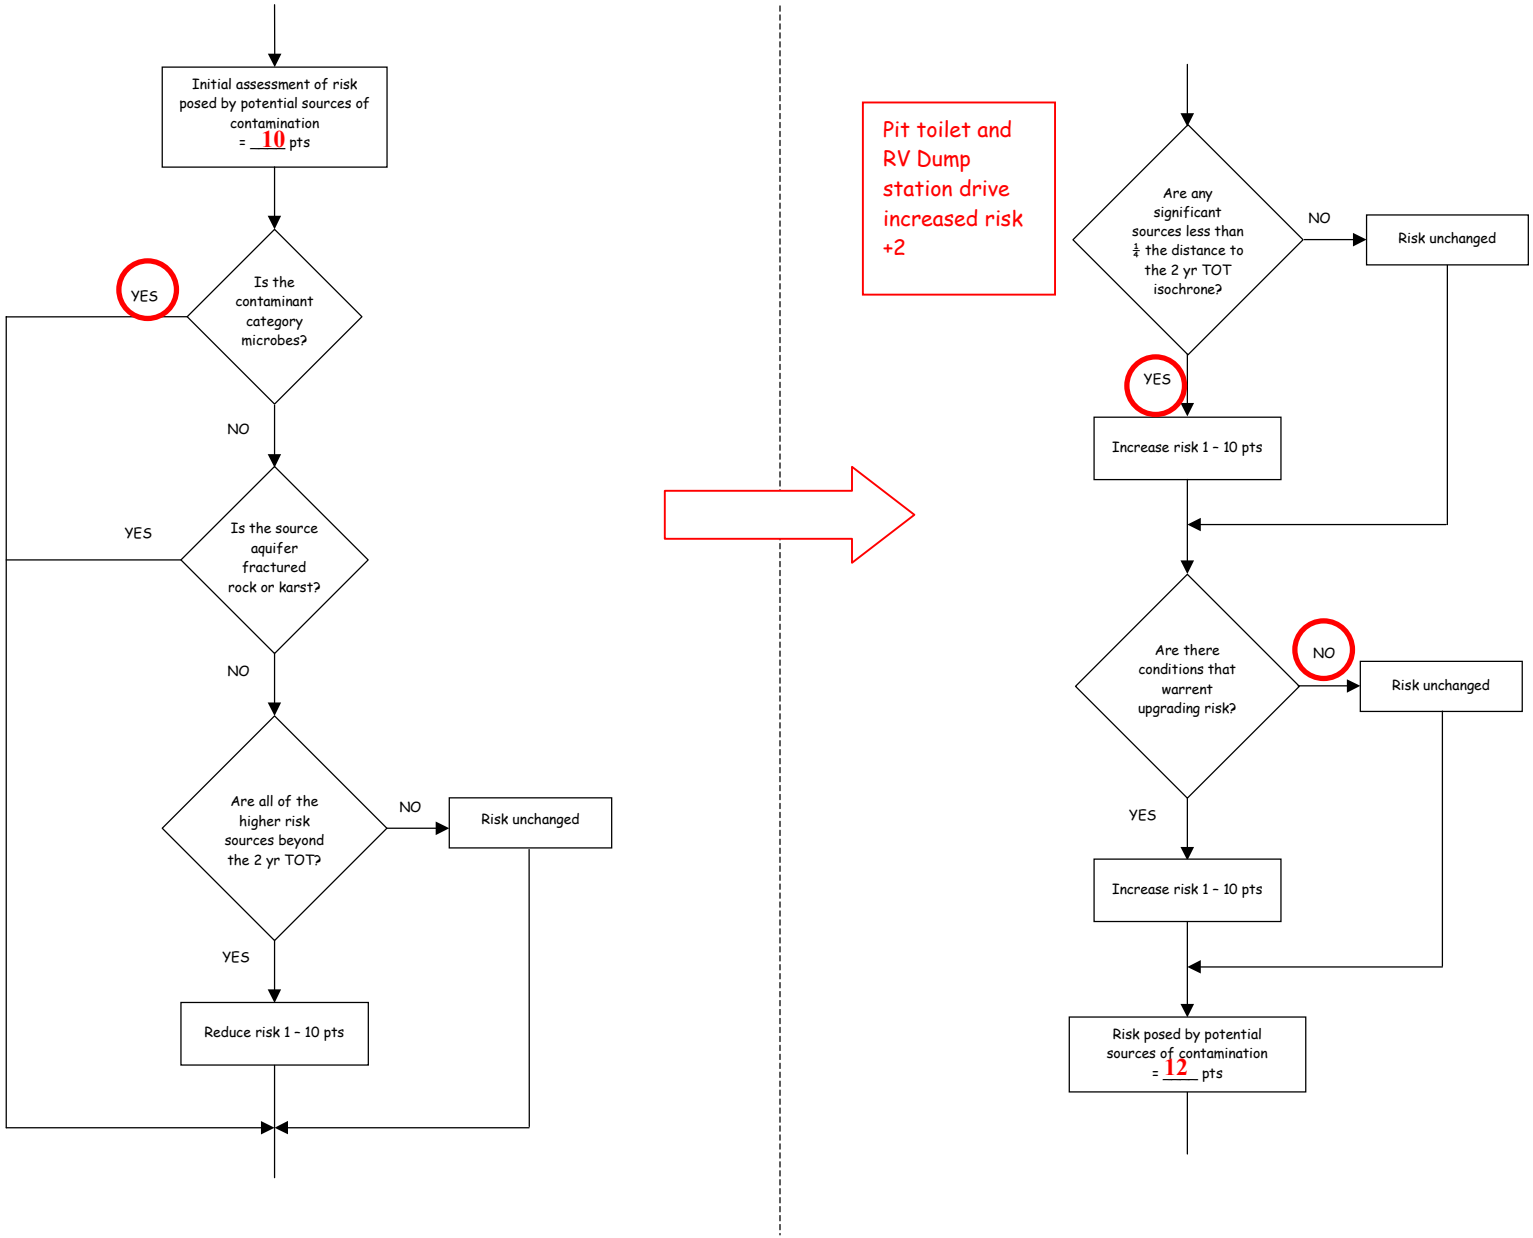
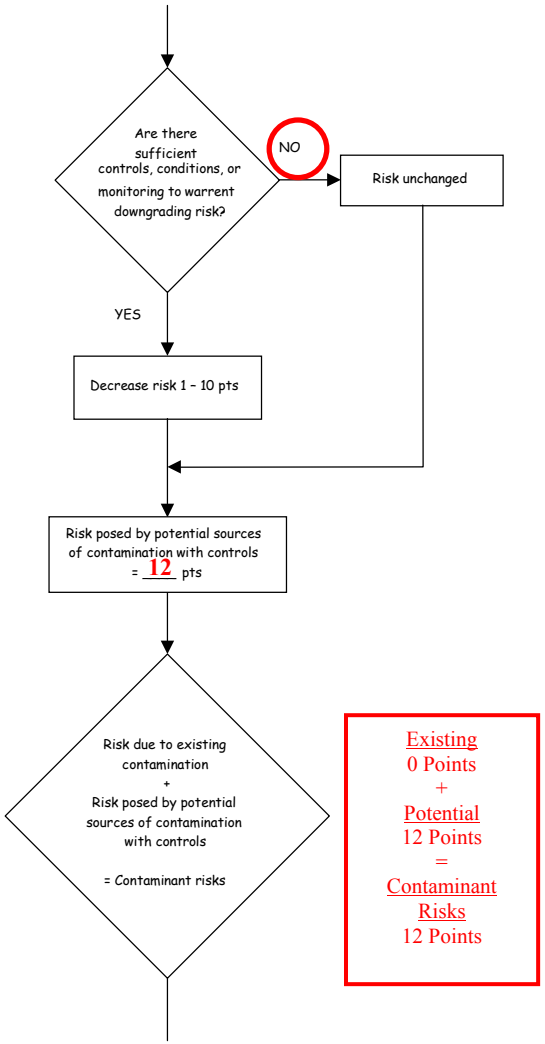
Chart 3. Contaminant risks for River's Edge Recreation Park – Bacteria & Viruses

Bacteria and Viruses were not detected in the source waters of River's Edge Recreation Park.

Existing
0 Points
+
Potential
12 Points
=
Contaminant Risks
12 Points

Contaminant risks* = 12 pts

Low

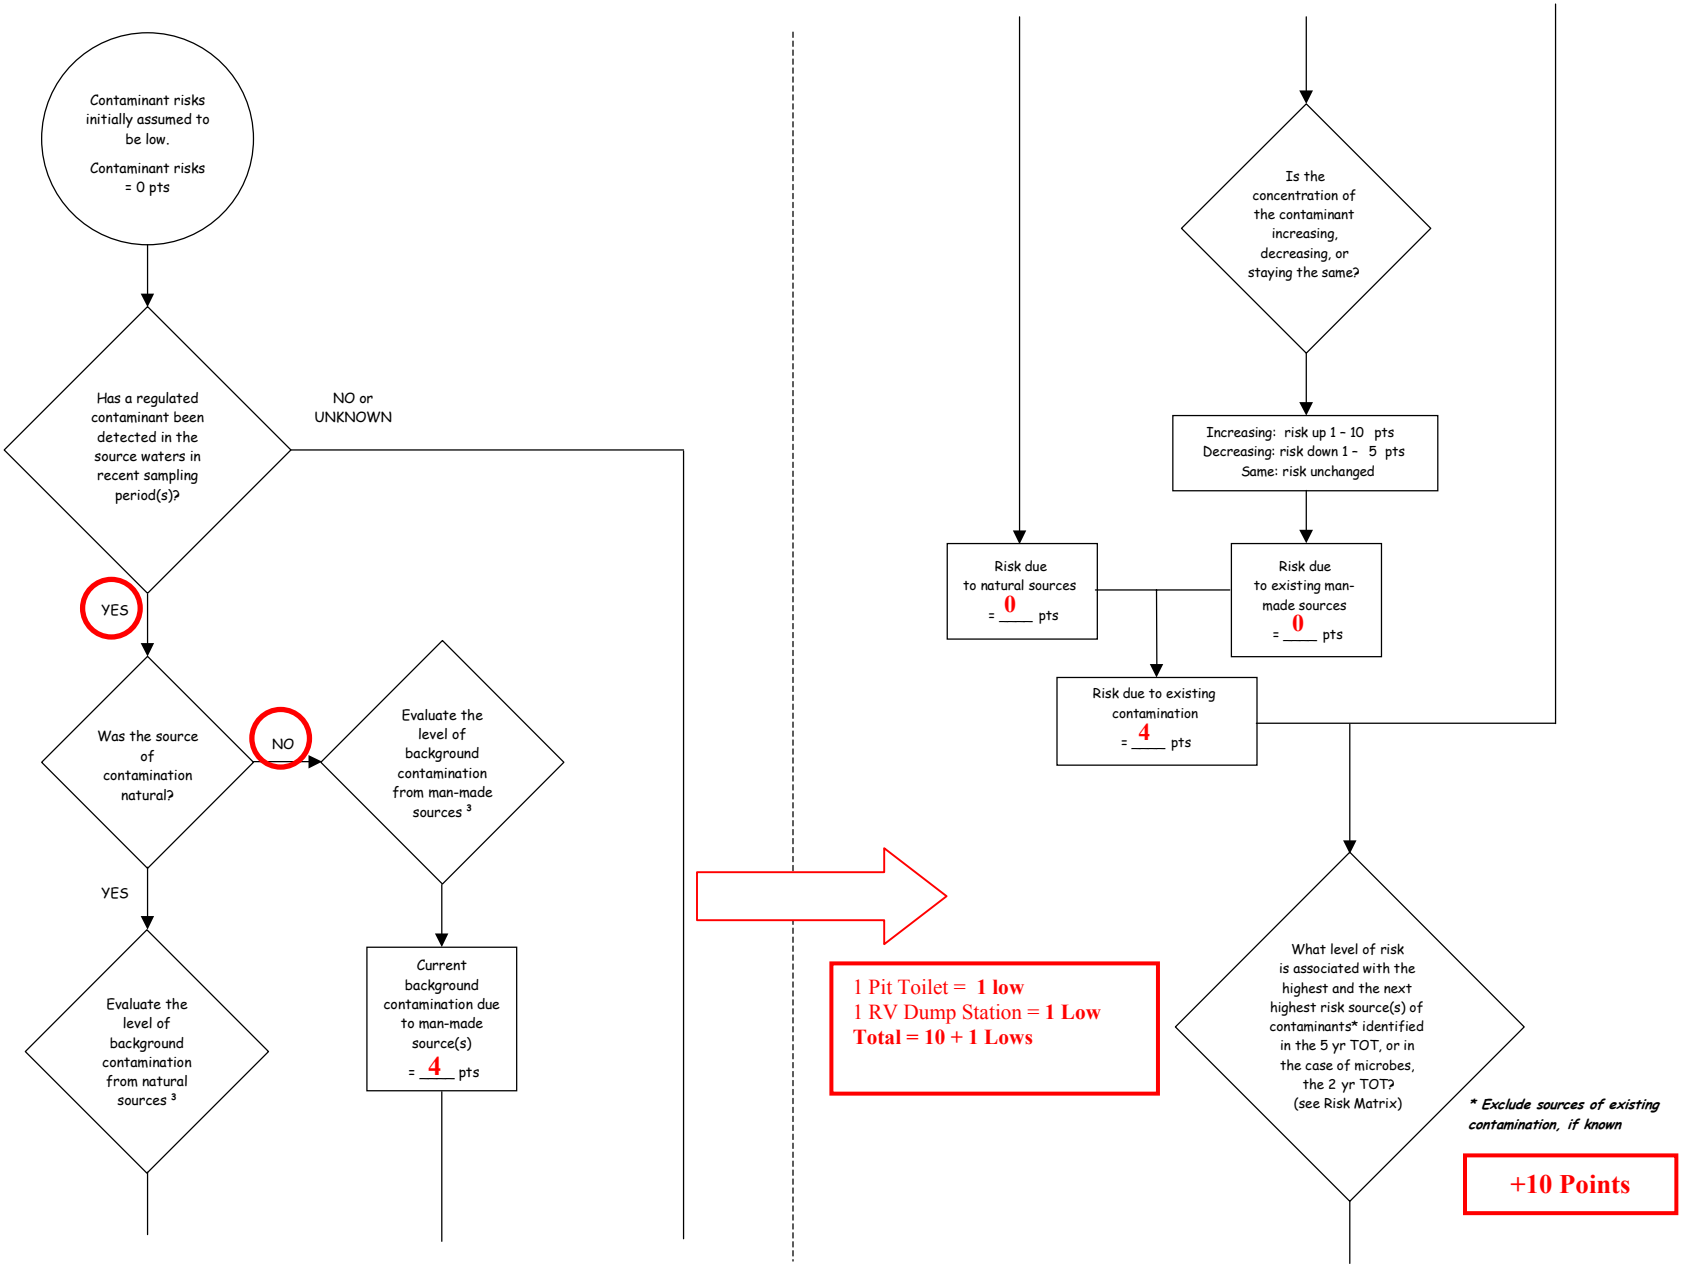
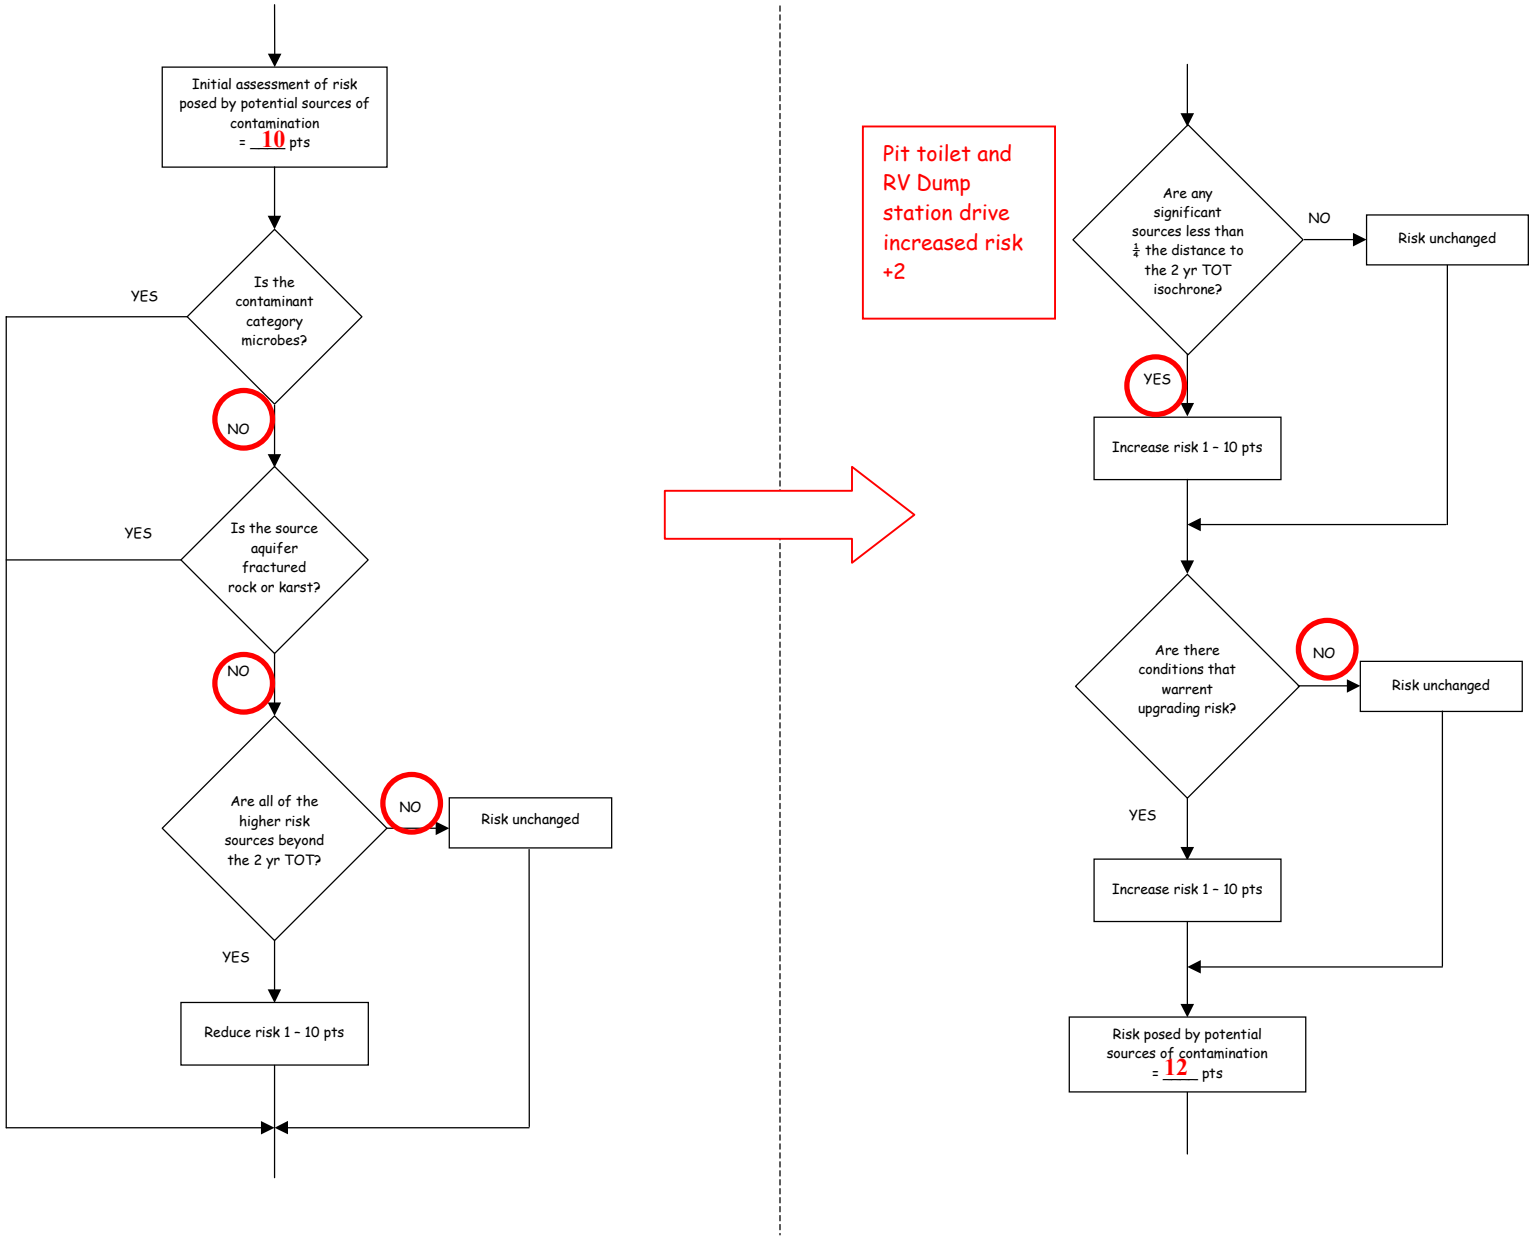
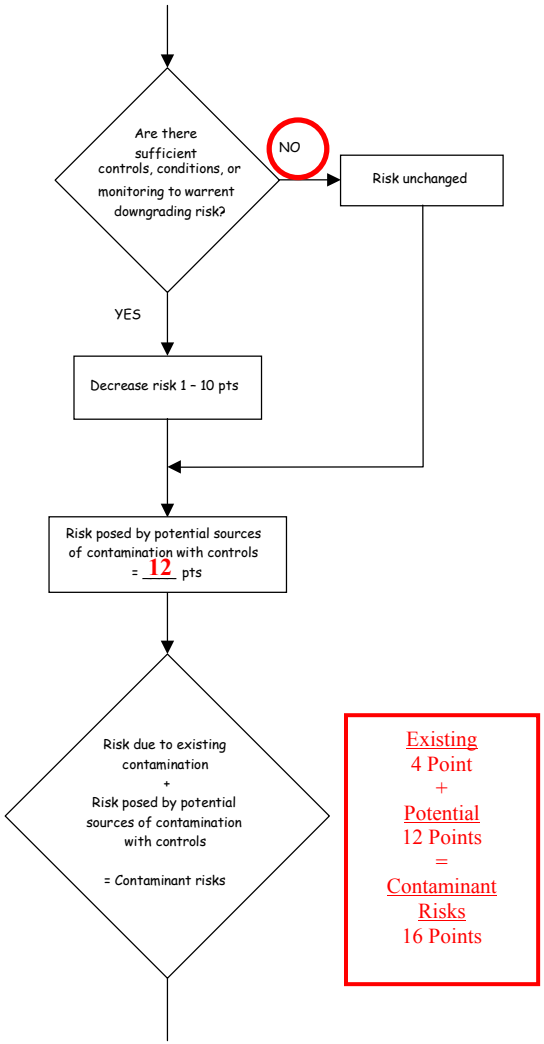
Chart 5. Contaminant risks for River's Edge Recreation Park– Nitrates and Nitrites

Sampling history of River's Edge Recreation Park source waters indicate low concentrations of nitrate (See Chart 6 – Contaminant Risks for Nitrates/Nitrites in Appendix D). Existing nitrate contamination is approximately 1% of the allowable limit (MCL) for this contaminant. Due to the high solubility and weak retention by soil, nitrates are very mobile in soil, moving at approximately the same rate as water. The current nitrate concentration in River's Edge Recreation Park remains at safe levels with respect to human health.

Existing
4 Point
+
Potential
12 Points
=
Contaminant
Risks
16 Points

Contaminant risks*
= 16 pts

Nitrate
1.66 mg/L on 6/25/01
0.80 mg/L on 7/19/00
0.83 mg/L on 5/25/99
0.30 mg/L on 7/23/98
0.48 mg/L 5/29/97
0.64 mg/L 5/15/96
0.59 mg/L 5/25/95
0.75 mg/L 5/17/94
Maximum Contaminant Level (MCL)
= 10mg/L
1.66/10
= 0.166 or 1% of MCL

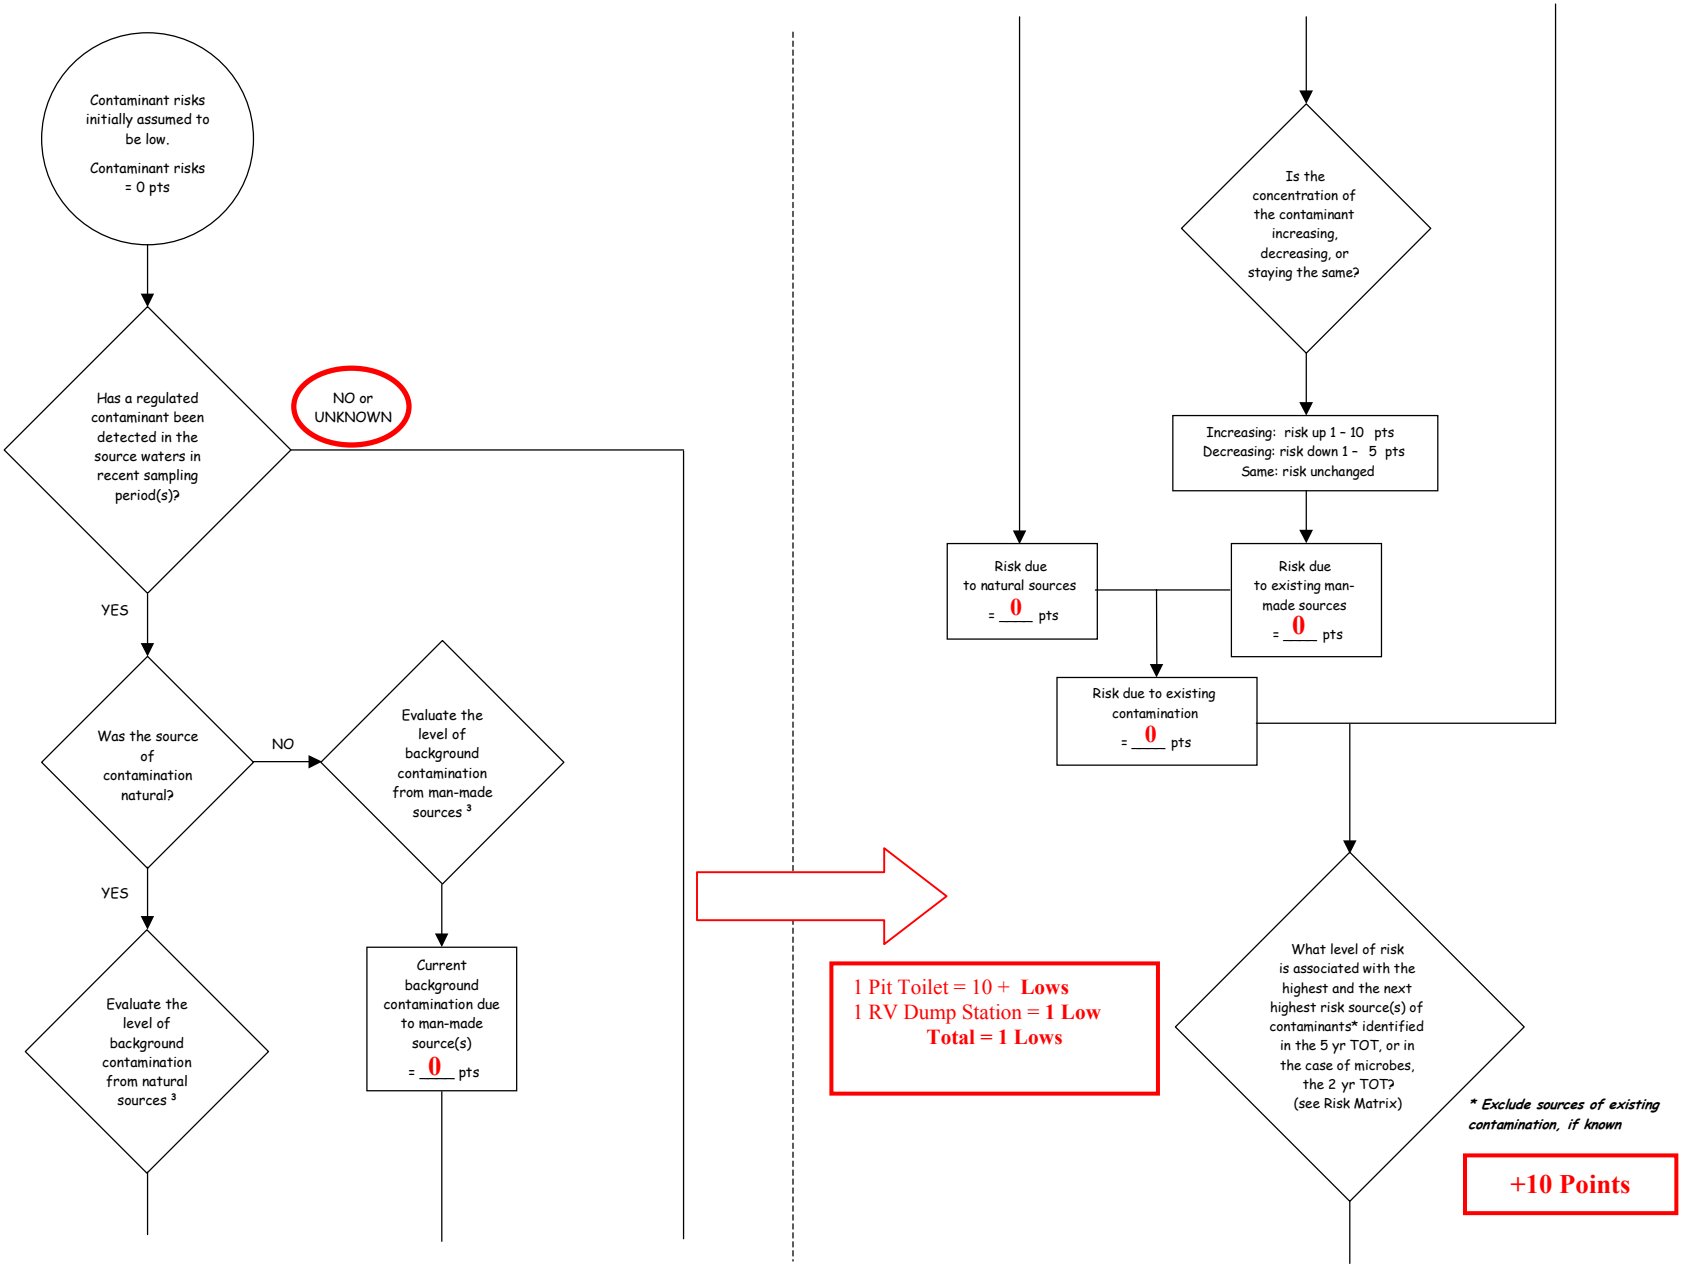
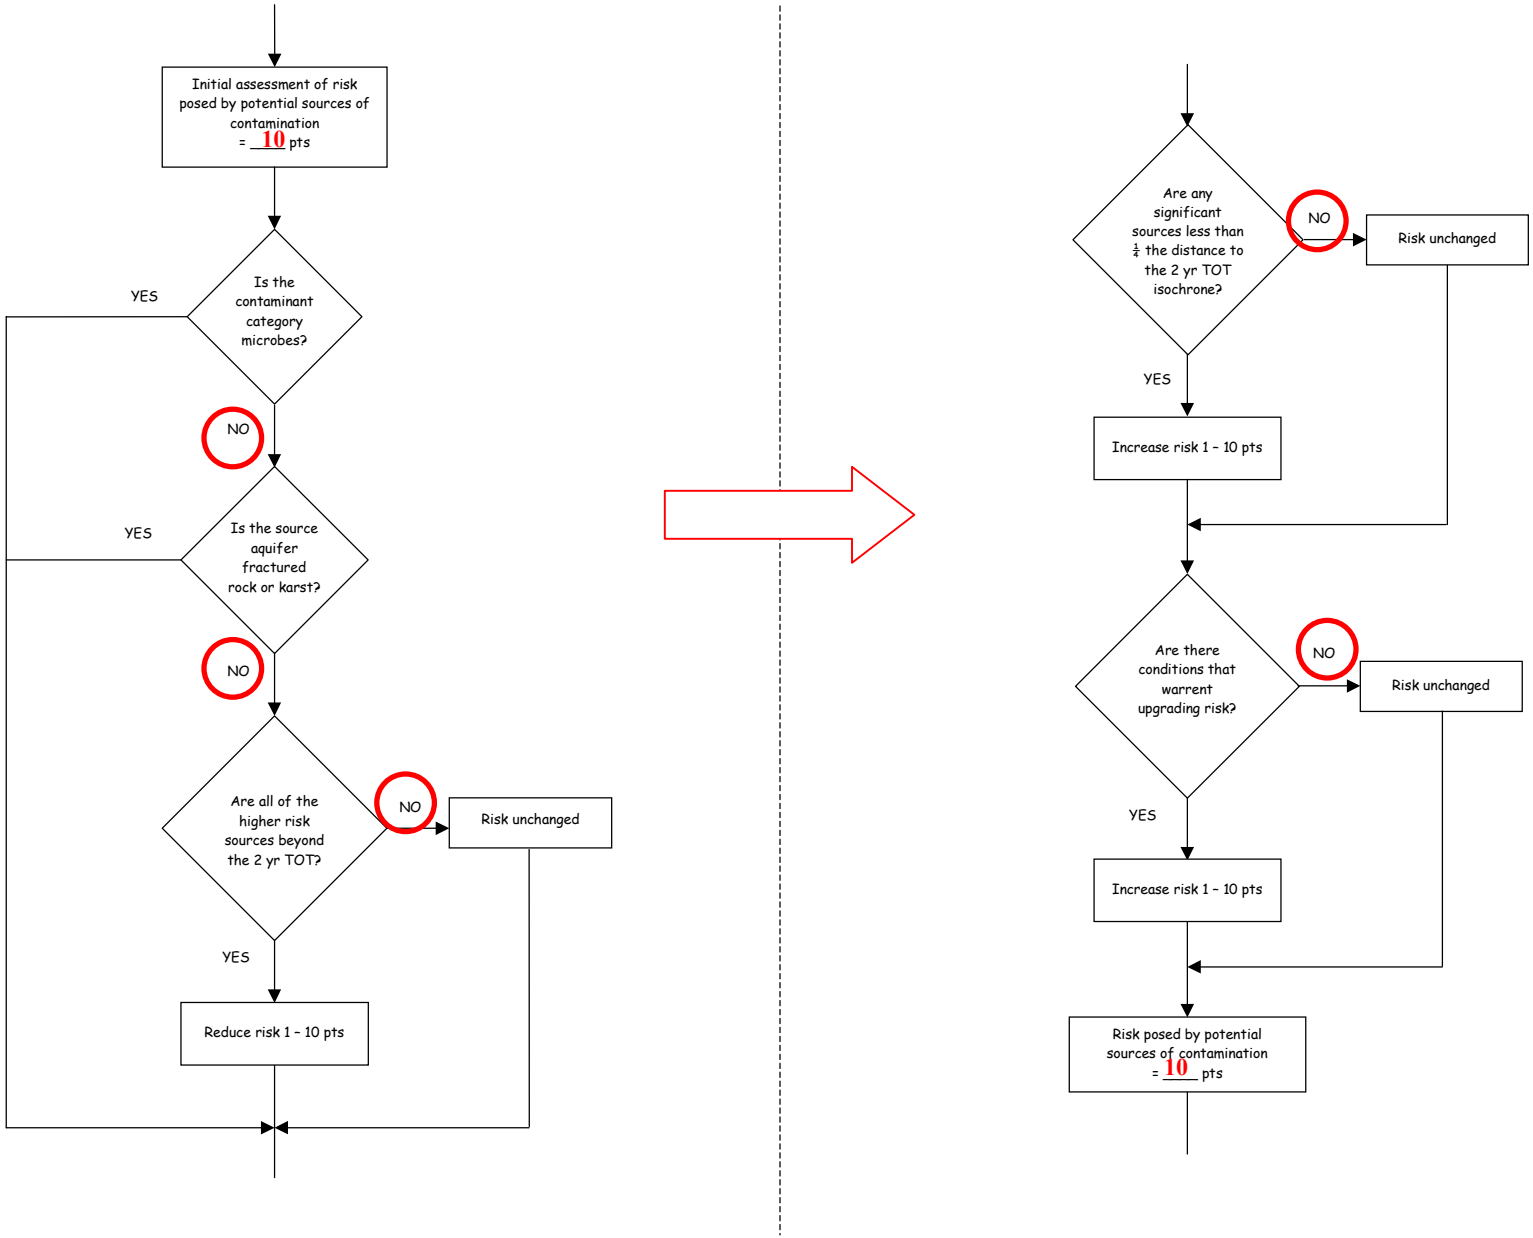
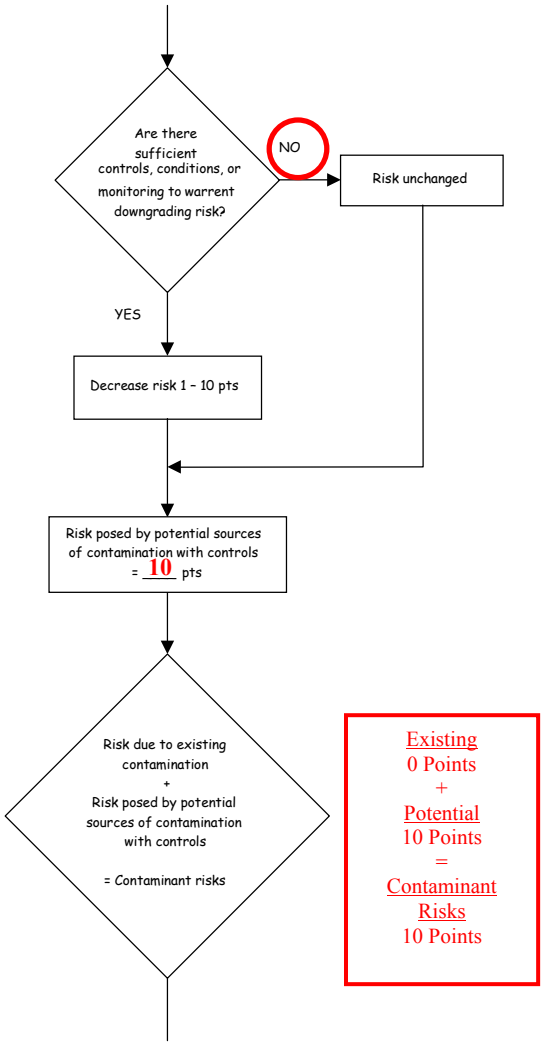
Chart 7. Contaminant risks for River's Edge Recreation Park – Volatile Organic Chemicals

Volatile Organic Chemicals were not detected in the source waters of River's Edge Recreation Park.

Existing
0 Points
+
Potential
10 Points
=
Contaminant Risks
10 Points

Low
