Source Water Assessment

A Hydrogeologic Susceptibility and Vulnerability Assessment for Mt. McKinley Princess Lodge - Well 2 Public Drinking Water System, Talkeetna Area, Alaska PWSID # 225601.002

Alaska Department of Environmental Conservation

December, 2008

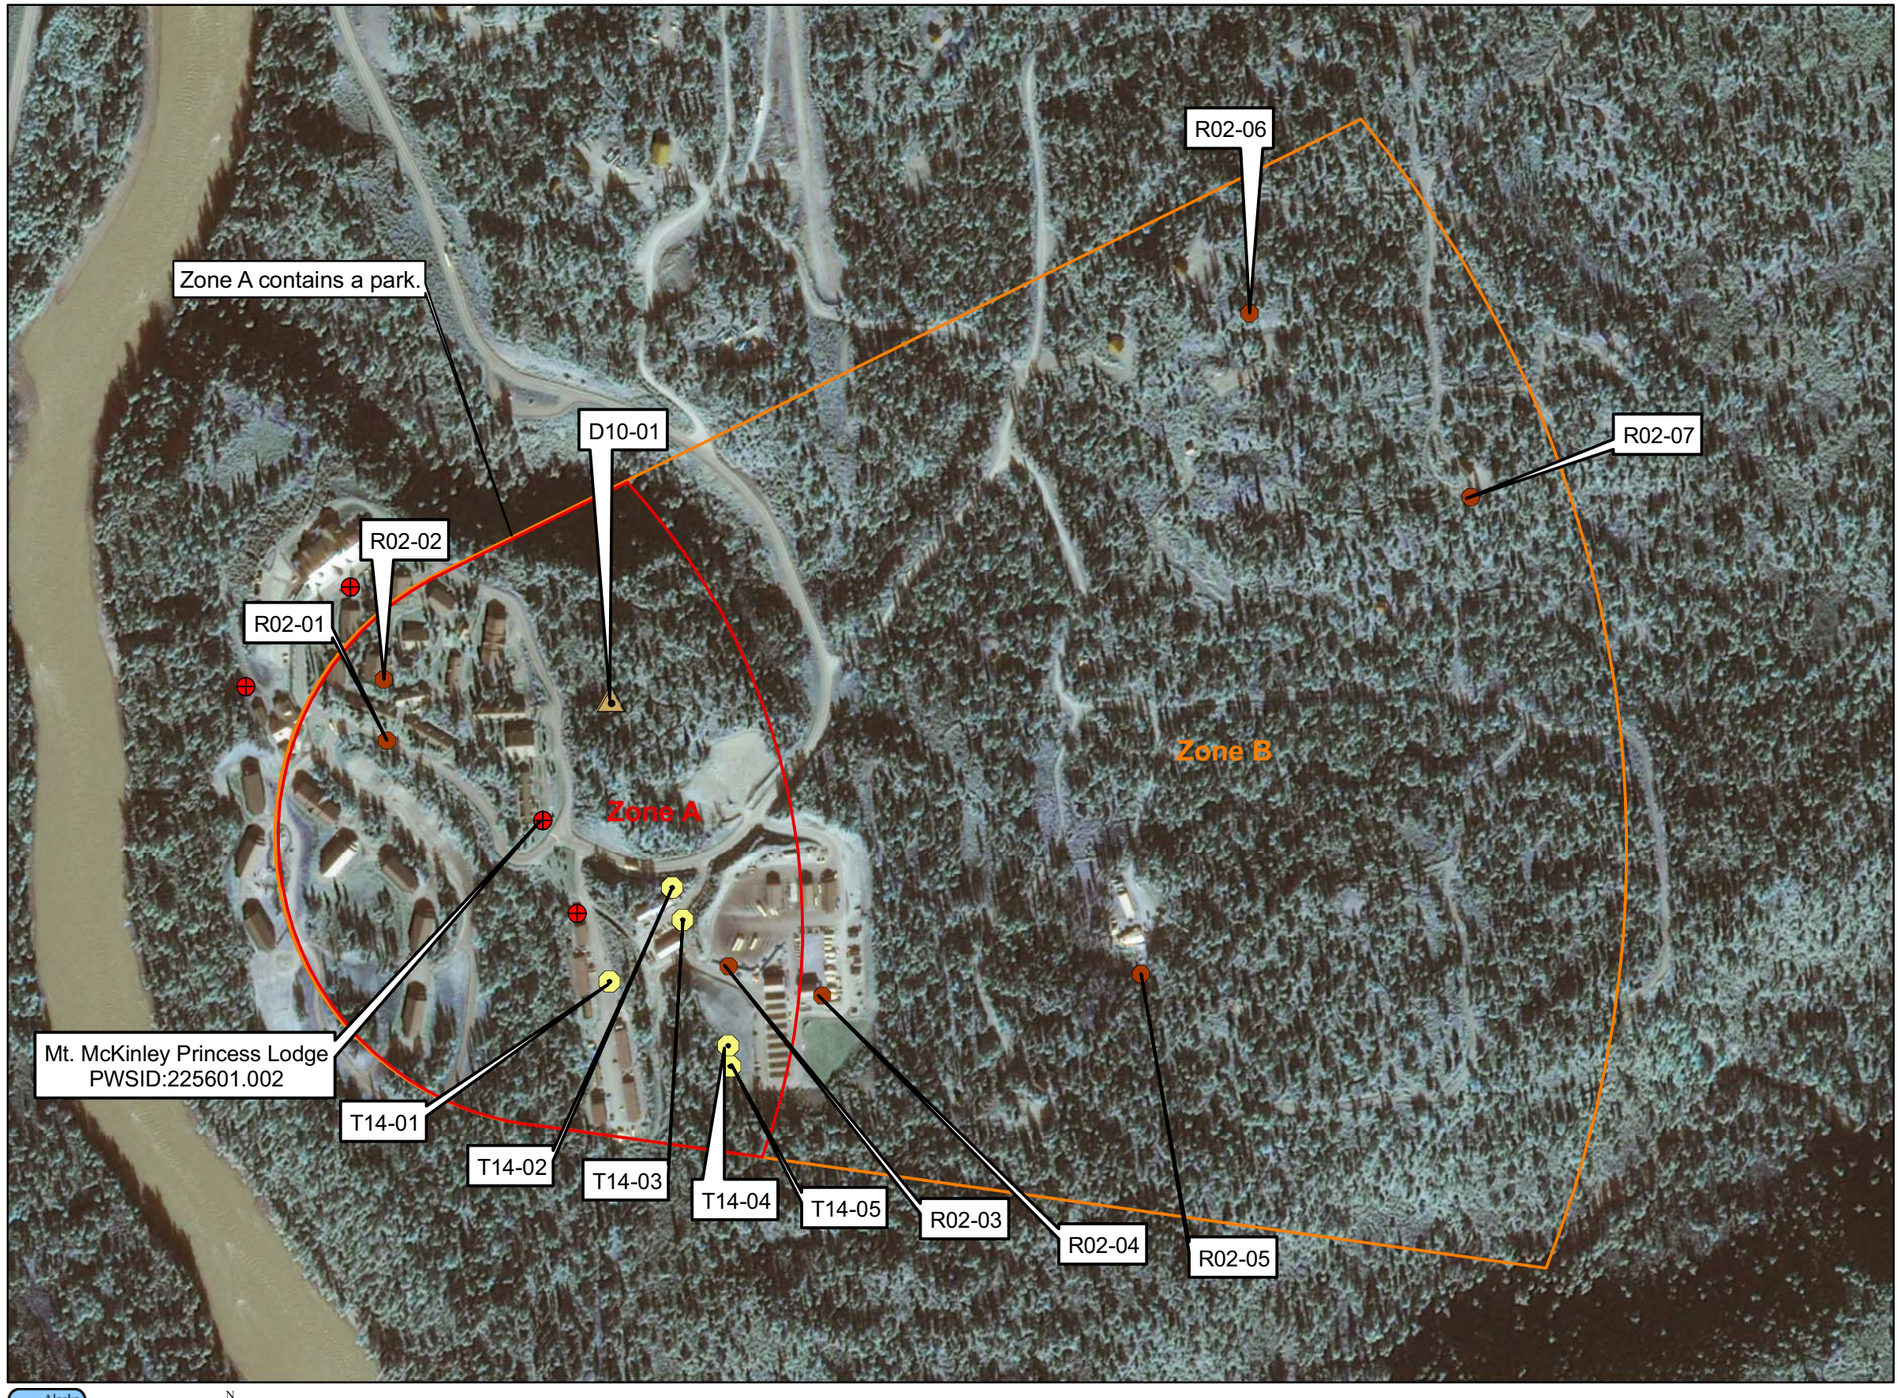
Appendix C Map C

The sources are displayed on Map C of Appendix C and summarized in Table 1 of Appendix B.

The contaminant risk for bacteria and viruses is **Very High,** with a large-capacity septic system, residential septic systems, and a park contributing to the risk to the drinking water well.
