A Hydrogeologic Susceptibility and Vulnerability Assessment for
Iditacup Espresso Drinking Water System,
Wasilla, Alaska
Iditacup Espresso PWSID # 225794.001

DRINKING WATER PROTECTION PROGRAM REPORT 822

Alaska Department of Environmental Conservation

January 2003

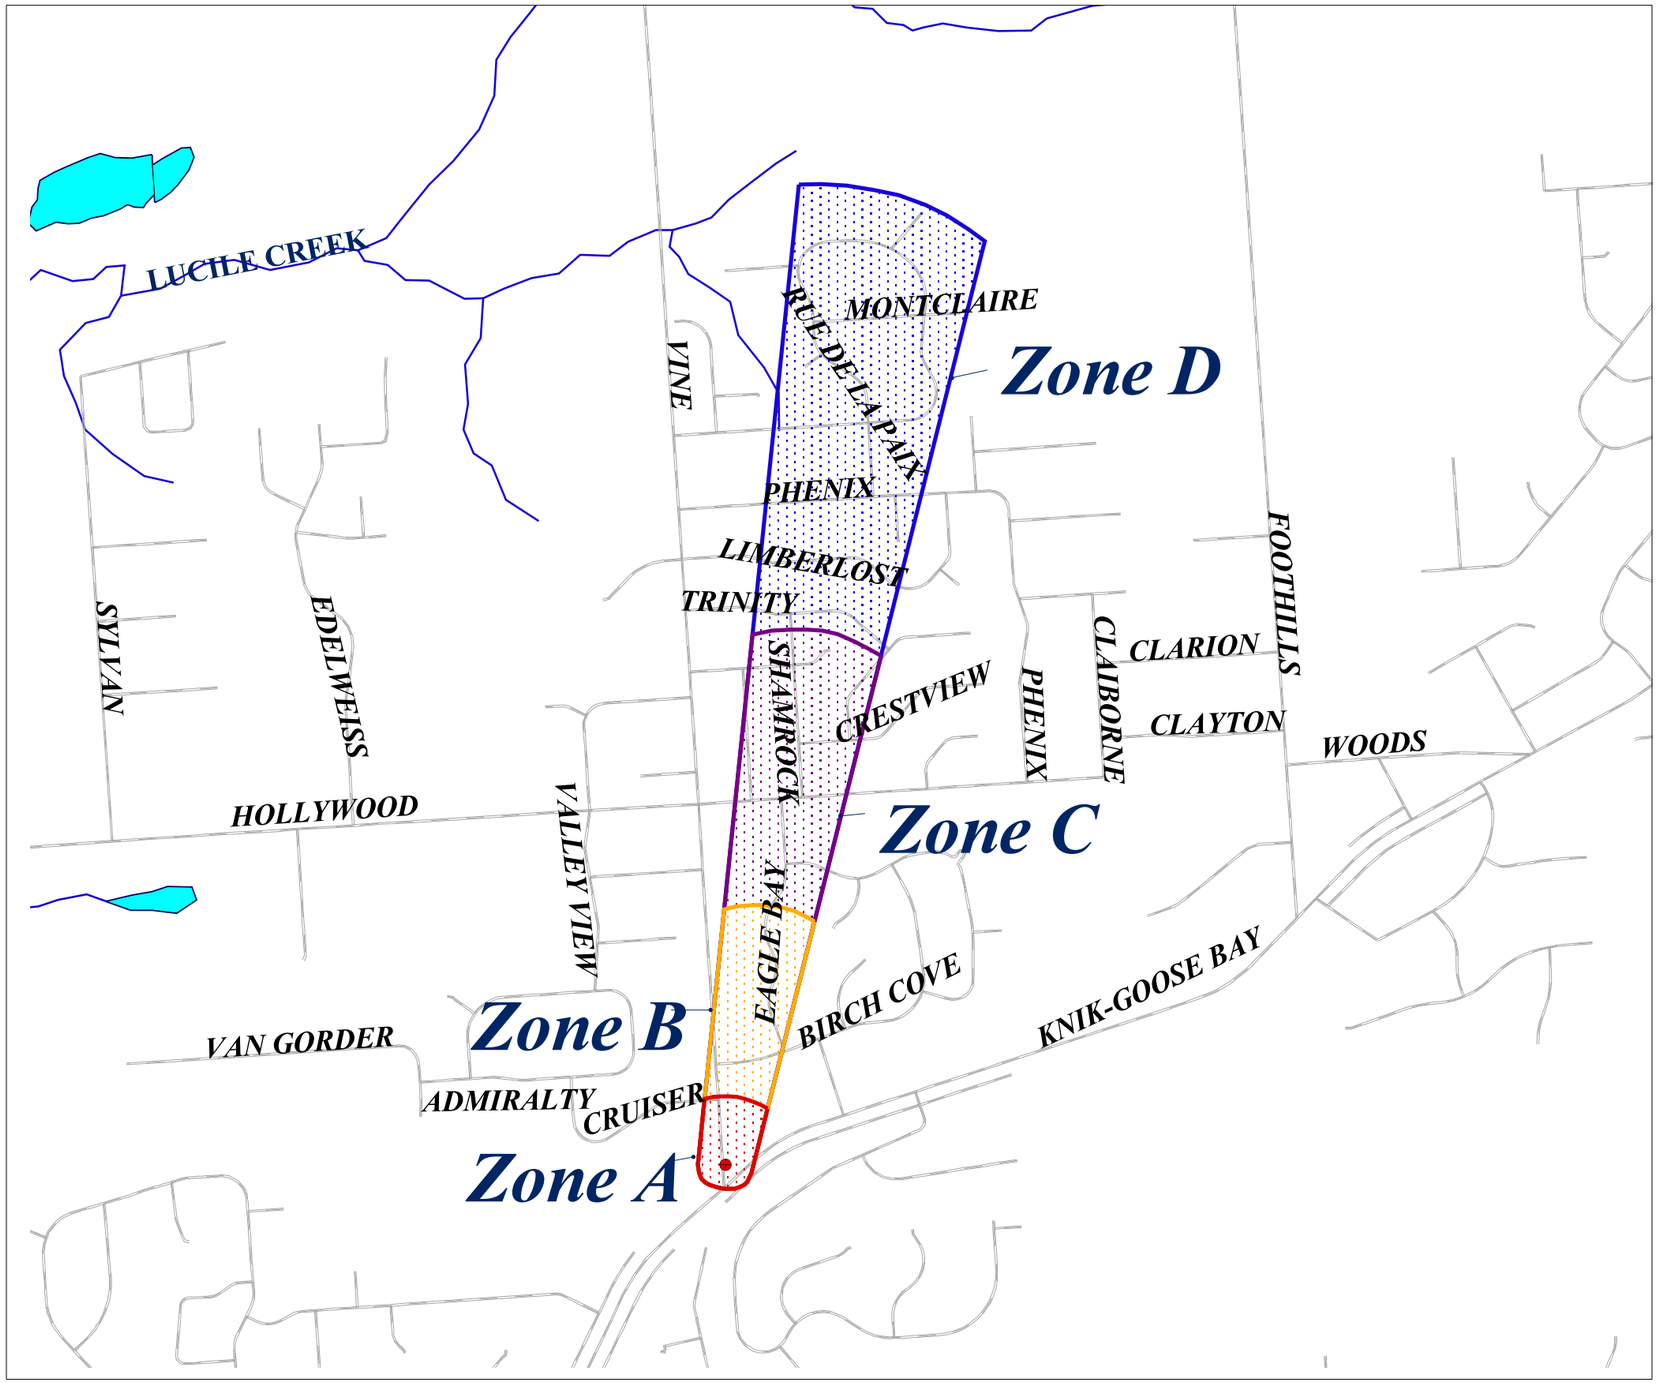
Map One

The DWPA for the Iditacup Espresso contain four zones: Zone A, Zone B, Zone C, and Zone D (see Map 1 in Appendix A).

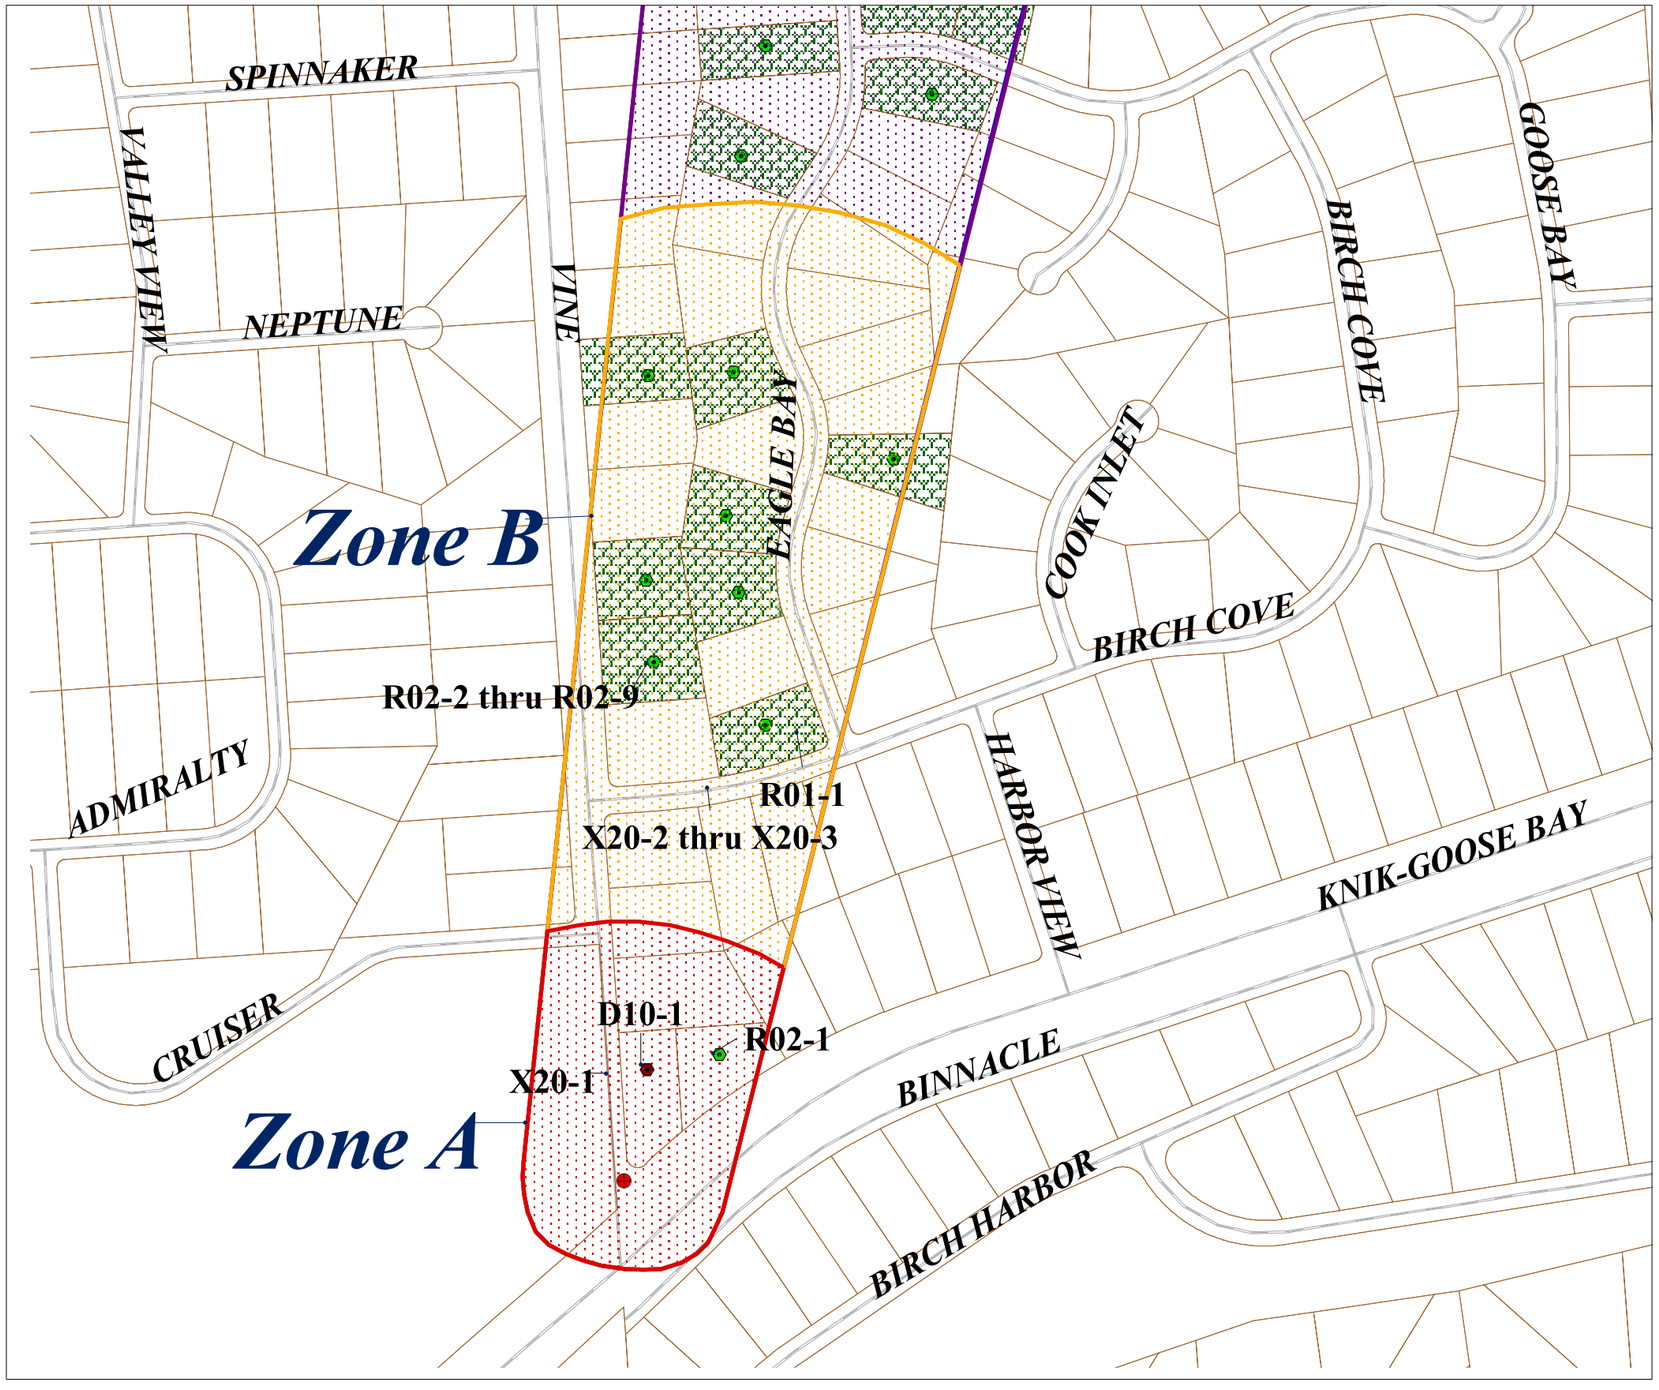
Map Two

The sources are displayed on Map 2 and Map 3 of Appendix B and summarized in table 1 of Appendix C.

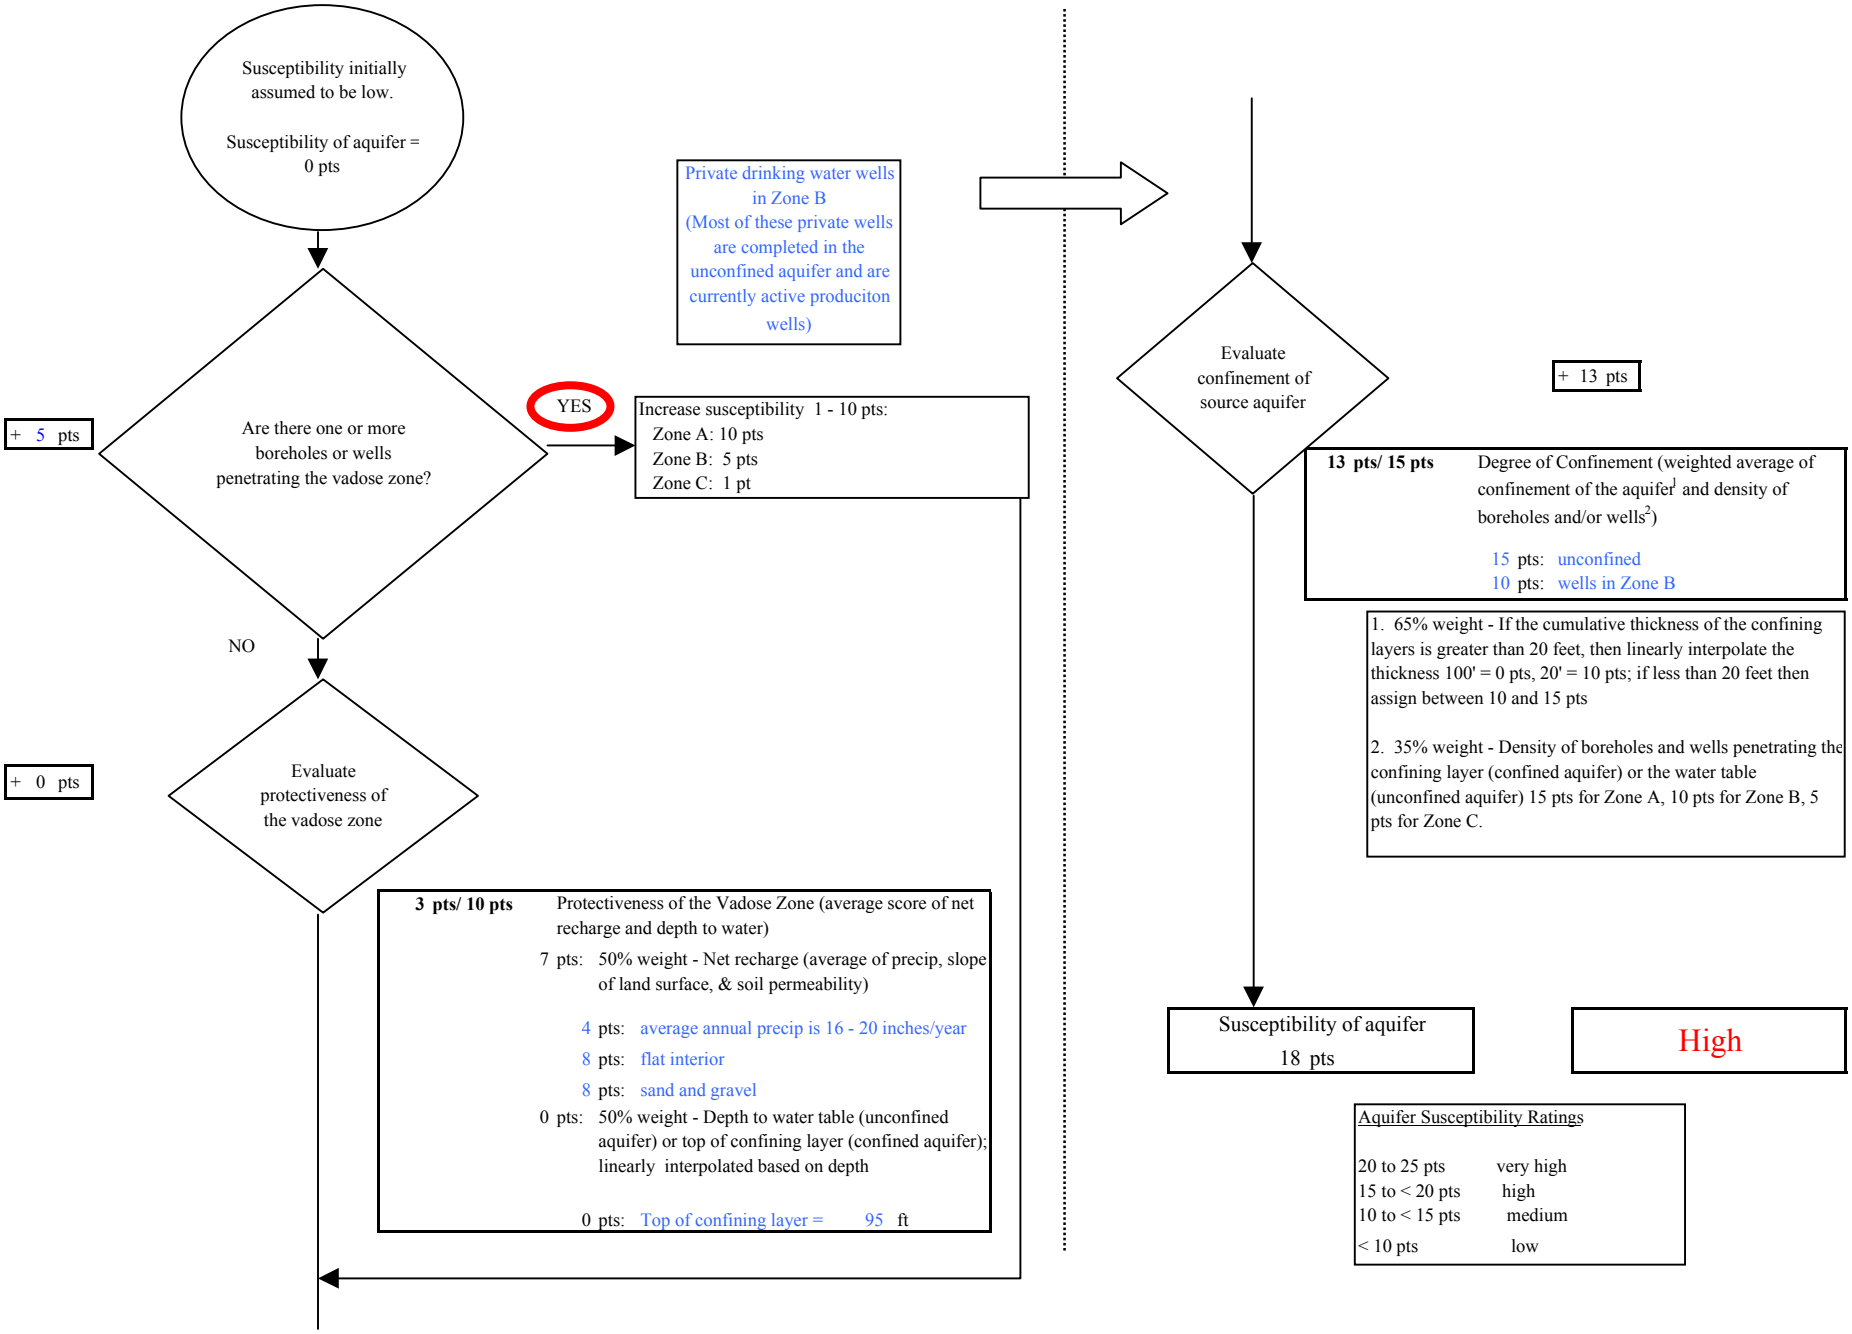
Chart 2. Susceptibility of the aquifer - Iditacup Espresso

The well for Iditacup Espresso is completed in an unconfined aquifer setting. Because an unconfined aquifer is recharged by surface water and precipitation that migrates downward from the surface, contaminants at the surface have the potential to adversely impact this aquifer. Table 2 shows the Susceptibility scores and ratings for Iditacup Espresso.

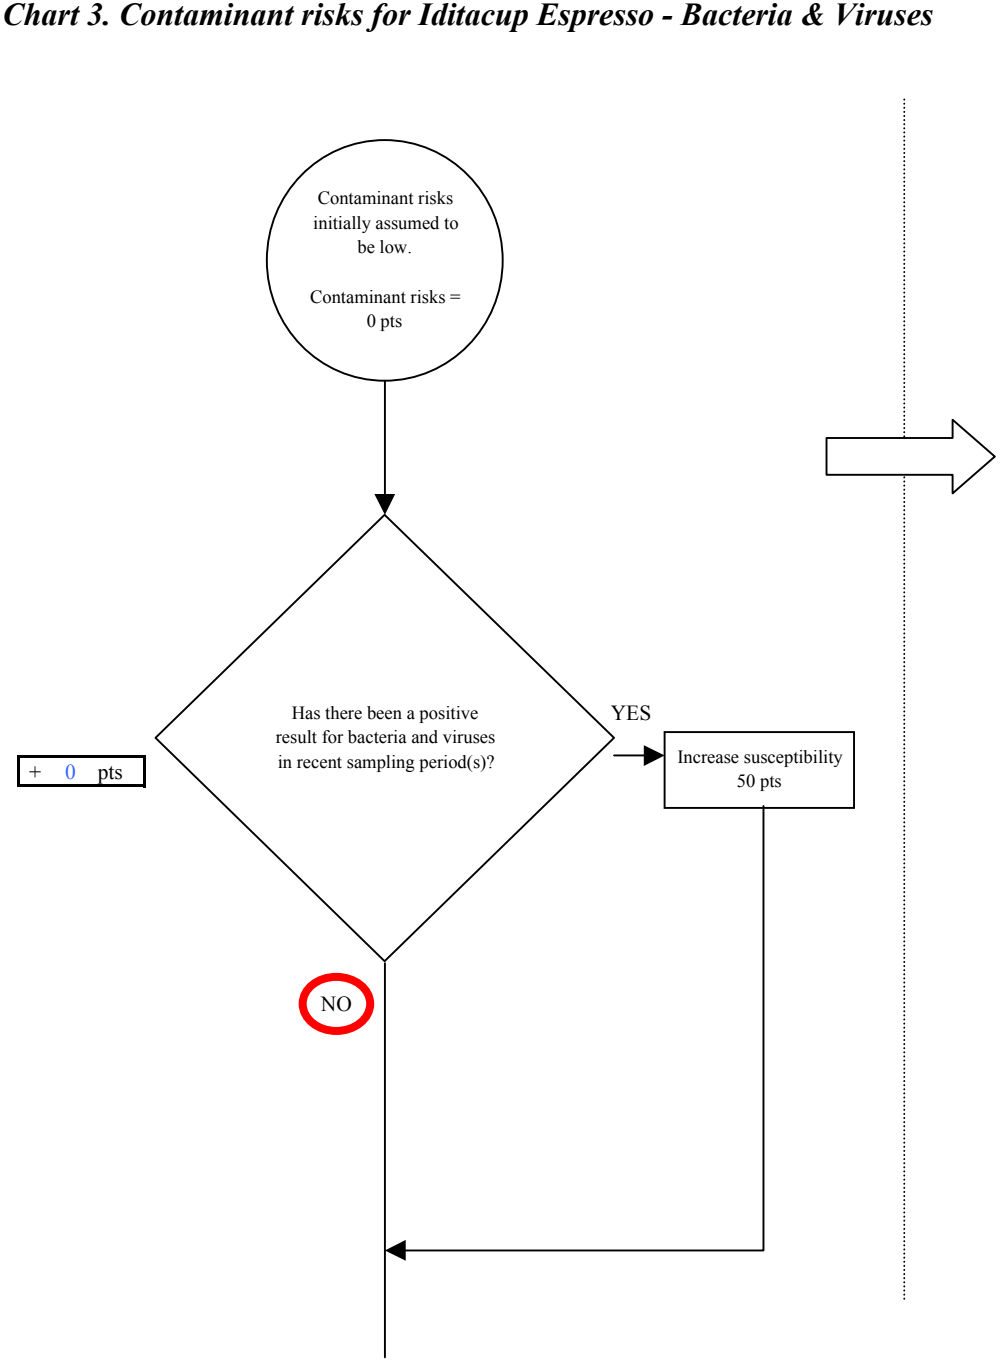
Chart 3. Contaminant risks for Iditacup Espresso - Bacteria & Viruses

The contaminant risk for bacteria and viruses is very high with a large capacity and residental septic system in Zone A presenting the most significant risk to the drinking water well (See Chart 3 – Contaminant Risks for Bacteria and Viruses in Appendix D). Recent sampling of Iditacup Espresso shows no detection of Bacteria and Viruses. After combining the contaminant risk for bacteria and viruses with the natural susceptibility of the well, the overall vulnerability of the well to contamination is medium.

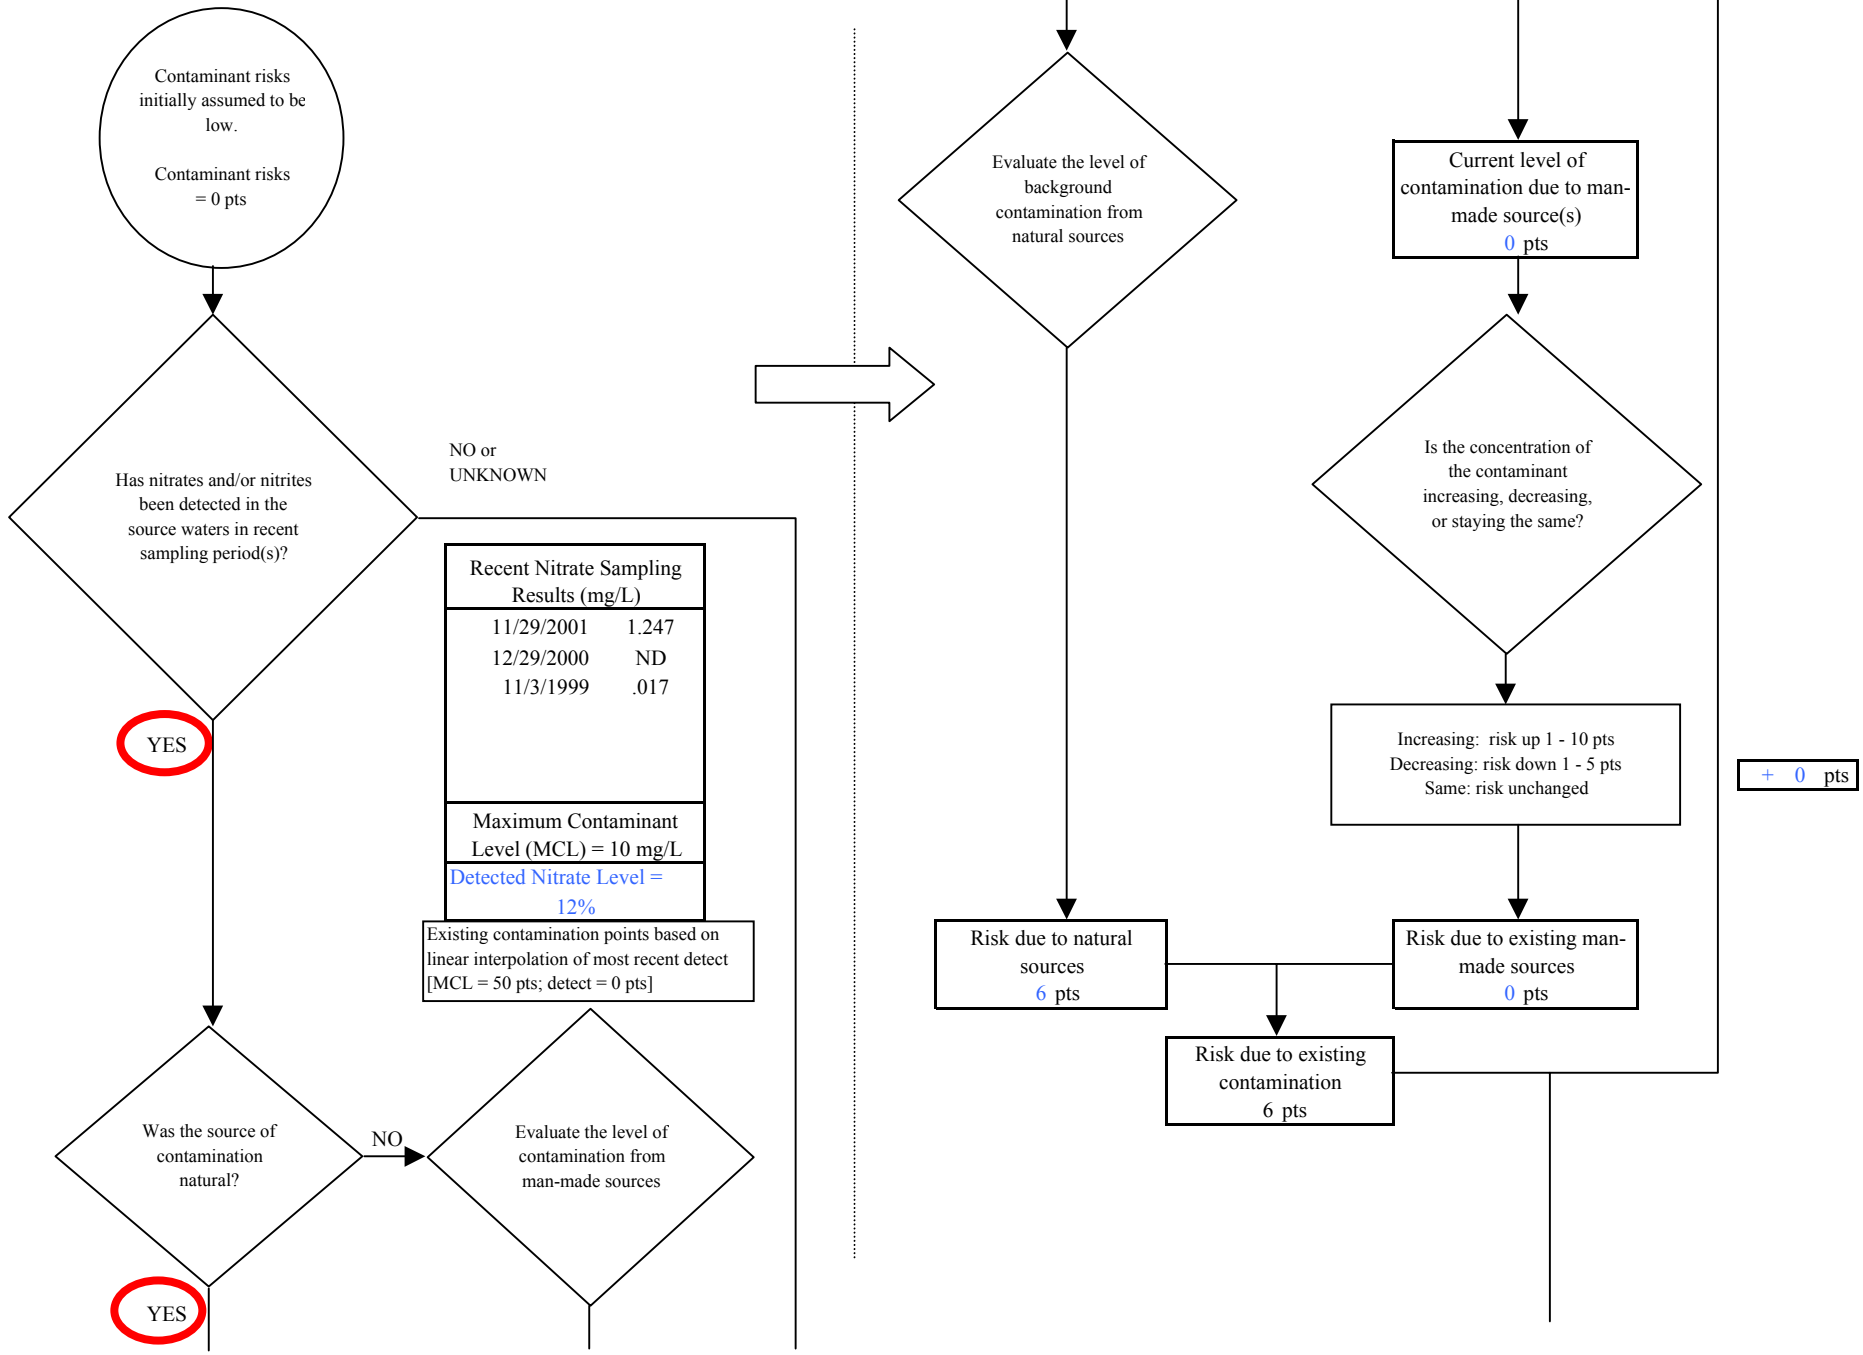
Chart 5. Contaminant risks for Iditacup Espresso - Nitrates and Nitrites

The contaminant risk for nitrates and nitrites is very high. Large capacity septic systems, because of their effluent discharge, pose the most significant contaminant risk to this source of public drinking water (See Chart 5 - Contaminant Risks for Nitrates and/or Nitrites in Appendix D). Nitrates are very mobile, moving at approximately the same rate as water.
