A Hydrogeologic Susceptibility and Vulnerability Assessment for LDS Willow Chapel Public Drinking Water System, Willow, Alaska PWSID # 222995.001

DRINKING WATER PROTECTION REPORT 1661

Alaska Department of Environmental Conservation

January, 2009

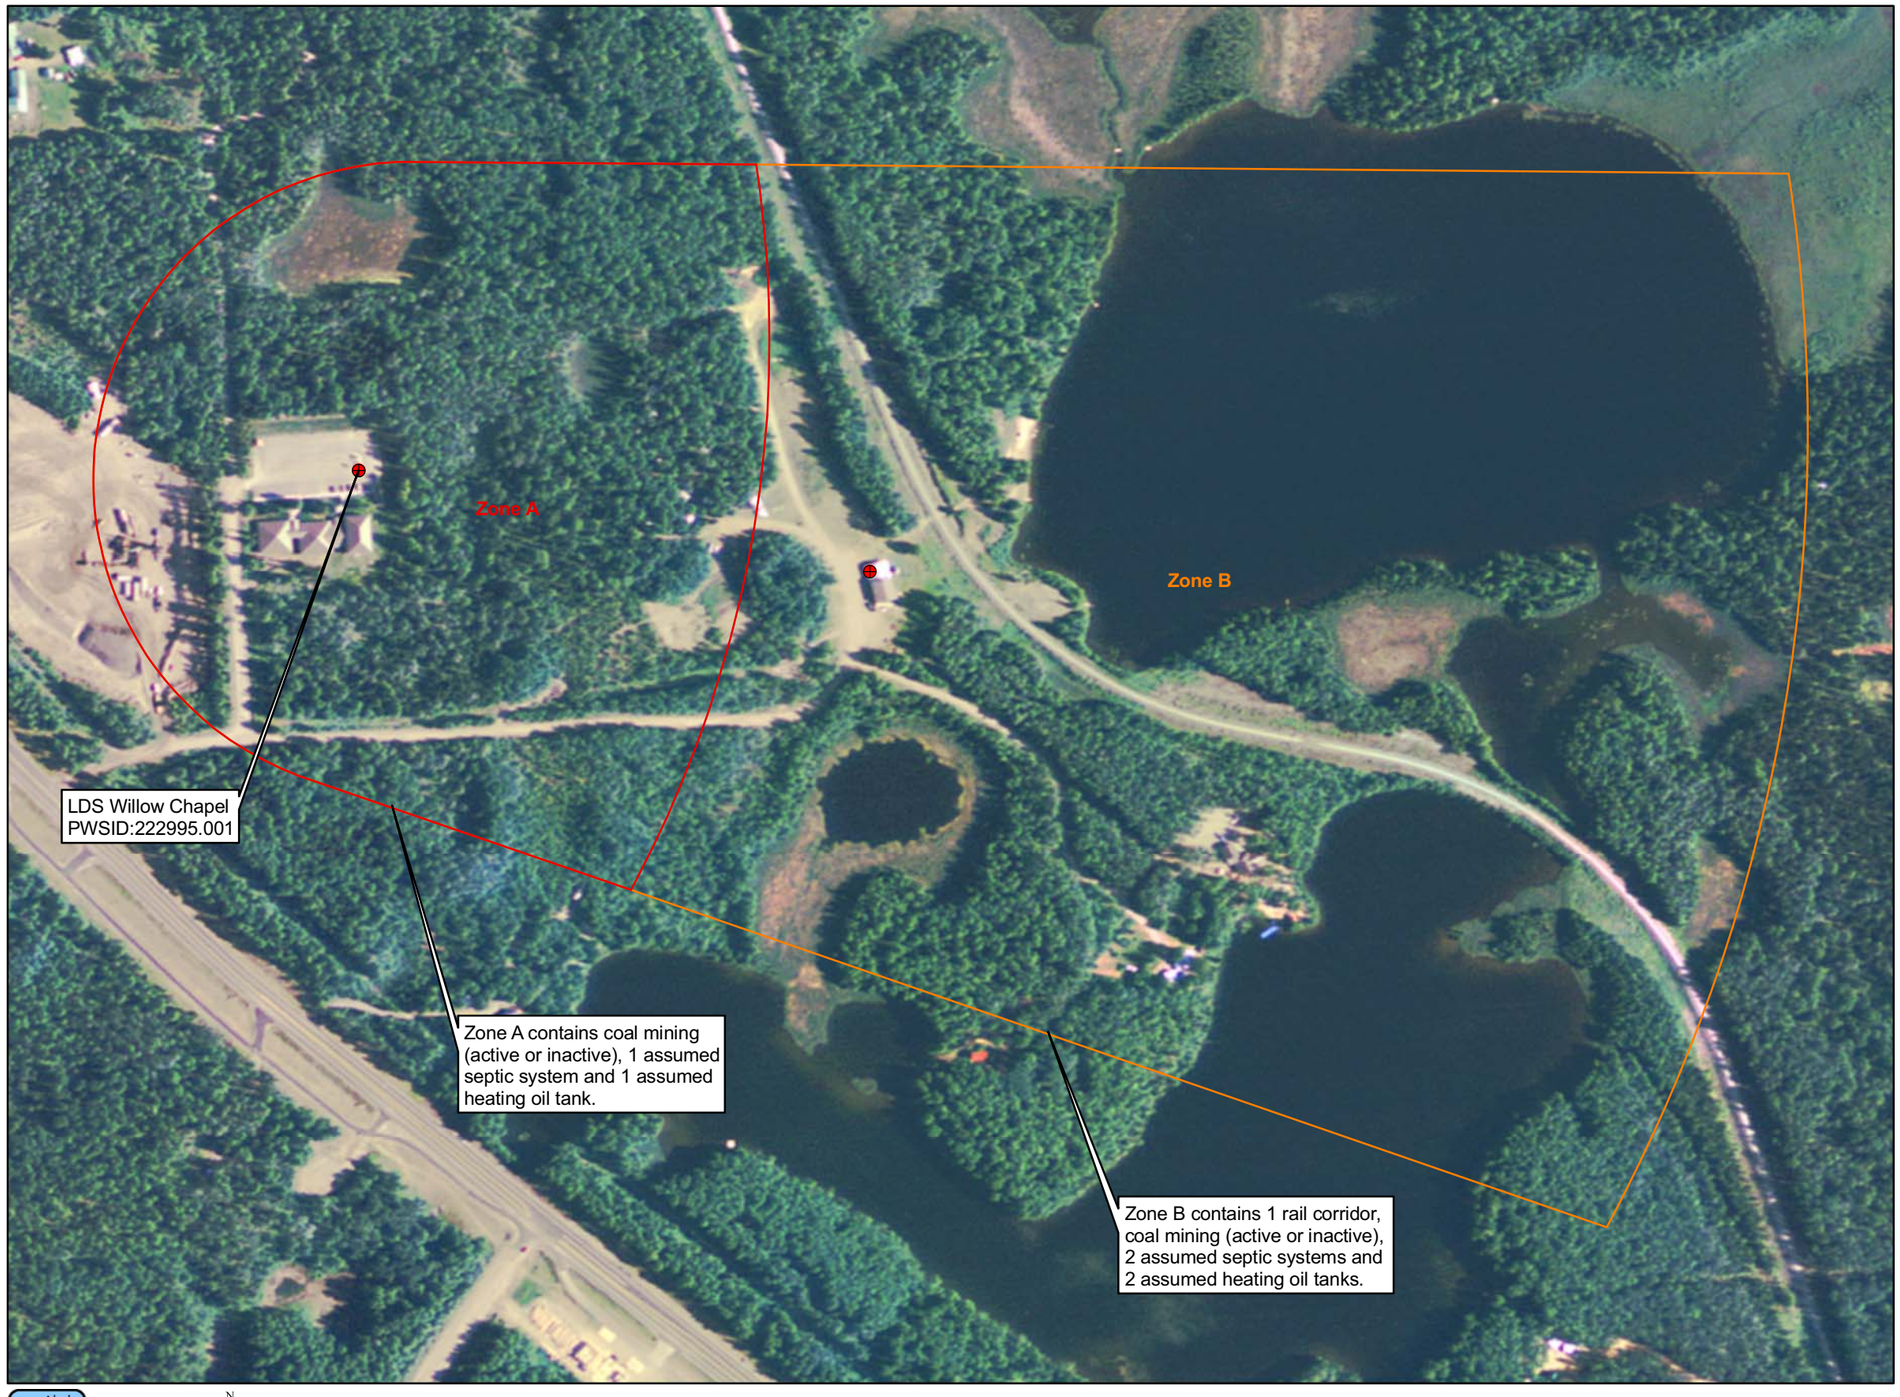
Appendix C Map C

The contaminant risk for volatile organic chemicals is **Very High** with septic systems, heating oil tanks, a coal mining area, and a rail corridor contributing to the risk to the drinking water well.
