A Hydrogeologic Susceptibility and
Vulnerability Assessment for
The Great Wall Hall Restaurant
Drinking Water System,
Anchorage, Alaska
PWSID # 213360.001

DRINKING WATER PROTECTION PROGRAM REPORT # 473
Alaska Department of Environmental Conservation

Source Water Assessment for The Great Wall Hall Restaurant's Source of Public Drinking Water, Anchorage, Alaska

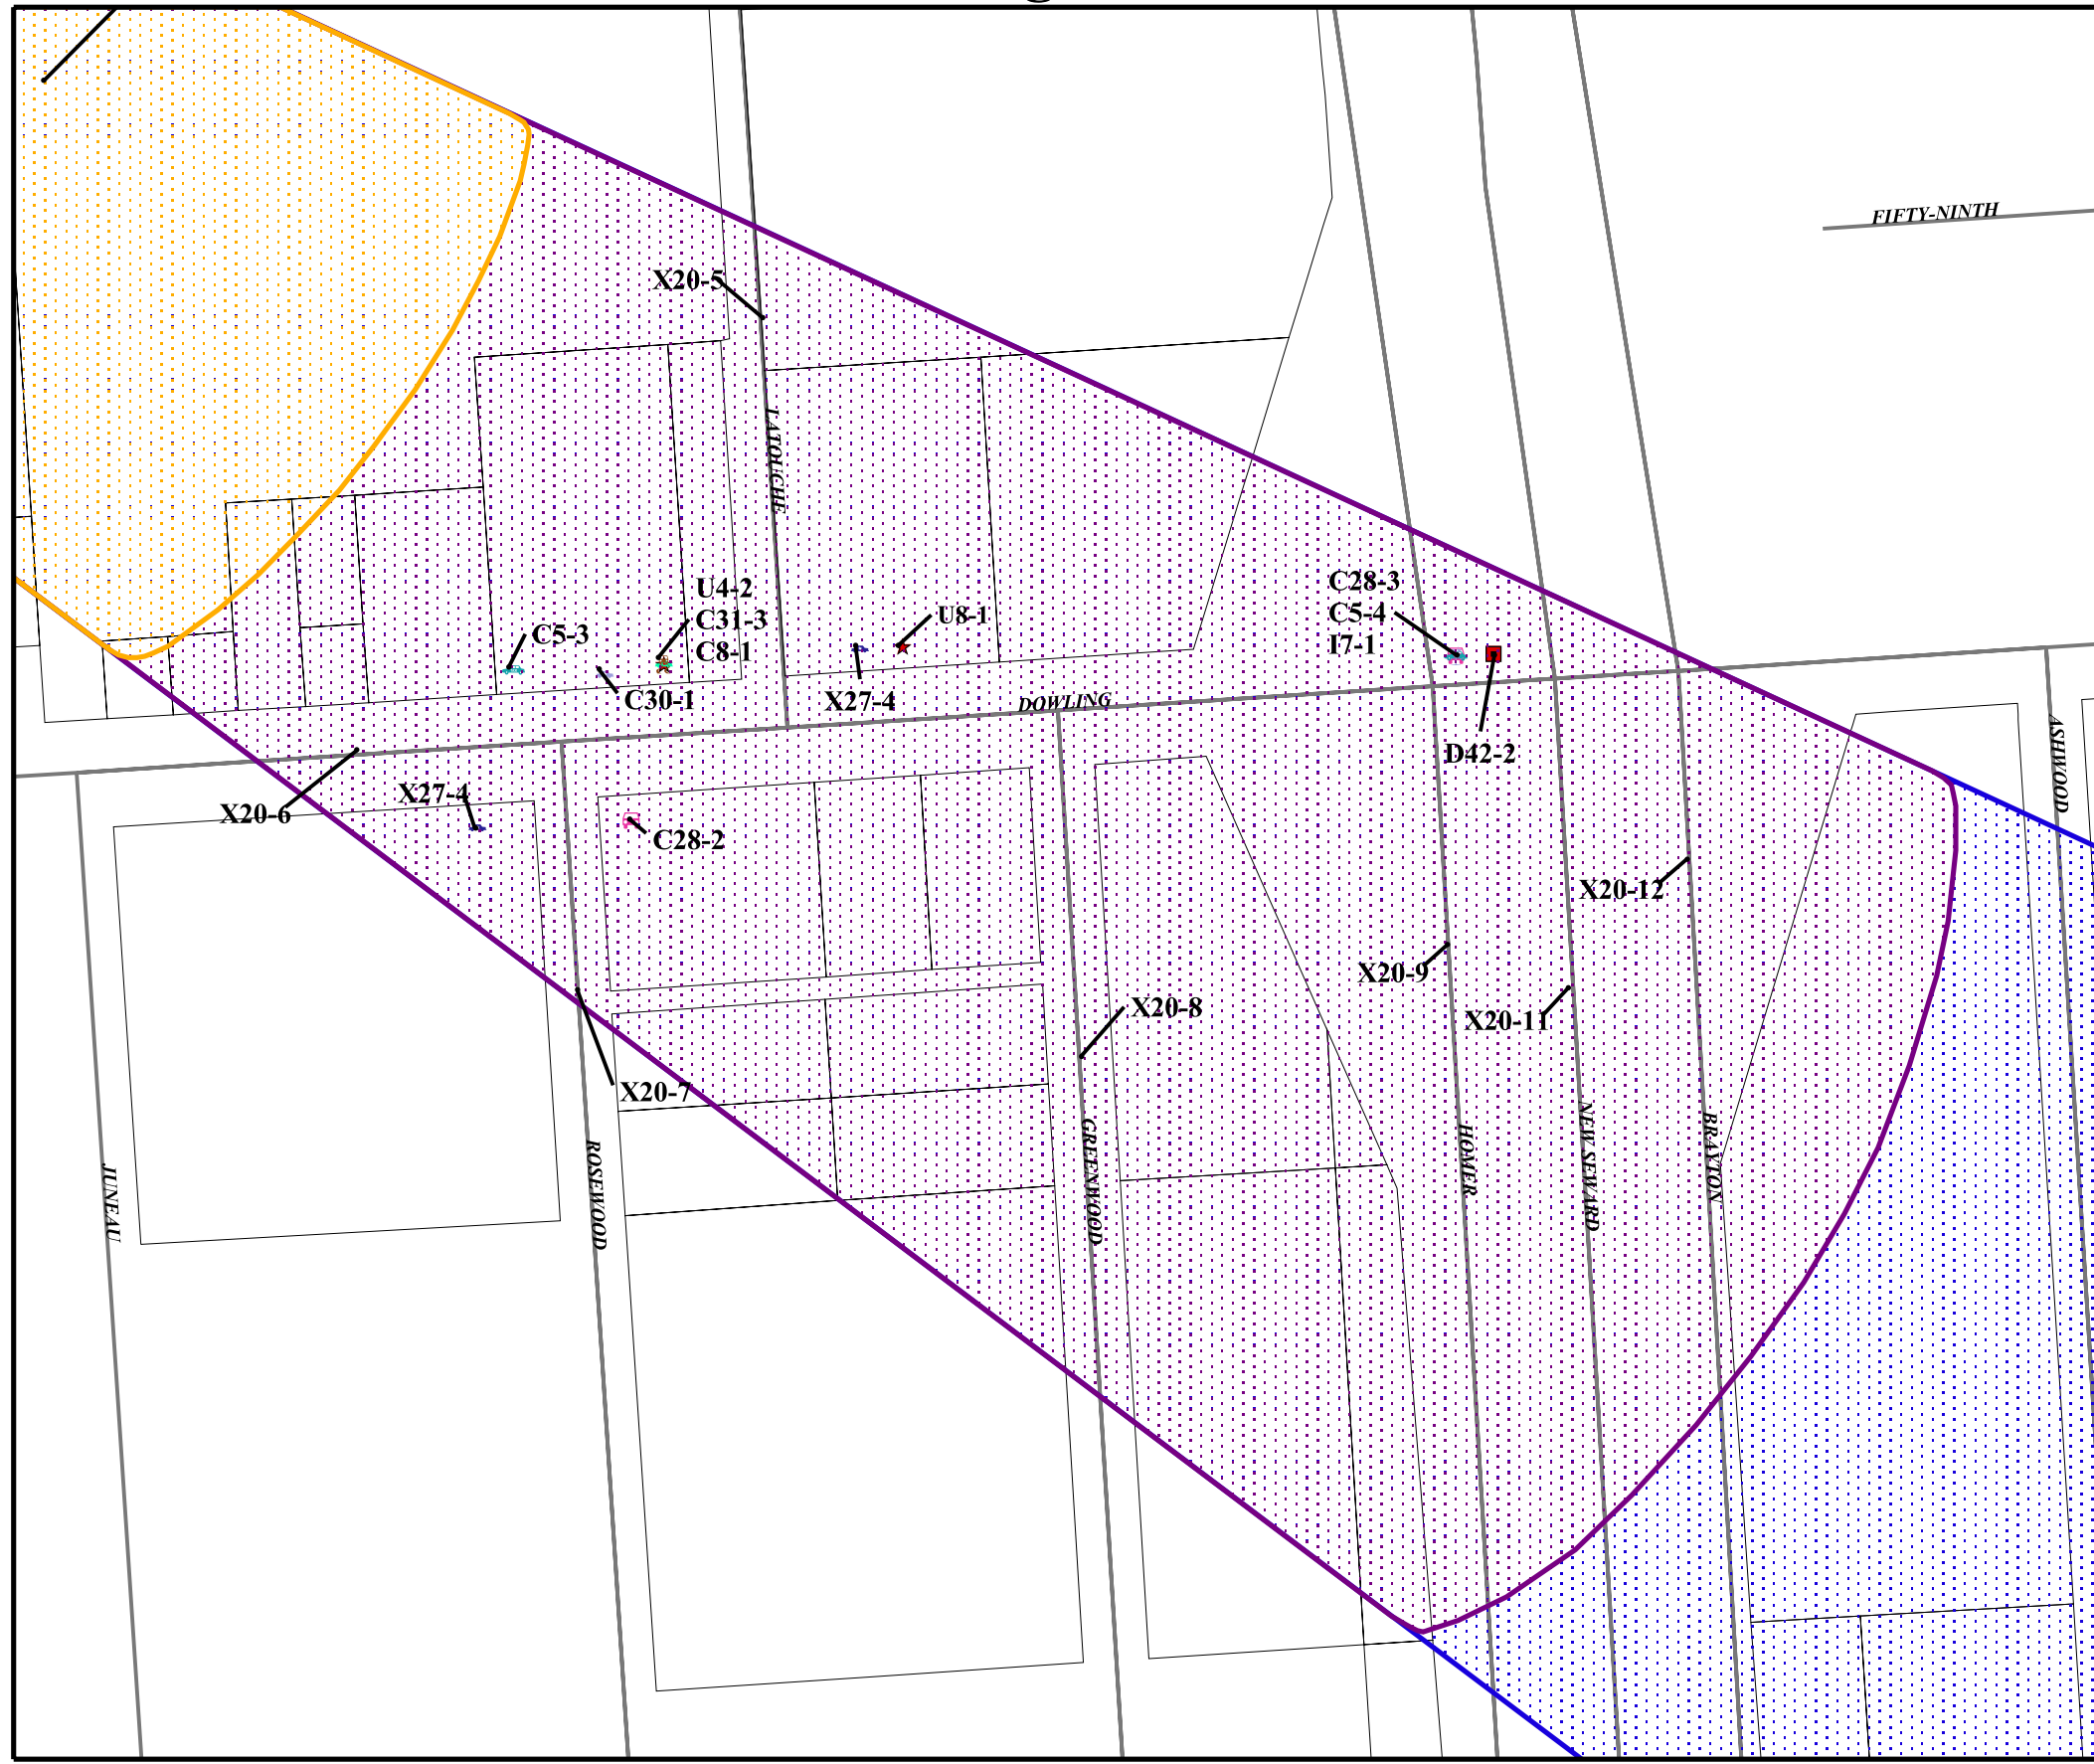
Map 4

Drinking Water Protection Area and Potential & Existing Contaminant Sources for The Great Wall Hall Restaurant

- Zone B Protection Area**
 Less Than 2 Years Travel Time
- Zone C Protection Area**
 Less Than 5 Years Travel Time
- Zone D Protection Area**
 Less Than 10 Years Travel Time

- Potential Contaminant Sources**
- Hardware Stores (C17)
 - Motor Vehicle Dealerships - With Service Departments (C27)
 - Motor/Motor Vehicle Supply Stores (C28)

- Appliance Repair Shops (C3)
 - Motor Vehicle Rental Facilities (C30)
 - Motor/Motor Vehicle Repair Shops (C31)
 - Printers, Publishers, Copiers (C37)
 - Windshield/Glass Shops (C44)

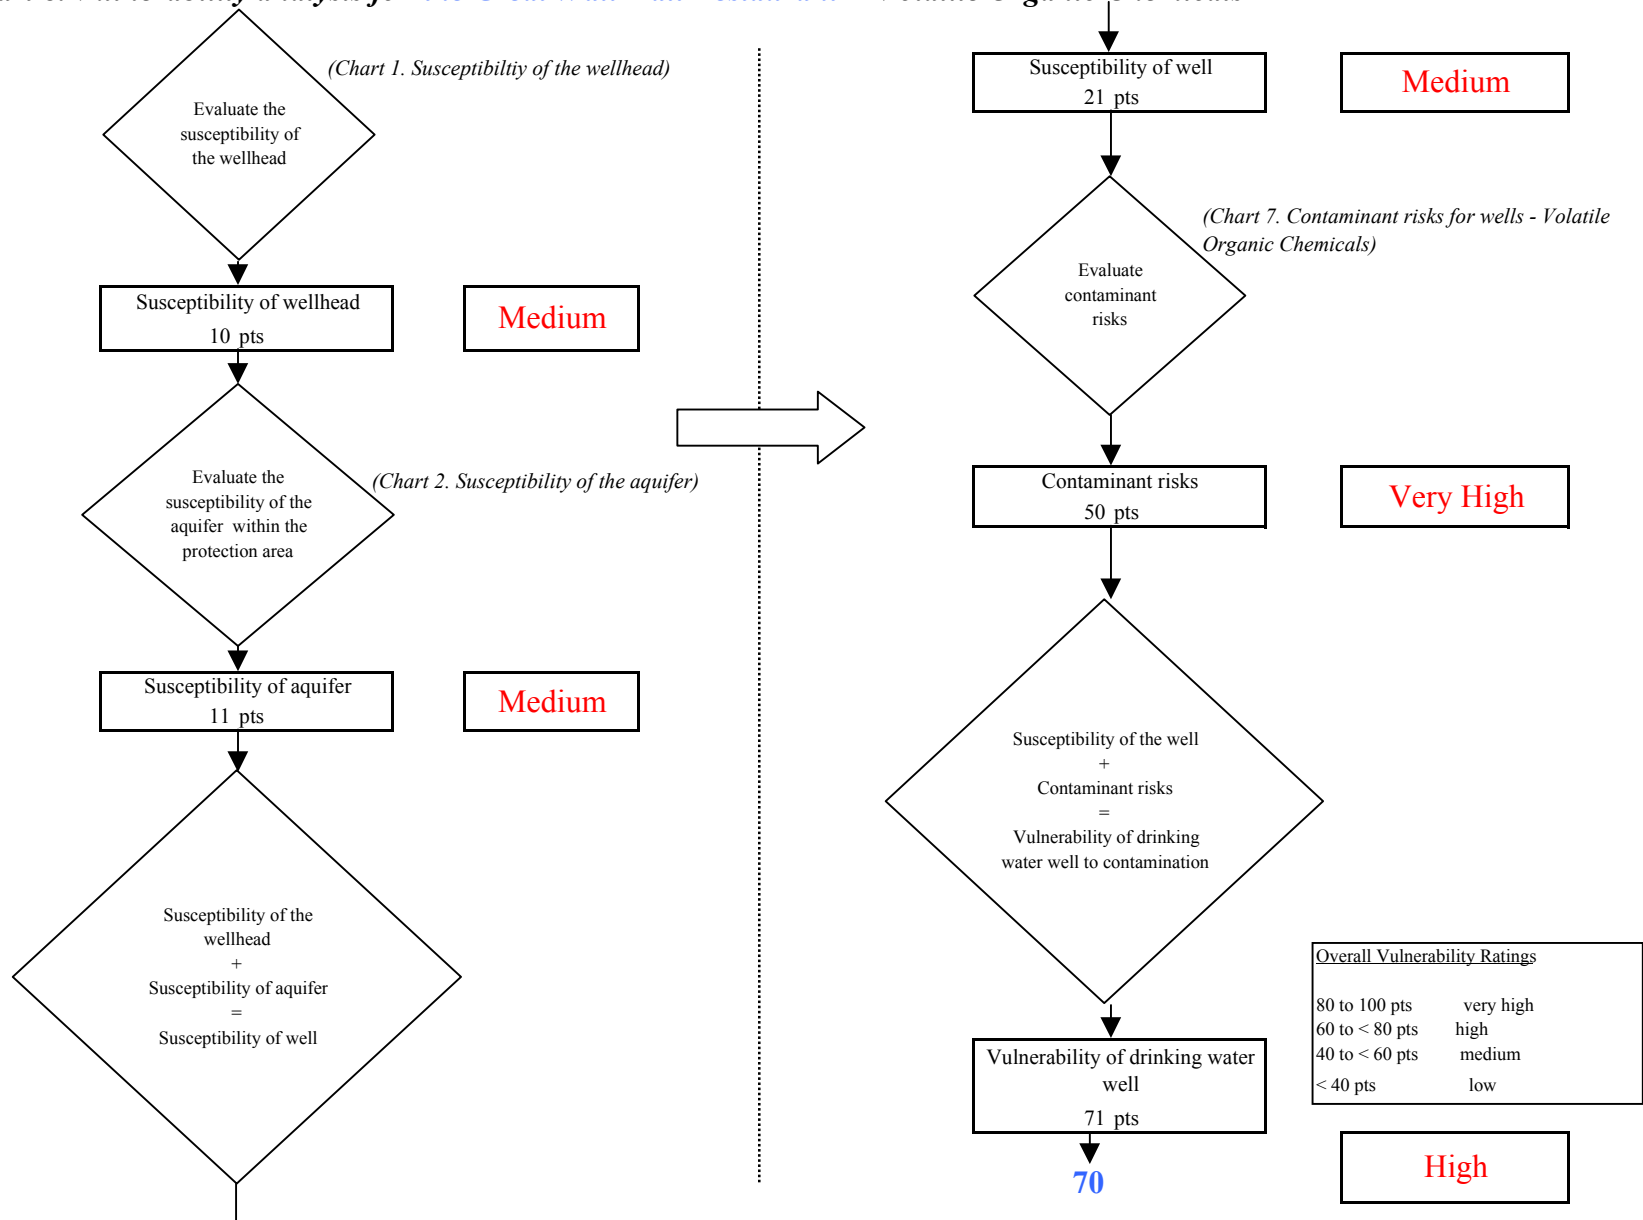
Chart 8. Vulnerability analysis for the Great Wall Hall Restaurant - Volatile Organic Chemicals

A *Source Water Assessment* has been completed for the source of public drinking water serving The Great Wall Hall Restaurant. The overall vulnerability of this source to contamination is **Medium** for bacteria and viruses, nitrates and/or nitrites, and **High** for volatile organic chemicals. This assessment of contaminant risks can be used as a foundation for local voluntary protection efforts as well as a basis for the continuous efforts on the part of The Great Wall Hall Restaurant to protect public health. It is anticipated that *Source Water Assessments* will be updated every five years to reflect any changes in the vulnerability and/or susceptibility of The Great Wall Hall Restaurant's public drinking water source.
