Hydrogeologic Susceptibility and Vulnerability Assessment for Municipality of Anchorage Drinking Water Well #25, Anchorage, Alaska

DRINKING WATER PROTECTION PROGRAM REPORT 17

By MICHAEL J. CROTTEAU

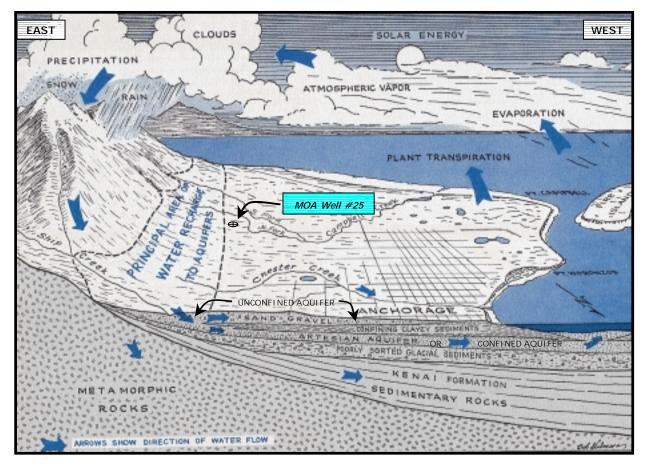
Figure 2. Generalized hydrologic cycle in the Anchorage-area [Barnwell, George, Dearborn, Weeks, and Zenone, 1972].

In the Anchorage-area, two principal groundwater flow systems or aquifers exist (see Figure 2). The upper unconfined aquifer or water-table aquifer is separated from a lower confined aquifer system by layers of silty, clayey glacially derived sediments (confining layer) [Ulery and Updike, 1983]. The lower confined aquifer system consists of a series of hydrologically interconnected layers and lenses of gravel, sand and silt that, collectively, form the confined aquifer. The nfining layer ranges from 0 to 270 feet thick throughout the Anchorage-area and generally thins with increasing distance from Cook Inlet, thus pinching out at the mountain front [Patrick, Brabets, and Glass, 1989].

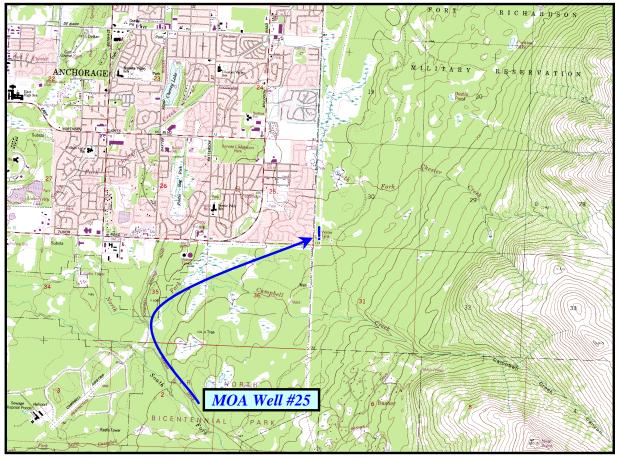
Figure 3. Map showing the location of the drinking water sources for MOA Well #25 [Base: USGS Anchorage A8 NE].

Wastewater Utility (AWWU). The source consists of one well near the base of the Chugach Mountains and is at an elevation of 350 feet above sea level. The well is located approximately 600 feet east of Pioneer Drive, 1.3 miles from the base of the Chugach Mountains, and 0.6 miles south-southwest of the South Fork of Chester Creek (see Figure 3). According to the well log, MOA Well #25 does not appear to be grouted and penetrates gravel, brown clay, silt, and till, and sand and gravel to a total depth of 183 feet below land surface. The well is screened from 64 to 75 feet below land surface and had a static water level of 44 feet below land surface at the time of drilling (5/11/73).

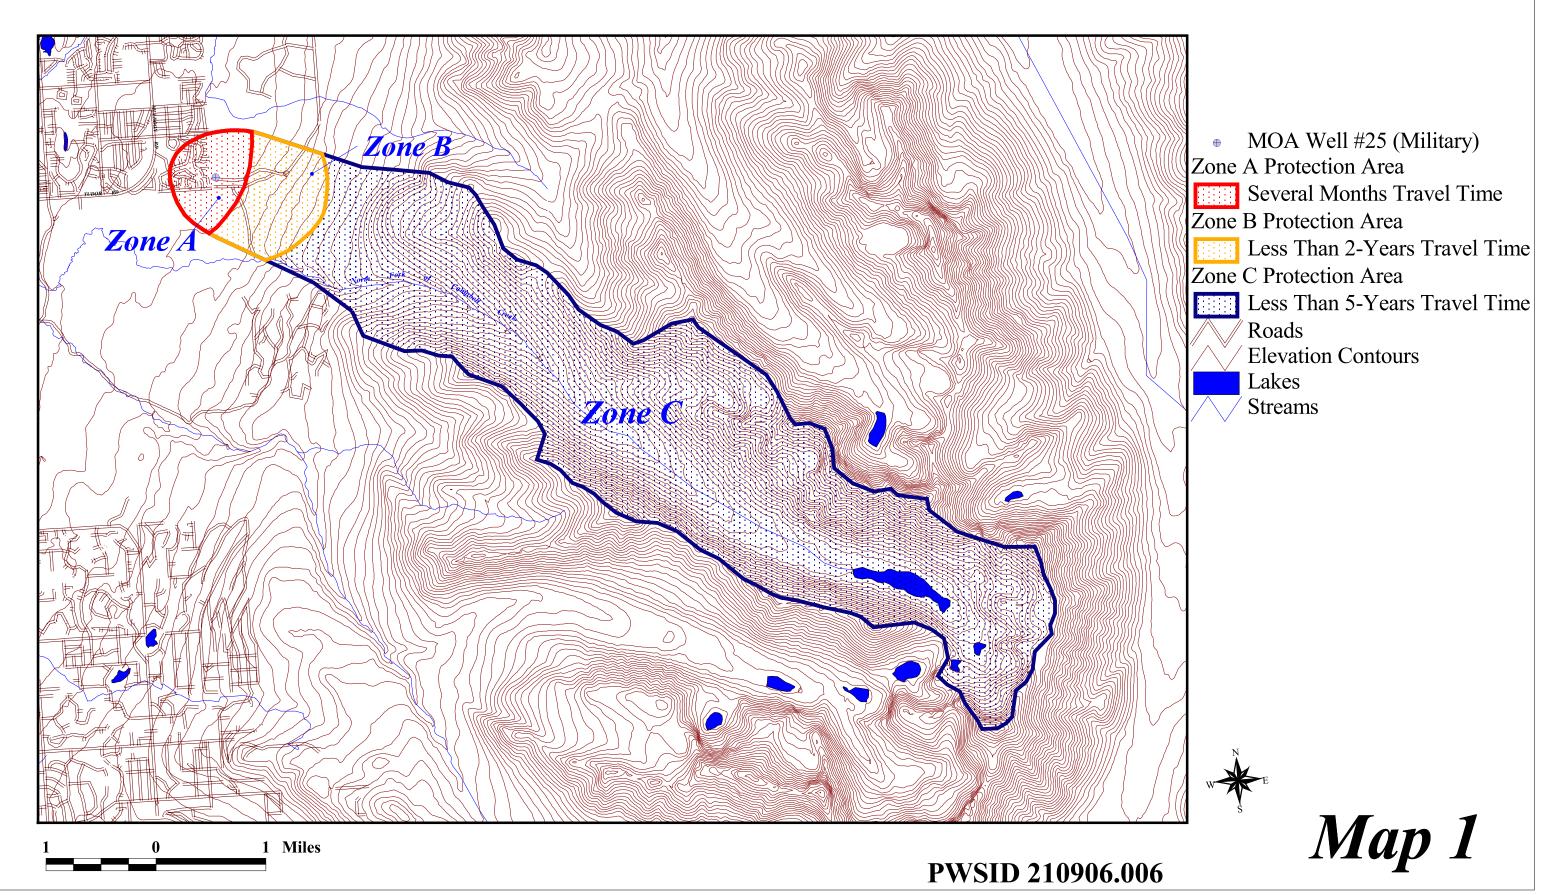
MOA Well #25 Drinking Water Protection Area

Drinking Water Protection Area for MOA Military Well #25

The Zone B protection area for MOA Well #25 corresponds to a time-of-travel of less than two years and extends toward to base of the Chugach Mountains. Lastly, the Zone C protection area extends from Zone B to the top of the watershed divide for the North Fork of Campbell Creek.

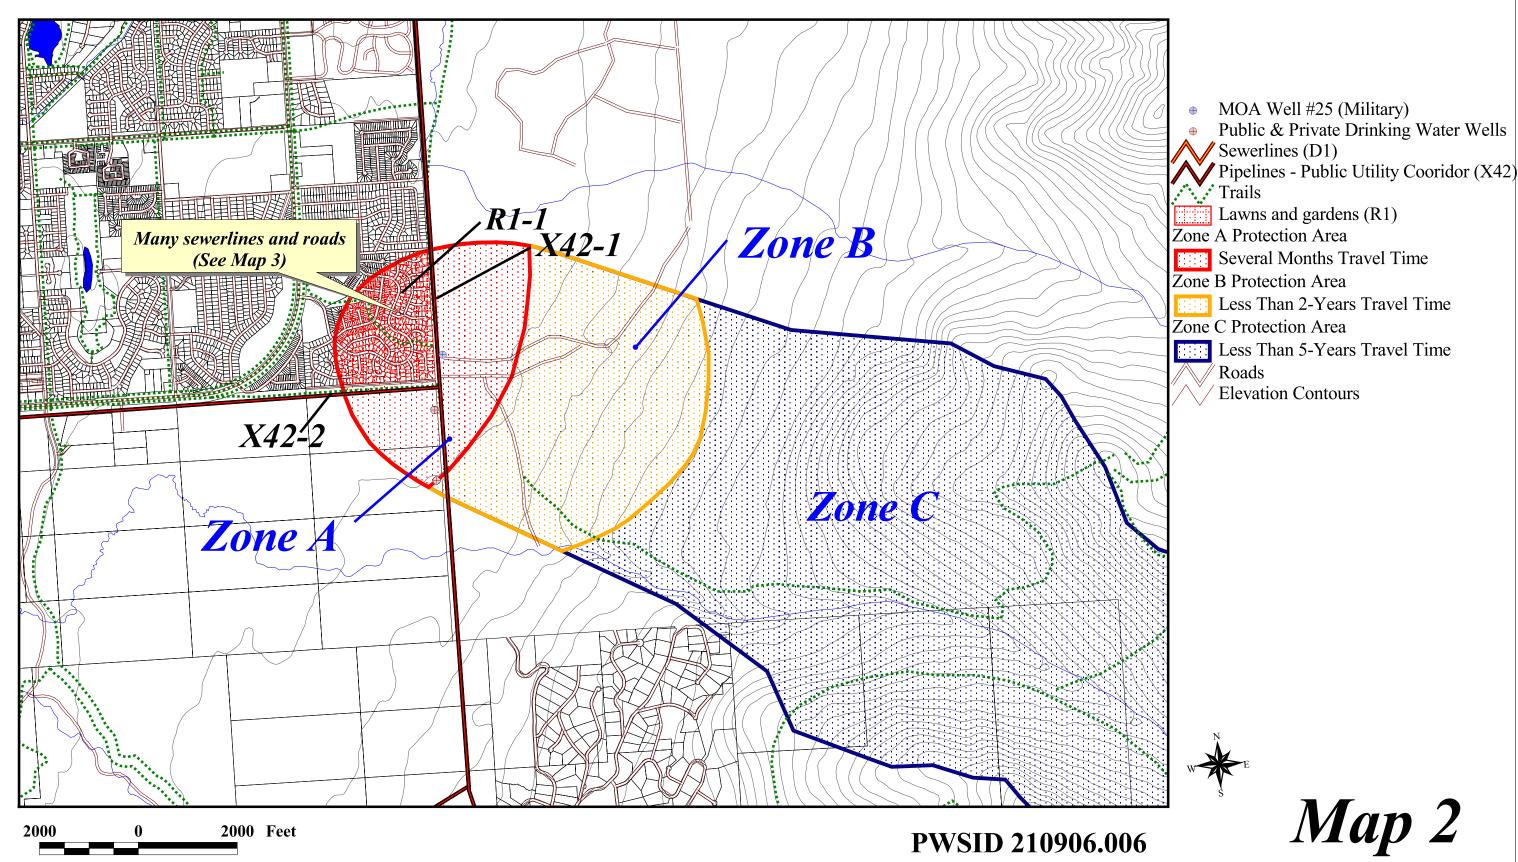
MOA Well #25 Drinking Water Protection Area and Potential & Existing Contaminant Sources

Drinking Water Protection Area for MOA Military Well #25 and Potential & Existing Sources of Contamination

Maps 2 through Map 3 in Appendix C depict the Contaminant Source Inventory for MOA Well #25. Inventoried potential sources of contamination within Zones A through Zone B were associated with residential and light industrial type activities (see Table 1 in Appendix A). Zone C contains only old roads and trails. On account of the low use of these roads and trails in Zone C, these potential sources of contamination were not considered in determining the vulnerability of this drinking water source to contamination. Below is a summary of the contaminant sources inventoried within the MOA Well #25 protection area:

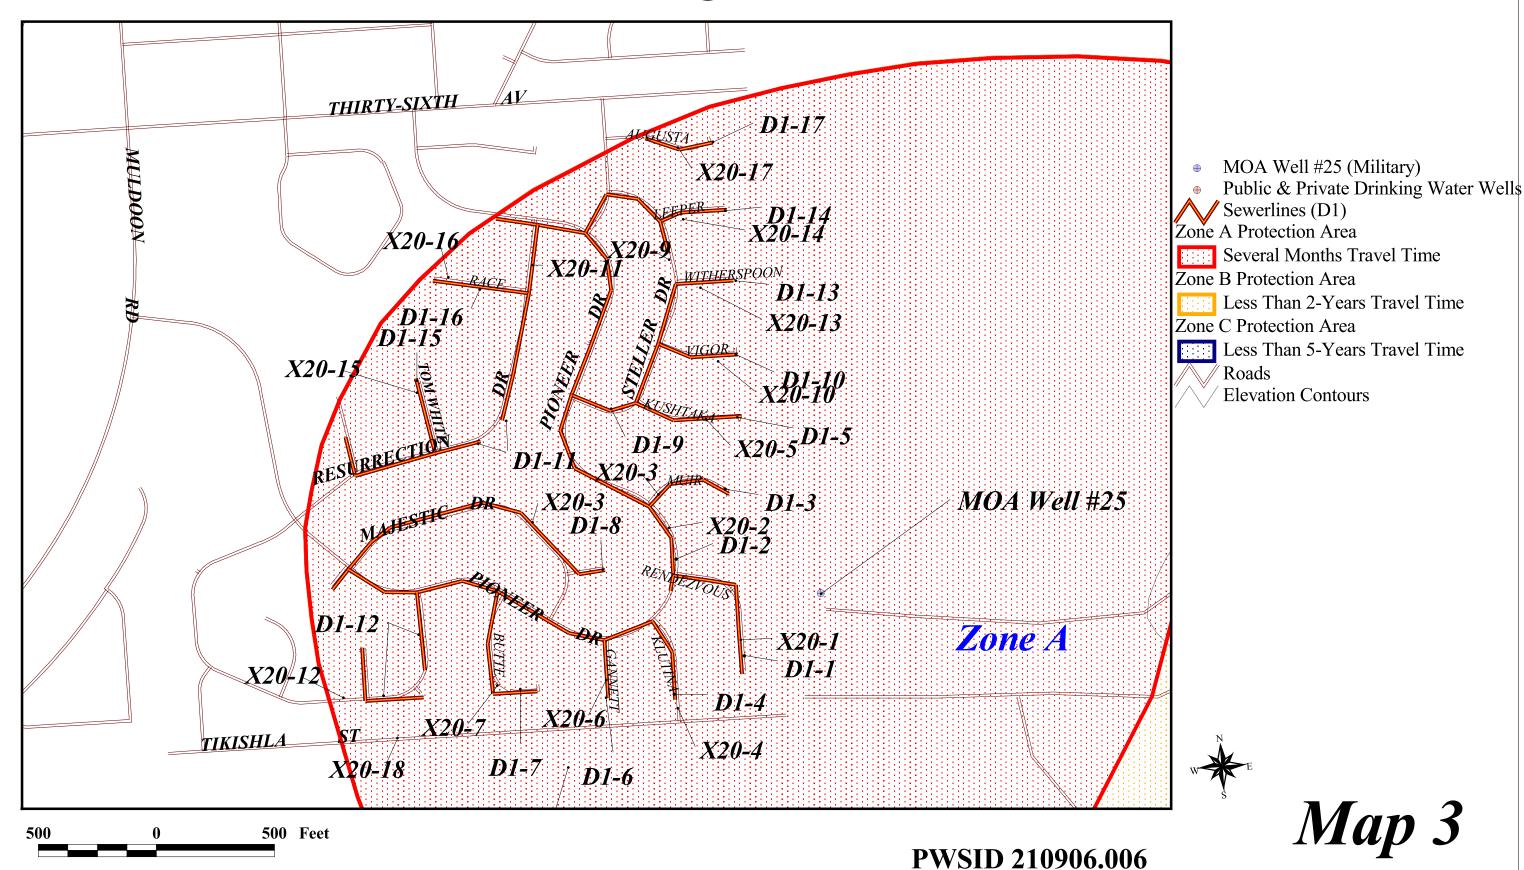
Drinking Water Protection Area for MOA Military Well #25 and Potential & Existing Sources of Contamination

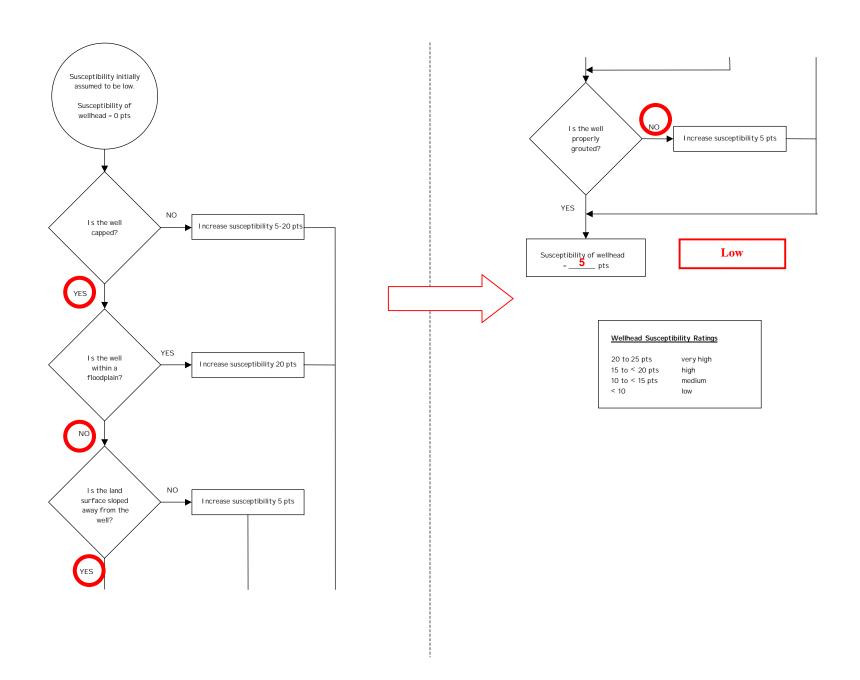
Chart 1. Susceptibility of the wellhead – MOA Well #25

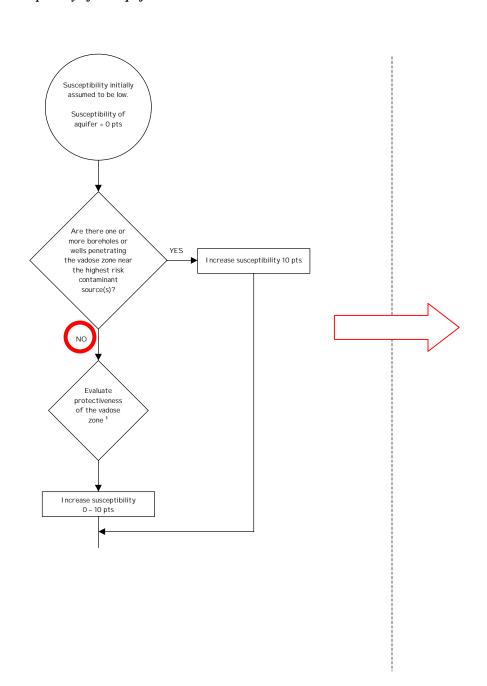
Chart 2. Susceptibility of the aquifer – MOA Well #25

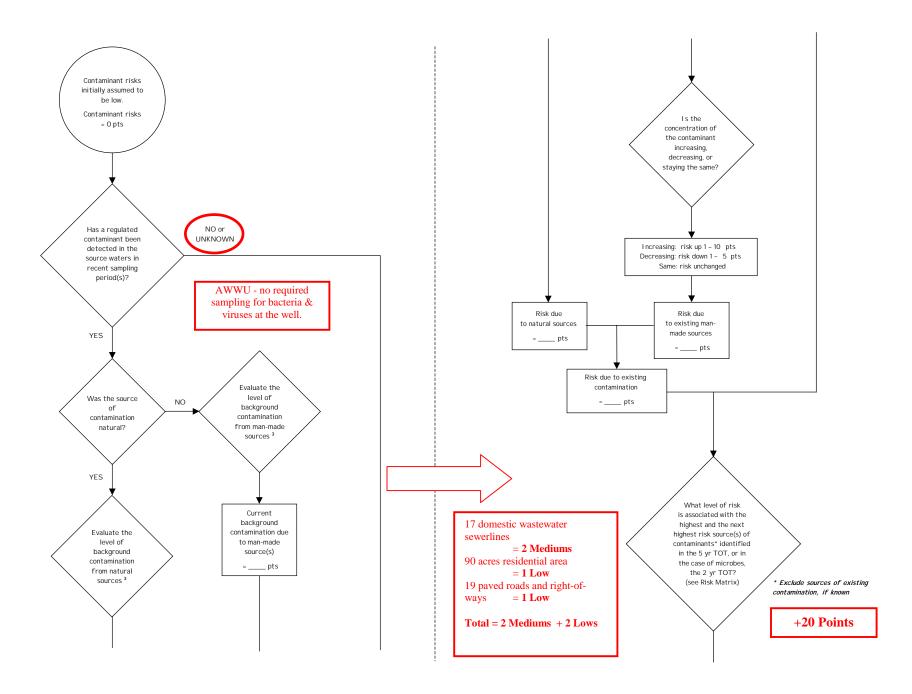
Chart 3. Contaminant risks for MOA Well #25 – Bacteria & Viruses

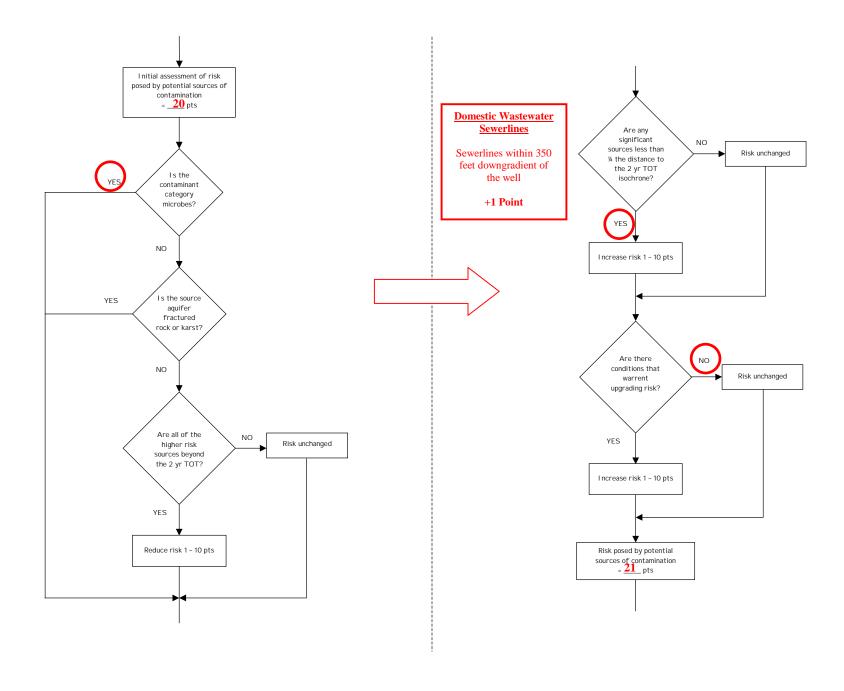
Chart 3. Contaminant risks for MOA Well #25 - Bacteria & Viruses (Continued)

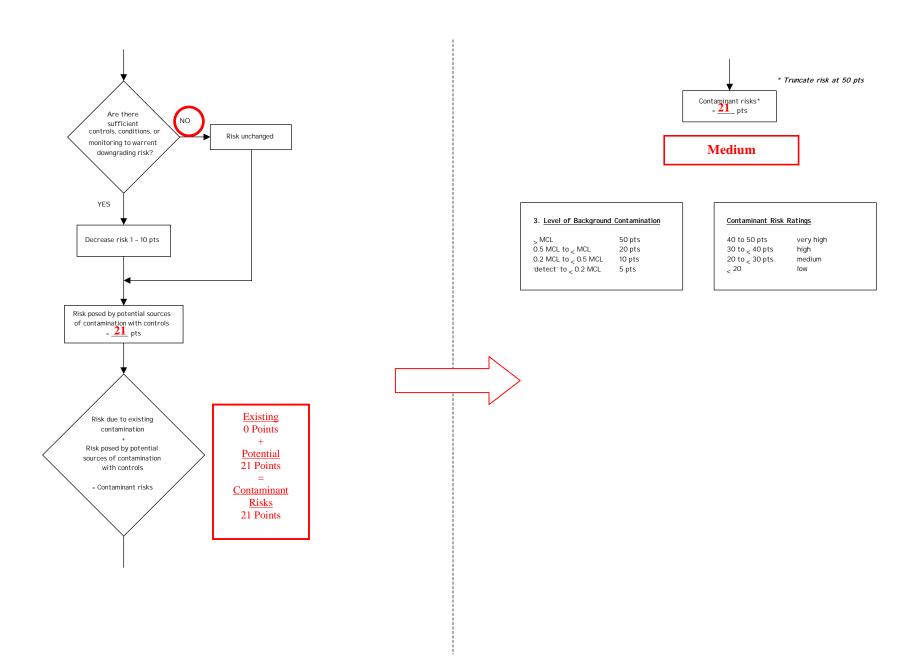
Chart 3. Contaminant risks for MOA Well #25 – Bacteria & Viruses (Continued)

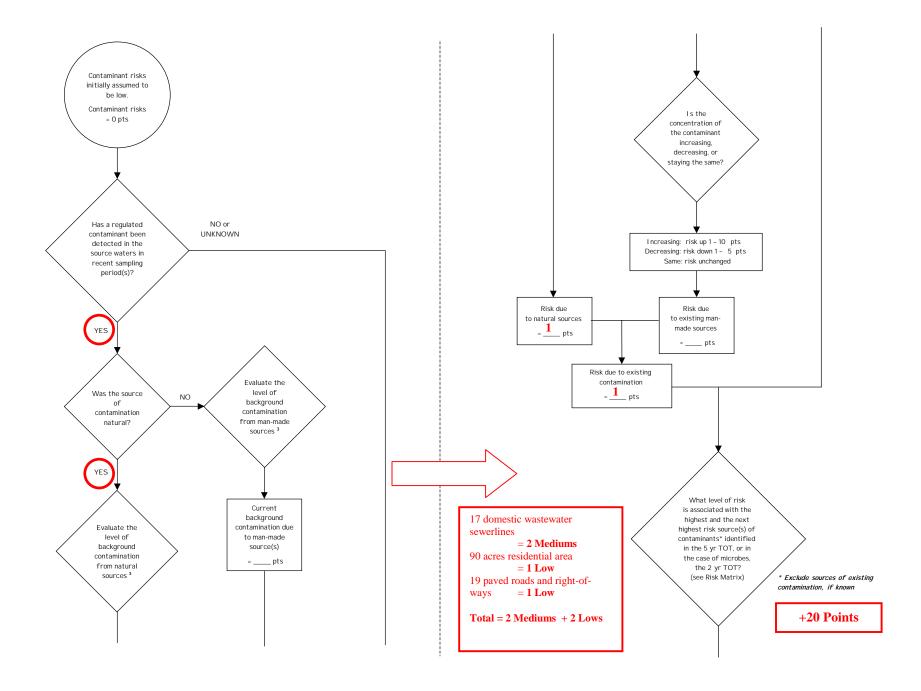
Chart 5. Contaminant risks for MOA Well #25 - Nitrates and Nitrites

Nitrates and/or nitrites are found in natural background concentrations at the site, as elsewhere in the Alaska. Sampling history of MOA Well #25 source waters indicate low concentrations of nitrate (See Chart 6 – Contaminant Risks for Nitrates/Nitrites in Appendix D). Existing nitrate contamination is approximately 5% of the allowable limit (MCL) for this contaminant. Due to the high solubility and weak retention by soil, nitrates are very mobile in soil, moving at approximately the same rate as water. Nevertheless, the current nitrate concentration in MOA Well #25 remains at safe levels with respect to human health.

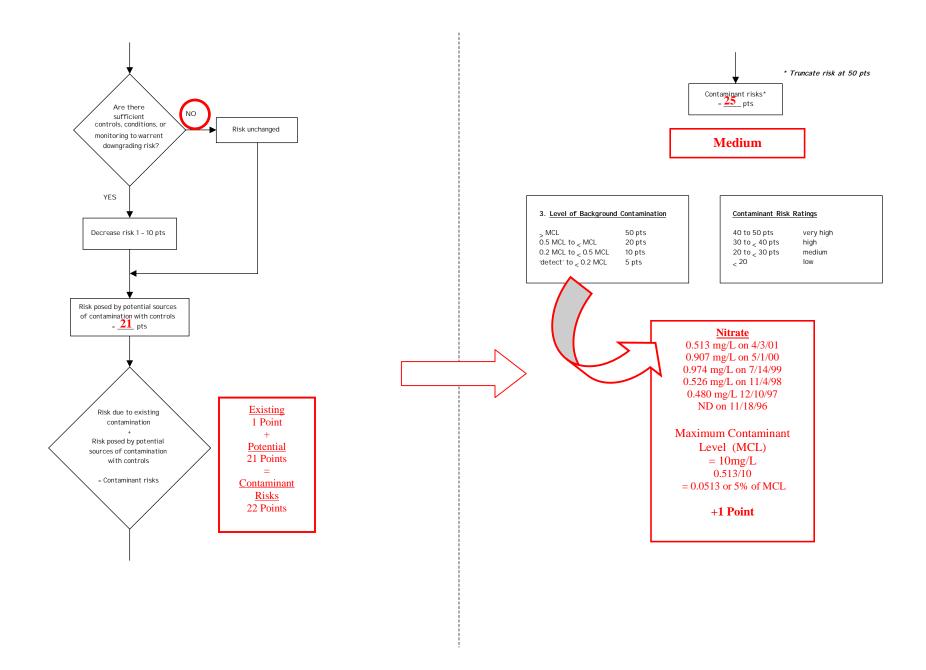
Chart 5. Contaminant risks for MOA Well #25 – Nitrates and Nitrites (Continued)

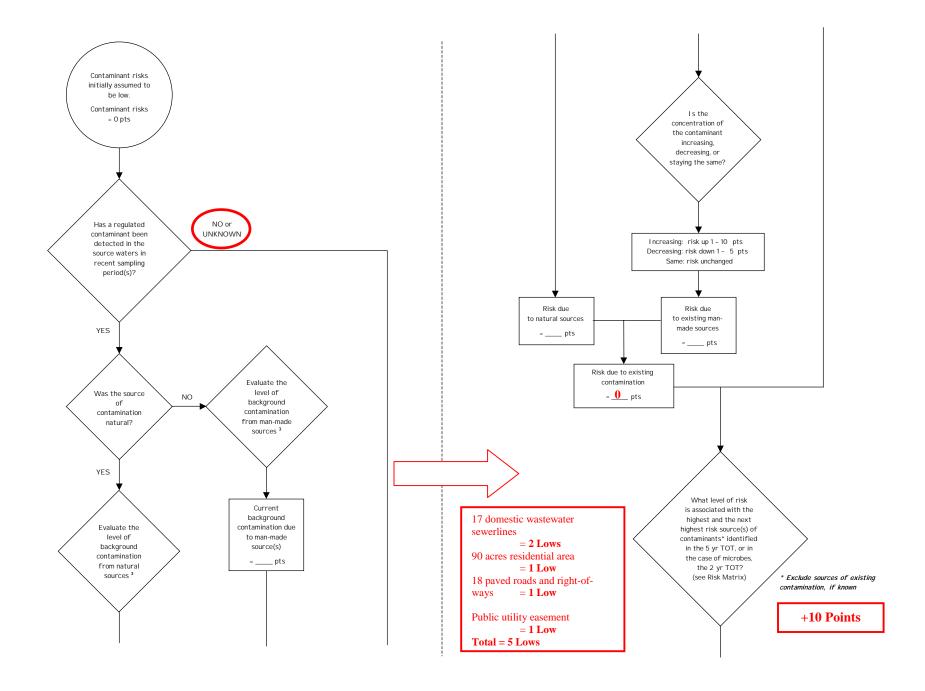
Chart 7. Contaminant risks for MOA Well #25 - Volatile Organic Chemicals

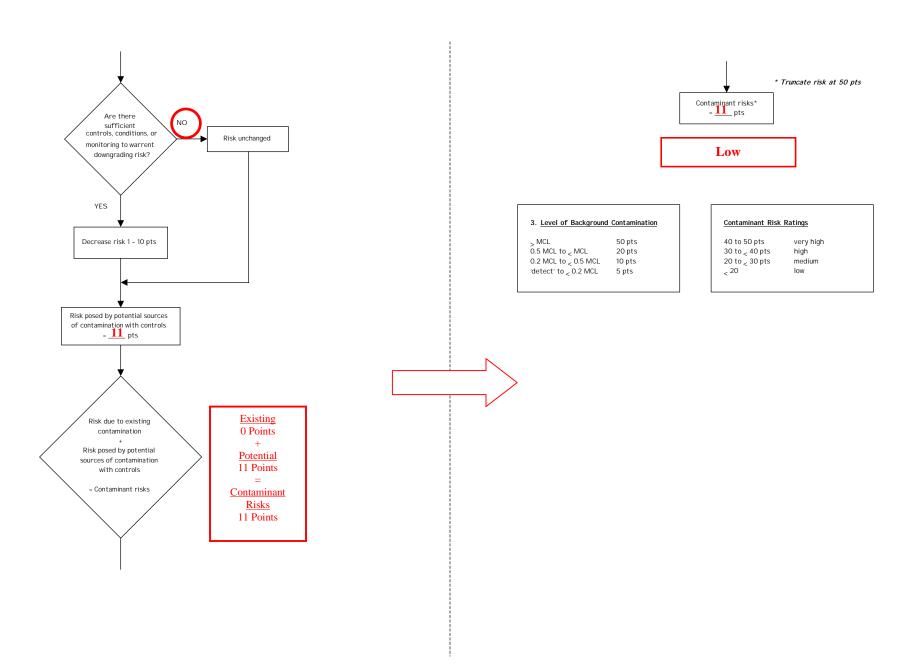
Chart 7. Contaminant risks for MOA Well #25 – Volatile Organic Chemicals (Continued)

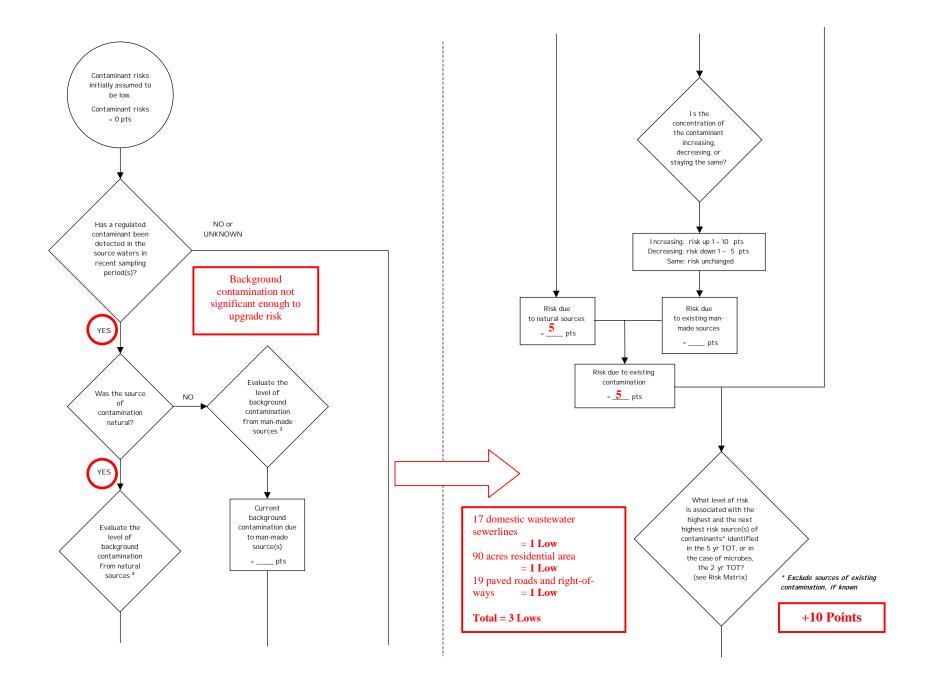
Chart 9. Contaminant risks for MOA Well #25 – Heavy Metals, Cyanide, and Other Inorganic Chemicals

In April of 2001, nickel was detected in the source waters of MOA Well #25. Existing nickel contamination is approximately 20% of the allowable limit (MCL) for this contaminant. The Maximum Contaminant Level or MCL is the maximum level of contaminant that is allowed to exist in drinking water and still be consumed by humans without harmful health effects. Nickel is a naturally occurring silvery metal found in the earth's crust in the form of various nickel minerals. Nickel and its compounds can be detected in all parts of the environment, including plants, animals and soil. Nickel can also be released to soils through domestic wastewater and the combustion of gasoline and diesel fuel. It is unknown whether this existing nickel contamination is naturally occurring or human-induced. In spite of the level of nickel in these source waters, current concentrations remain at safe drinking water levels for human consumption.

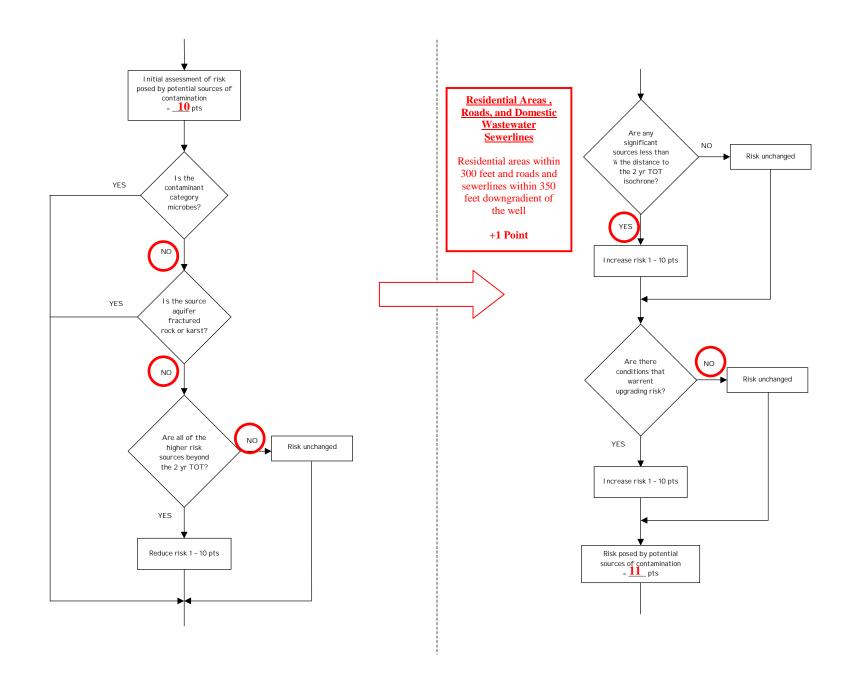
Chart 9. Contaminant risks for MOA Well #25 – Heavy Metals, Cyanide, and Other Inorganic Chemicals (Continued)

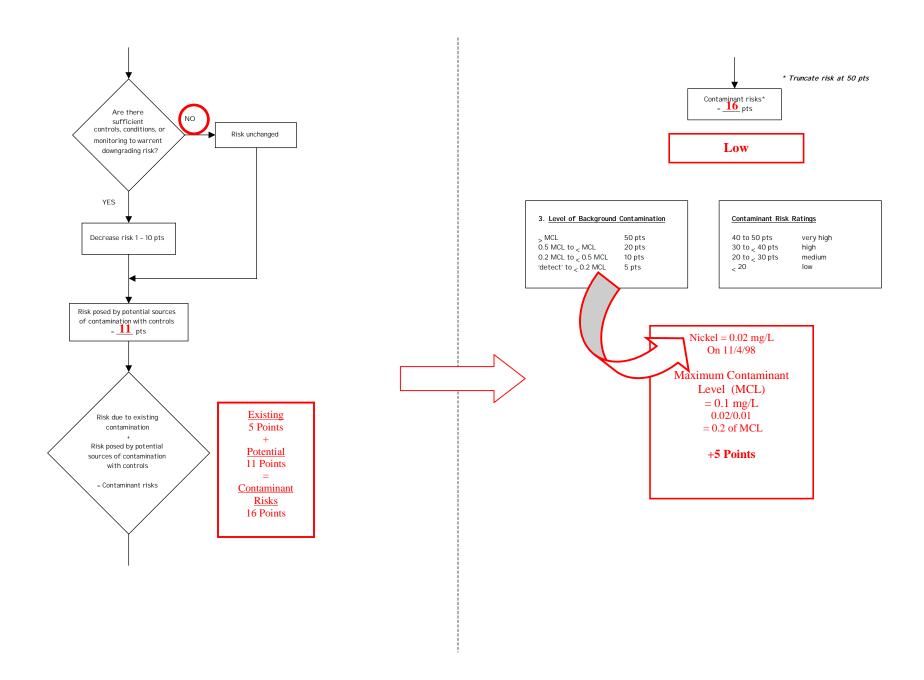
Chart 9. Contaminant risks for MOA Well #25 – Heavy Metals, Cyanide, and Other Inorganic Chemicals (Continued)

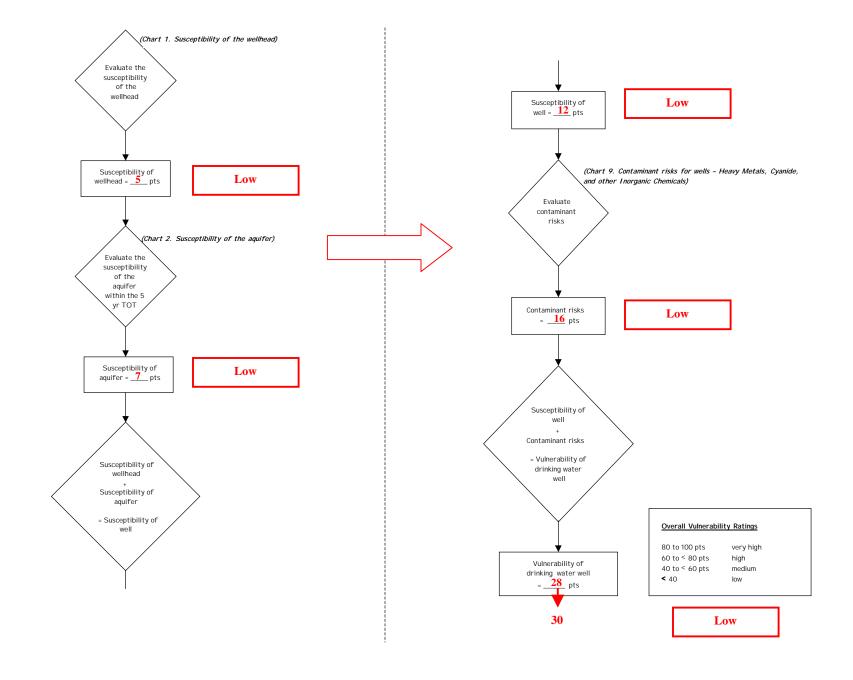
Chart 10. Vulnerability analysis for MOA Well #25 – Heavy Metals, Cyanide, and other Inorganic Chemicals

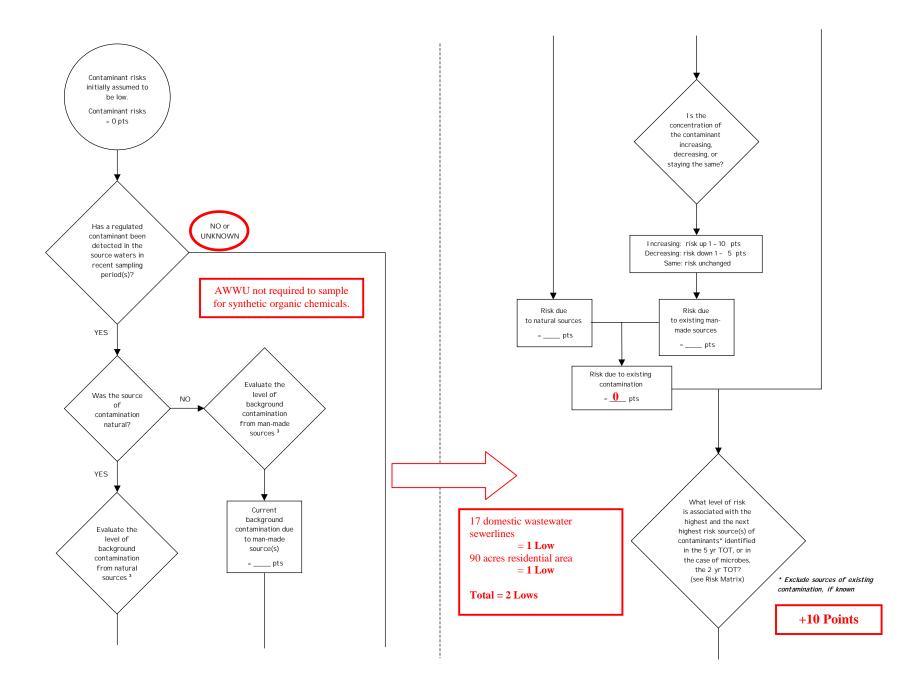
Chart 11. Contaminant risks for MOA Well #25 – Synthetic Organic Chemicals

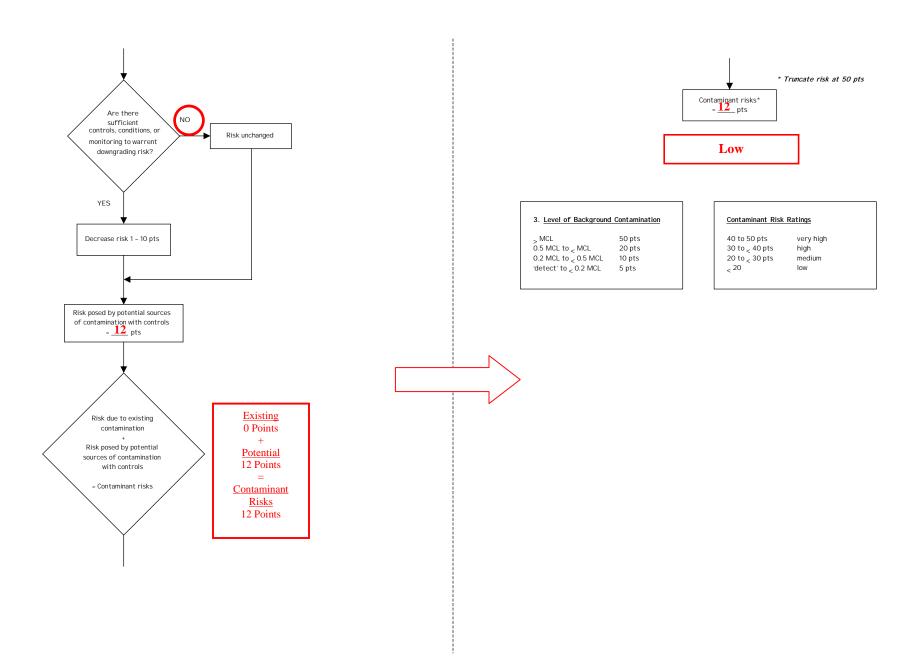
Chart 11. Contaminant risks for MOA Well #25 – Synthetic Organic Chemicals (Continued)

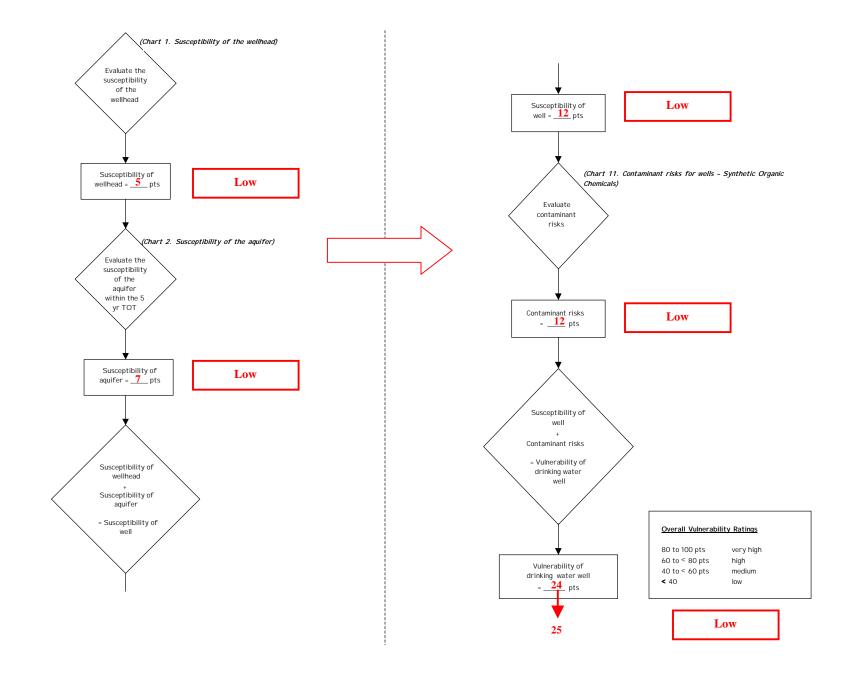
Chart 12. Vulnerability analysis for MOA Well #25 – Synthetic Organic Chemicals

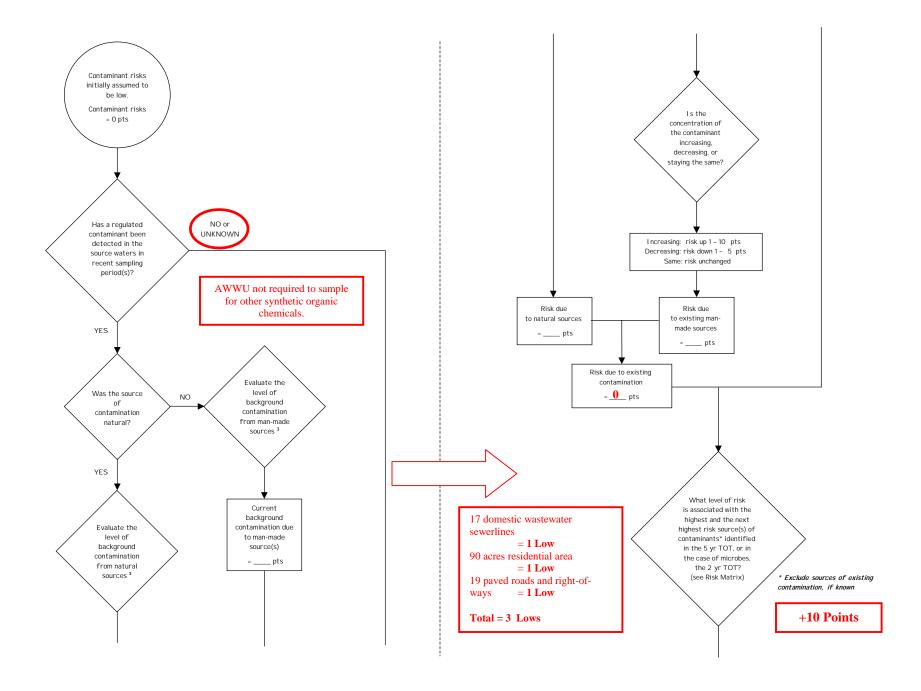
Chart 13. Contaminant risks for MOA Well #25 - Other Synthetic Organic Chemicals

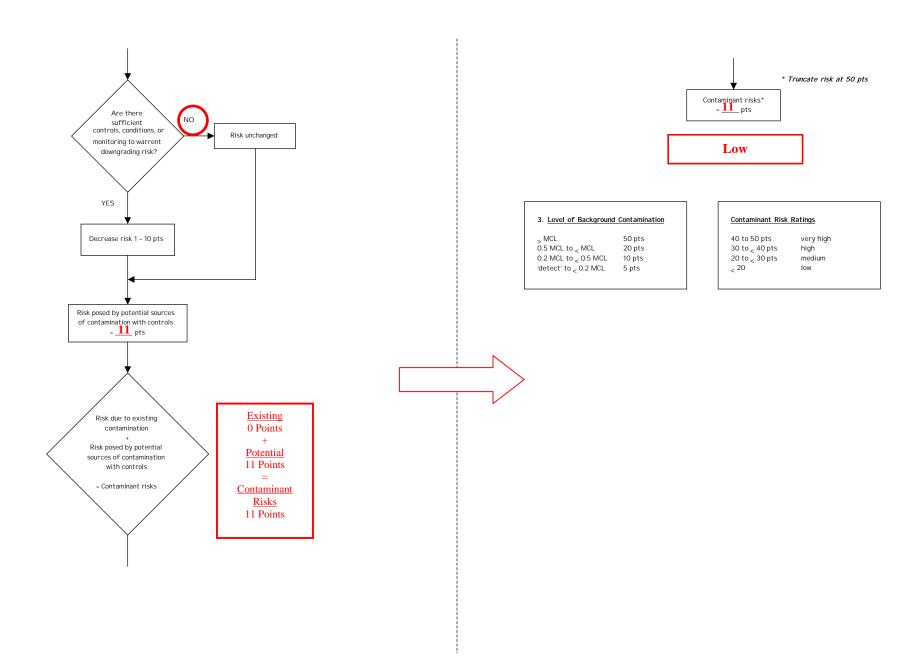
Chart 13. Contaminant risks for MOA Well #25 – Other Synthetic Organic Chemicals (Continued)

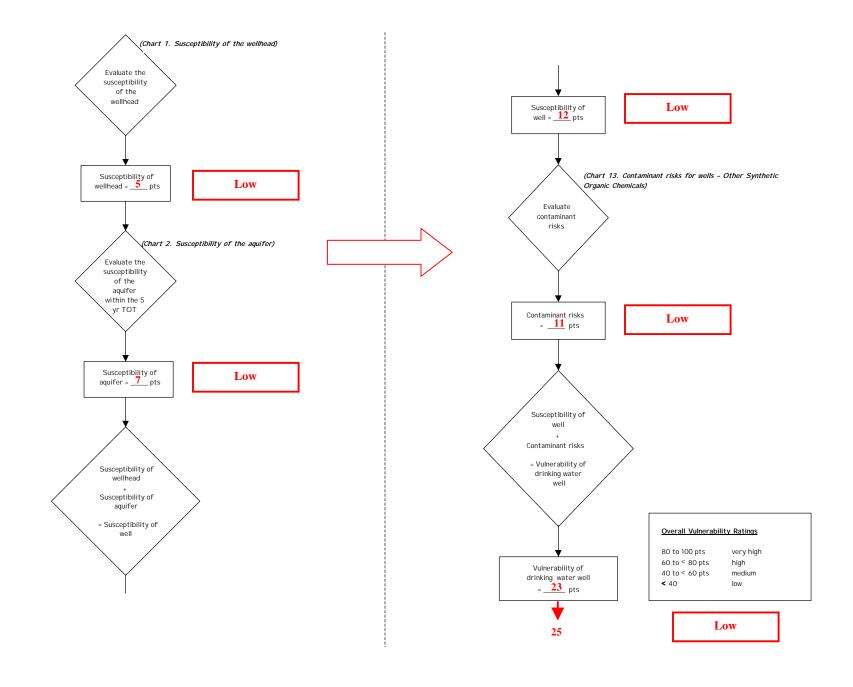
Chart 14. Vulnerability analysis for MOA Well #25 – Other Synthetic Organic Chemicals

A Source Water Assessment has been completed for the MOA Well #25 source of public drinking water. The overall vulnerability of this source to contamination is Low for bacteria and viruses, nitrates and/or nitrites, volatile organic chemicals, heavy metals, synthetic organic chemicals, and other synthetic organic chemicals. This assessment of contaminant risks can be used as a foundation for local voluntary protection efforts as well as a basis for the continuous efforts on the part of the Anchorage Water & Wastewater Utility to protect public health. It is anticipated that Source Water Assessments will be updated every five years to reflect any changes in the vulnerability and/or susceptibility of the public drinking water source.
