Source Water Assessment

A Hydrogeologic Susceptibility and Vulnerability Assessment for Bay View Terrace Drinking Water System, Dillingham, Alaska

PWSID # 261460.001

DRINKING WATER PROTECTION PROGRAM REPORT 1062 Alaska Department of Environmental Conservation

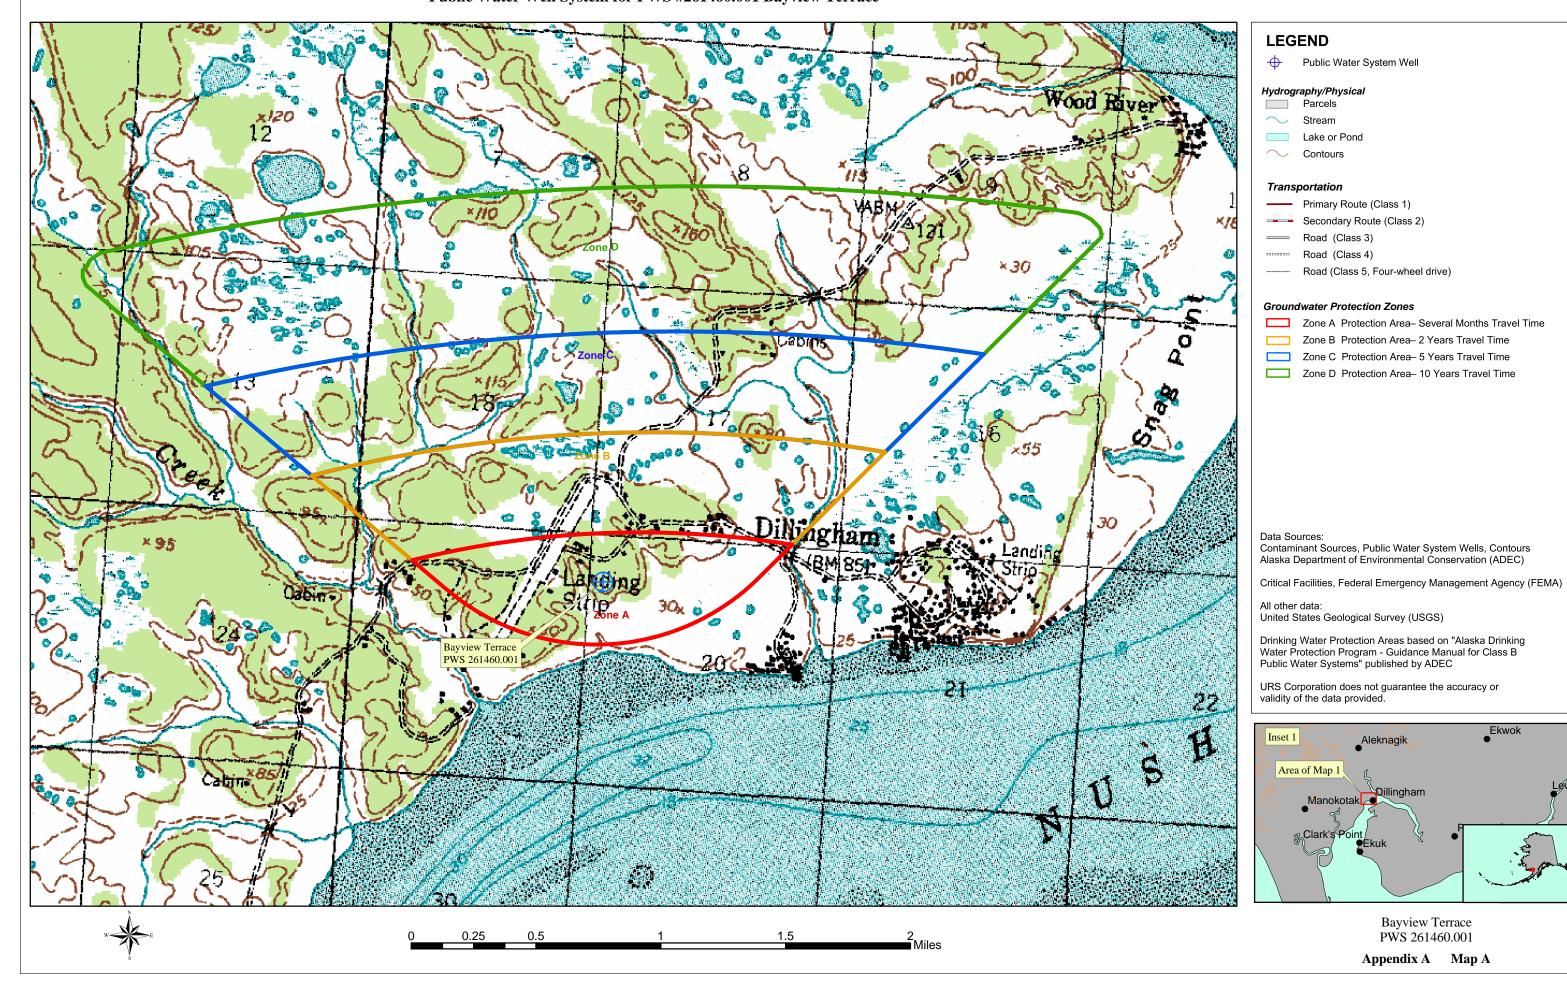
Drinking Water Protection Area Location Map (Map A)

Public Water Well System for PWS #261460.001 Bayview Terrace

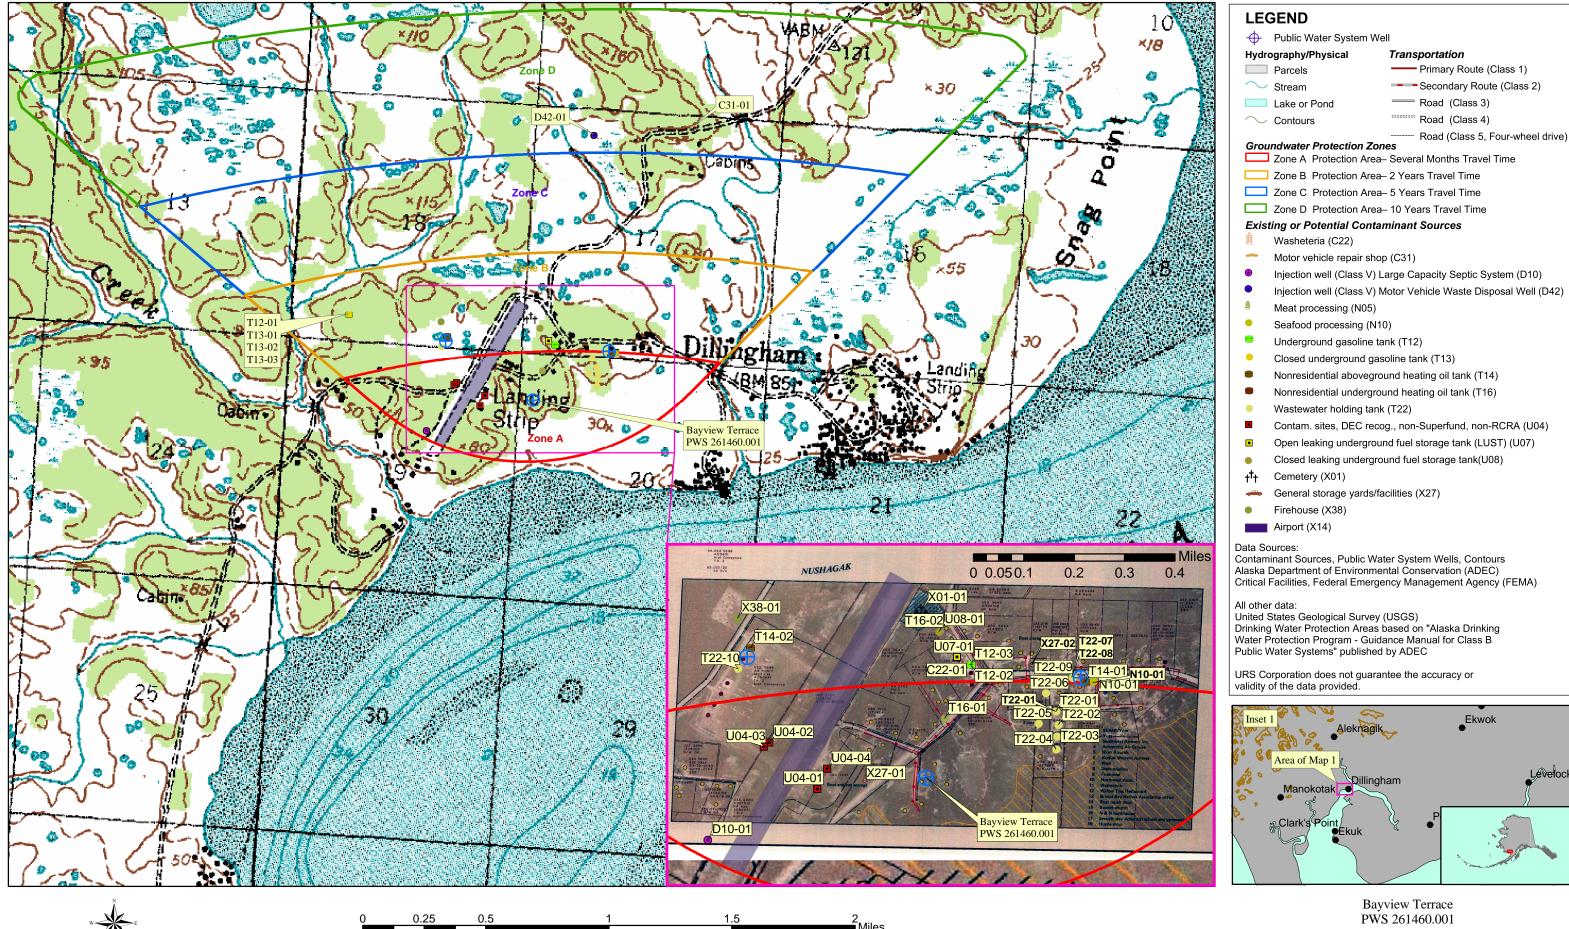
Drinking Water Protection Area and Potential and Existing Contaminant Sources (Map C)

Public Water Well System for PWS #261460.001 Bayview Terrace **Showing Potential and Existing Sources of Contamination**

The Drinking Water Protection Program has completed an inventory of potential and existing sources of contamination within the Bay View Terrace DWPA. This inventory was completed through a search of agency records and other publicly available information. Potential sources of contamination to the drinking water aquifer include a wide range of categories and types. Potential drinking water contaminants are found within agricultural, residential, commercial, and industrial areas, but can also occur within areas that have little or no development.

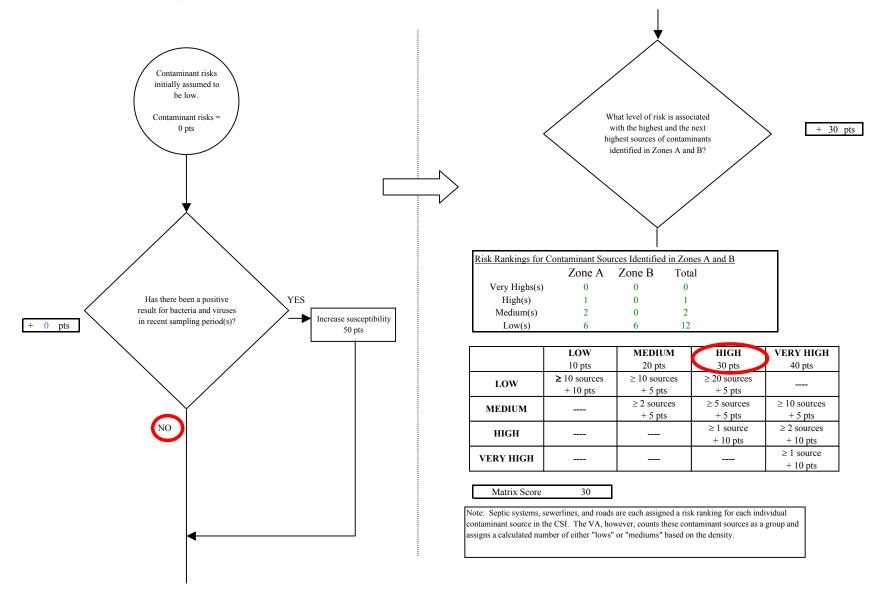
Chart 3. Contaminant risks for Bay View Terrace (PWS No. 261460.001) - Bacteria & Viruses NO Are there sufficient Initial assessment of risk posed by Risk unchanged controls, conditions, or potential sources of contamination monitoring to warrant = 30 pts downgrading risk? Are any YES significant Risk unchanged contaminant Reduce risk 1 - 10 pts sources within - 0 pts Zone A? The number and magnitude of Risk posed by potential sources of contaminant sources in YES contamination with controls Zone A determines a risk increase. See Table 2 for + 10 pts Increase risk 1 - 10 pts inventory. Existing Risk due to existing 0 pts contamination Are there any conditions that Risk unchanged Risk posed by potential sources warrant upgrading Potential of contamination with controls risk? 40 pts Contaminant risks Contaminant Risk YES 40 pts Increase risk 1 - 10 pts + 0 pts Contaminant risks* * Truncate risk at 50 pts 40 Contaminant Risk Ratings Risk posed by potential sources of contamination very high 40 to 50 pts 40 30 to < 40 pts high Very High $20 \text{ to} \le 30 \text{ pts}$

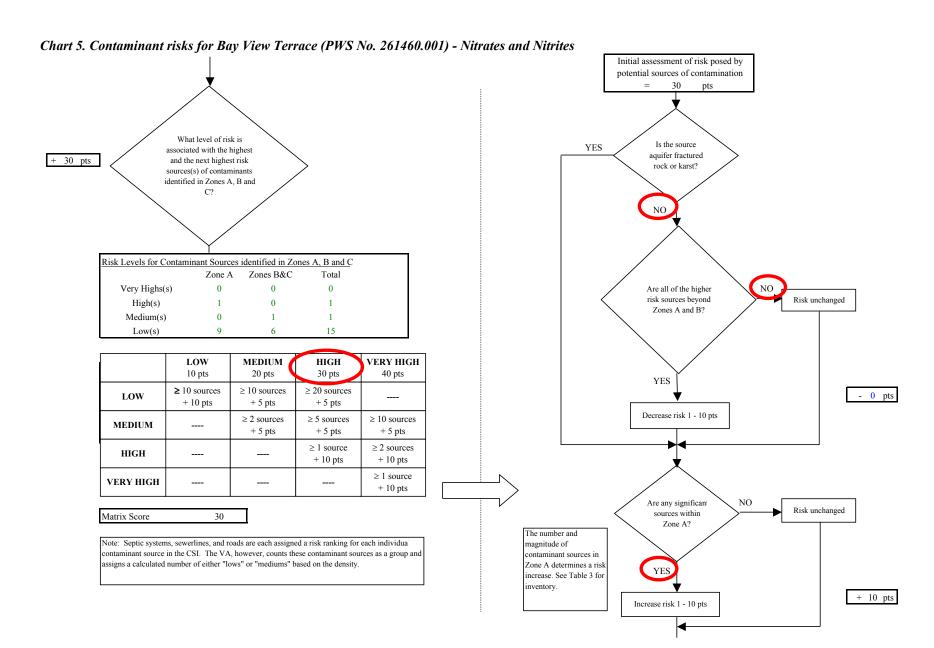
Chart 5. Contaminant risks for Bay View Terrace (PWS No. 261460.001) - Nitrates and Nitrites Existing NO Are there conditions 10 pts Risk unchanged that warrant upgrading risk? Risk due to existing Potential contamination 40 pts Risk posed by potential sources of contamination with controls Contaminant Risk YES 50 pts Contaminant risks 0 pts Increase risk 1 - 10 pts Risk posed by potential sources of contamination 40 pts *Truncate risk at 50 pts Contaminant risks* 50 Are there sufficient Contaminant Risk Ratings Very High controls, conditions, NO Risk unchanged very high or monitoring to 40 to 50 pts 30 to < 40 pts warrant downgrading high 20 to < 30 pts medium < 20 pts low YES 0 pts Decrease risk 1 - 10 pts Risk posed by potential sources of contamination with controls

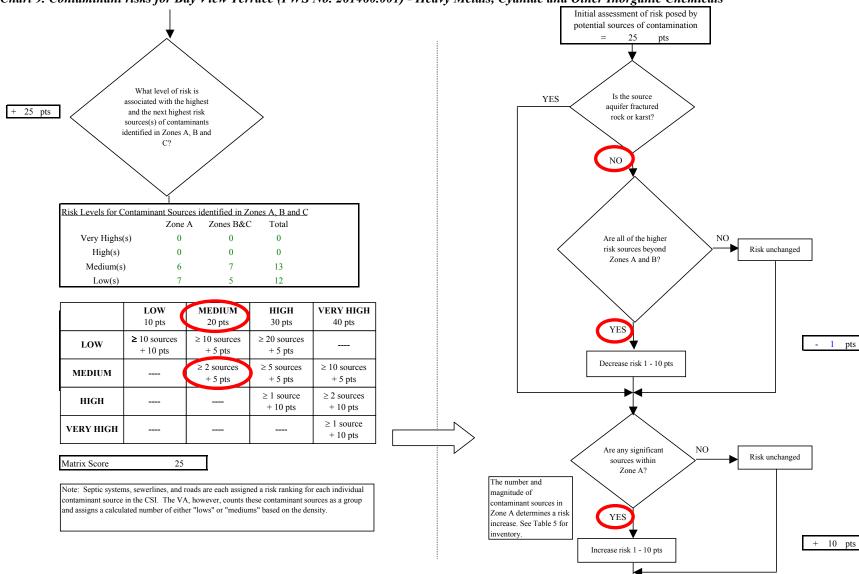
Chart 9. Contaminant risks for Bay View Terrace (PWS No. 261460.001) - Heavy Metals, Cyanide and Other Inorganic Chemicals Existing Are there conditions 0 pts Risk unchanged upgrading risk? Risk due to existing Potential contamination 36 pts The number and magnitude of Risk posed by potential sources contaminant sources in of contamination with controls Contaminant Risk Zone D determines a YES 36 pts risk increase. See Table Contaminant risks 5 for inventory. 2 pts Increase risk 1 - 10 pts Risk posed by potential sources of contamination 36 pts Contaminant risks* *Truncate risk at 50 pts 36 Contaminant Risk Ratings Are there sufficient High NQ controls, conditions, Risk unchanged 40 to 50 pts very high or monitoring to 30 to < 40 pts warrant downgrading high risk? 20 to < 30 pts medium < 20 pts low YES 0 pts Decrease risk 1 - 10 pts Risk posed by potential sources of contamination with controls 36 pts

The contaminant risk for heavy metals, cyanide and other inorganic chemicals is **High**. The risk is primarily attributed to the presence of an injection well located in Zone D. Numerous other potential contaminant sources are also found within the protection area (see Table 5 – Appendix B).

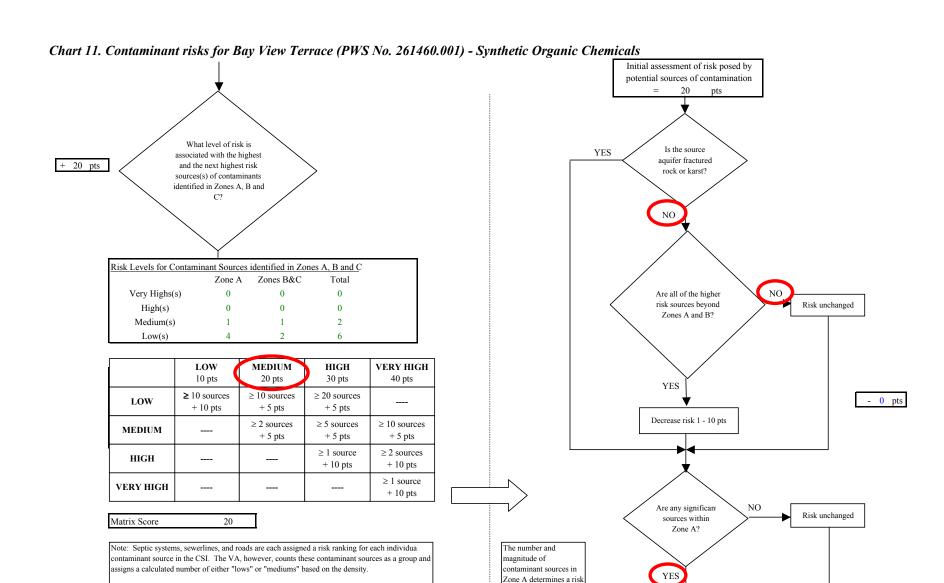
Chart 11. Contaminant risks for Bay View Terrace (PWS No. 261460.001) - Synthetic Organic Chemicals Existing NO Are there conditions 0 pts Risk unchanged that warrant upgrading risk? Risk due to existing Potential contamination 25 pts Risk posed by potential sources of contamination with controls Contaminant Risk YES 25 pts Contaminant risks 0 pts Increase risk 1 - 10 pts Risk posed by potential sources of contamination 25 pts *Truncate risk at 50 pts Contaminant risks* 25 Are there sufficient Contaminant Risk Ratings Medium controls, conditions, NO Risk unchanged or monitoring to 40 to 50 pts very high warrant downgrading 30 to < 40 pts high 20 to < 30 pts medium < 20 pts low YES 0 pts Decrease risk 1 - 10 pts Risk posed by potential sources of contamination with controls

The contaminant risk for synthetic organic chemicals is **Medium**. The risk is primarily attributed to the presence of a cemetery and an airport in Zones A and B. Numerous potential contaminant sources are found within the protection area (see Table 6-Appendix B).

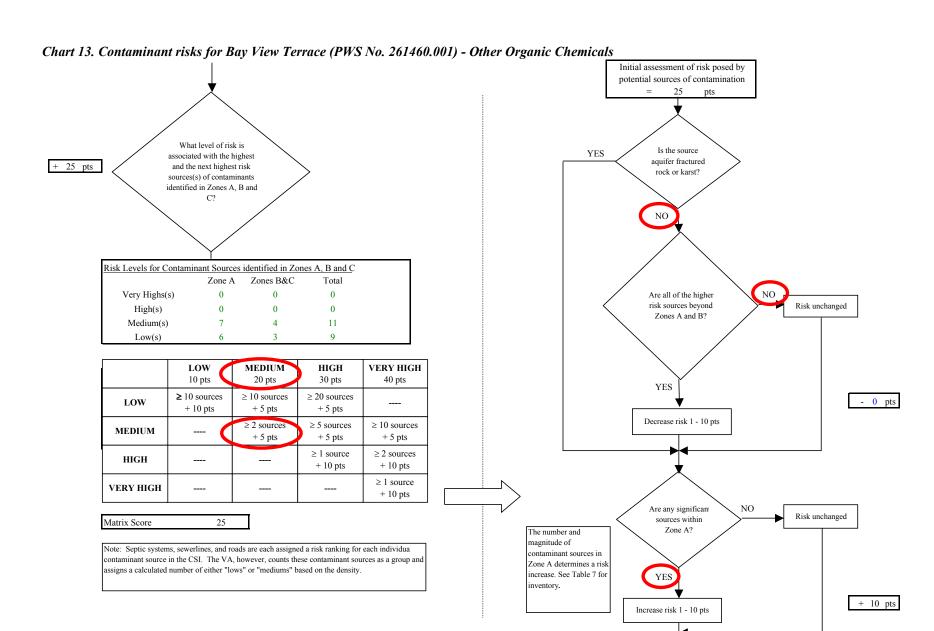
Chart 13. Contaminant risks for Bay View Terrace (PWS No. 261460.001) - Other Organic Chemicals Existing NO Are there conditions 0 pts Risk unchanged that warrant upgrading risk? Risk due to existing Potential contamination 35 pts Risk posed by potential sources of contamination with controls Contaminant Risk YES 35 pts Contaminant risks 0 pts Increase risk 1 - 10 pts Risk posed by potential sources of contamination 35 pts *Truncate risk at 50 pts Contaminant risks* 35 Are there sufficient Contaminant Risk Ratings High controls, conditions, NO Risk unchanged or monitoring to 40 to 50 pts very high 30 to < 40 pts warrant downgrading high 20 to < 30 pts medium < 20 pts low YES 0 pts Decrease risk 1 - 10 pts Risk posed by potential sources of contamination with controls

The contaminant risk for other organic chemicals is **High**. The risk is primarily attributed to the presence of wastewater holding tanks and an airport located in Zones A and B. Numerous other potential contaminant sources are also found within the protection area (see Table 7 – Appendix B).
