A Hydrogeologic Susceptibility and Vulnerability Assessment for Badger Den Drinking Water System, Fairbanks area, Alaska PWSID 311184

October 2003

DRINKING WATER PROTECTION PROGRAM REPORT Report 1246 Alaska Department of Environmental Conservation

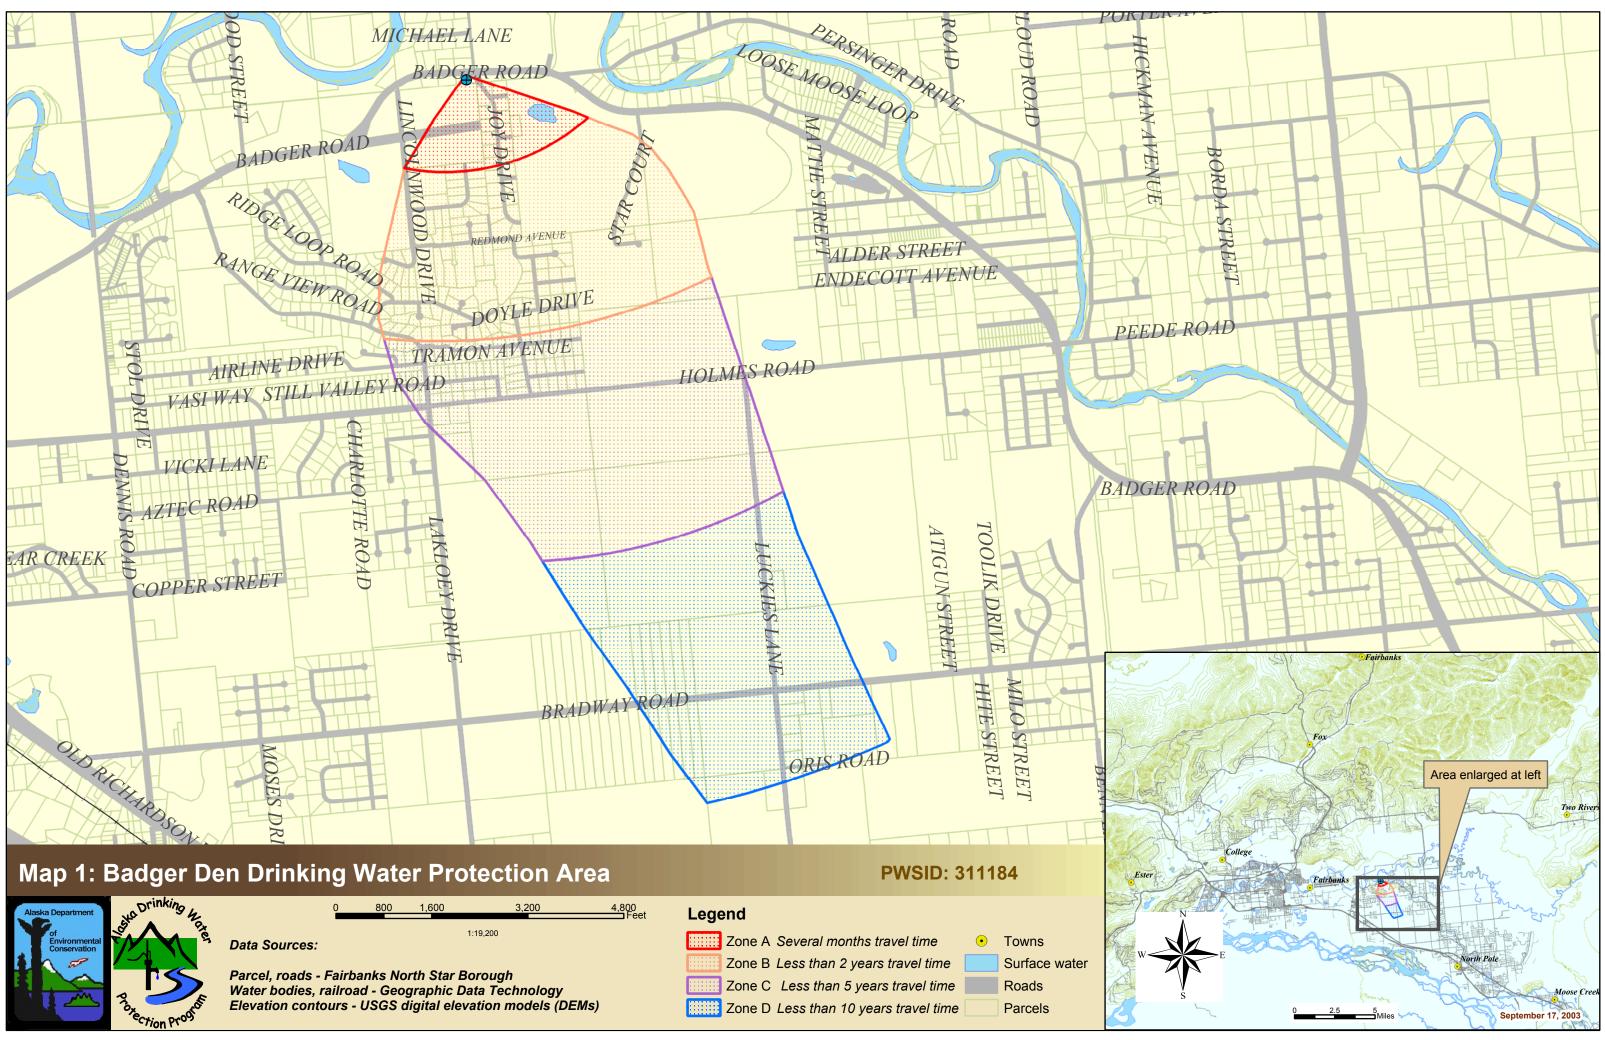
Badger Den Drinking Water Protection Area Location Map (Map 1)

eye			
	Zone A Several months travel time	•	Towns
	Zone B Less than 2 years travel time		Surface w
	Zone C Less than 5 years travel time		Roads
	Zone D Less than 10 years travel time		Parcels

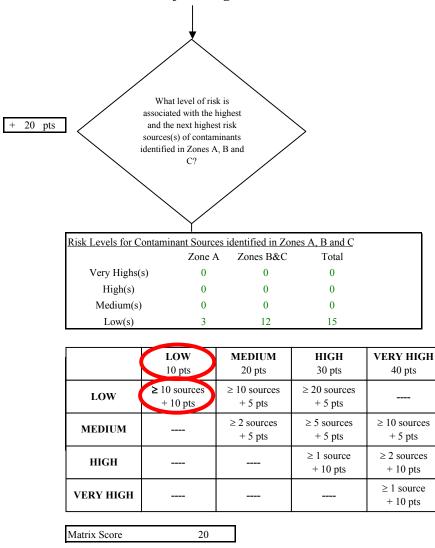
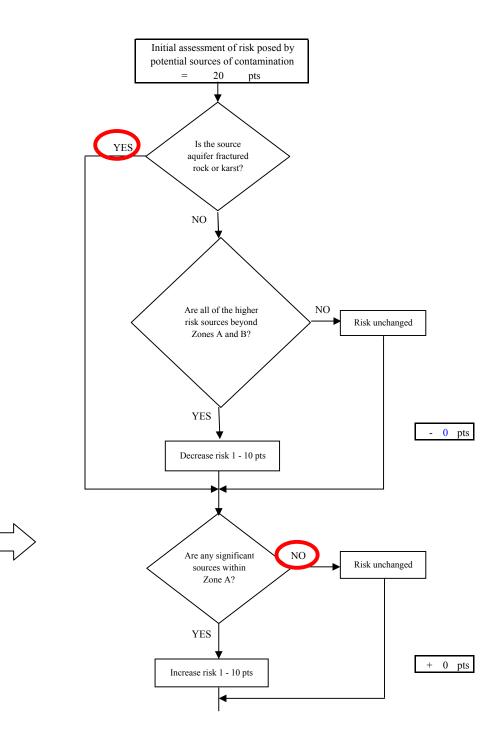
Note: Septic systems, sewerlines, and roads are each assigned a risk ranking for each individual contaminant source in the CSI. The VA, however, counts these contaminant sources as a group and assigns a calculated number of either "lows" or "mediums" based on the density.

Chart 5. Contaminant risks for Badger Den - Nitrates and Nitrites Existing NO Are there conditions 1 pts Risk unchanged that warrant + upgrading risk? Risk due to existing Potential contamination 20 pts $^{+}$ Risk posed by potential sources = of contamination with controls Contaminant Risk = YES 21 pts Contaminant risks 0 pts Increase risk 1 - 10 pts Risk posed by potential sources of contamination 20 pts Contaminant risks* *Truncate risk at 50 pts = 21 pts Contaminant Risk Ratings Are there sufficient Medium controls, conditions, NO Risk unchanged or monitoring to 40 to 50 pts very high 30 to < 40 ptshigh warrant downgrading risk? 20 to < 30 pts medium < 20 pts low YES 0 pts Decrease risk 1 - 10 pts Risk posed by potential sources of contamination with controls 20 pts
