Source Water Assessment

A Hydrogeologic Susceptibility and
Vulnerability Assessment for
Fairbanks Christian Center Drinking Water
System,

Fairbanks area, Alaska

DRINKING WATER PROTECTION PROGRAM REPORT Report 1017
Alaska Department of Environmental Conservation

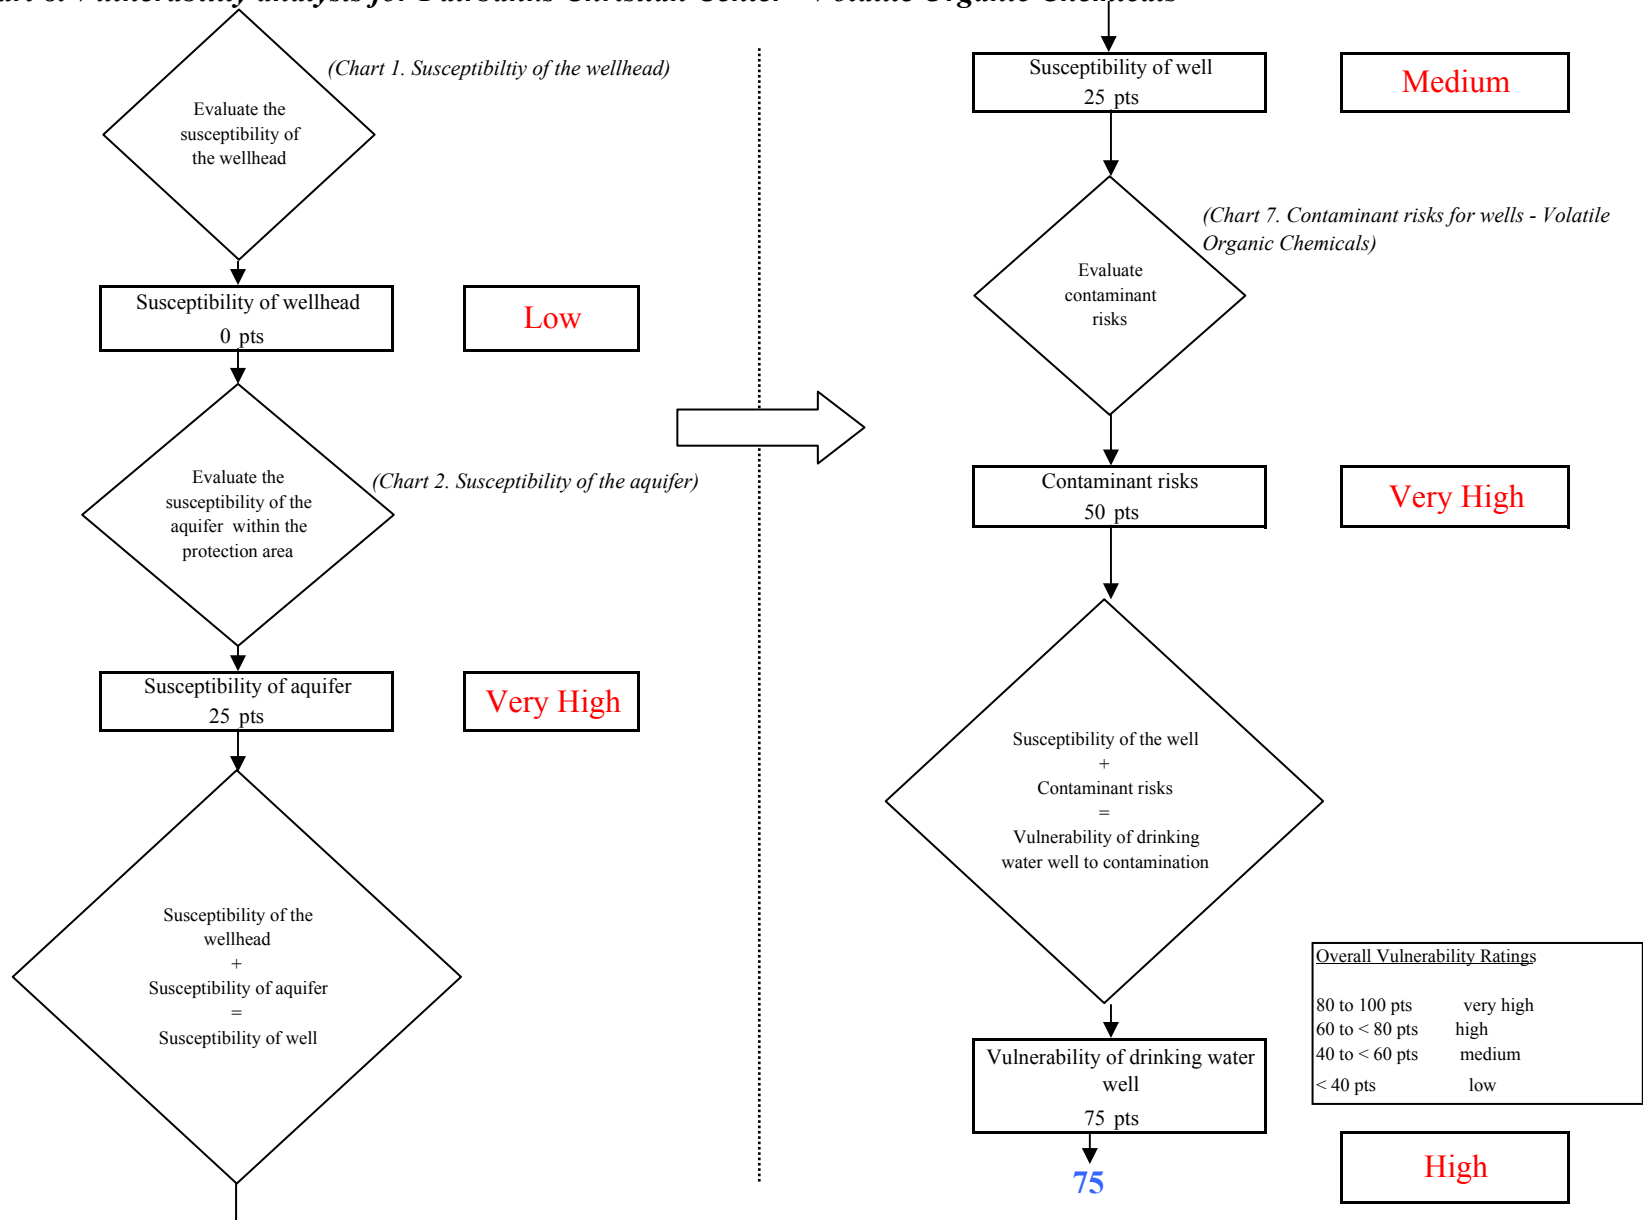
Chart 8. Vulnerability analysis for Fairbanks Christian Center - Volatile Organic Chemicals
