Source Water Assessment

A Hydrogeologic Susceptibility and
Vulnerability Assessment for
Circle M Lounge Drinking Water System,
Fairbanks area, Alaska

PWSID # 370081

DRINKING WATER PROTECTION PROGRAM REPORT Report 1015
Alaska Department of Environmental Conservation

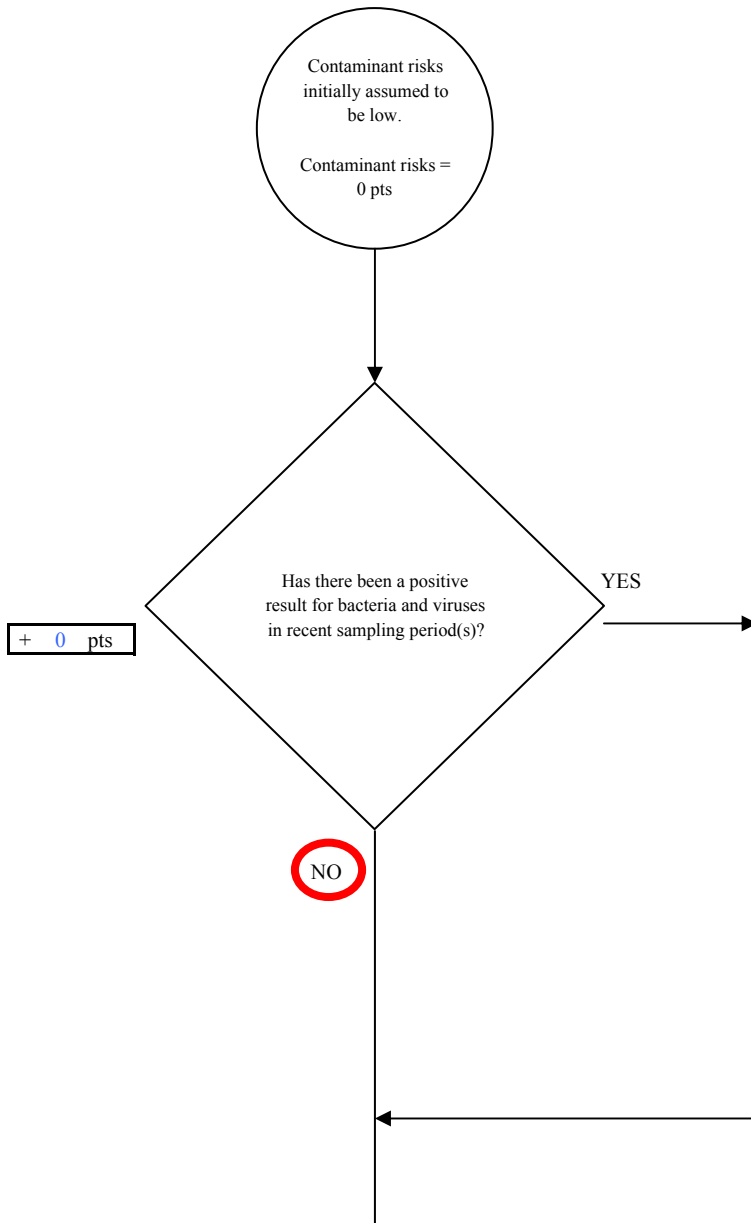
Chart 3. Contaminant risks for Circle M Lounge - Bacteria & Viruses

Risk Rankings for Contaminant Sources Identified in Zones A and B

Zone A	Zone B	Total
Very High(s)	0	0	0
High(s)	0	0	0
Medium(s)	0	0	0
Low(s)	6	4	10
