A Hydrogeologic Susceptibility and Vulnerability Assessment for Lower Chena Dome Trailhead Drinking Water System, Fairbanks Area, Alaska PWSID 311875

March 2004

DRINKING WATER PROTECTION PROGRAM REPORT Report 1427
Alaska Department of Environmental Conservation

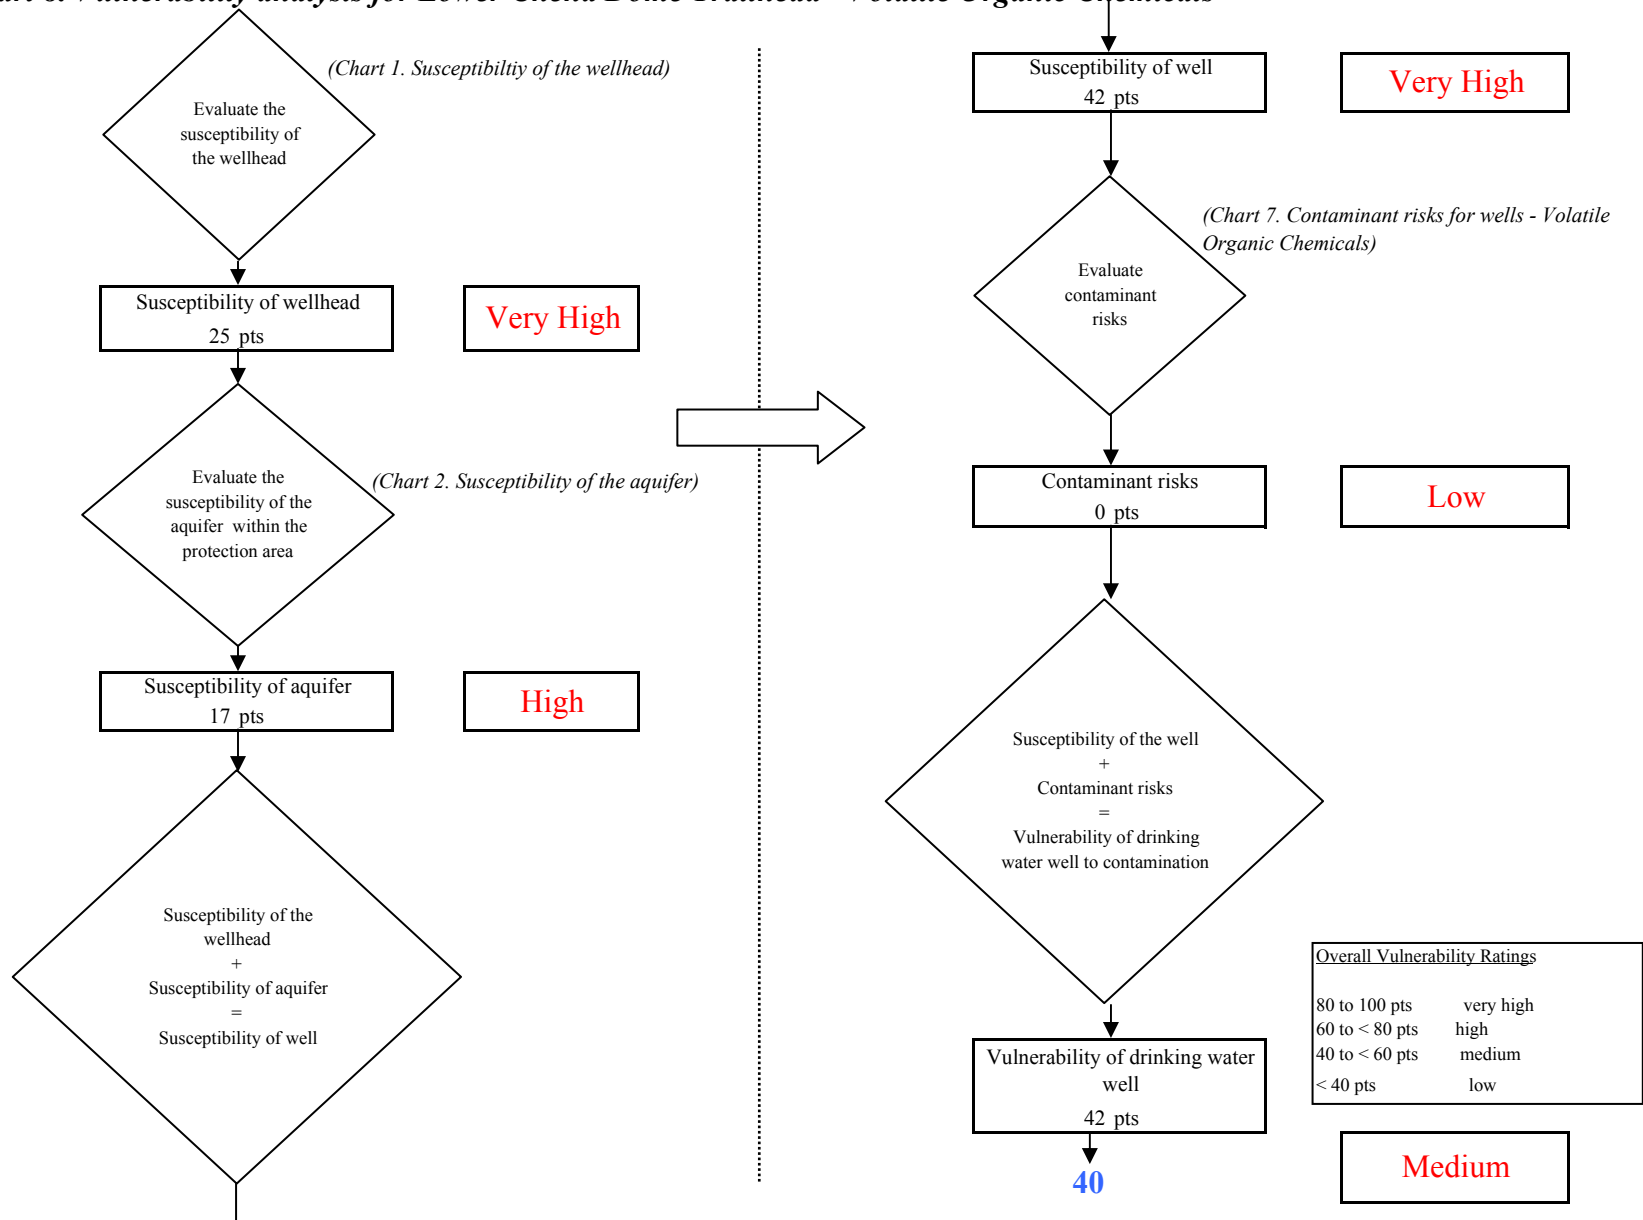
Chart 8. Vulnerability analysis for Lower Chena Dome Trailhead - Volatile Organic Chemicals
