# Source Water Assessment

A Hydrogeologic Susceptibility and  
Vulnerability Assessment for  
Riverview RV Park Drinking Water  
System,

Fairbanks area, Alaska

PWSID 313306

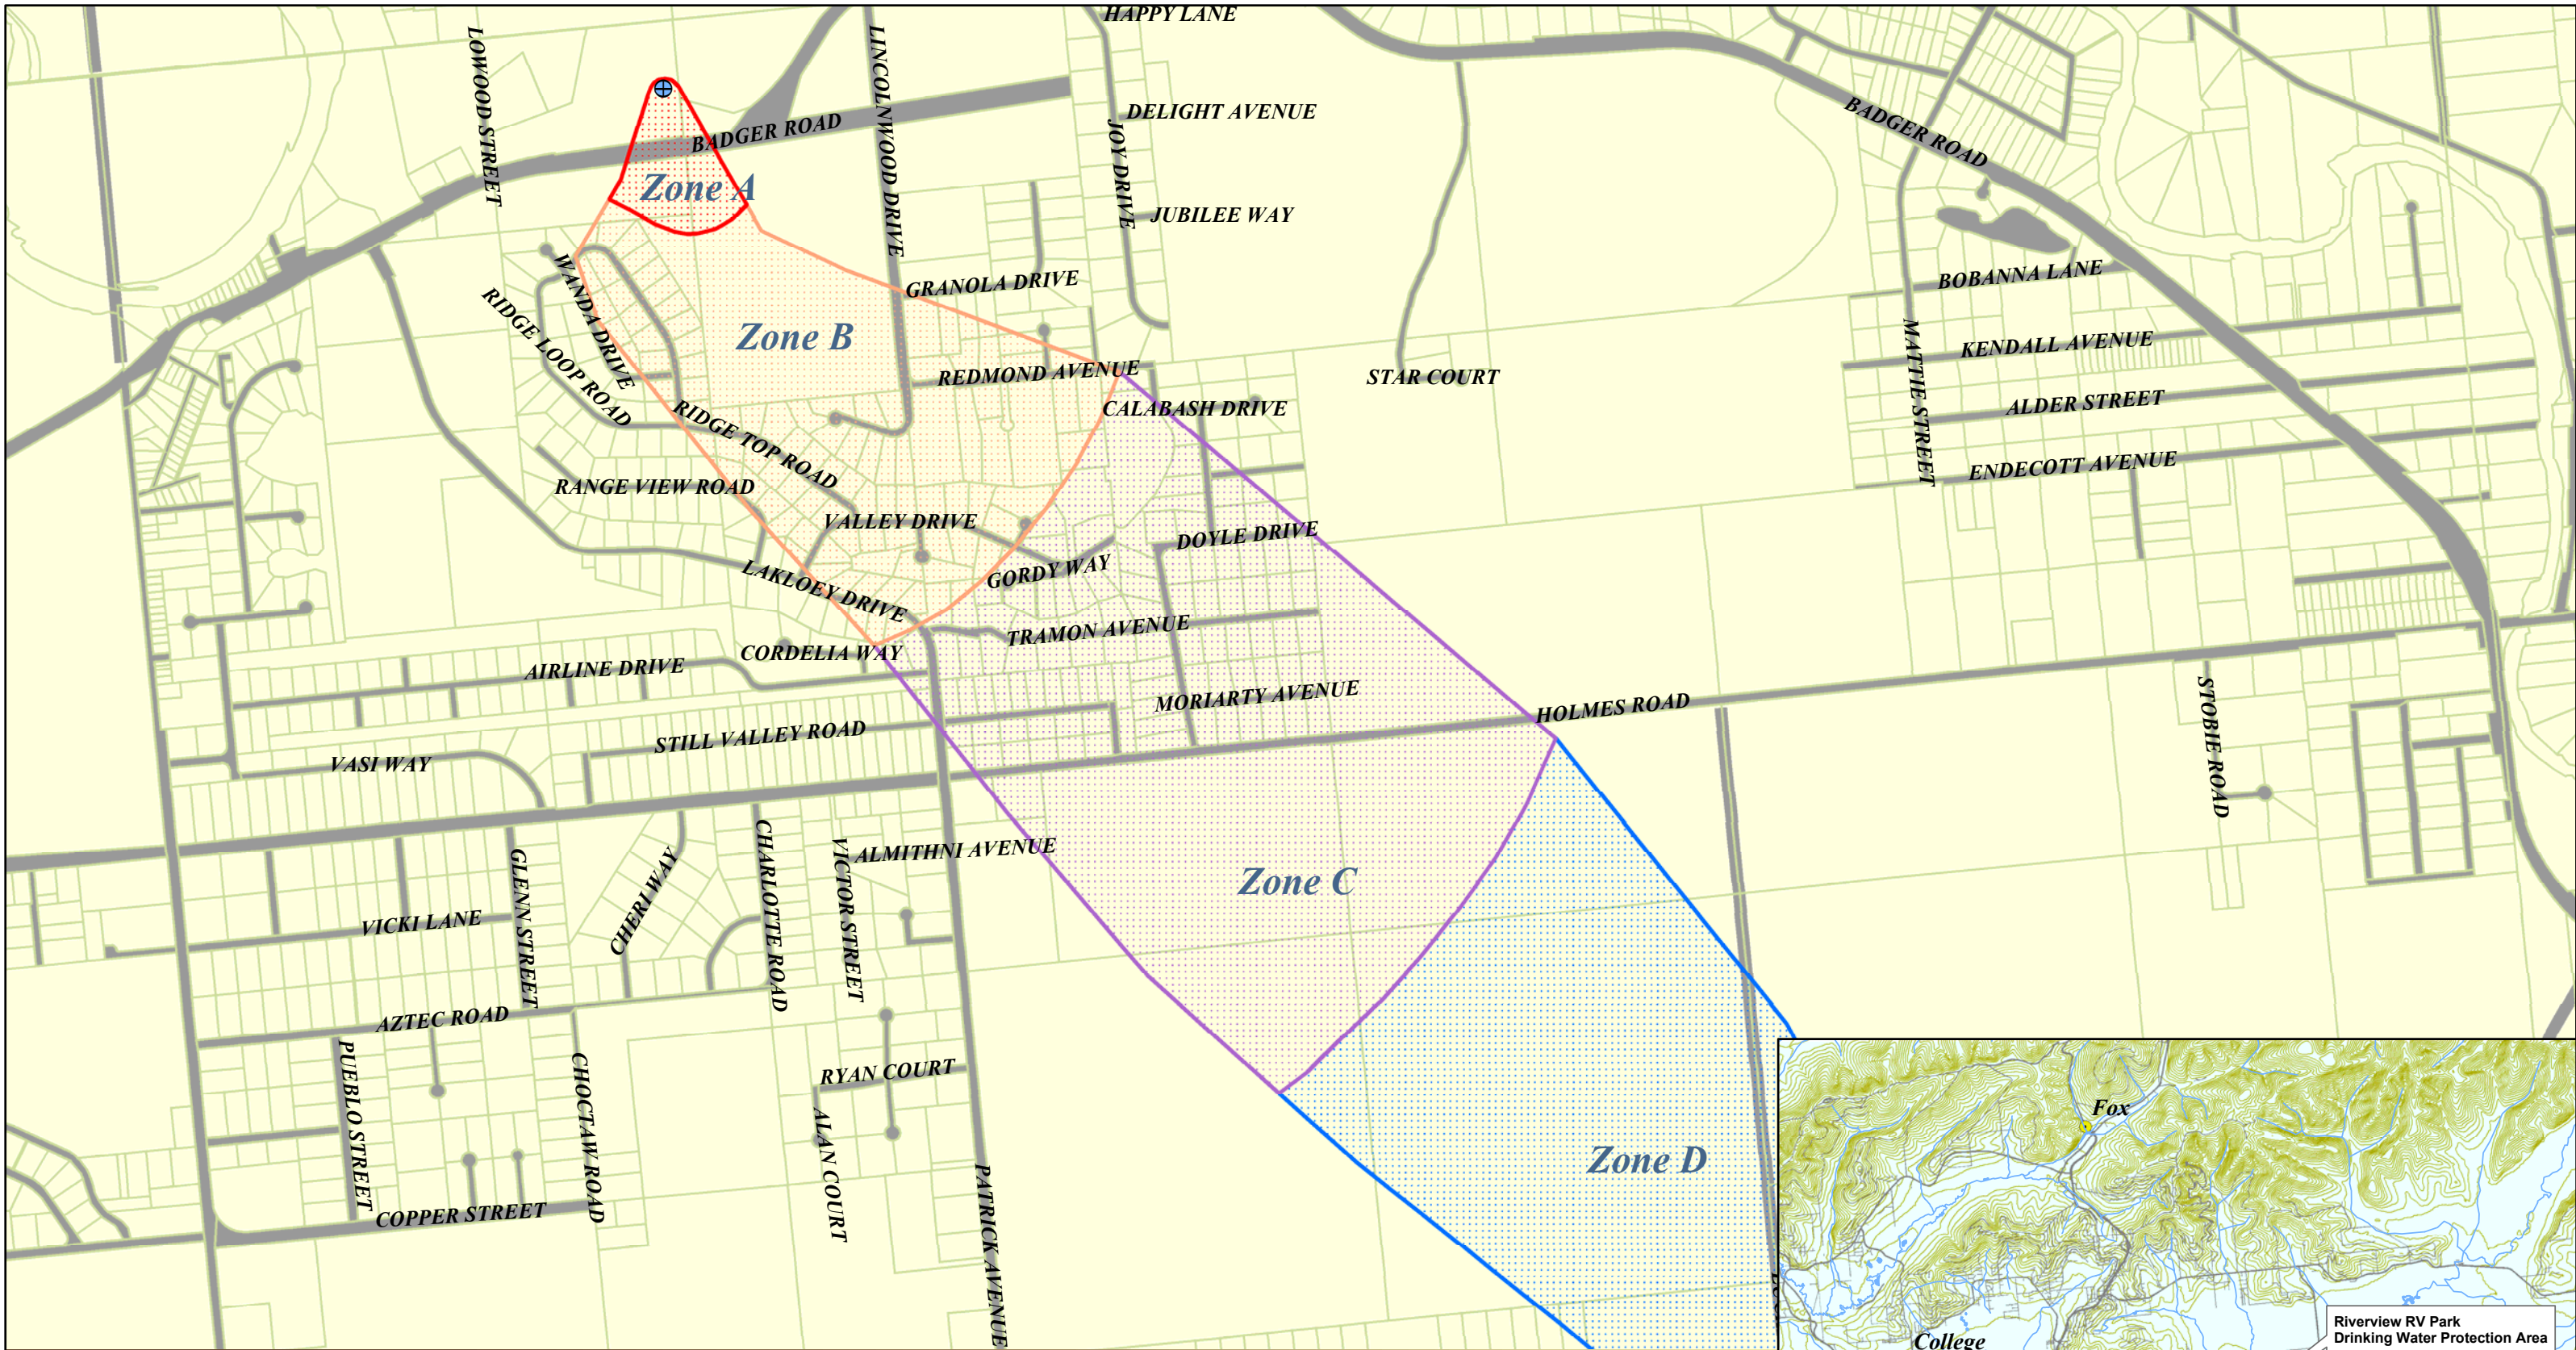
**Map 1: Riverview RV Park Drinking Water Protection Area**

### **Riverview RV Park Drinking Water Protection Area Location Map (Map 1)**

Riverview RV Park public water system is a Class B (non-community) water system. The system consists of one well on Badger Road in Fairbanks, Alaska (T1S, R1E, Section 15) (See Map 1 of Appendix A). Fairbanks is the largest town in the Fairbanks North Star Borough which is near the center of Alaska (Please see the inset of Map 1 in Appendix A for location). The Borough's current population is 82,840 making it the second-largest population center in the state (ADCED, 2002). Communities located within the Borough include: College, Eielson Air Force Base, Ester, Fairbanks, Fox, Harding Lake, Moose Creek, North Pole, Pleasant Valley, Salcha, and Two Rivers.

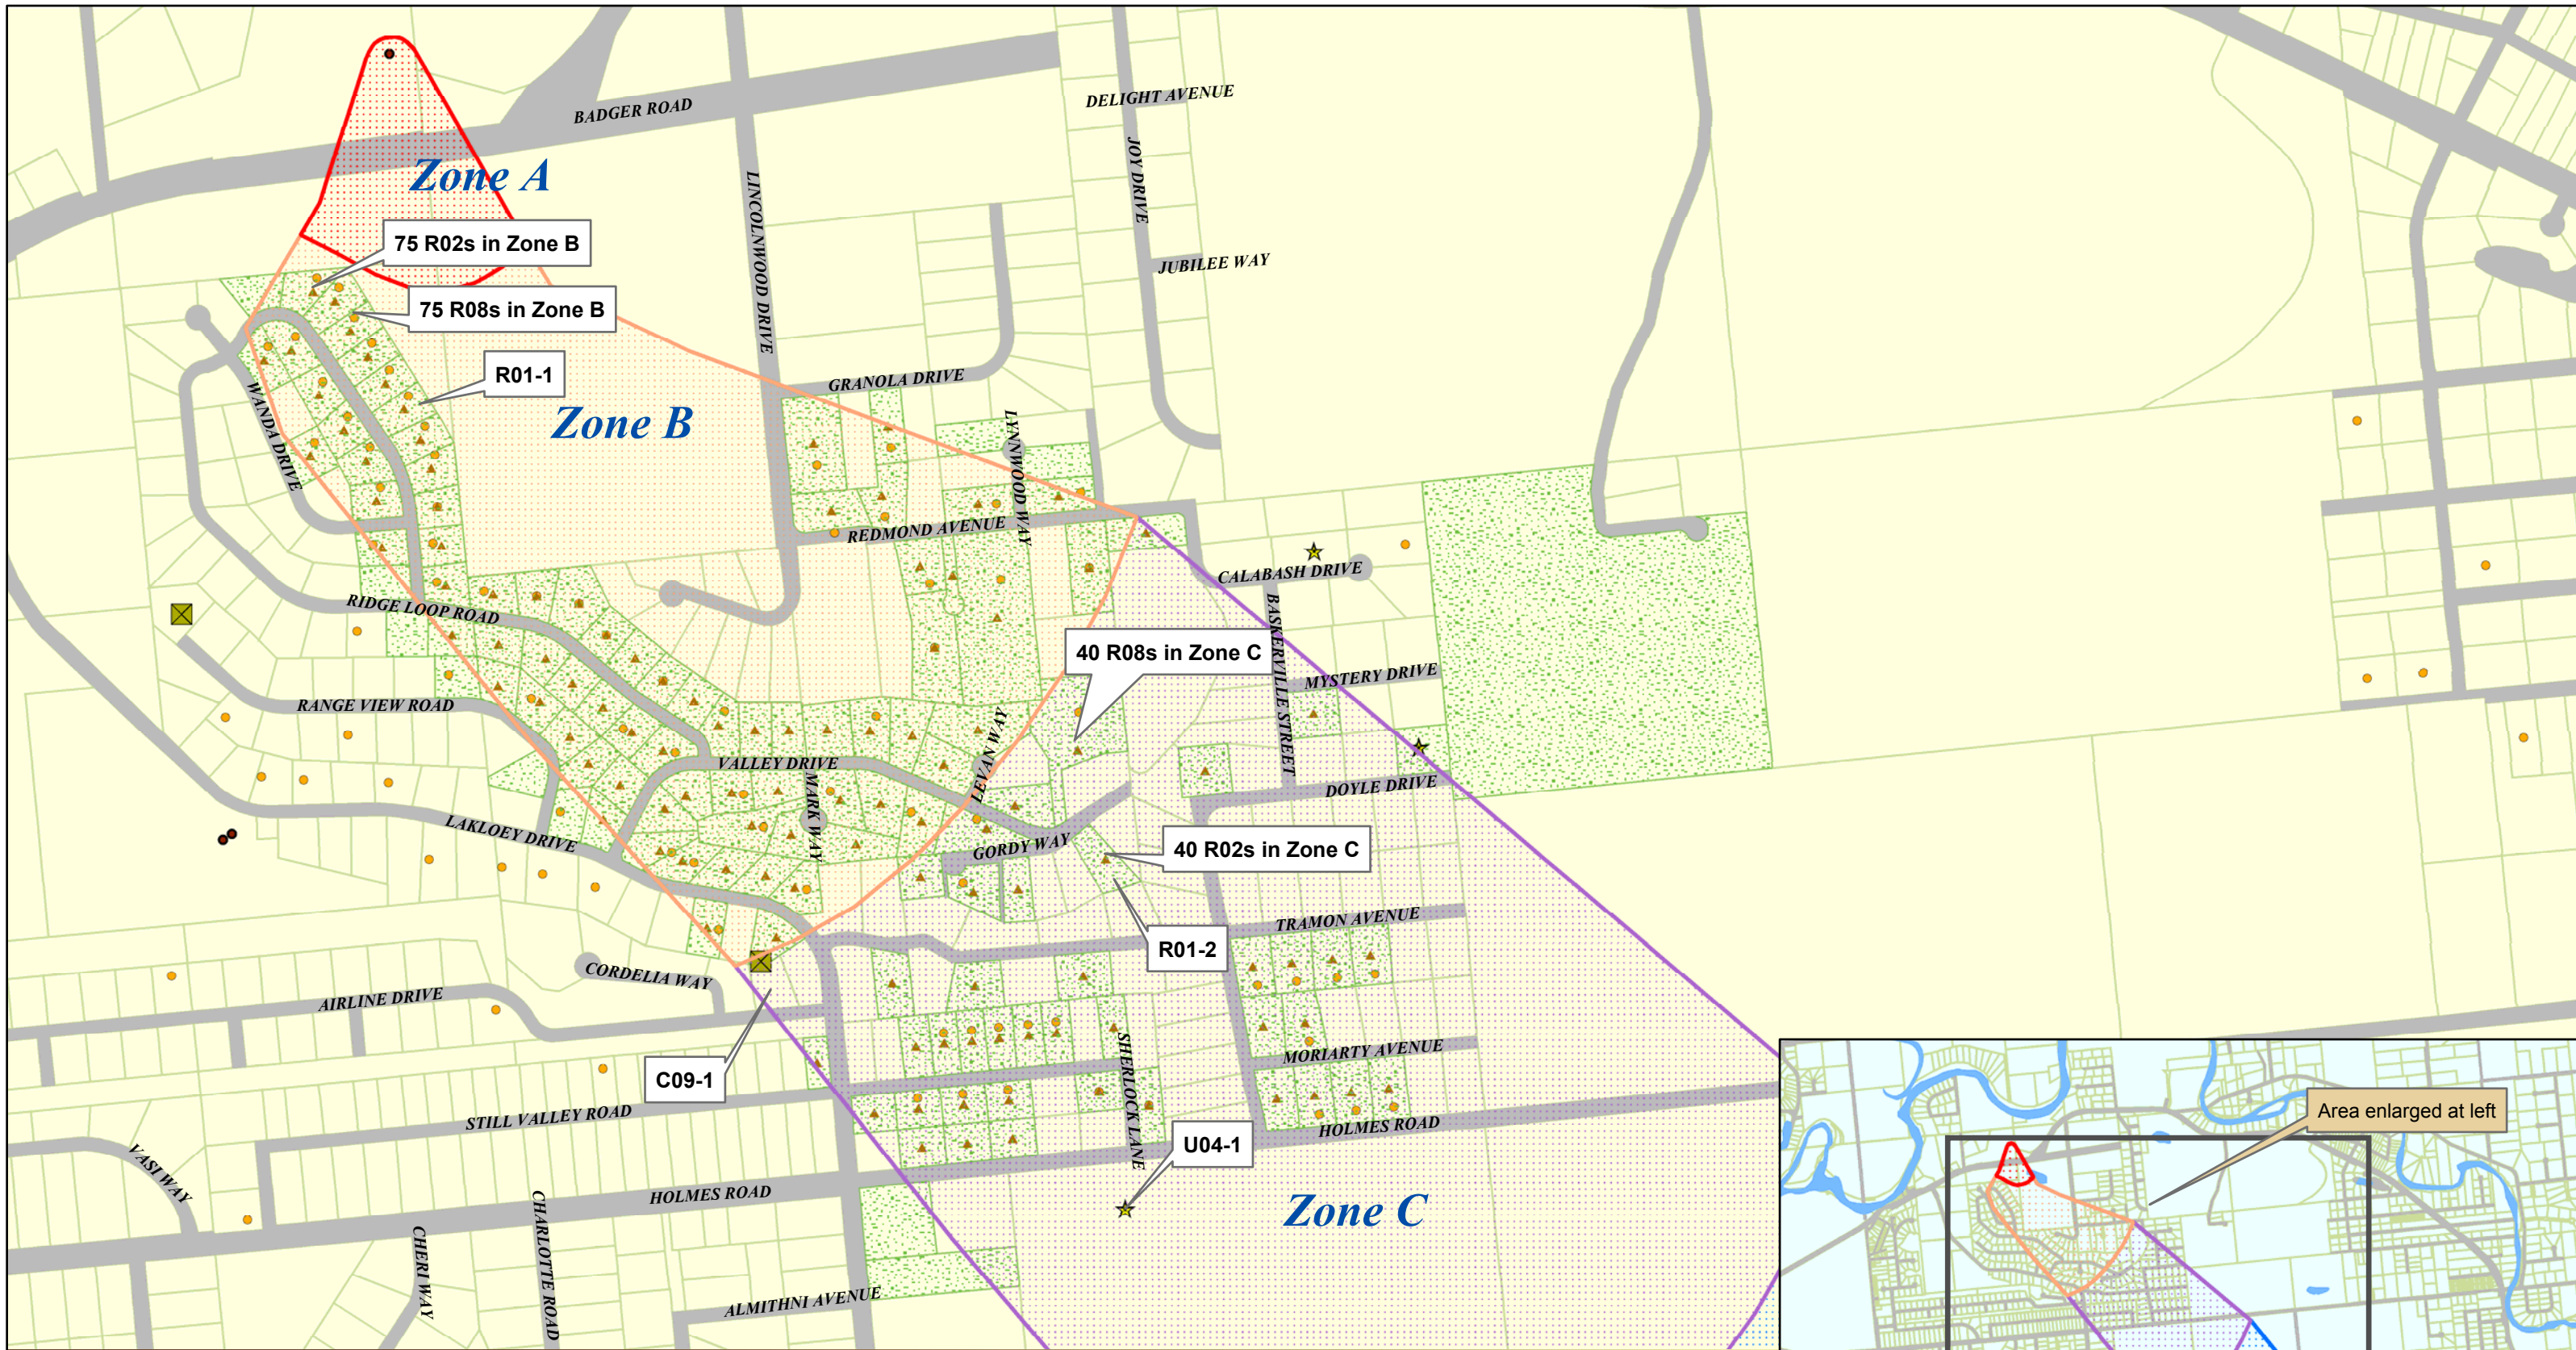
**Map 2: Riverview RV Park Potential Contaminant Sources**

### **Riverview RV Park Drinking Water Protection Area and Potential and Existing Contaminant Sources (Map 2)**

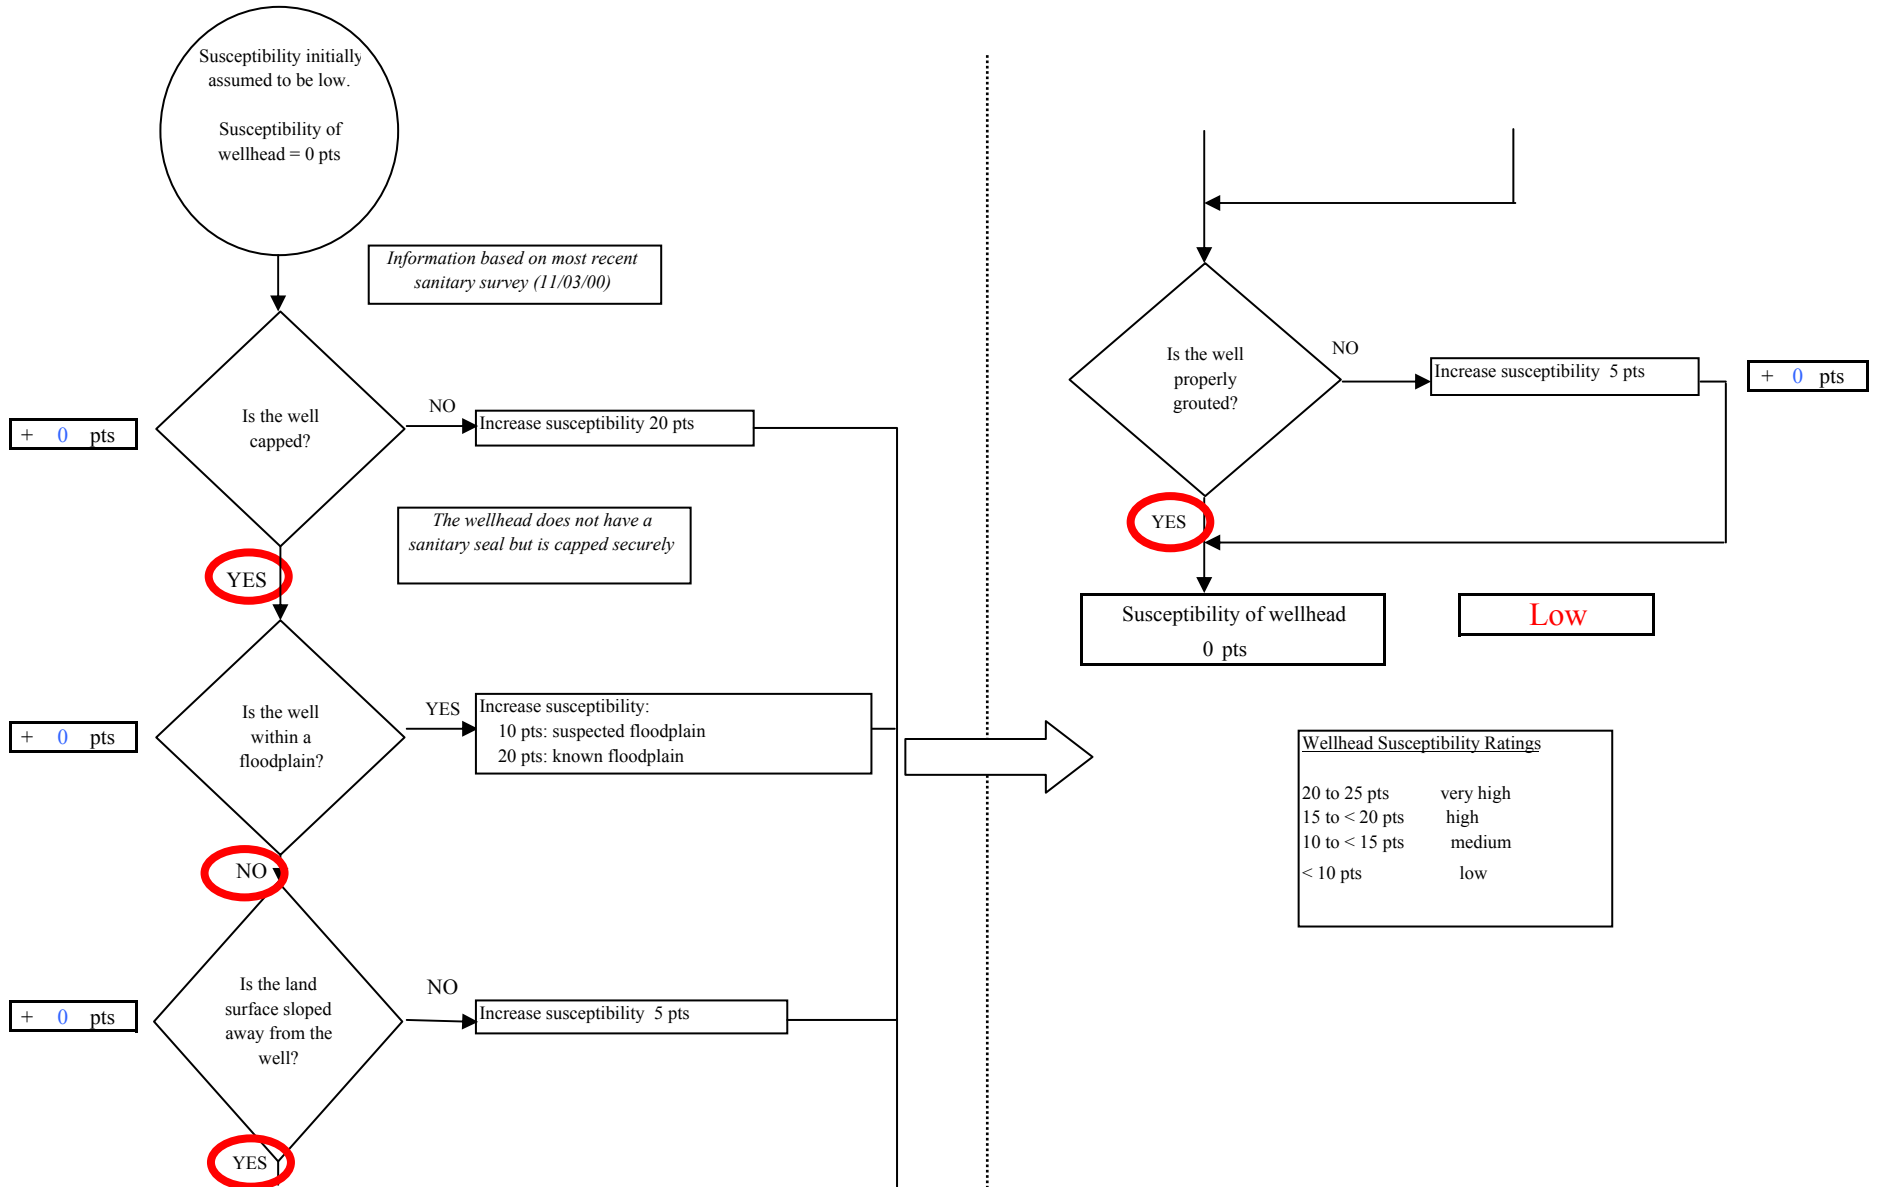
**Chart 1. Susceptibility of the wellhead - Riverview RV Park**

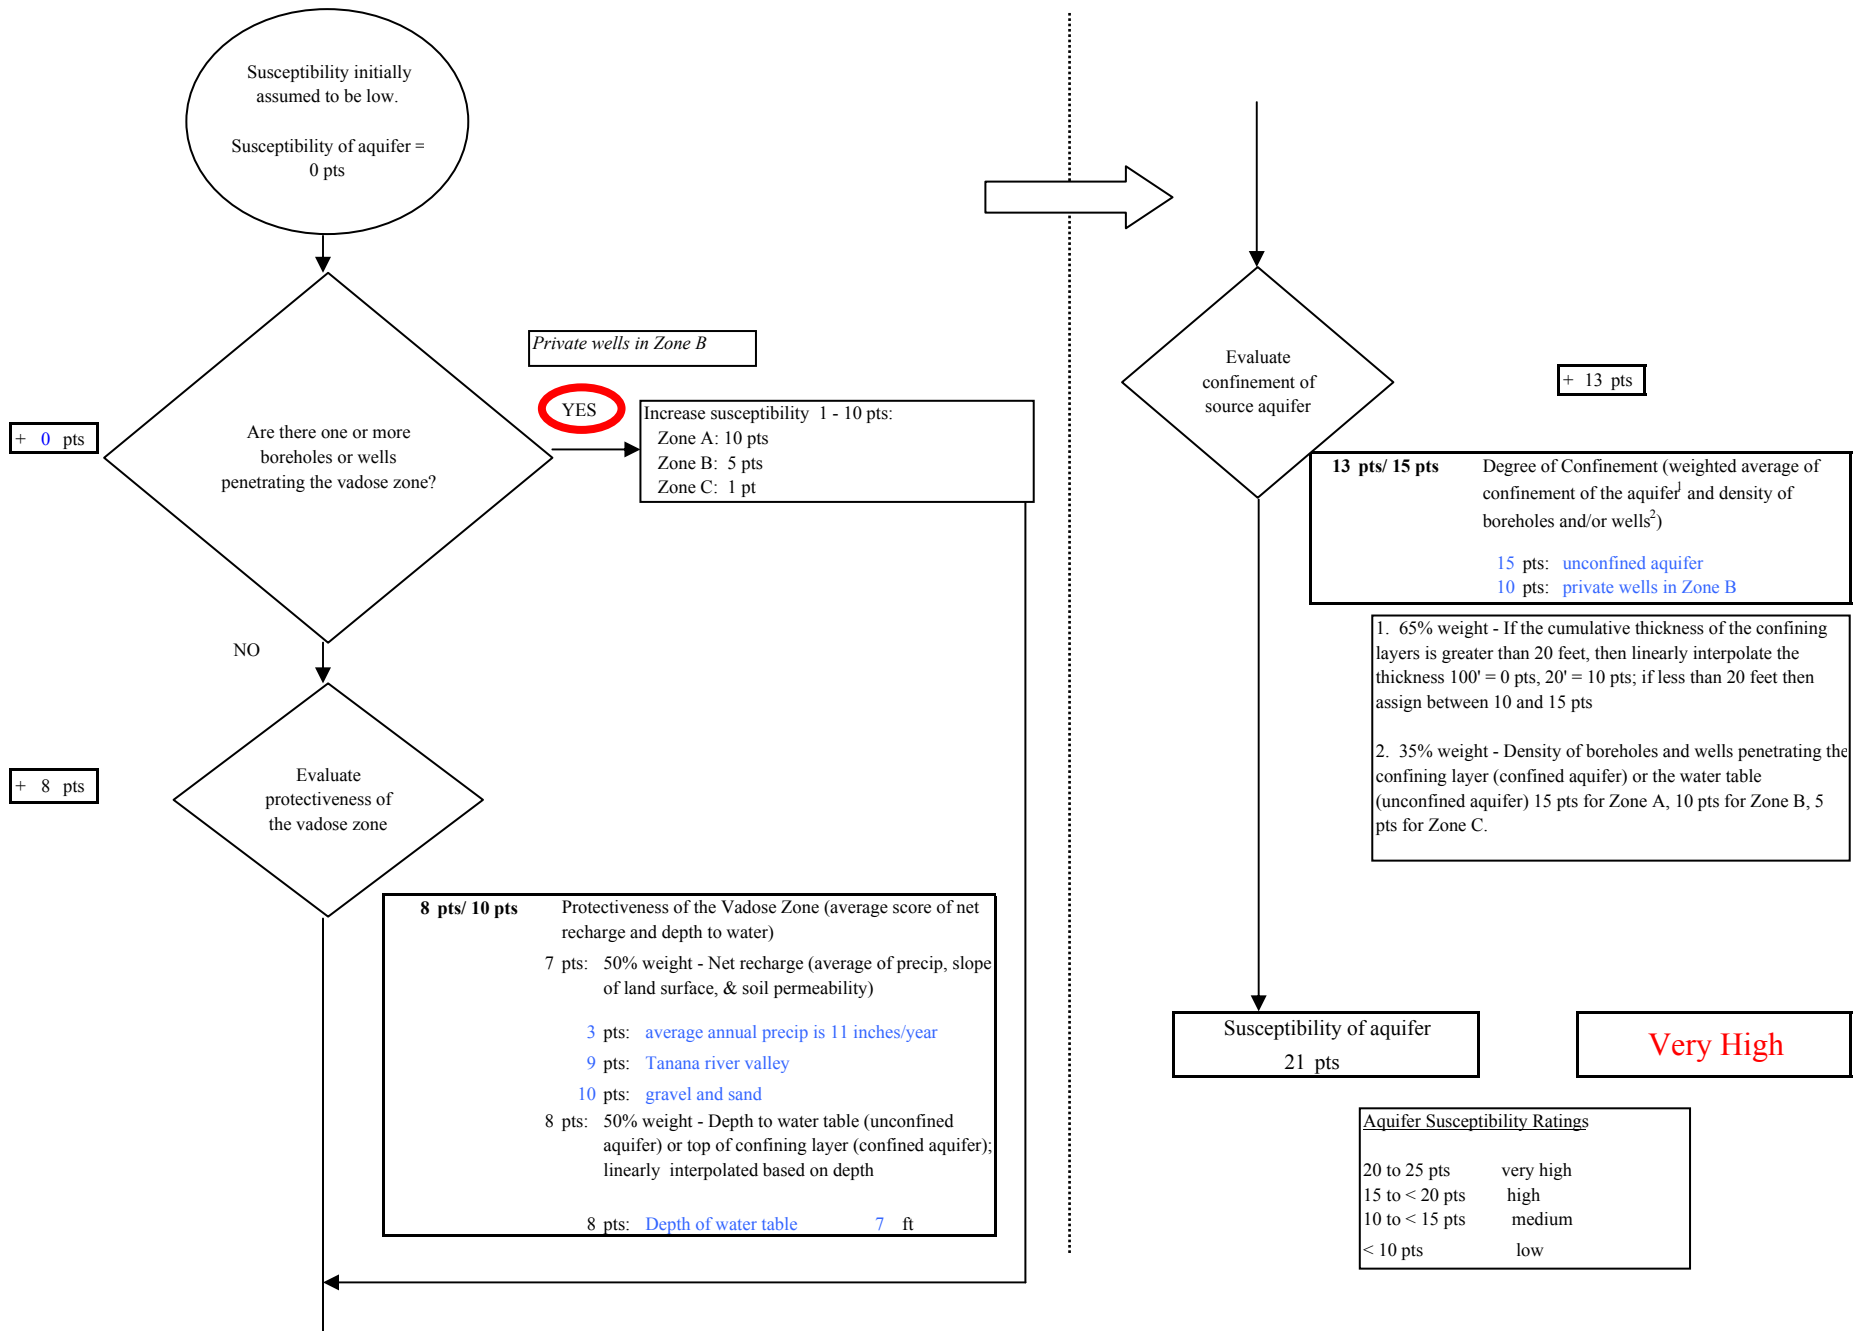
**Chart 2. Susceptibility of the aquifer - Riverview RV Park**

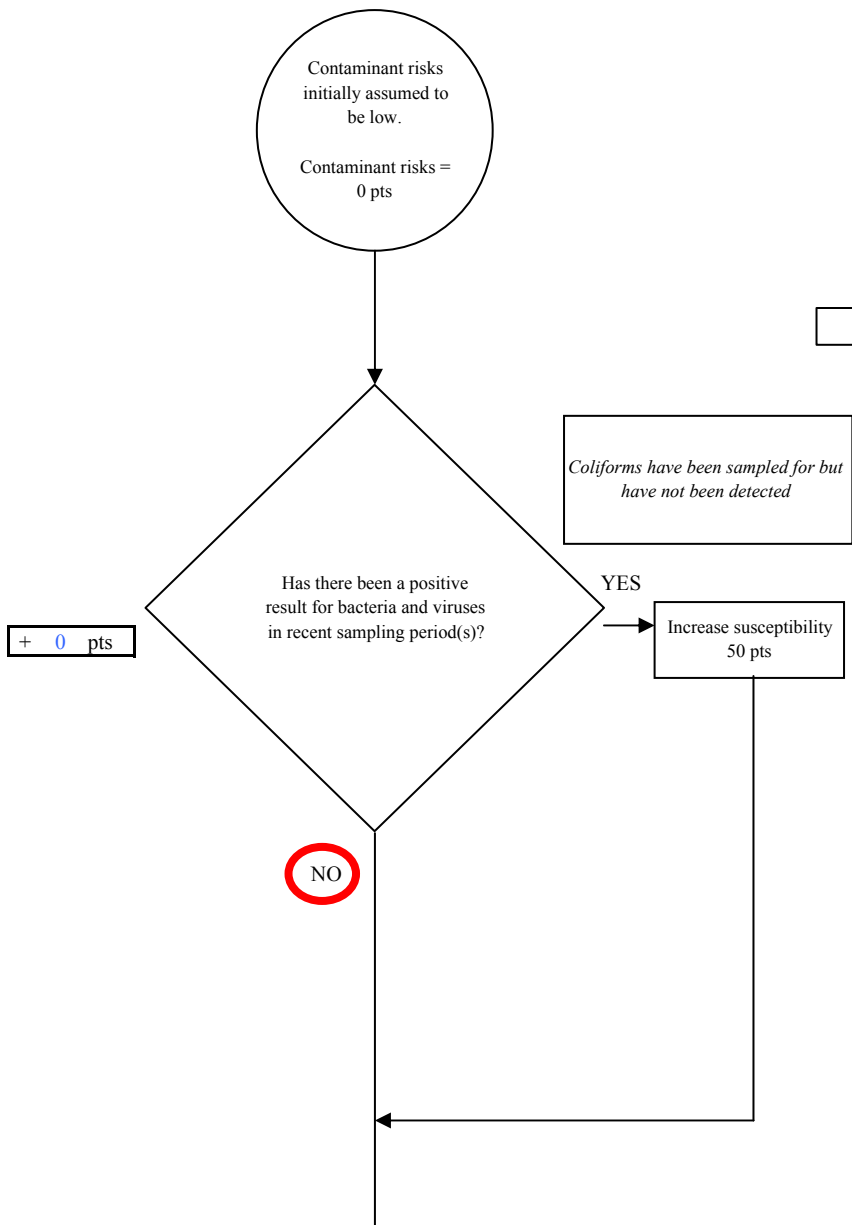
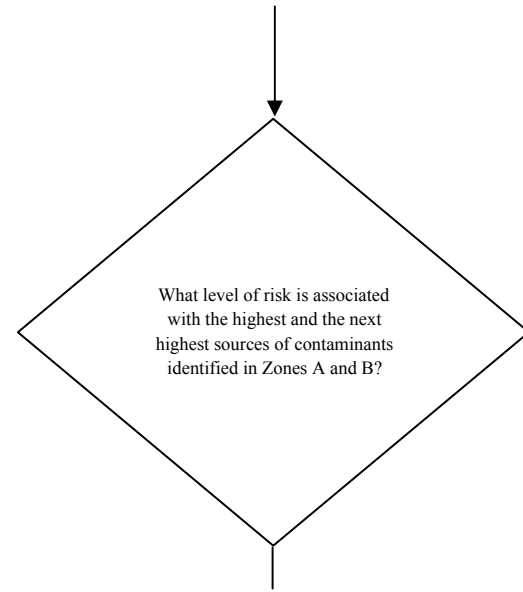
**Chart 3. Contaminant risks for Riverview RV Park - Bacteria & Viruses**

Risk Rankings for Contaminant Sources Identified in Zones A and B			
	Zone A	Zone B	Total
Very High(s)	0	0	0
High(s)	0	0	0
Medium(s)	0	0	0
Low(s)	1	10	11

Note: Septic systems, sewerlines, and roads are each assigned a risk ranking for each individual contaminant source in the CSI. The VA, however, counts these contaminant sources as a group and assigns a calculated number of either "lows" or "mediums" based on the density.

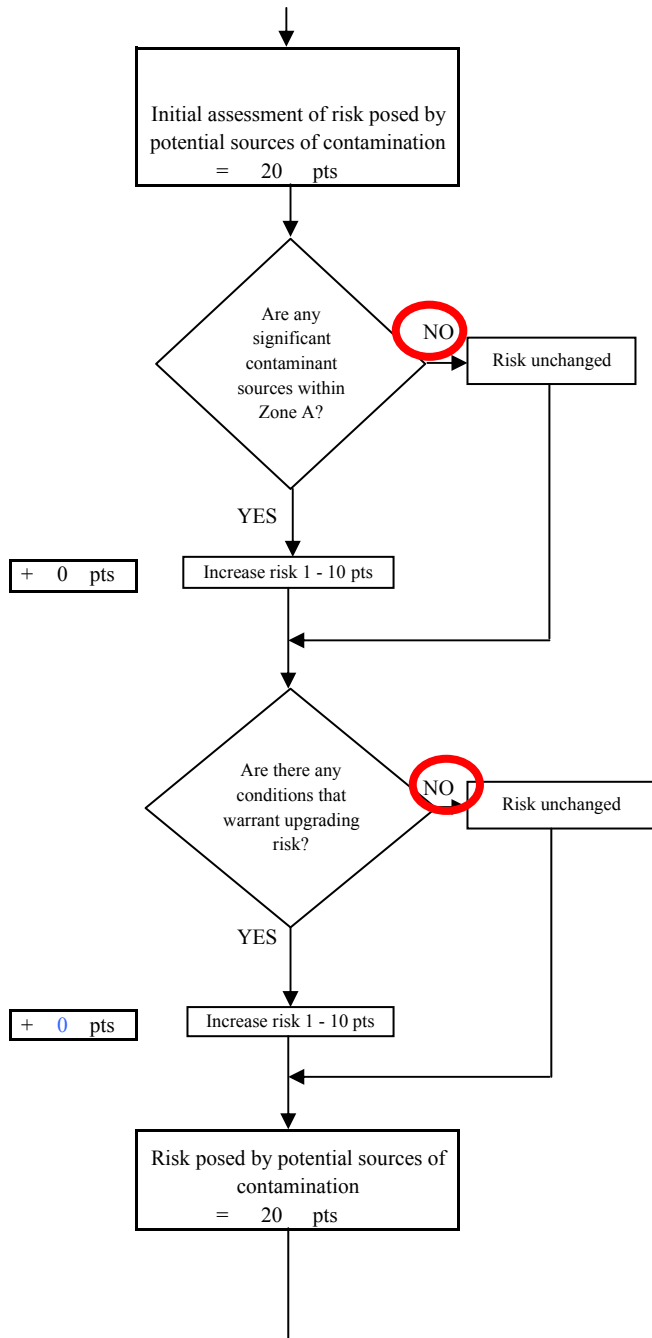
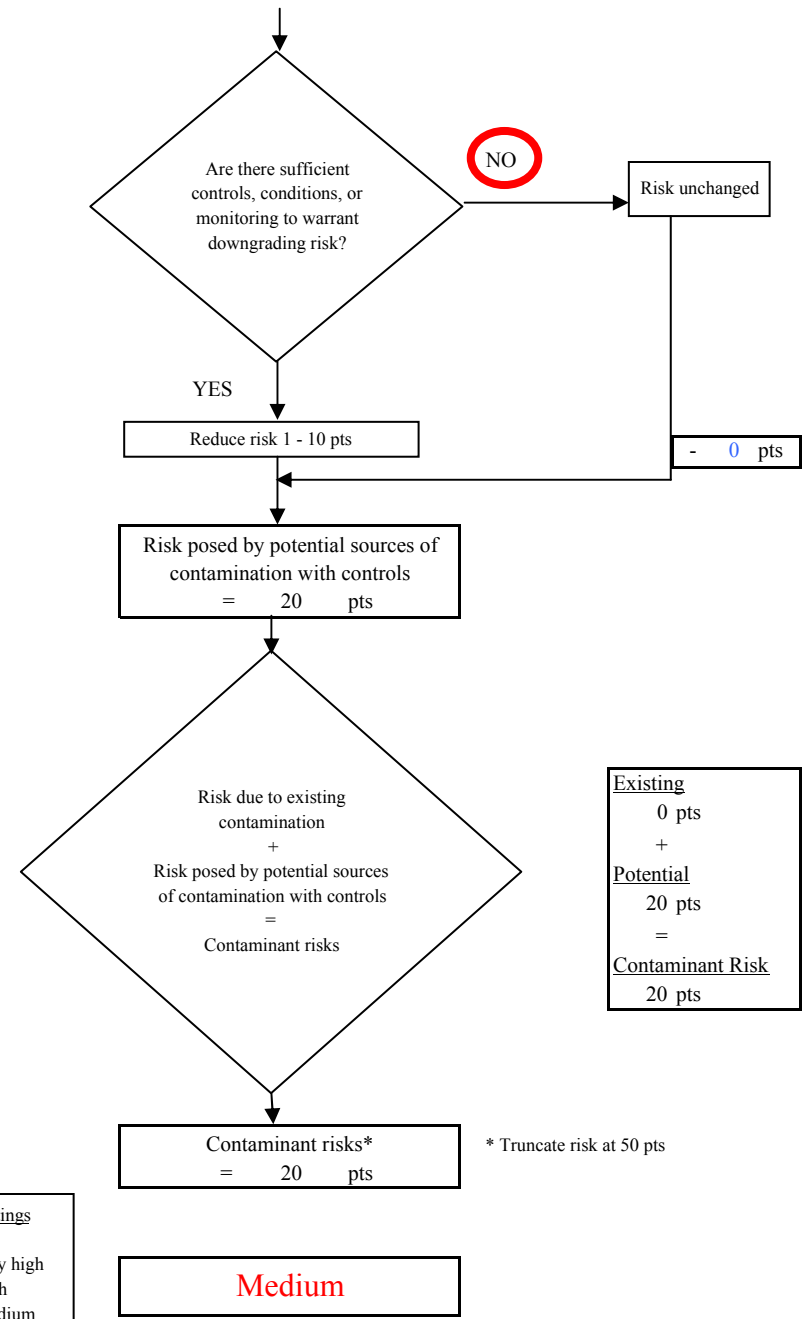
**Chart 3. Contaminant risks for Riverview RV Park - Bacteria & Viruses**

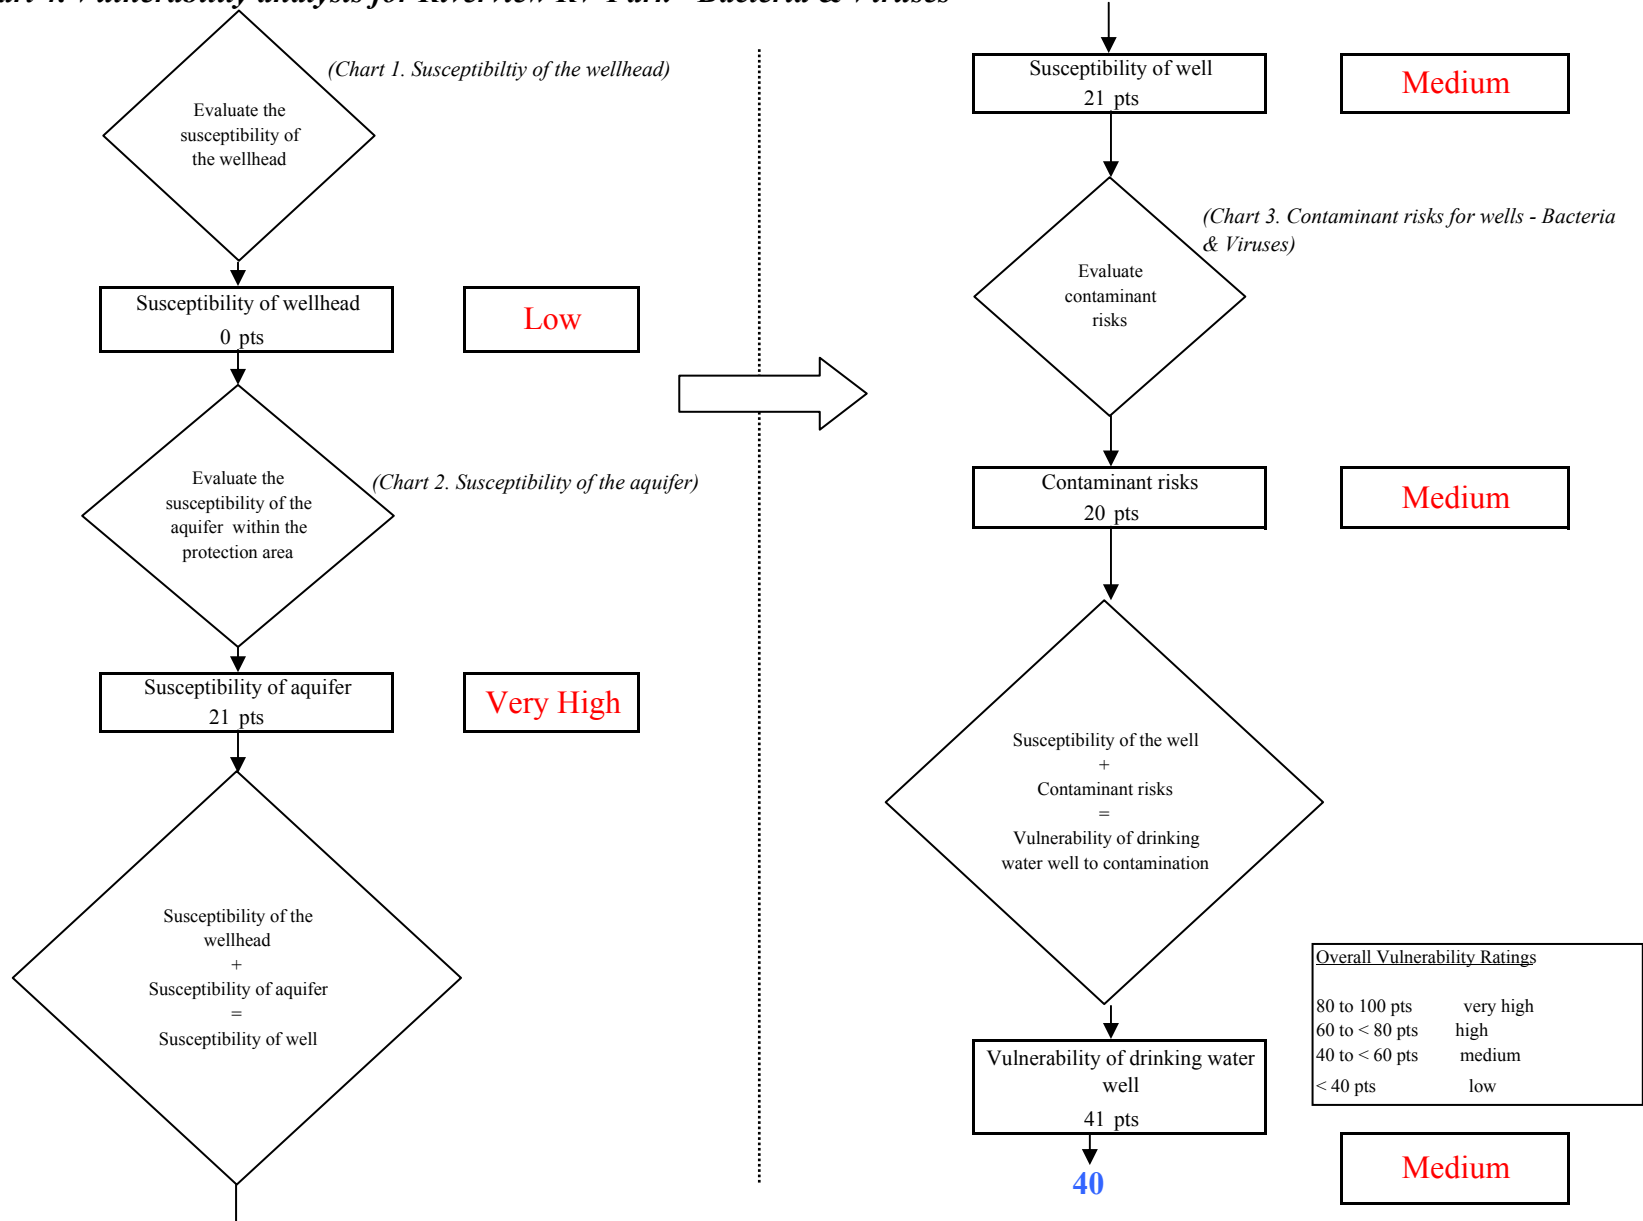
**Chart 4. Vulnerability analysis for Riverview RV Park - Bacteria & Viruses**

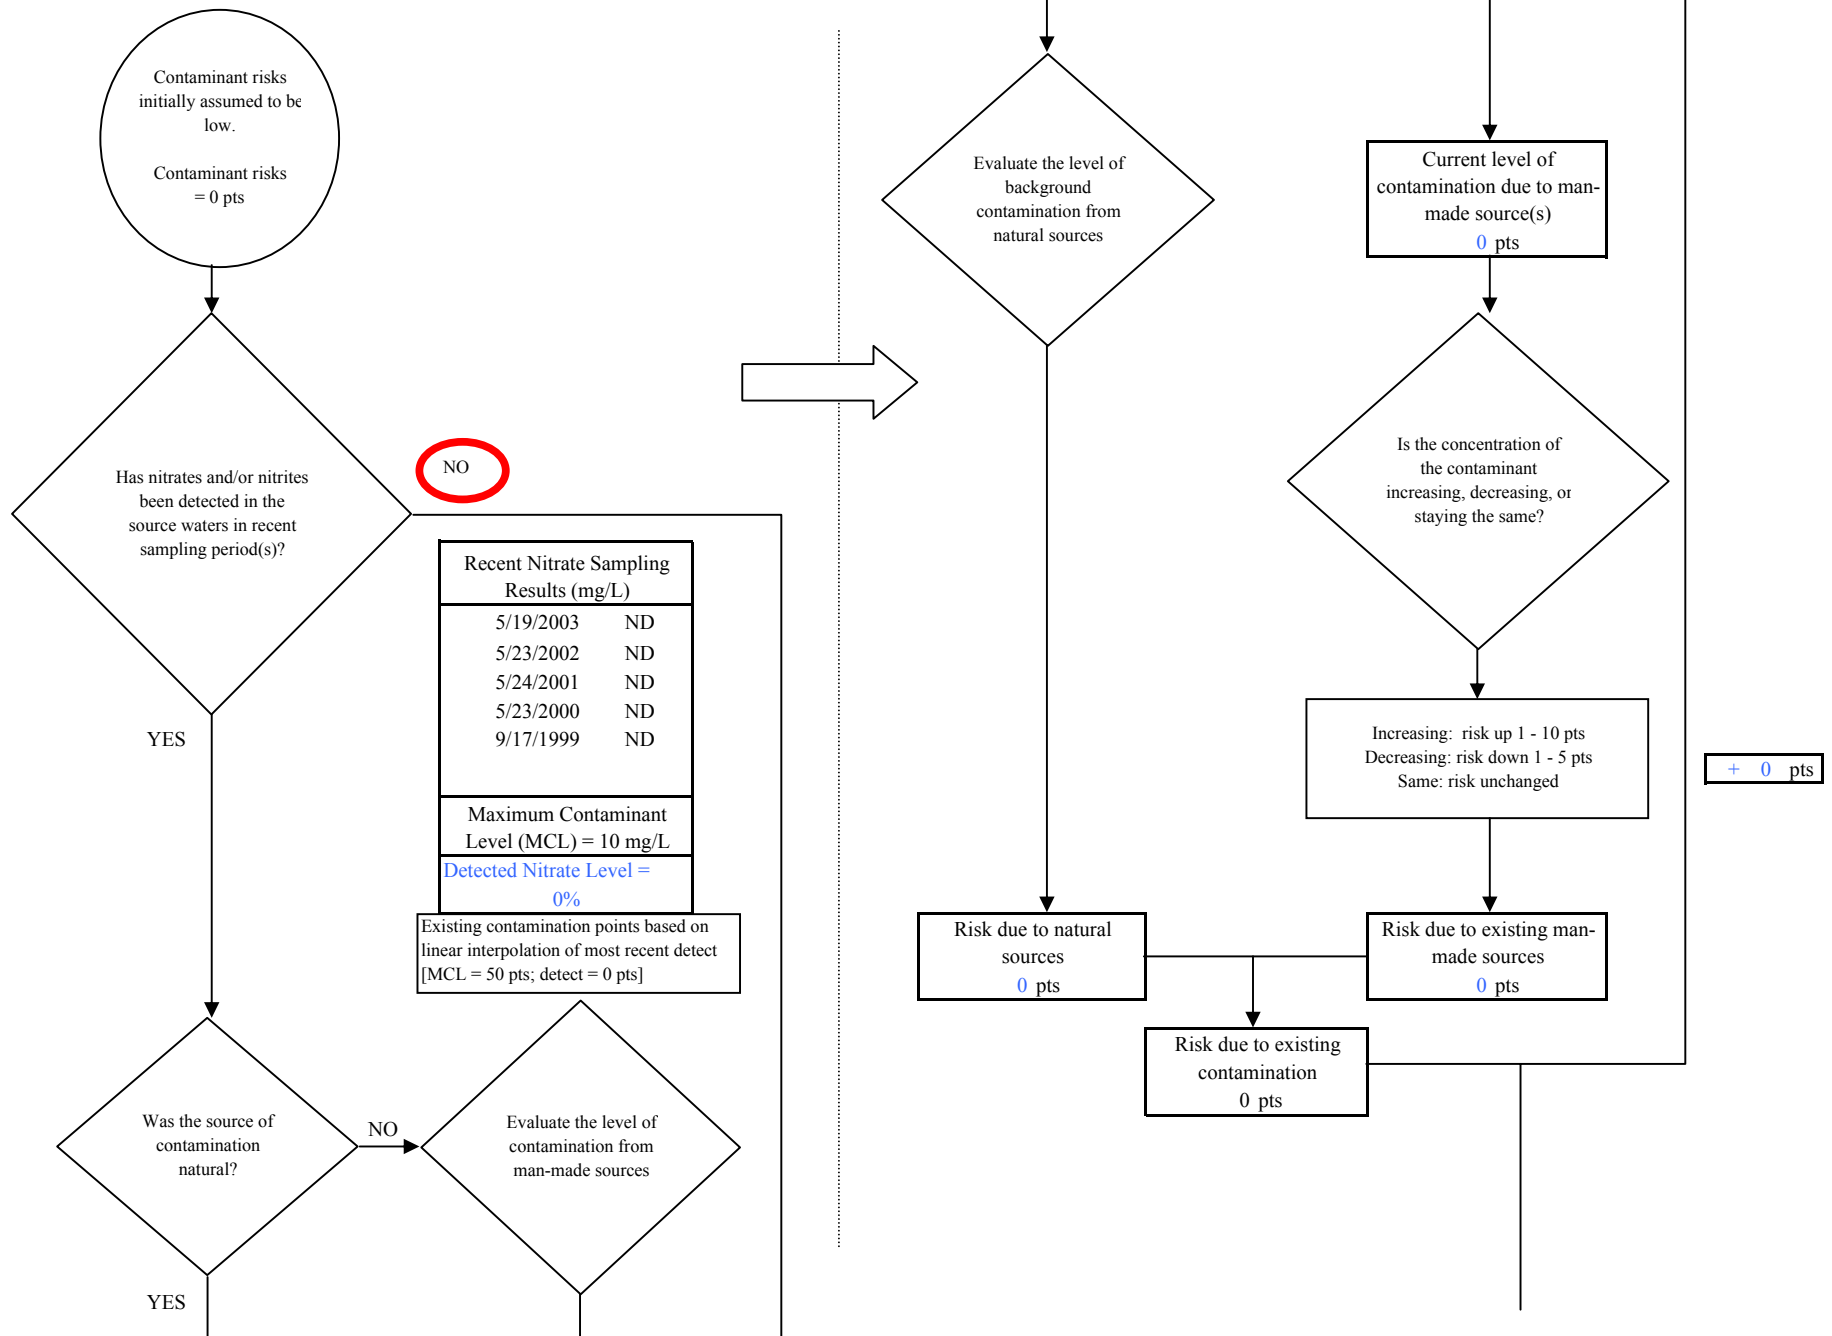
Chart 5. Contaminant risks for Riverview RV Park - Nitrates and Nitrites

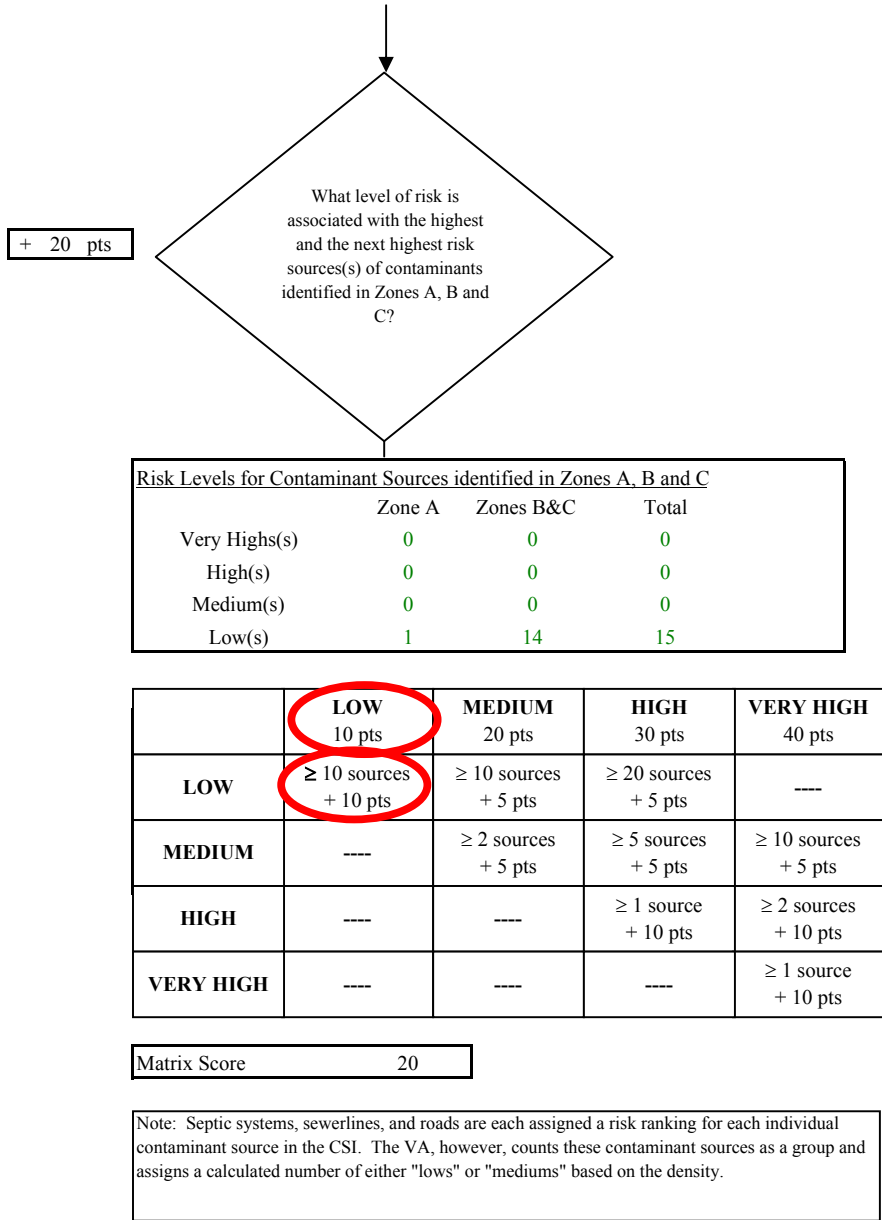
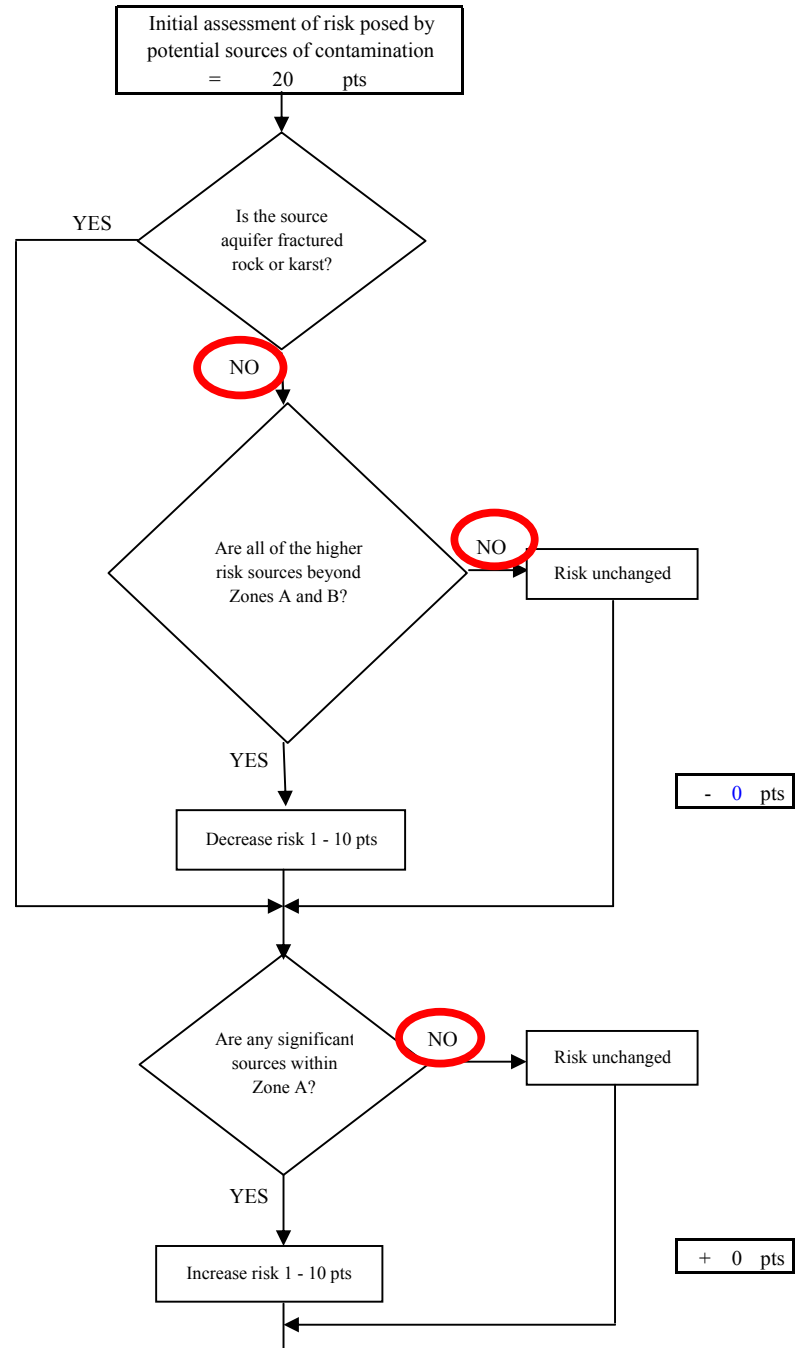
Chart 5. Contaminant risks for Riverview RV Park - Nitrates and Nitrites
