# Source Water Assessment

A Hydrogeologic Susceptibility and  
Vulnerability Assessment for  
Riverview RV Park Drinking Water  
System,

Fairbanks area, Alaska

PWSID 313306

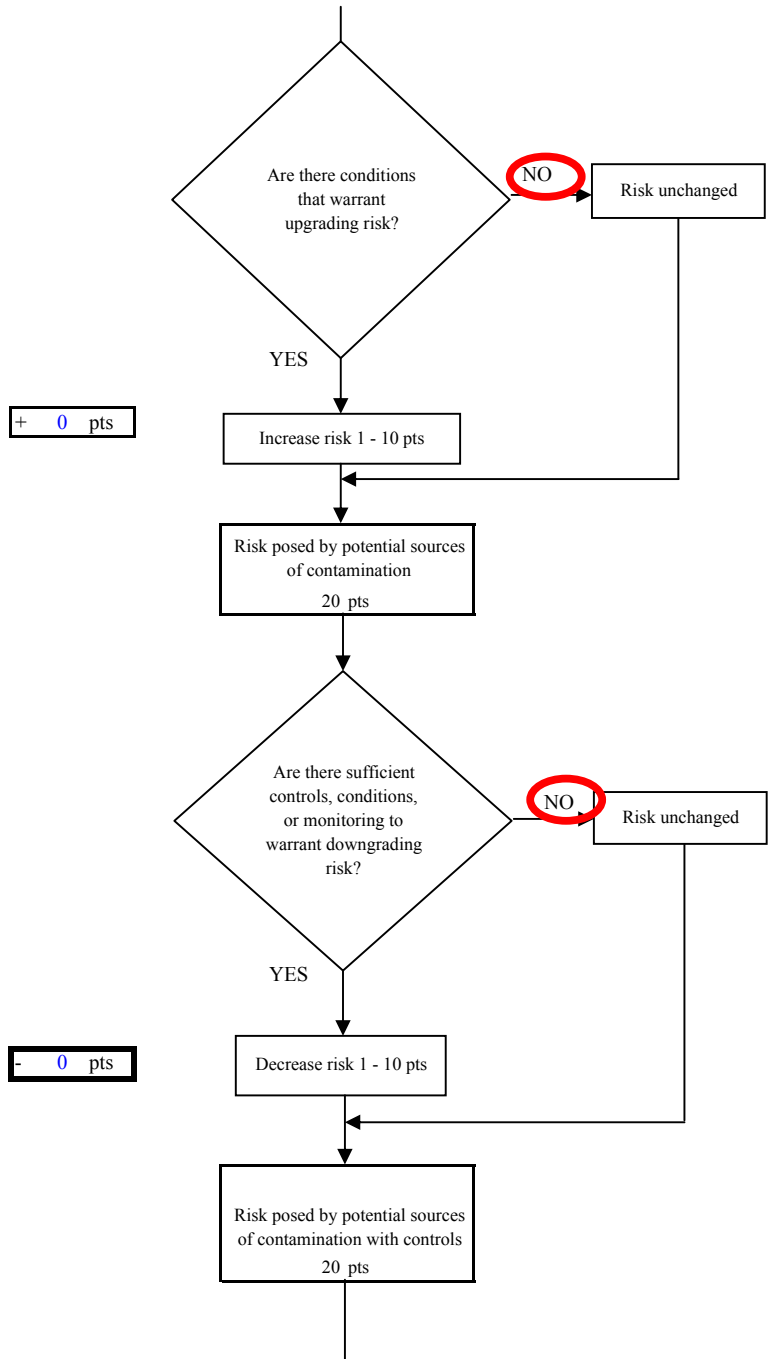
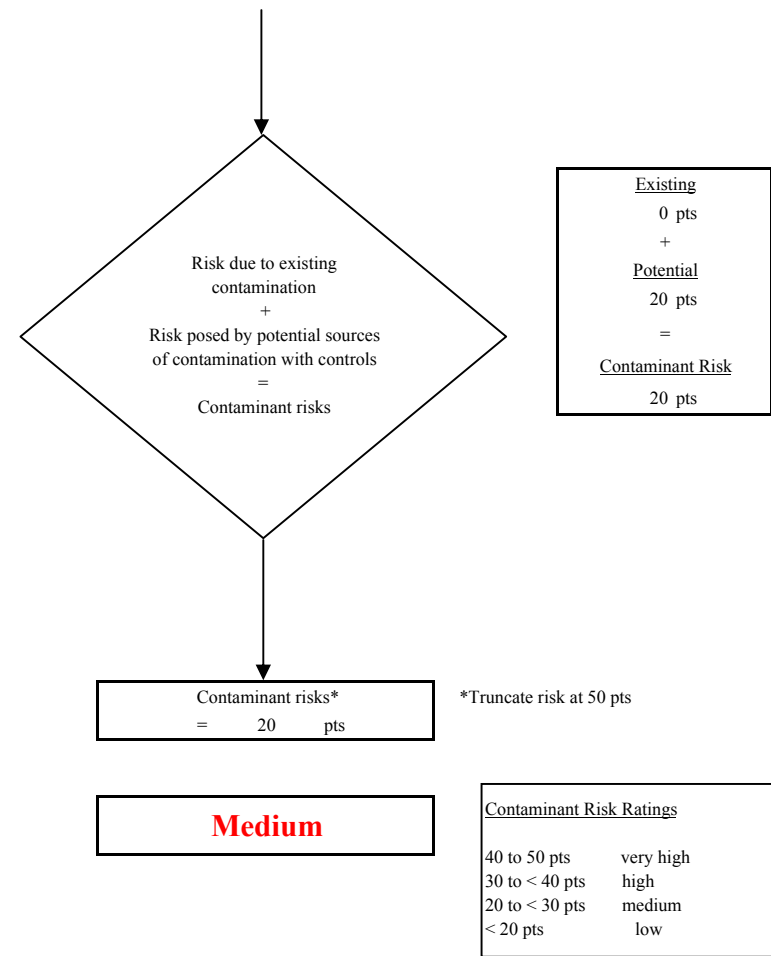
**Chart 5. Contaminant risks for Riverview RV Park - Nitrates and Nitrites**

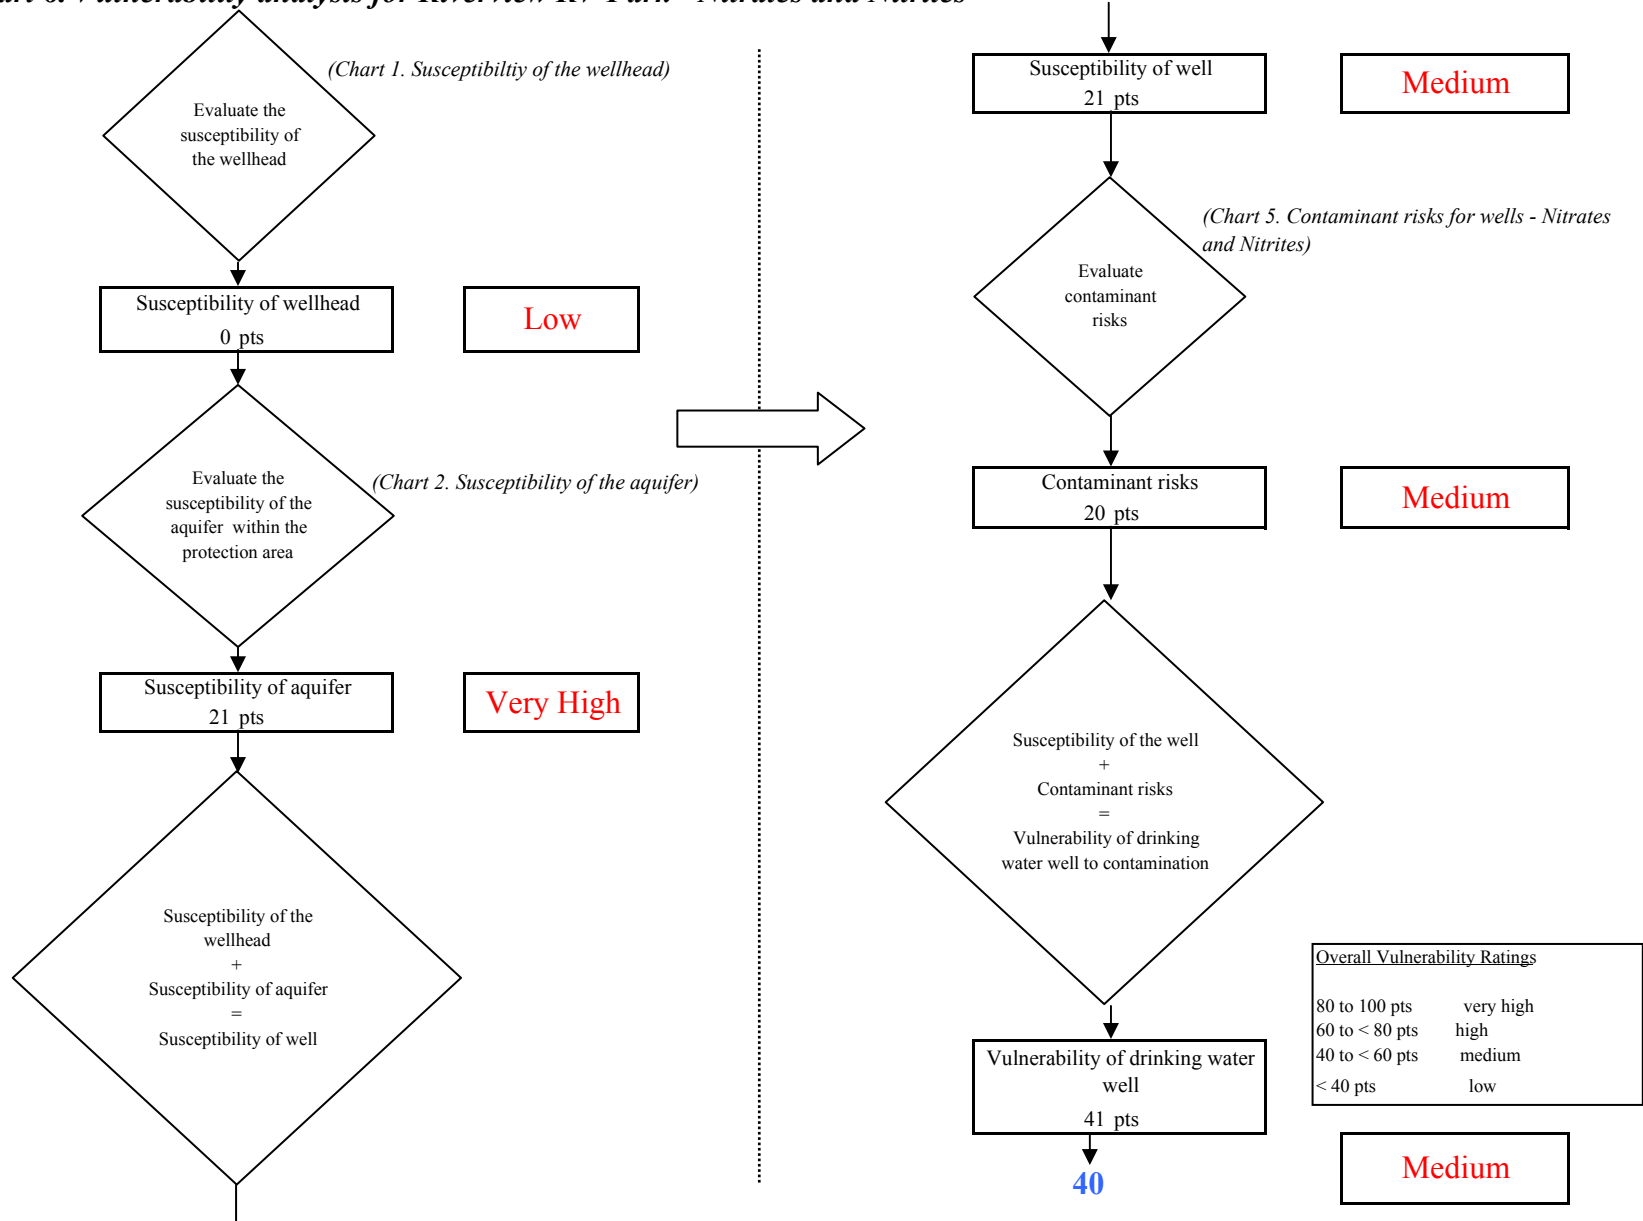
**Chart 6. Vulnerability analysis for Riverview RV Park - Nitrates and Nitrites**

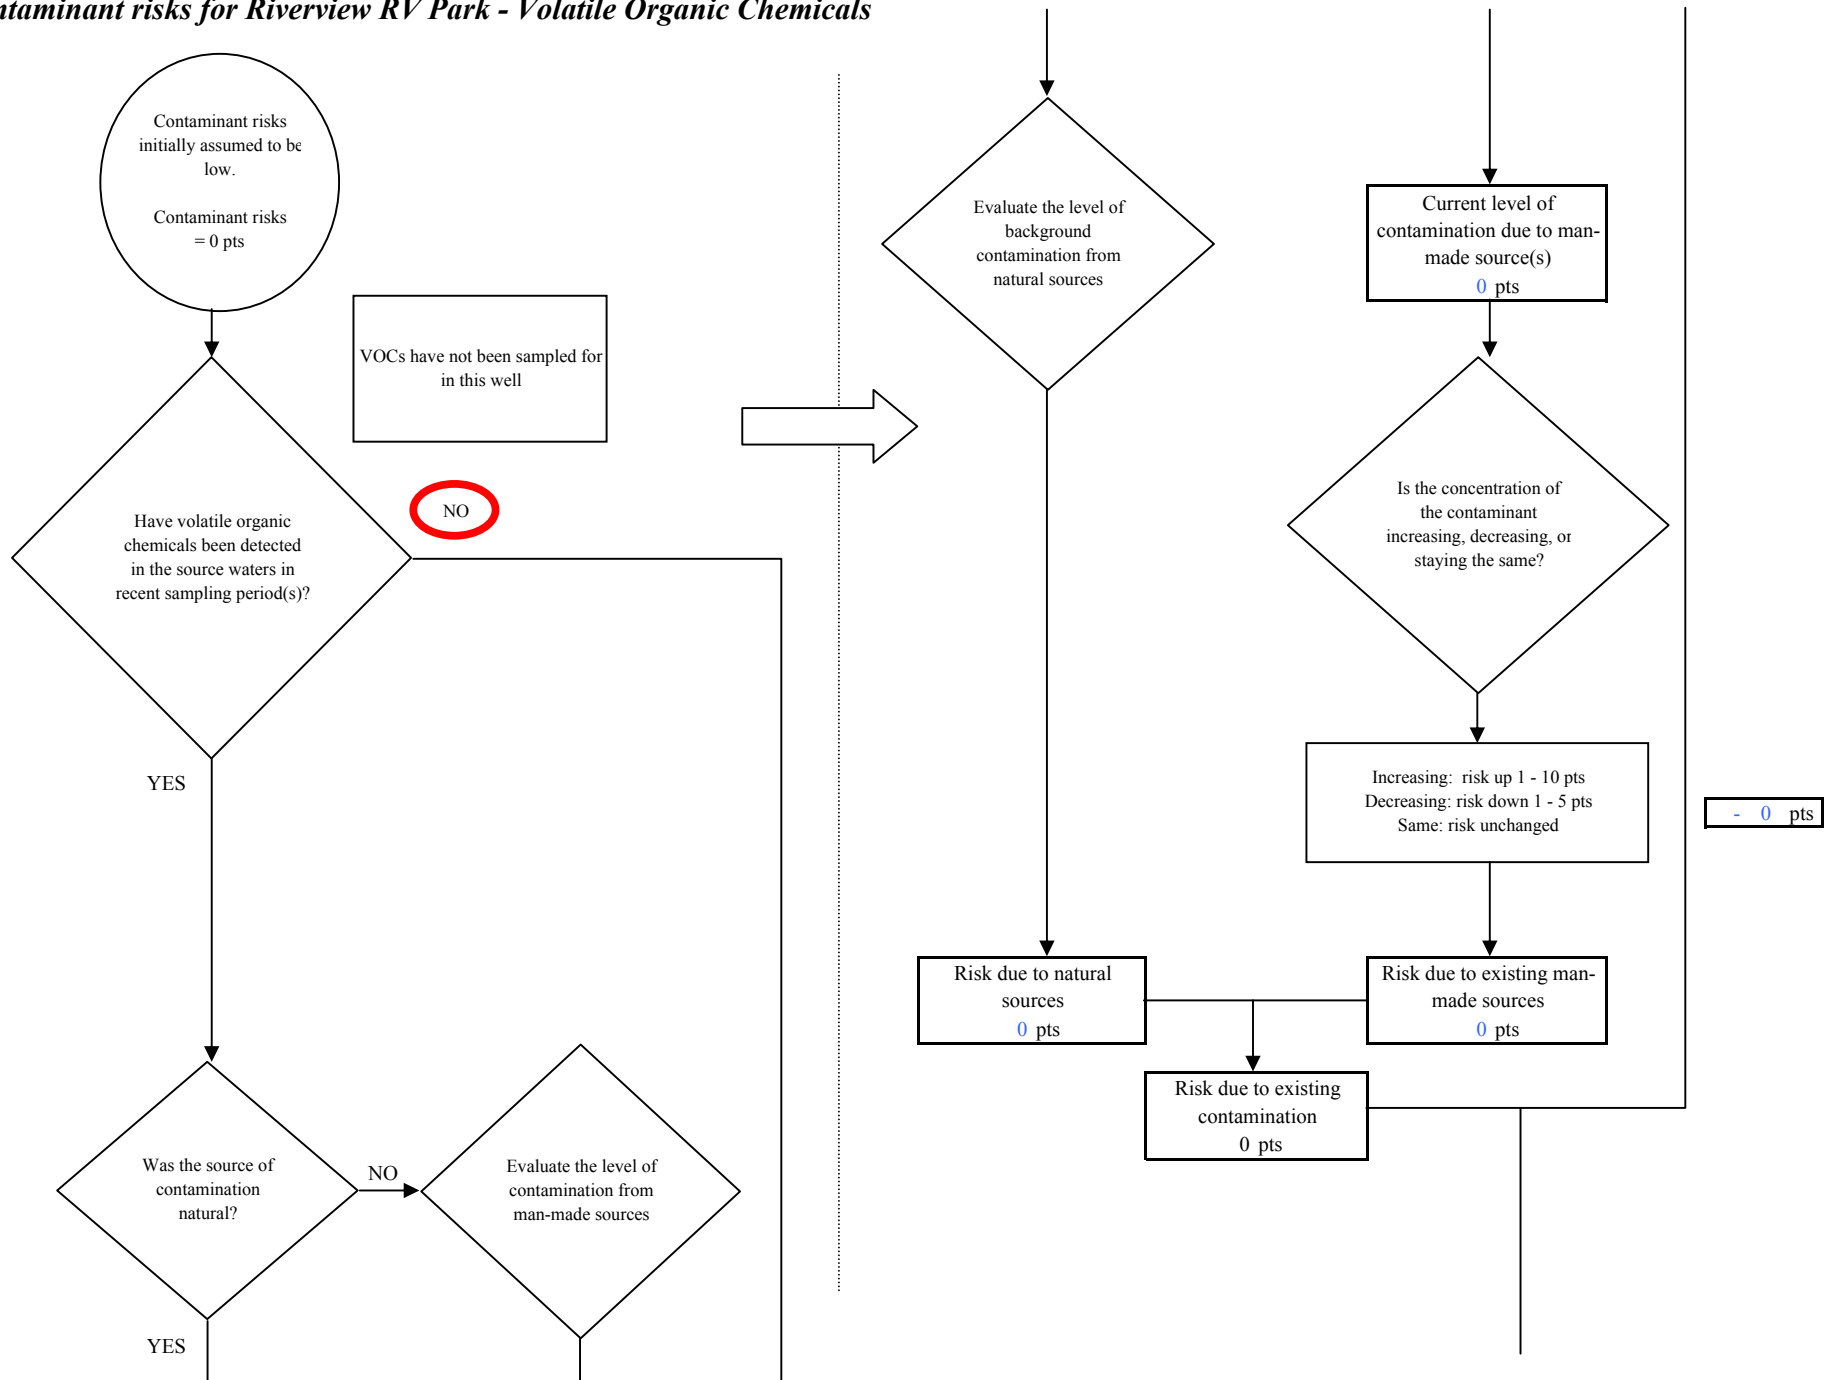
**Chart 7. Contaminant risks for Riverview RV Park - Volatile Organic Chemicals**

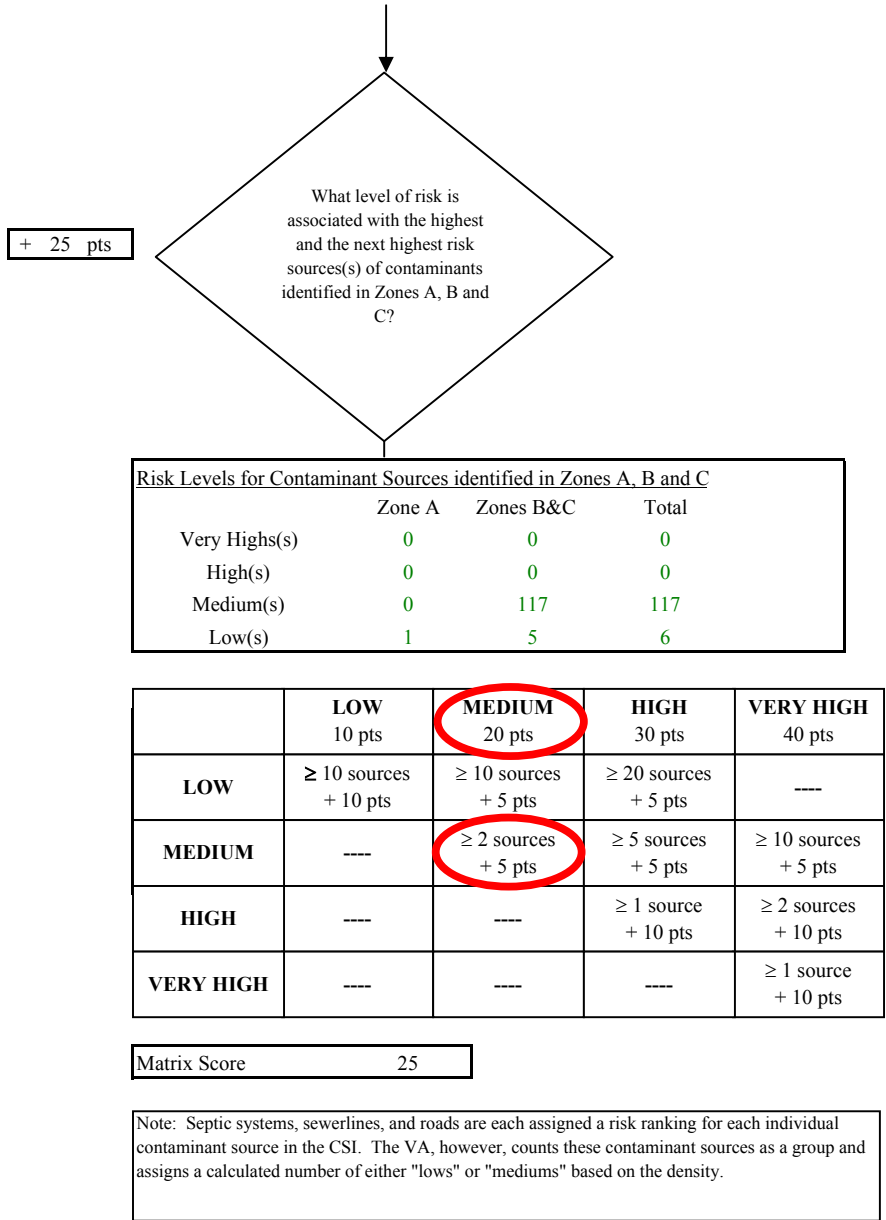
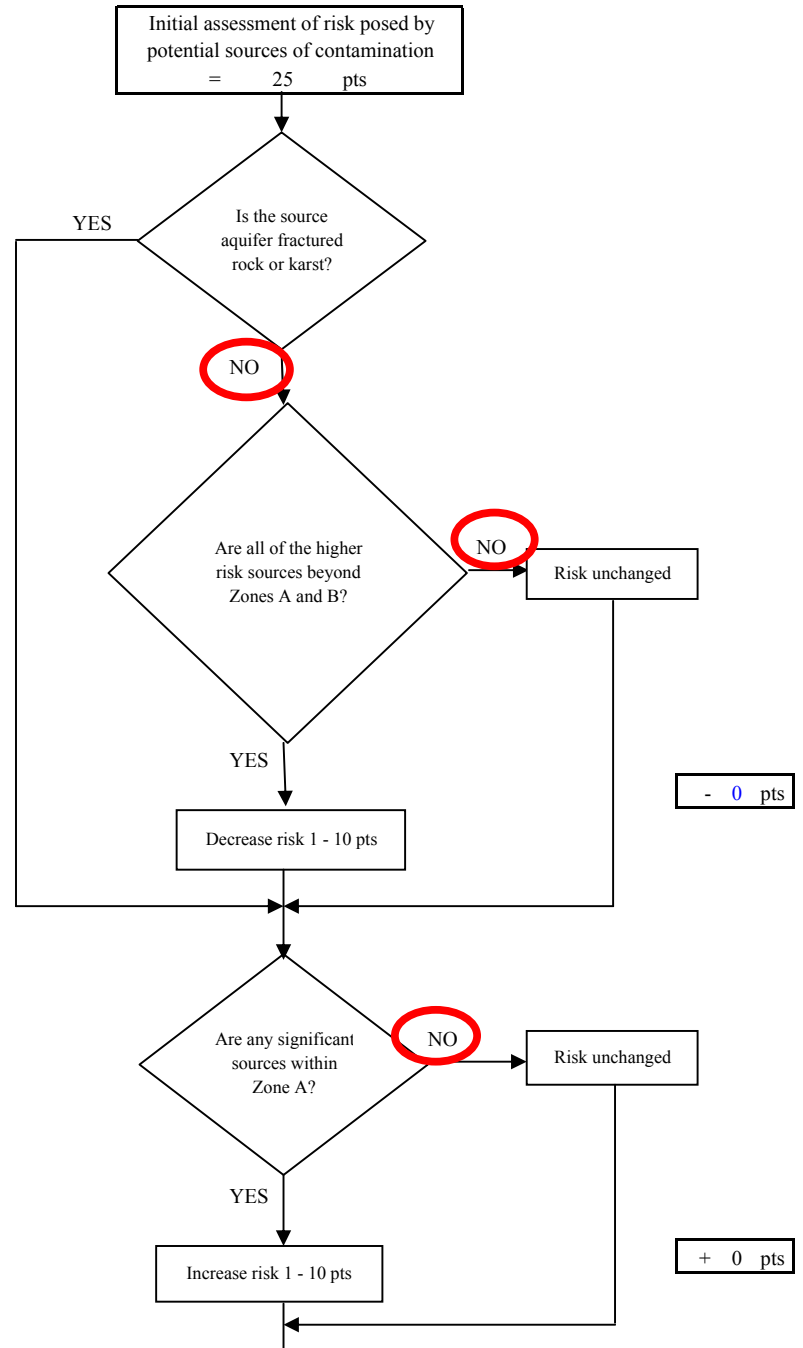
**Chart 7. Contaminant risks for Riverview RV Park - Volatile Organic Chemicals**

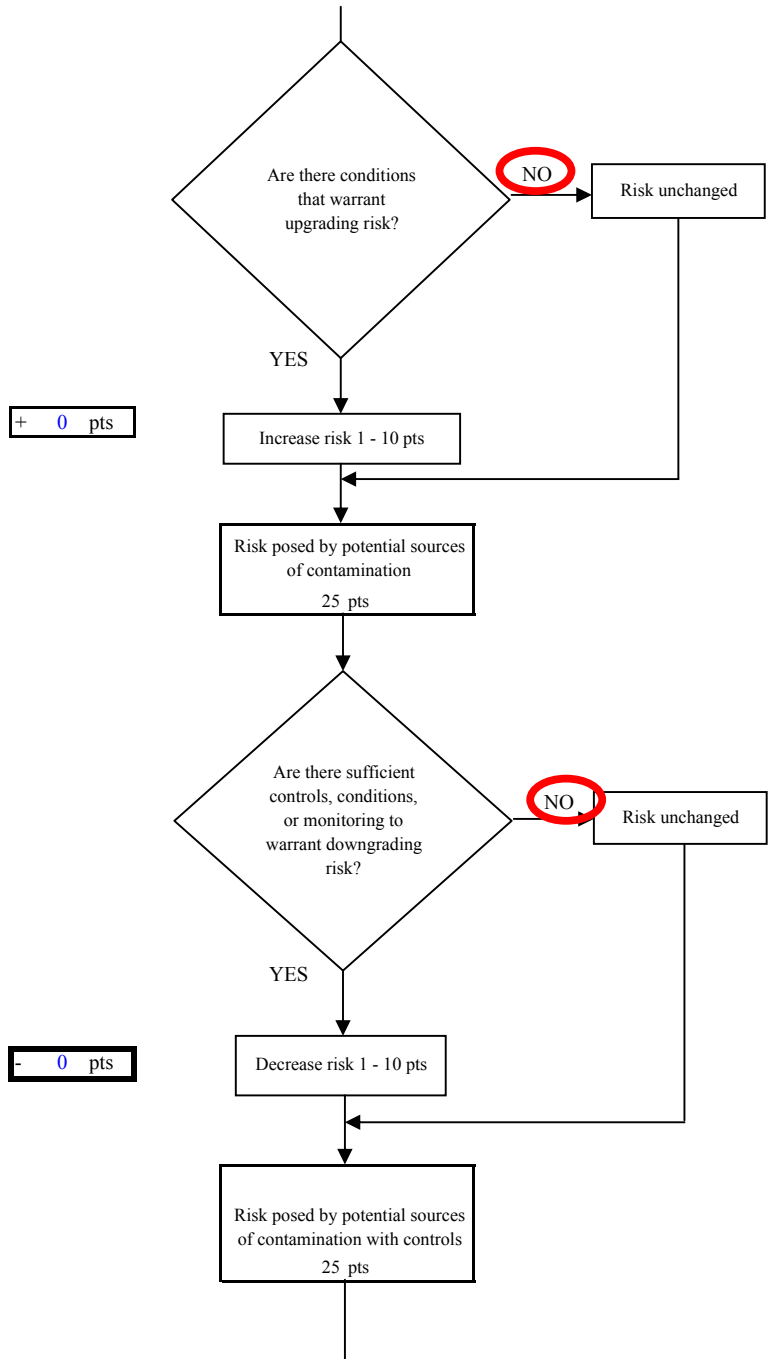
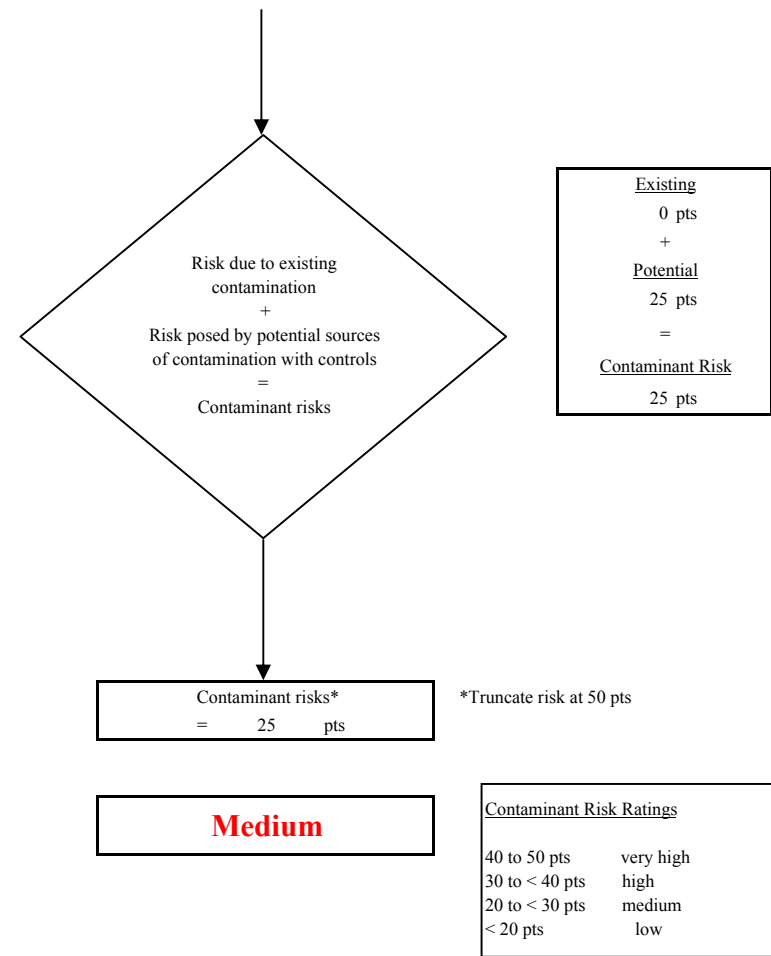
**Chart 7. Contaminant risks for Riverview RV Park - Volatile Organic Chemicals**

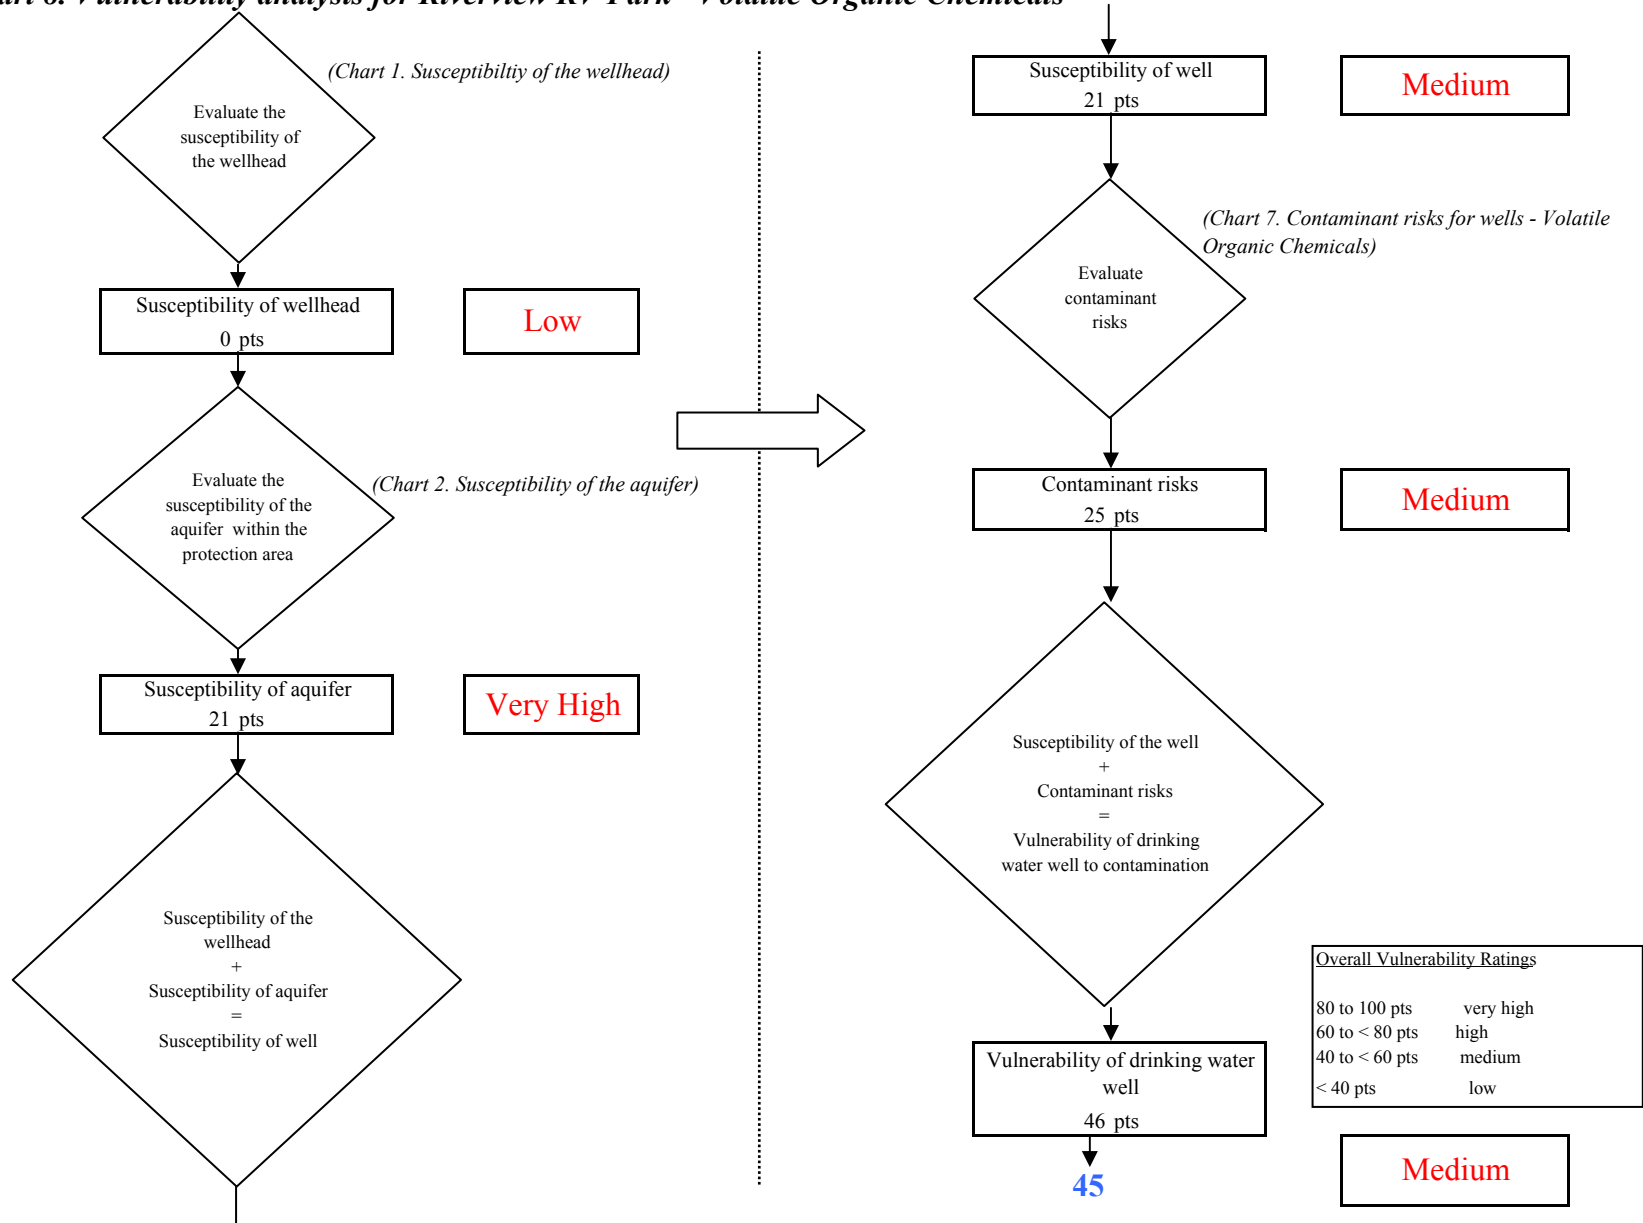
**Chart 8. Vulnerability analysis for Riverview RV Park - Volatile Organic Chemicals**
