Hydrogeologic Susceptibility and Vulnerability Assessment for Girdwood Station Mall Public Drinking Water Well, Girdwood, Alaska

DRINKING WATER PROTECTION PROGRAM REPORT 3

August 2000

By MICHAEL. J. CROTTEAU

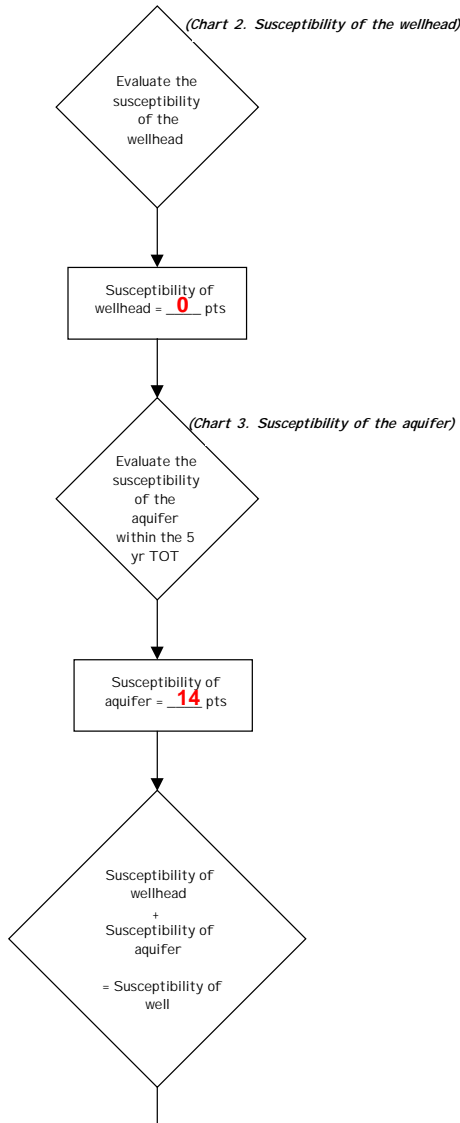
Chart 1. Vulnerability analysis for Bacteria & Viruses – Girdwood Station Mall

Appendix D contains four charts, which together form the ‘Vulnerability Analysis’ for a source water assessment for a public drinking water source. Chart 1 contains the ‘Vulnerability Analysis for bacteria and viruses’. Chart 2 analyzes the ‘Susceptibility of the Wellhead’ to contamination by looking at the construction of the well and its surrounding area. Chart 3 analyzes the ‘Susceptibility of the Aquifer’ to contamination by looking at the naturally occurring attributes of the water source and influences on the groundwater system that might lead to contamination. Lastly, Chart 4 analyzes ‘Contaminant Risks’ for the drinking water source with respect to bacteria and viruses. This portion of the analysis examines any existing or historical contamination that has been detected at the drinking water source through routine sampling. It also reviews contamination that has or may have occurred but has not arrived or been detected at the well. The ‘Contaminant Risks’ portion of the analysis also considers potential sources of contaminants. Chart 5 through 8 contains the Vulnerability Analysis for nitrates and/or nitrites and volatile organic chemicals, respectively.

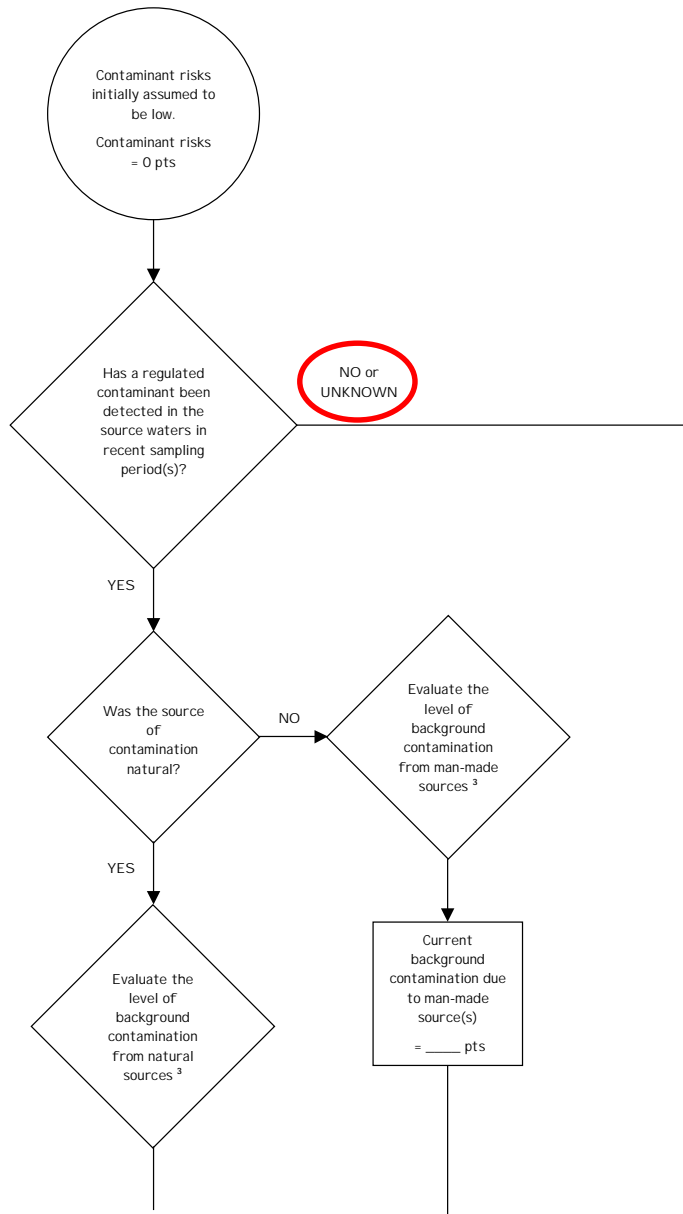
Chart 4. Contaminant risks for Girdwood Station Mall – Bacteria & Viruses

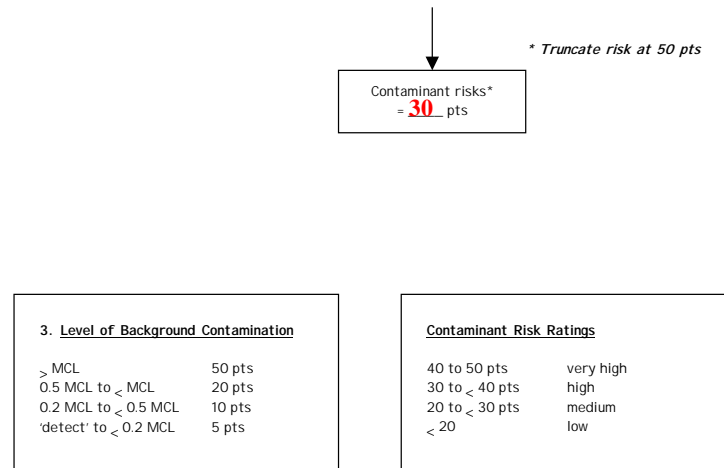
Chart 4. Contaminant risks for Girdwood Station Mall – Bacteria & Viruses (Continued)

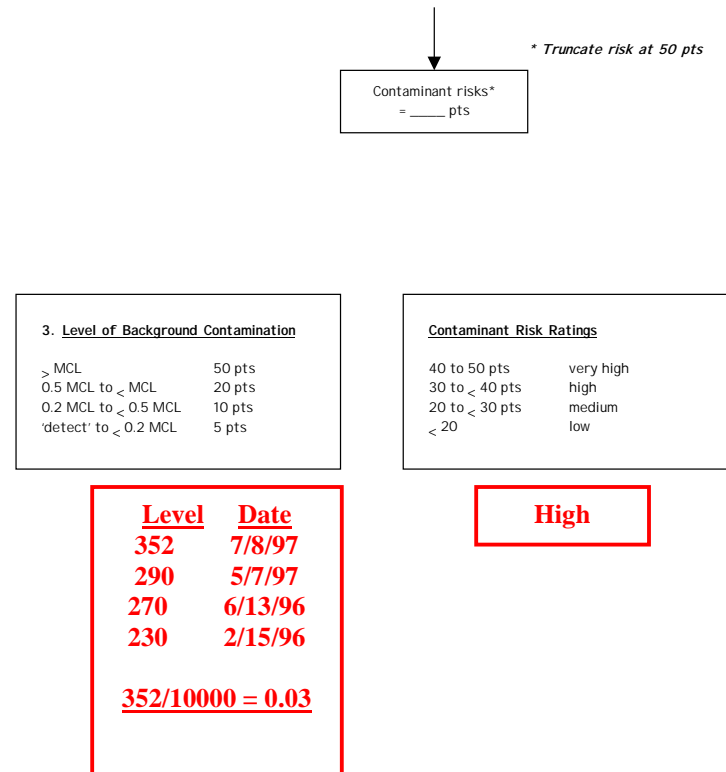
Chart 6. Contaminant risks for Girdwood Station Mall – Nitrates/Nitrites (Continued)
