Source Water Assessment

A Hydrogeologic Susceptibility and
Vulnerability Assessment for

Bay View Motel

PWSID 241795

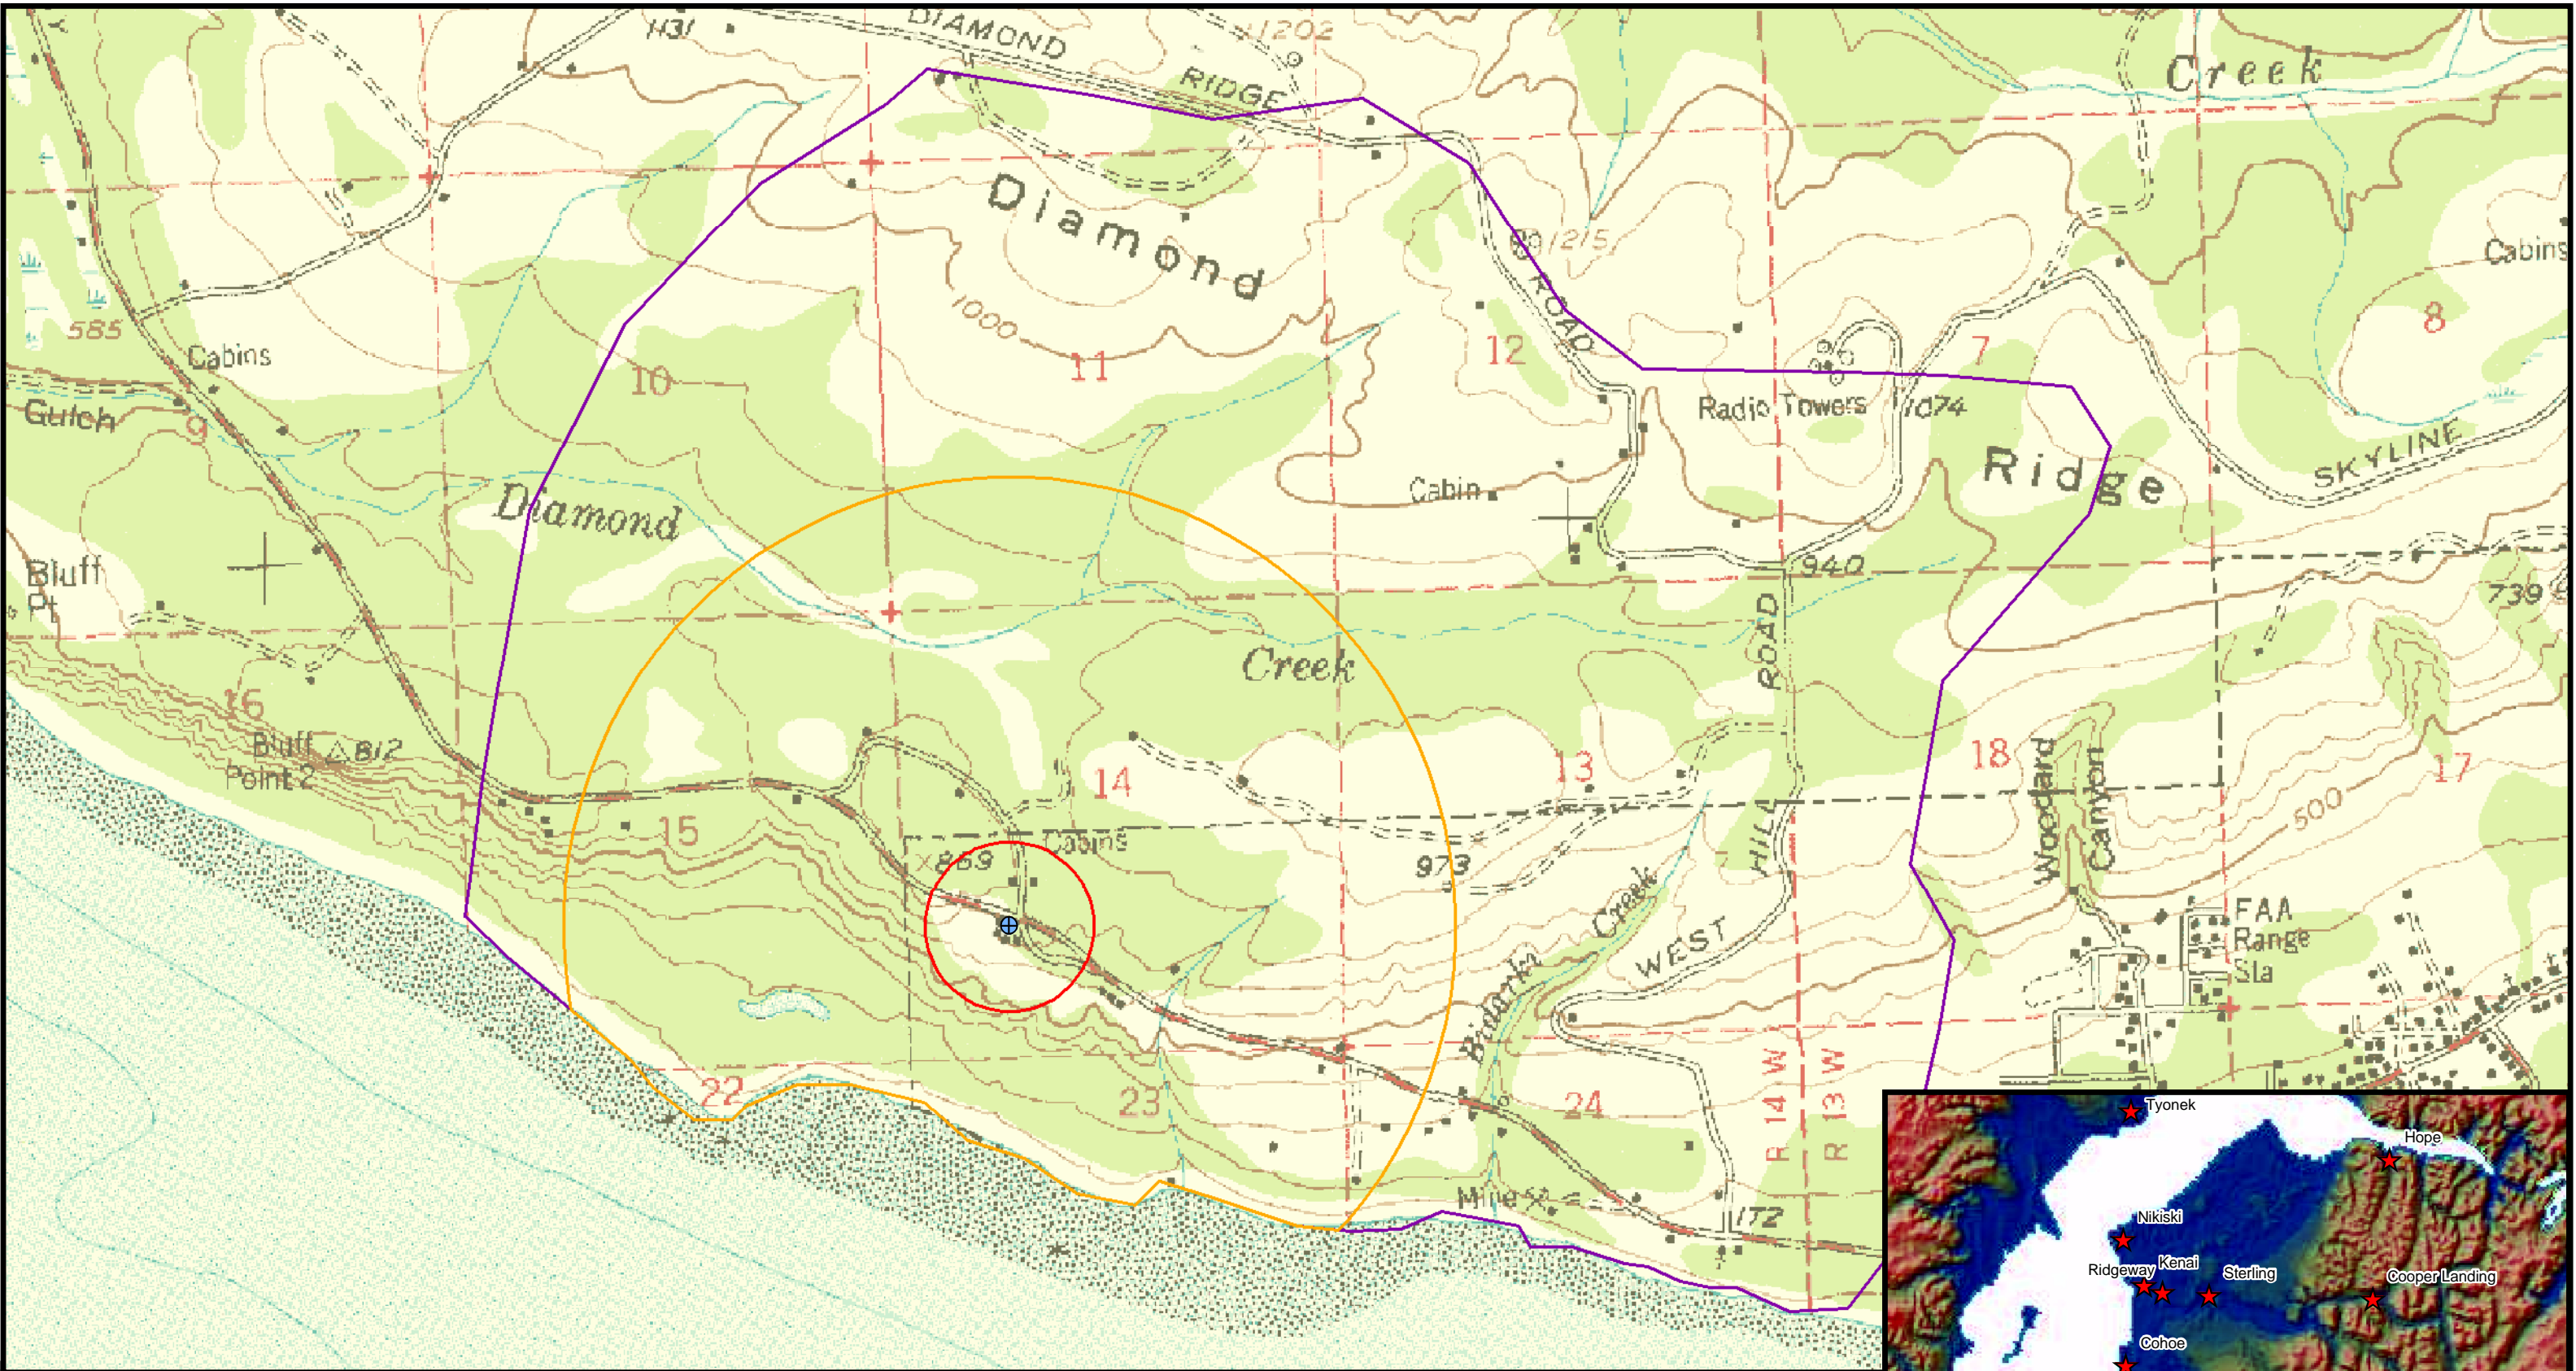
Map 1-Bay View Motel-Drinking Water Protection Area

Bay View Motel Drinking Water Protection Area Location Map (Map 1)

The protection area for the Bay View Motel intake includes each of these Zones (See Map 1 of Appendix A).

The drinking water protection area outlined for the Bay View Motel on Map 1 of Appendix A will serve as the focus for voluntary protection efforts.
