Source Water Assessment

A Hydrogeologic Susceptibility and Vulnerability Assessment for Elf's Den Drinking Water System, North Pole, Alaska PWSID 370031

DRINKING WATER PROTECTION PROGRAM REPORT Report 1277
Alaska Department of Environmental Conservation

Source Water Assessment for Elf's Den Drinking Water System North Pole, Alaska PWSID 370031

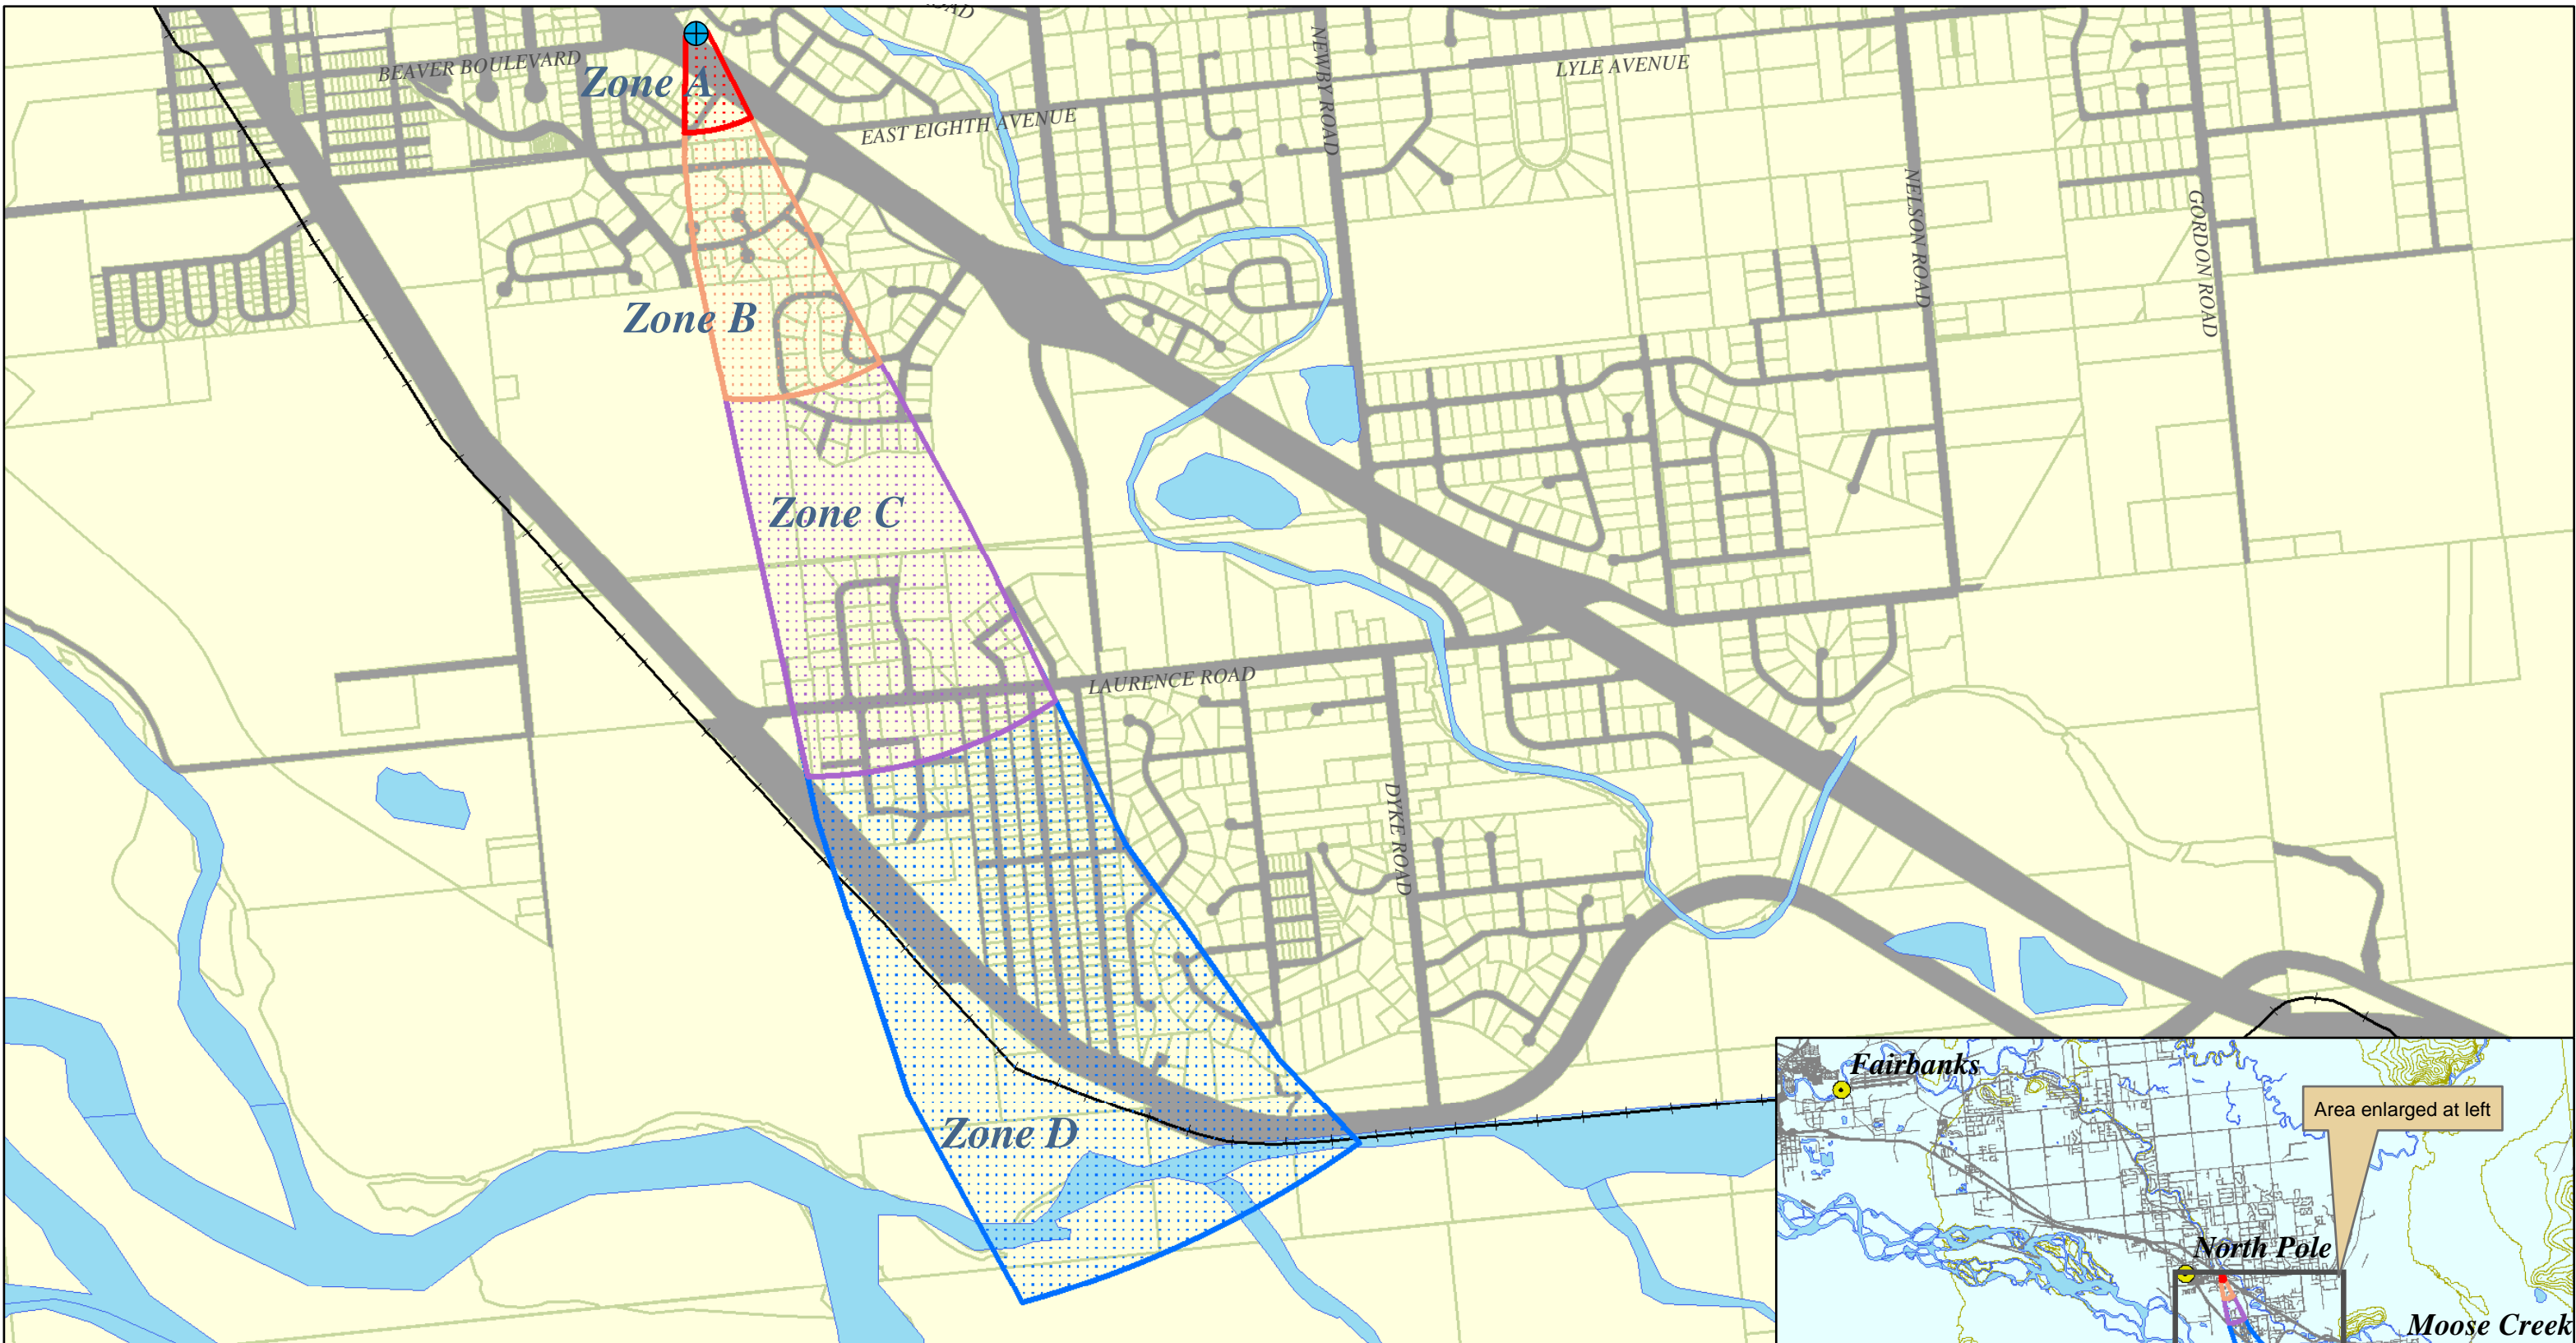
Map 1: Elf's Den Drinking Water Protection Area

Elf's Den Drinking Water Protection Area Location Map (Map 1)

Because of uncertainties and changing site conditions, a factor of safety is added to the groundwater capture zone to form the drinking water protection area for the well.

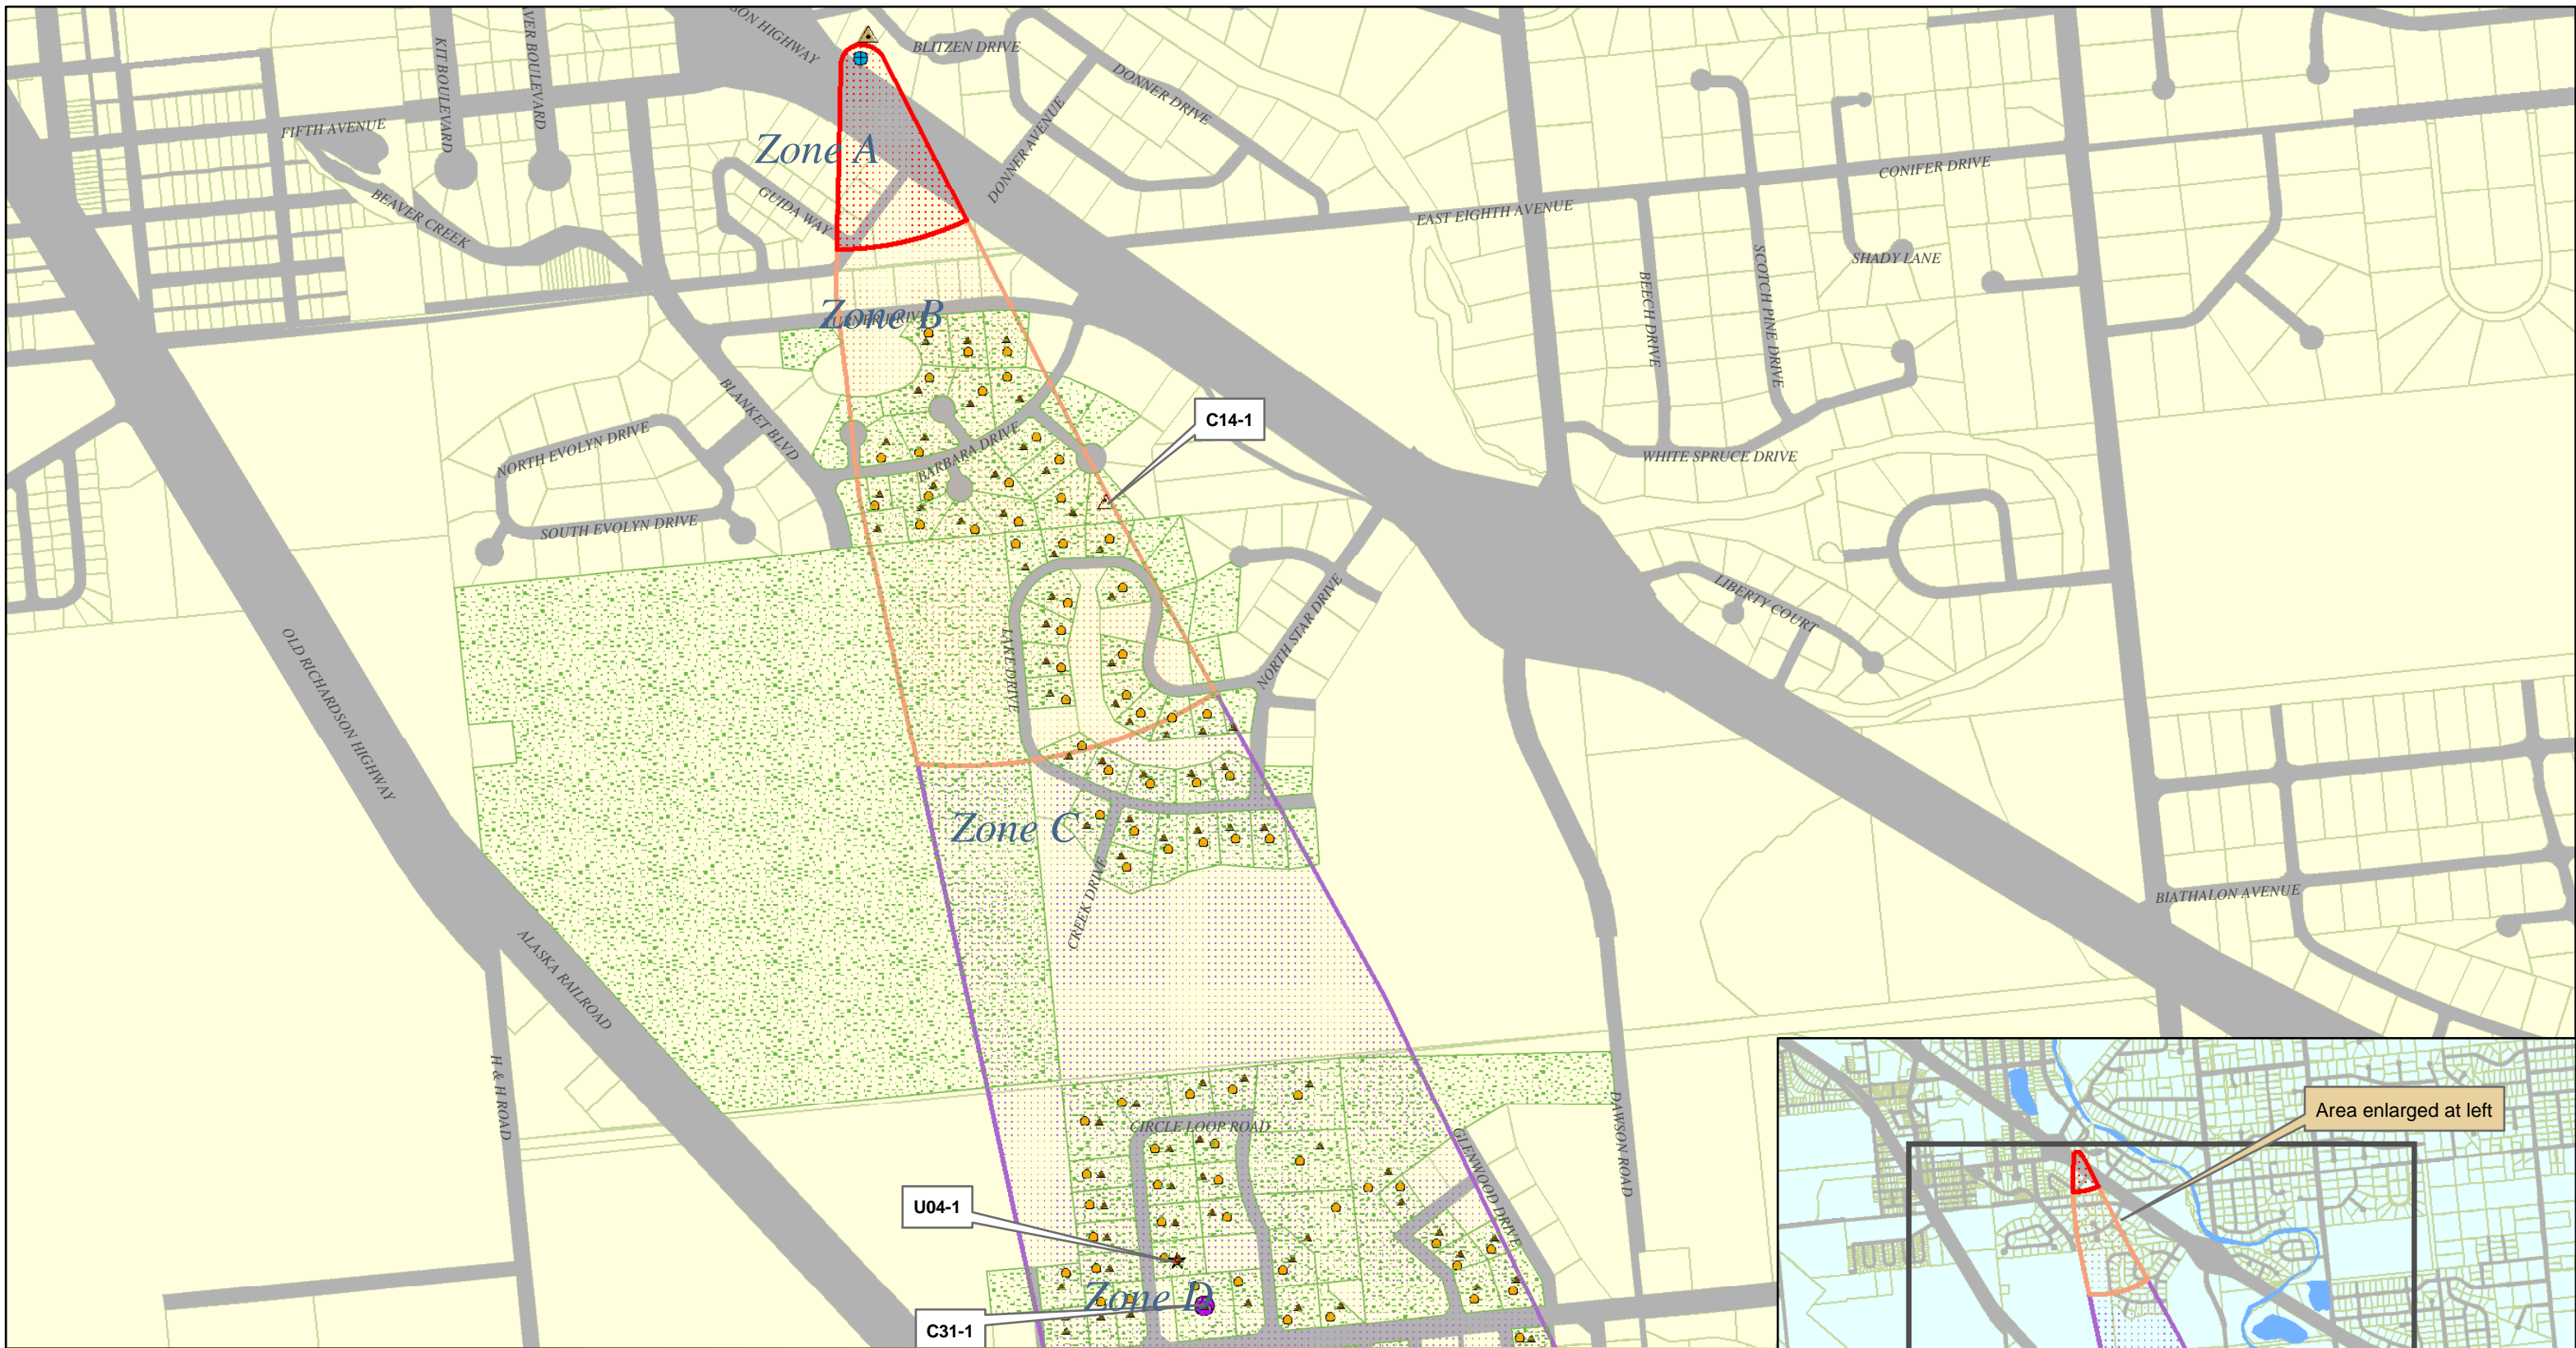
Map 2: Elf's Den Potential Contaminant Sources

Elf's Den Drinking Water Protection Area and Potential and Existing Contaminant Sources (Map 2)

- △ C14, Furniture manufacturing
- C31, Motor vehicle repair shop
- ▲ D10, Large capacity septic system
- ★ U04, DEC-recognized contaminated site
- R08, Residential heating oil tanks
- ▲ R02, Residential septic systems
- ▬ Roads
- ▬ Parcels
- ▬ Surface water
- ▬ R01, Residential area

There is also a DEC-recognized contaminated site in Zone C of the protection area (RecKey 1999310103801). Soil and groundwater contamination from a leaking residential heating oil tank was discovered in 1999. The site is being monitored for contaminant migration.
