# Source Water Assessment

A Hydrogeologic Susceptibility and  
Vulnerability Assessment for  
Mistletoe Mall Drinking Water System,  
North Pole, Alaska

PWSID 313225

DRINKING WATER PROTECTION PROGRAM REPORT Report 1275  
Alaska Department of Environmental Conservation

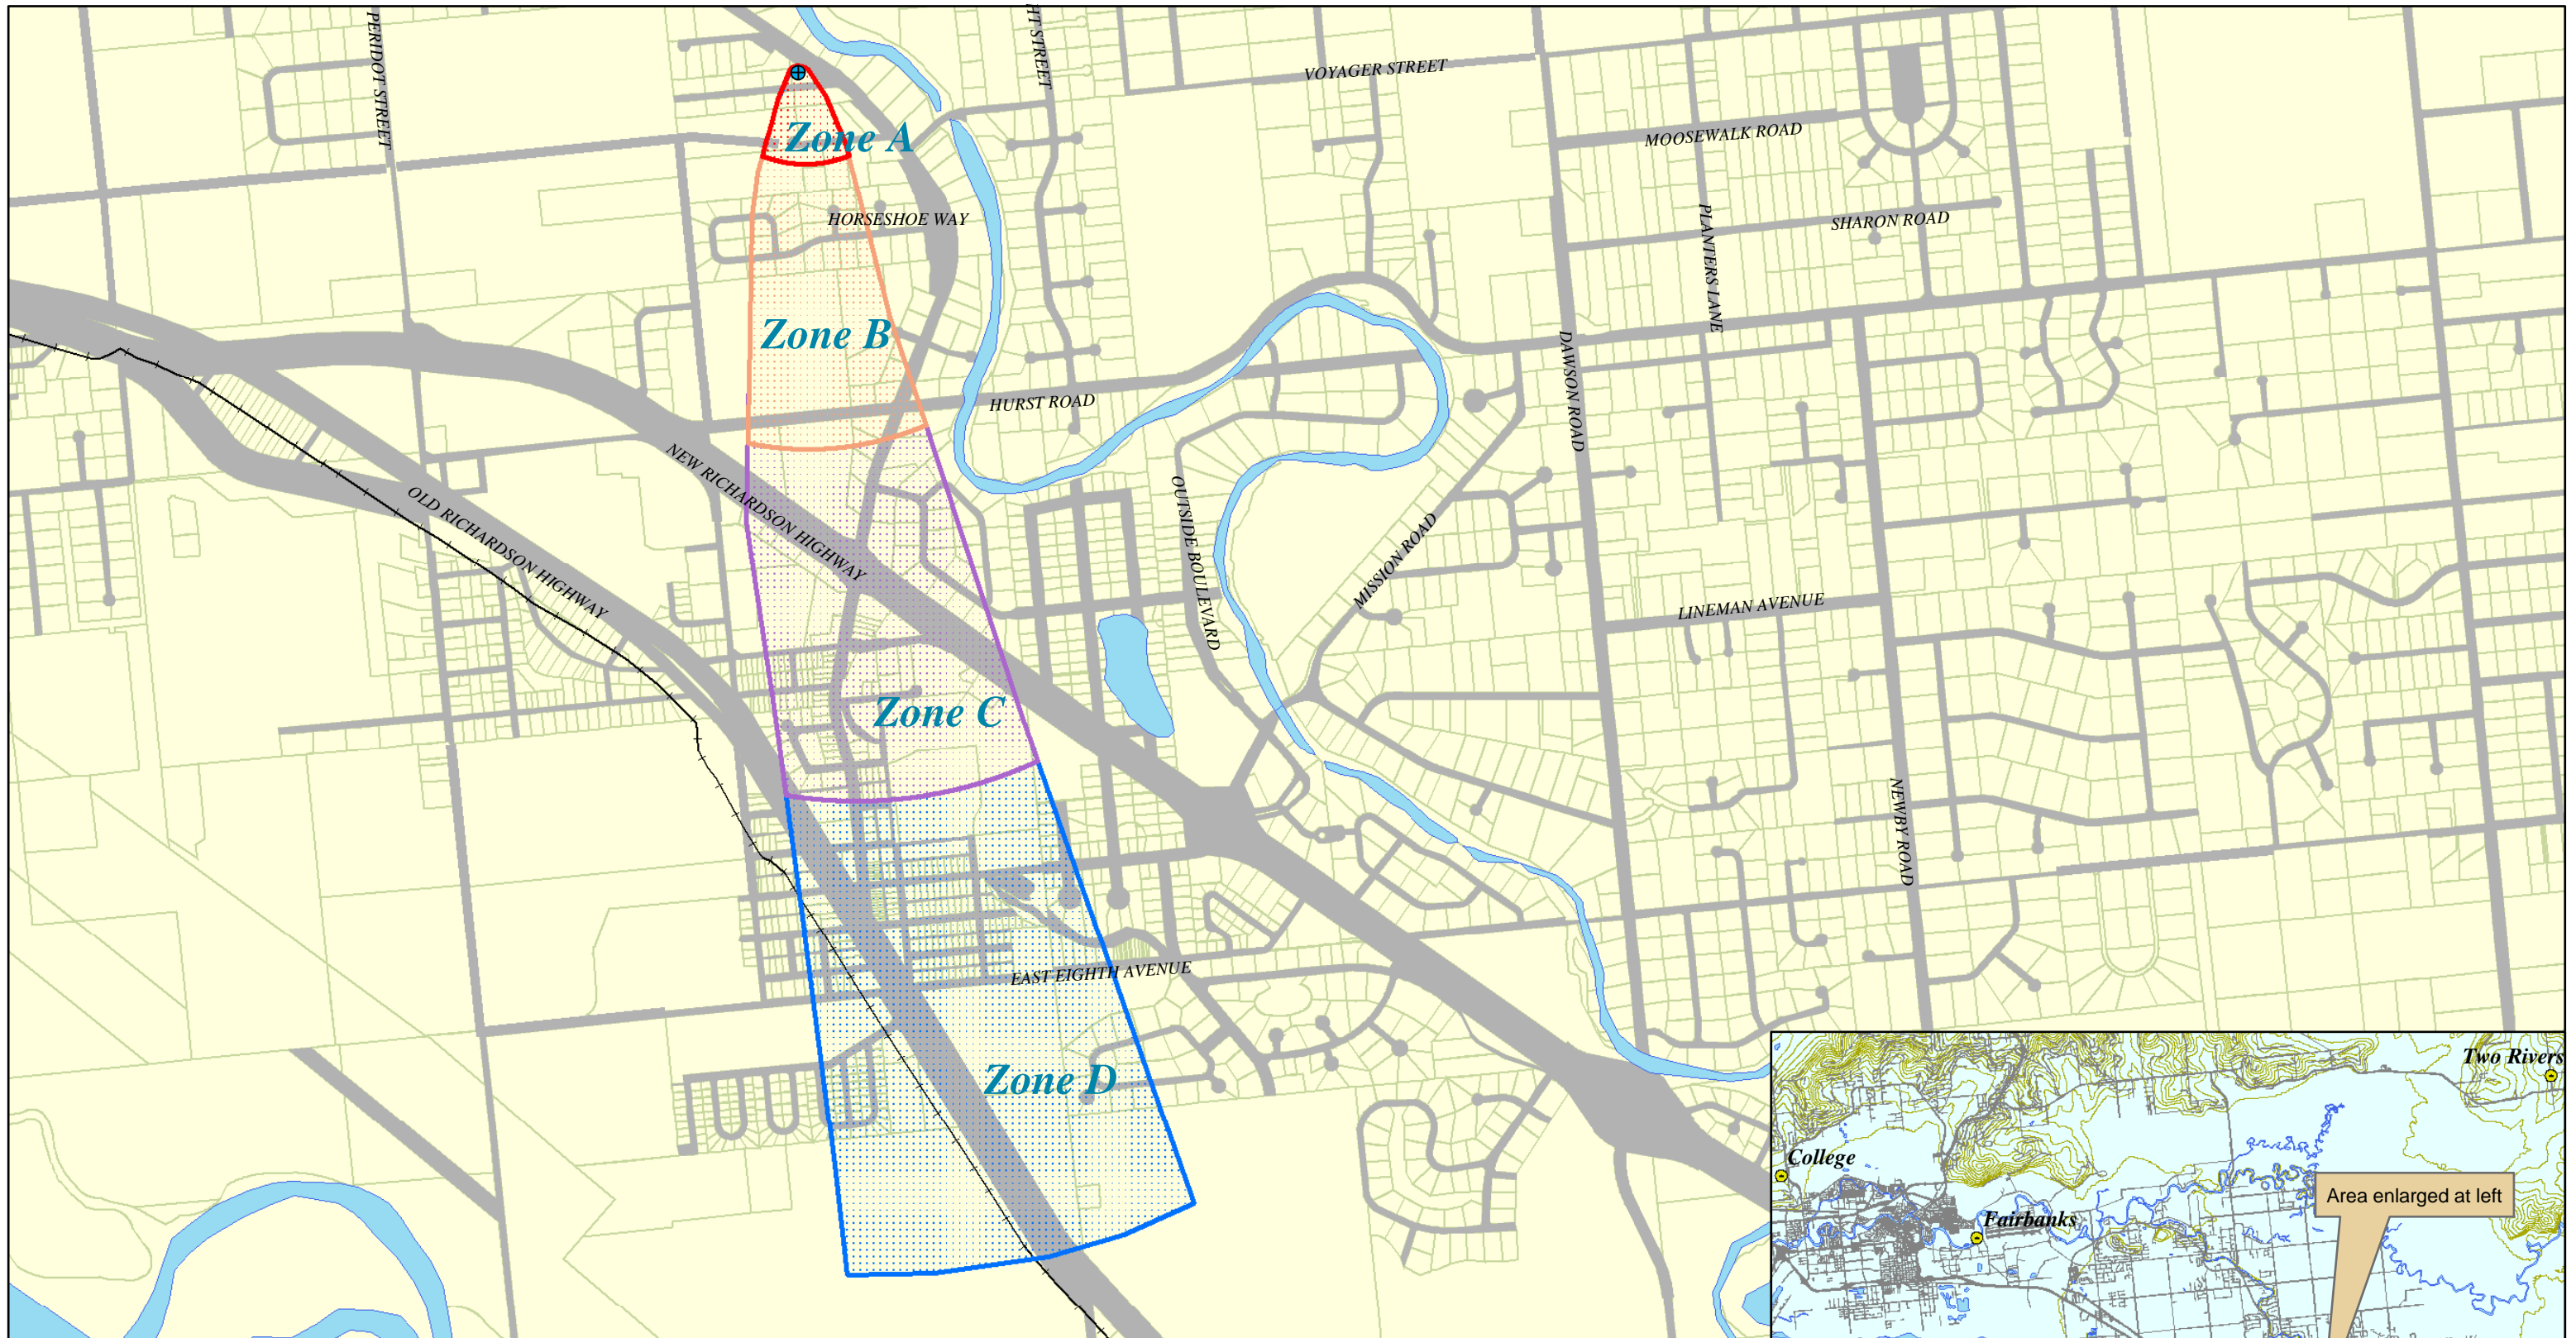
**Map 1: Mistletoe Mall Drinking Water Protection Area**

**Legend**

- Mistletoe Mall well
- Zone A Several months travel time
- Zone B Less than 2 years travel time
- Zone C Less than 5 years travel time
- Zone D Less than 10 years travel time
- Towns
- Surface water
- Roads
- Parcels

| APPENDIX | A. Mistletoe Mall Drinking Water Protection Area (Map 1) | |
