# Hydrogeologic Susceptibility and Vulnerability Assessment for Palmer Church of God, Inc. Drinking Water Well, Palmer, Alaska

DRINKING WATER PROTECTION PROGRAM REPORT 106

By Michael Baxter, B.E.S.T. Resource

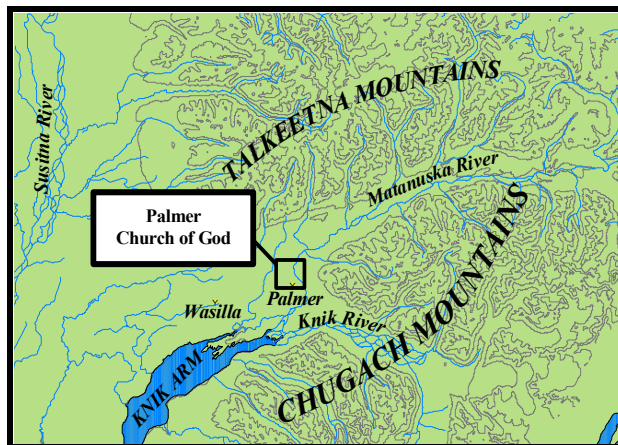
Figure 1. Index map showing the location of well assessment

The purpose of this environmental assessment is to provide public water system owners/operators, communities, and local governments with information they can use to preserve the quality of Alaska's public drinking water supplies. This assessment was completed for the Palmer Church of God source of public drinking water. This source consists of one well in the Palmer area (Figure 1). This assessment, known under the Alaska Drinking Water Protection Program as

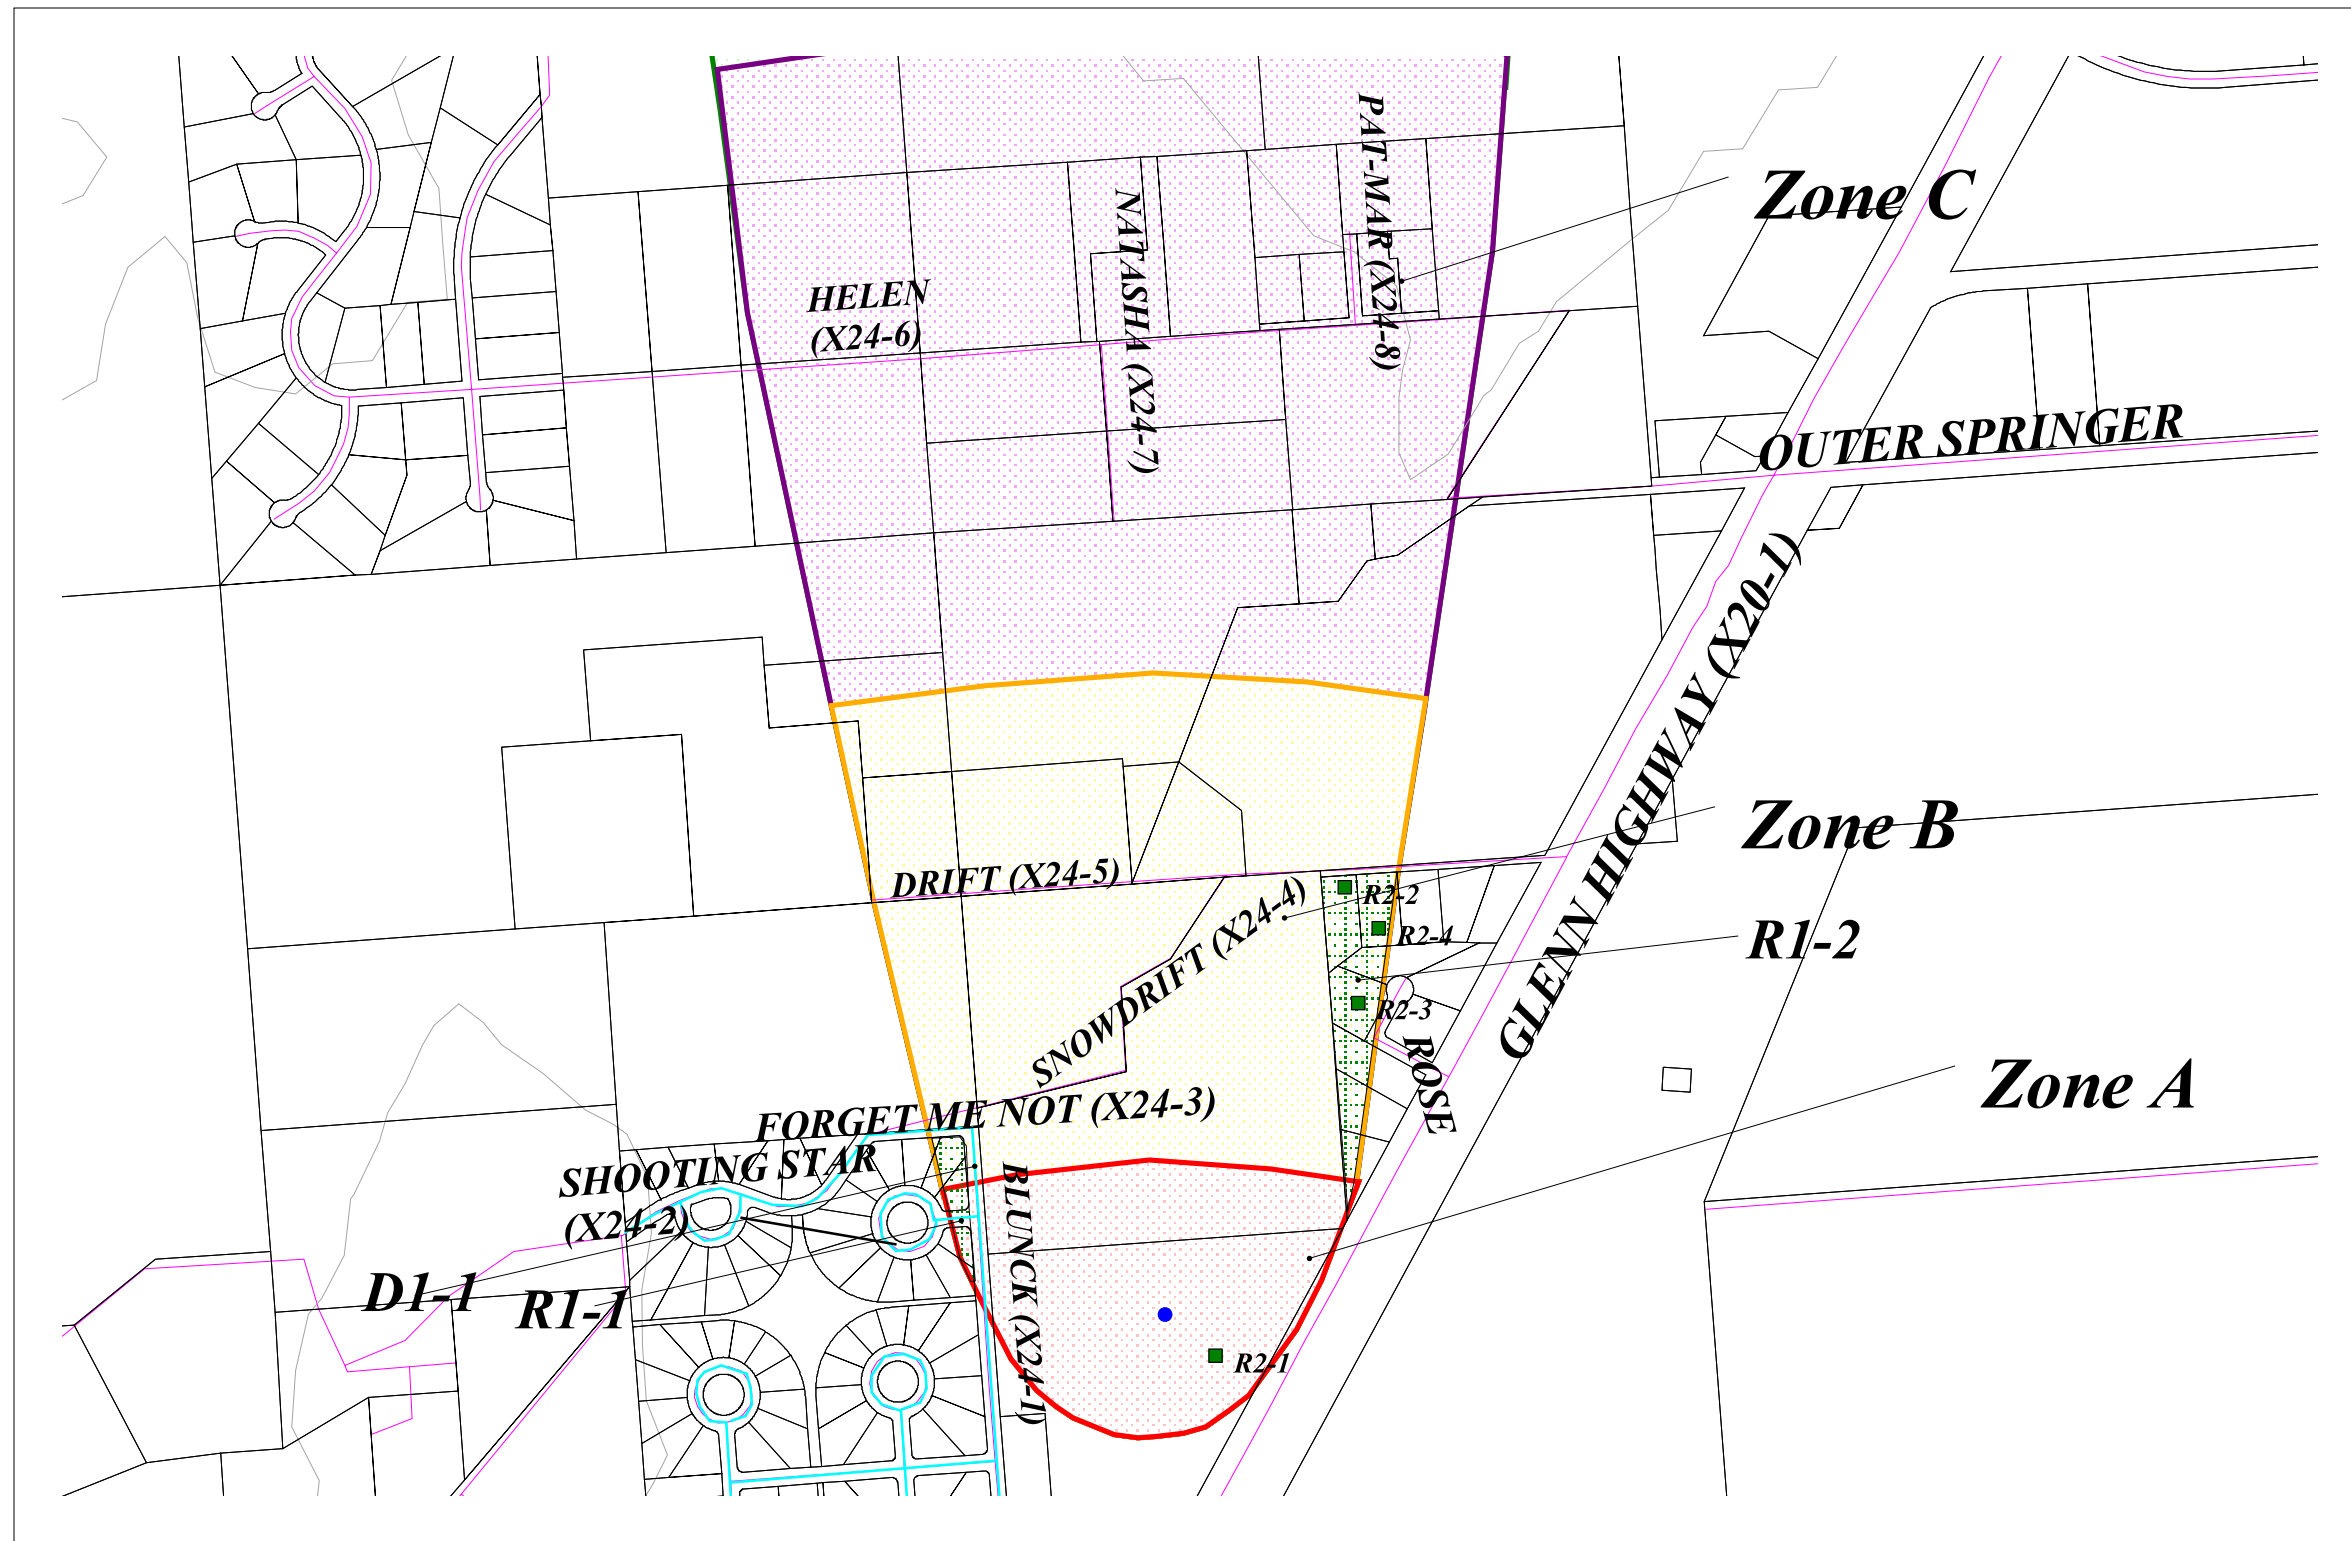
# Drinking Water Protection Areas Potential & Existing Sources of Contamination for Palmer Church of God

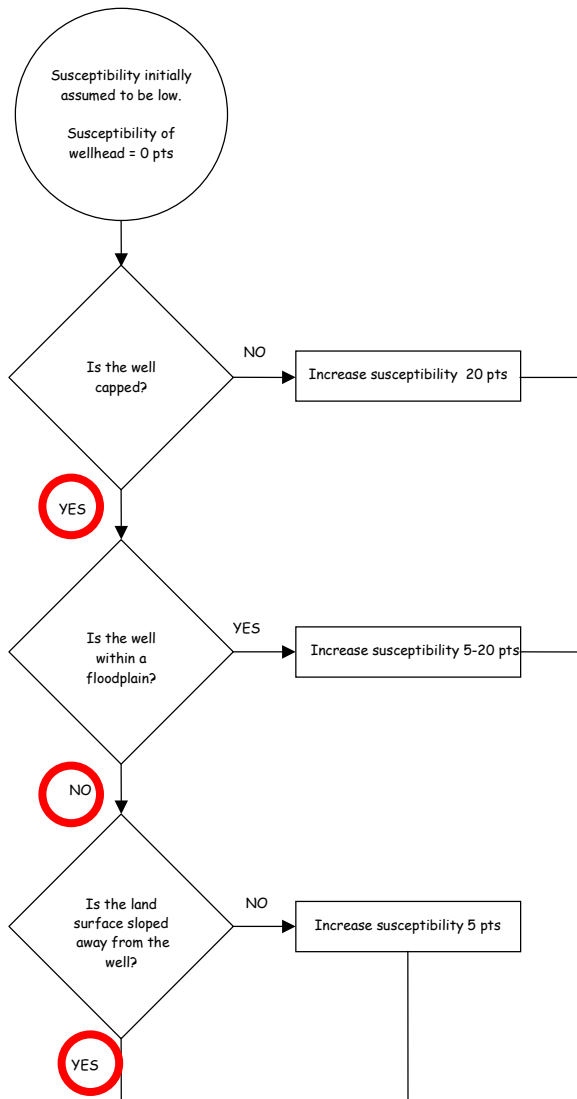
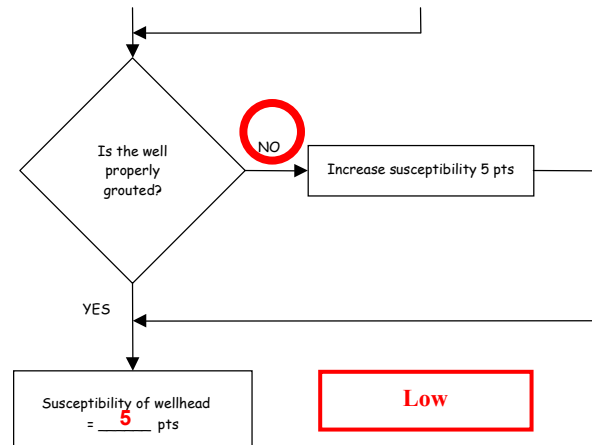
**Chart 1. Susceptibility of the wellhead – Palmer Church of God**

<u>Wellhead Susceptibility Ratings</u>	
20 to 25 pts	very high
15 to < 20 pts	high
10 to < 15 pts	medium
< 10	low

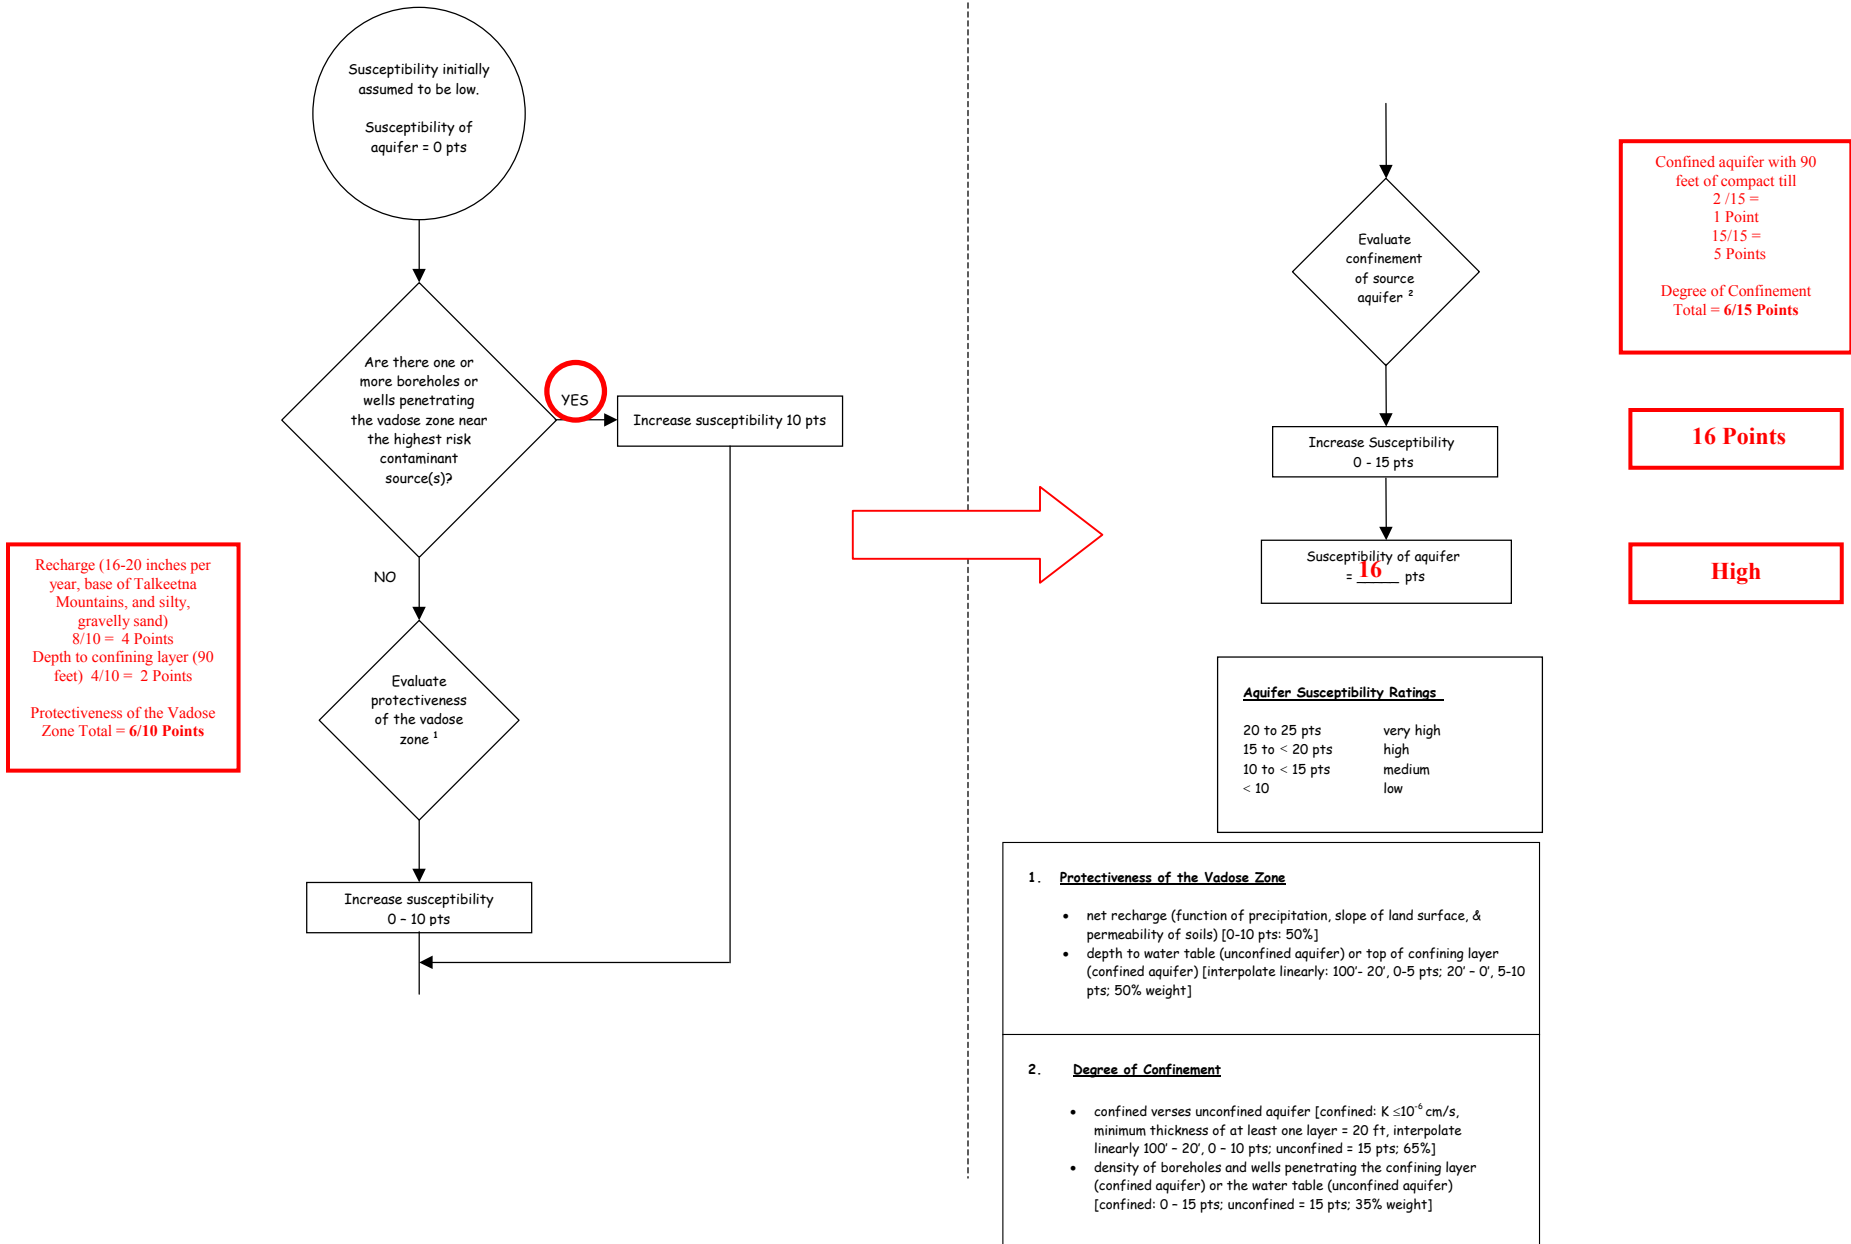
**Chart 2. Susceptibility of the aquifer – Palmer Church of God, Inc.**

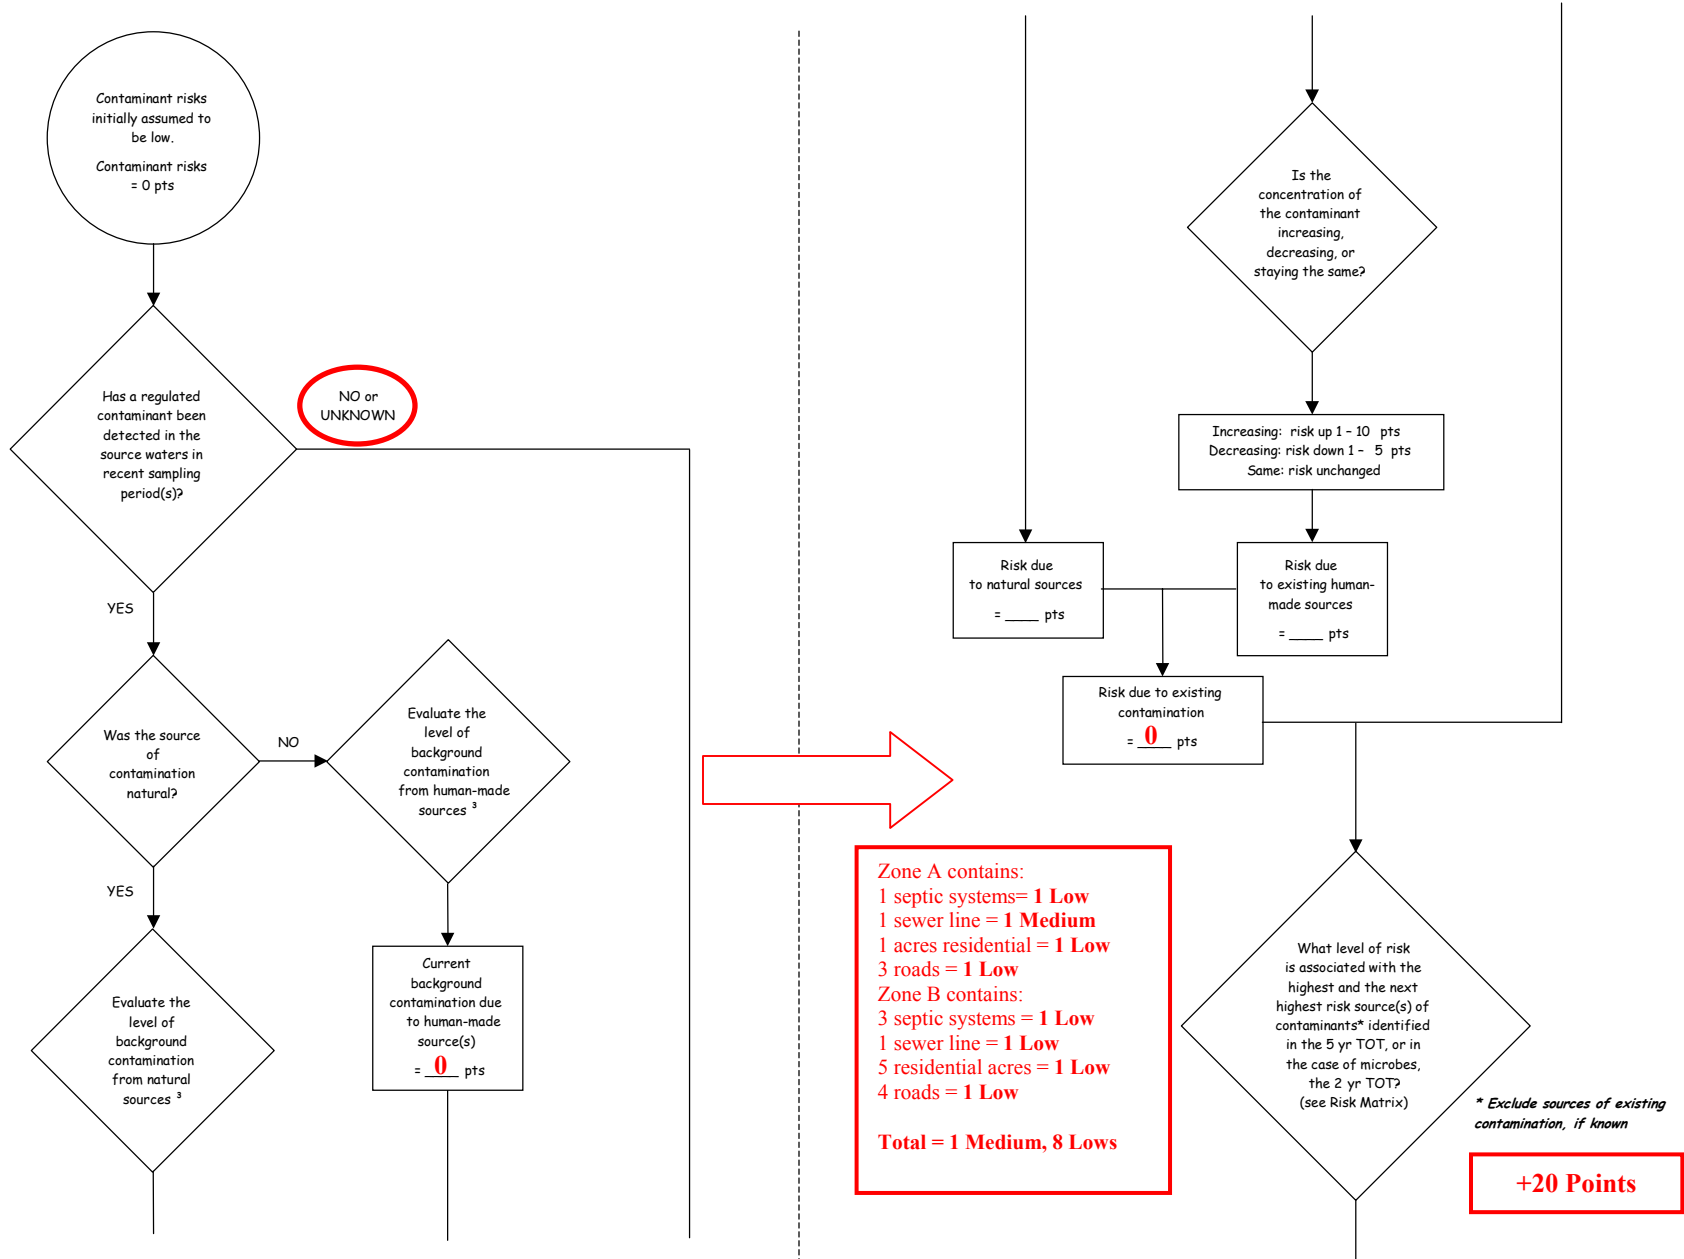
Chart 3. Contaminant risks for Palmer Church of God, Inc. – Bacteria & Viruses

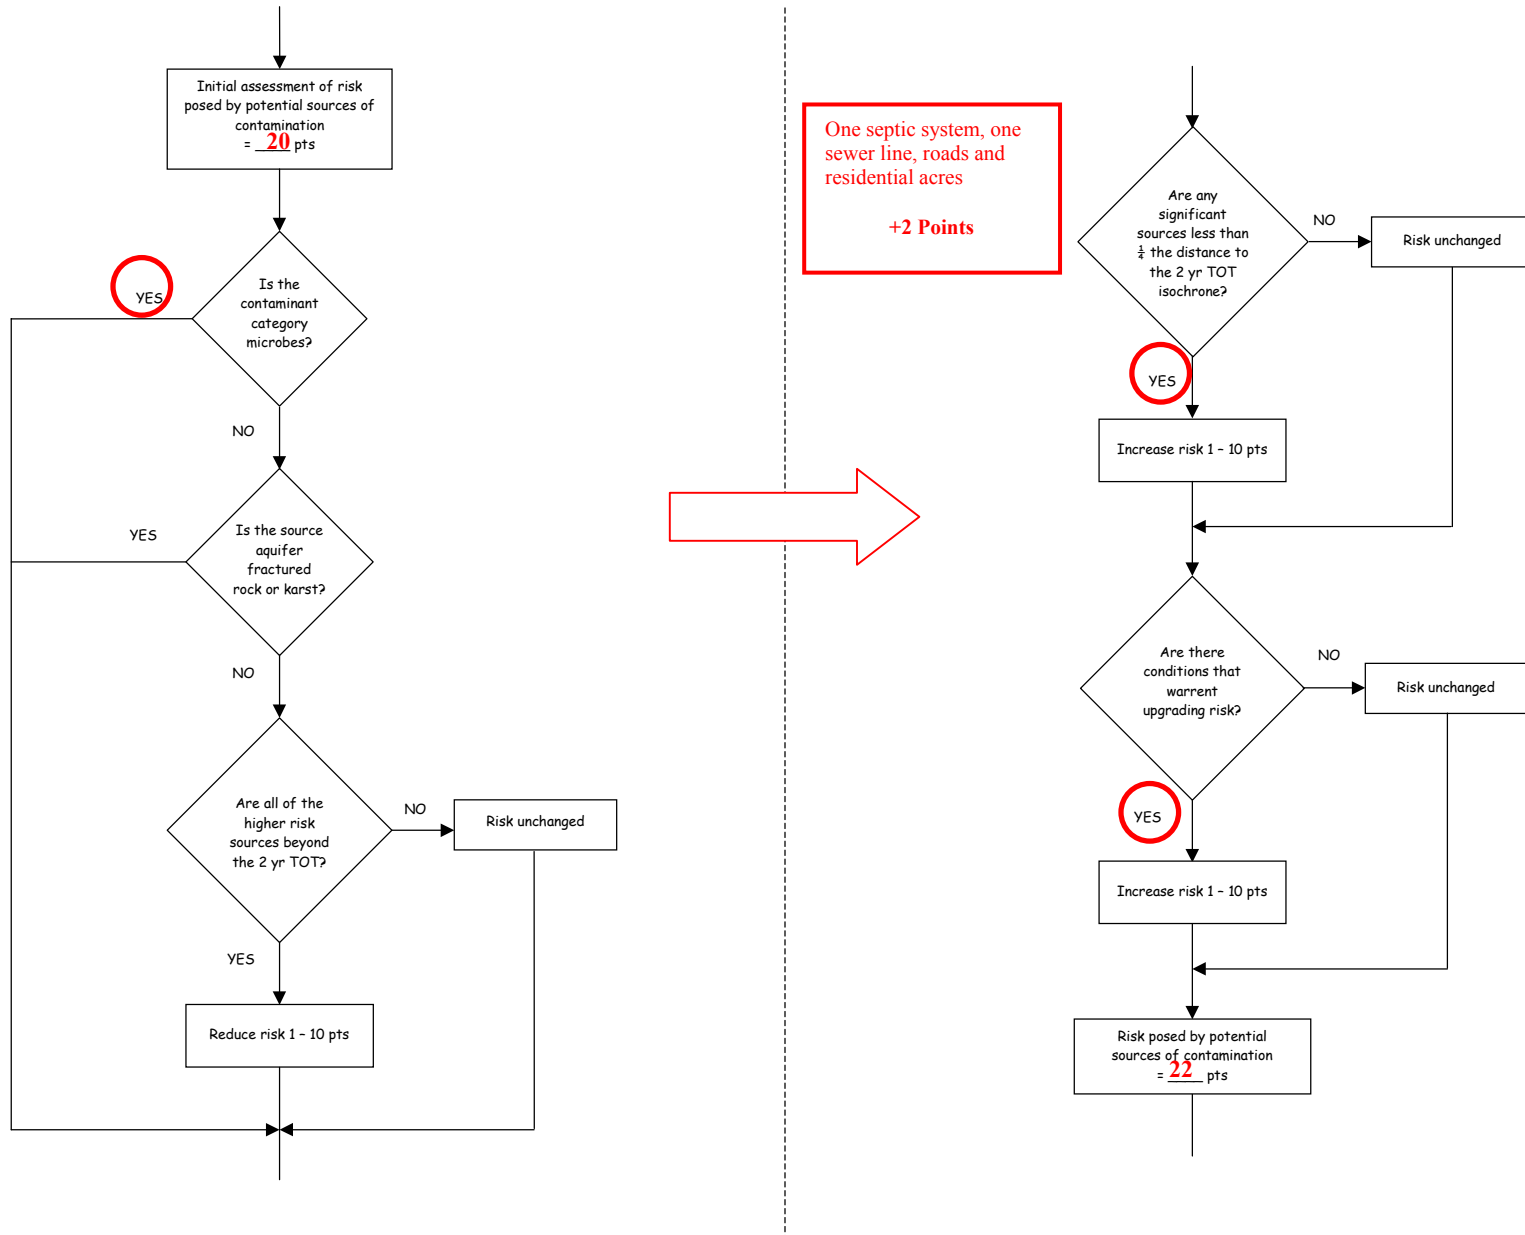
Chart 3. Contaminant risks for Palmer Church of God, Inc. – Bacteria & Viruses (Continued)

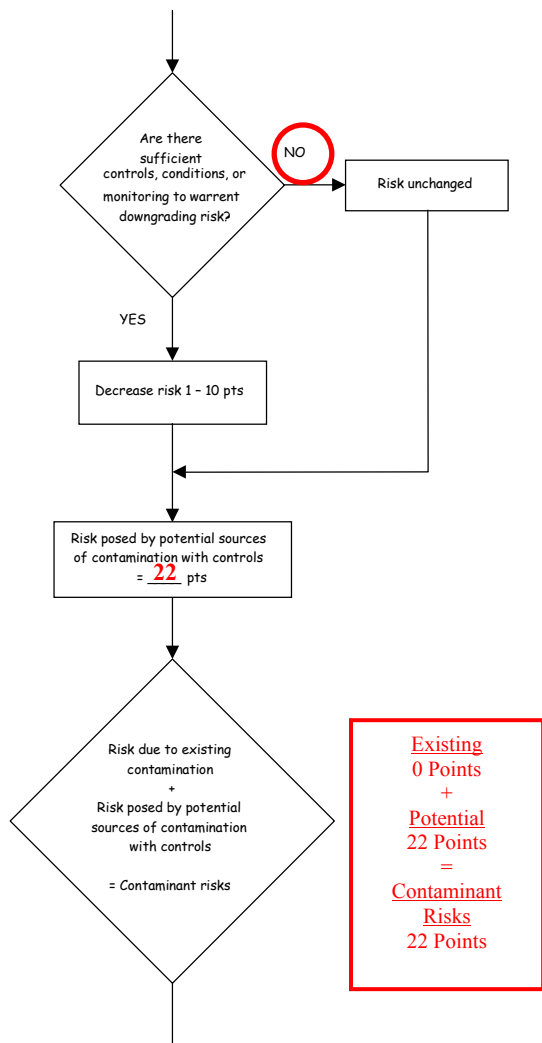
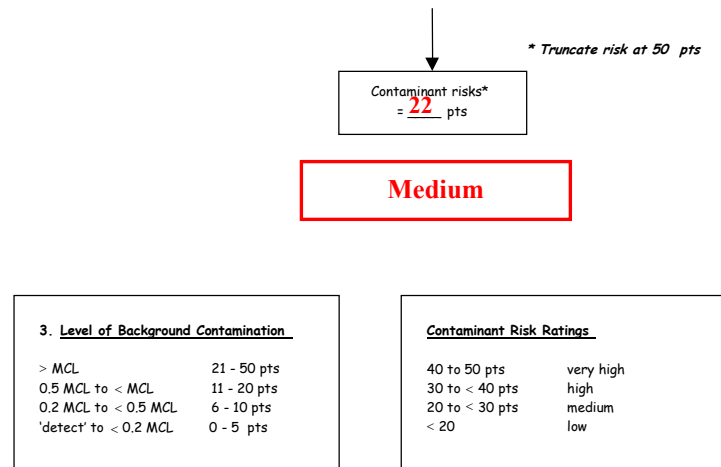
Chart 3. Contaminant risks for Palmer Church of God, Inc. – Bacteria & Viruses (Continued)

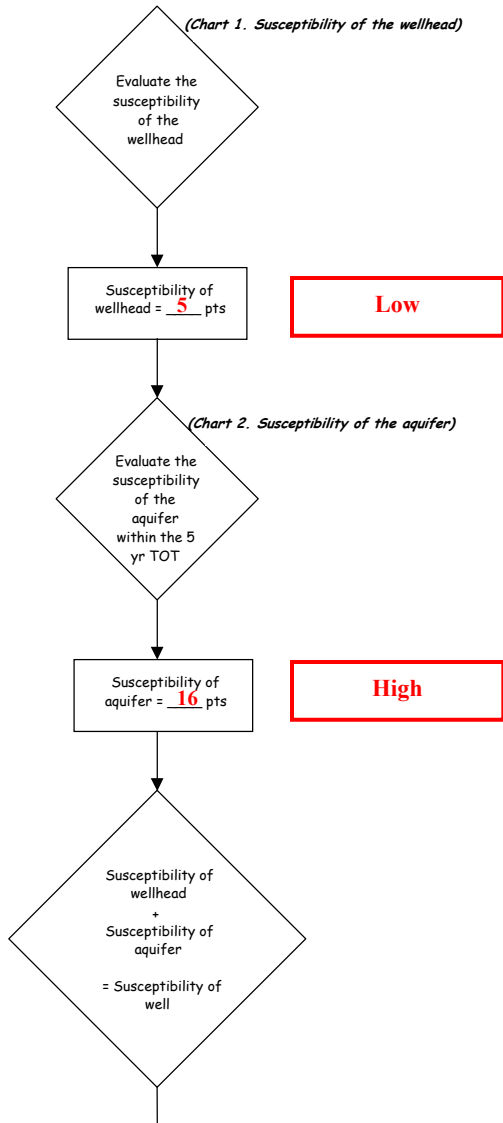
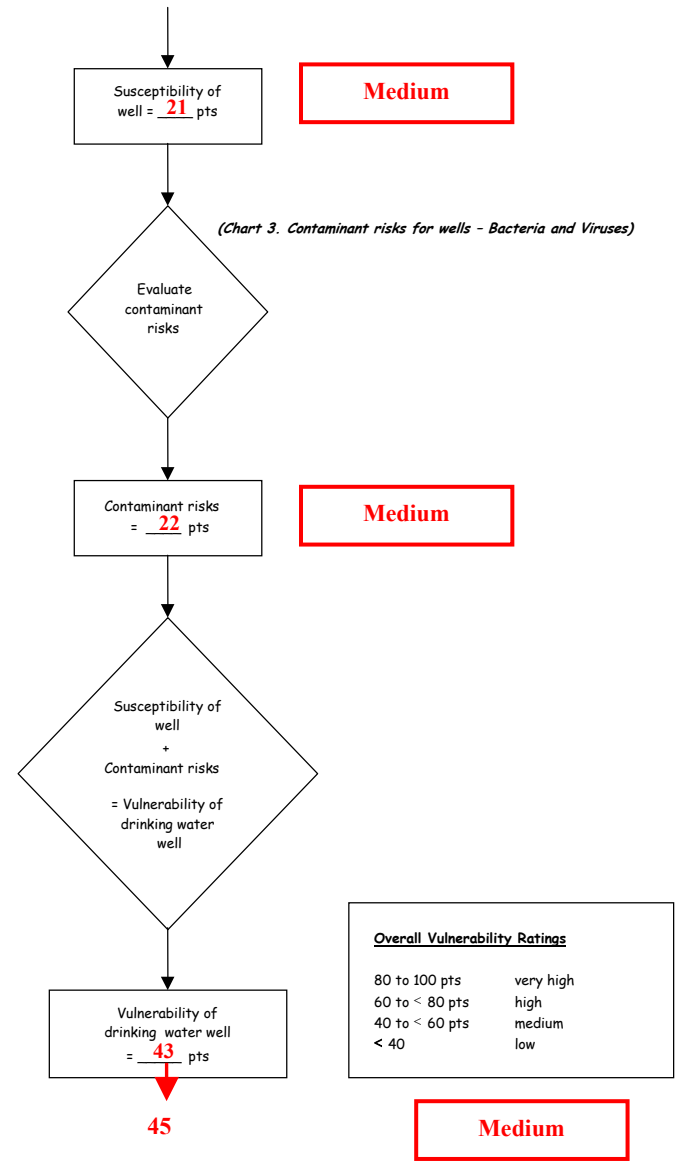
**Chart 4. Vulnerability analysis for Palmer Church of God– Bacteria & Viruses**

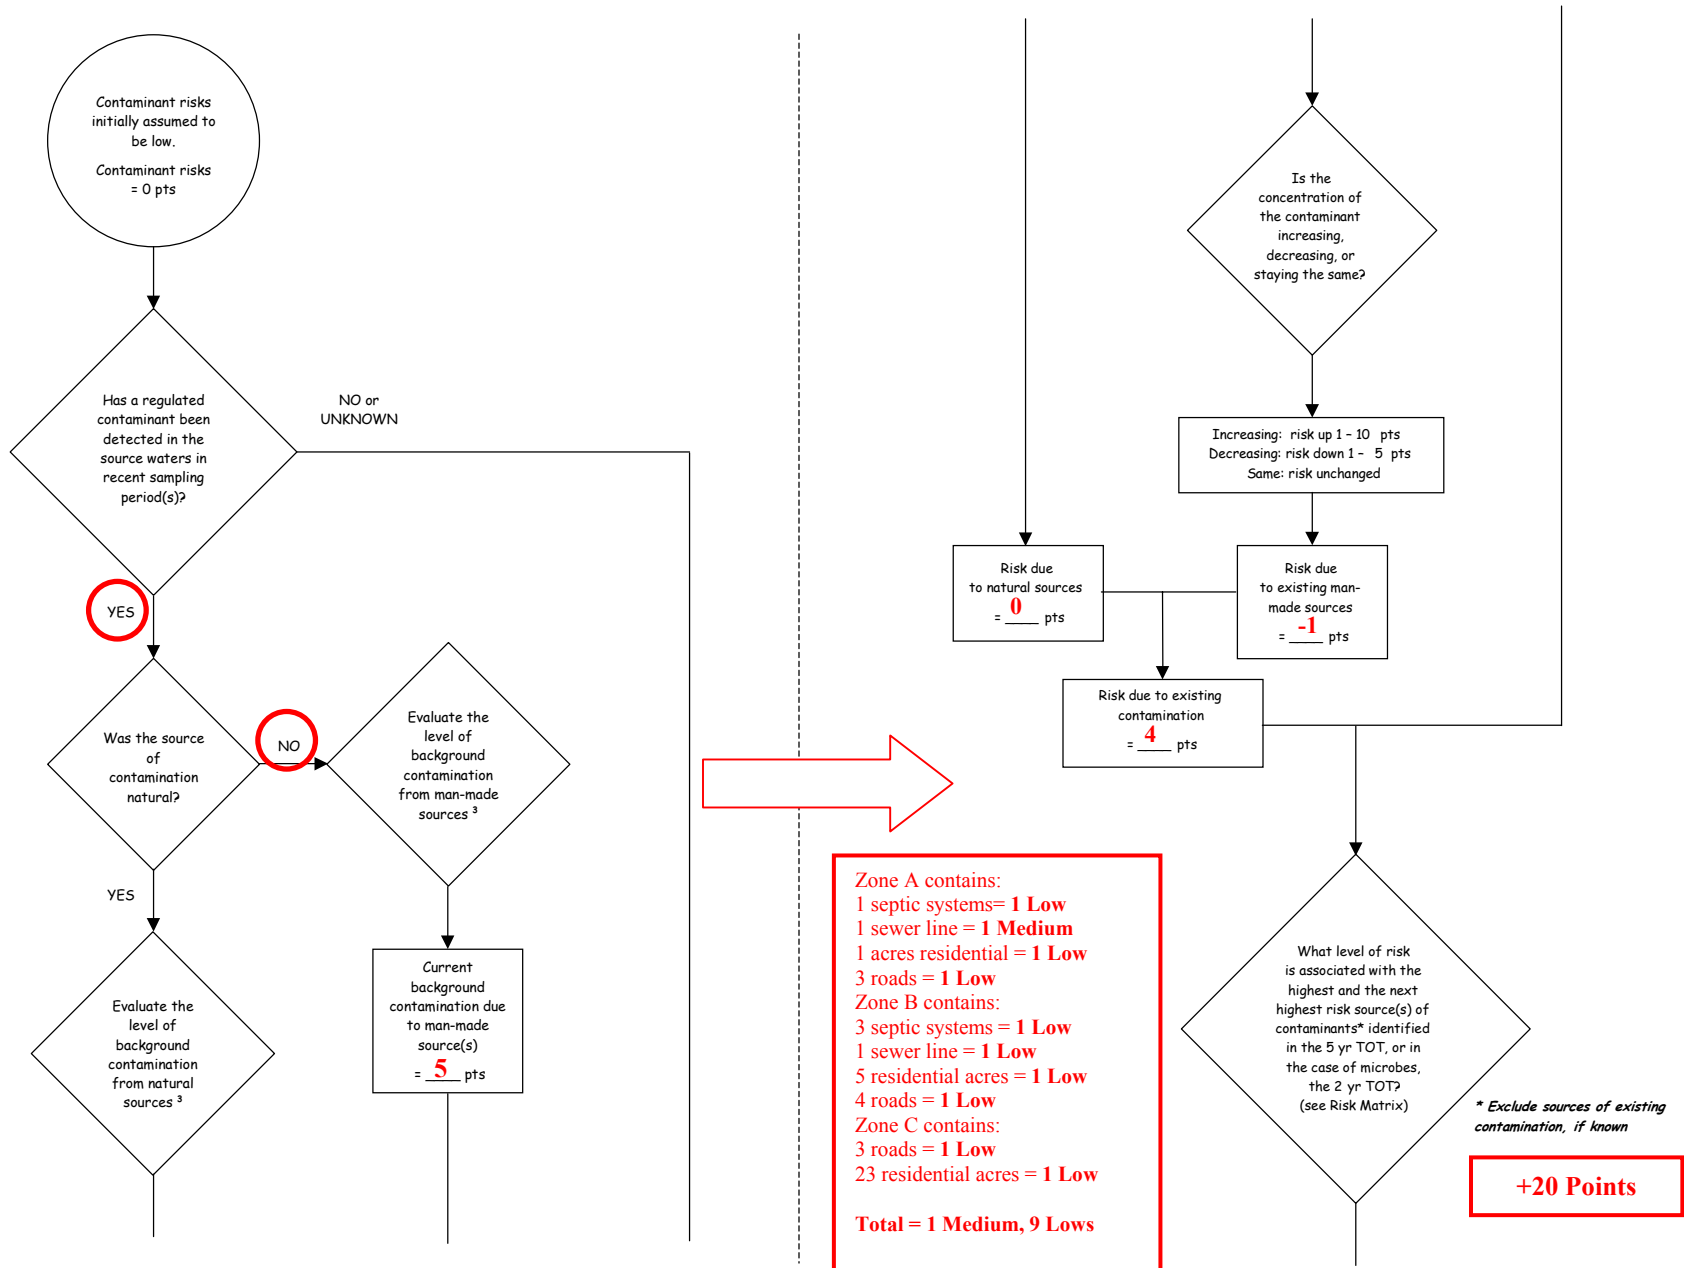
Chart 5. Contaminant risks for Palmer Church of God, Inc.– Nitrates and Nitrites

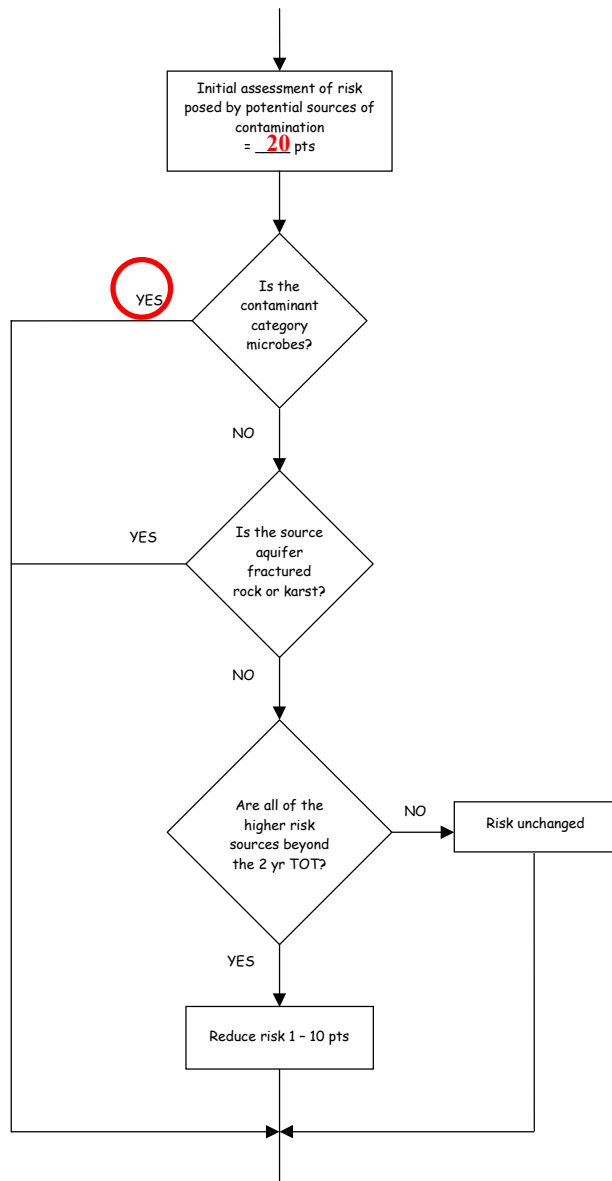
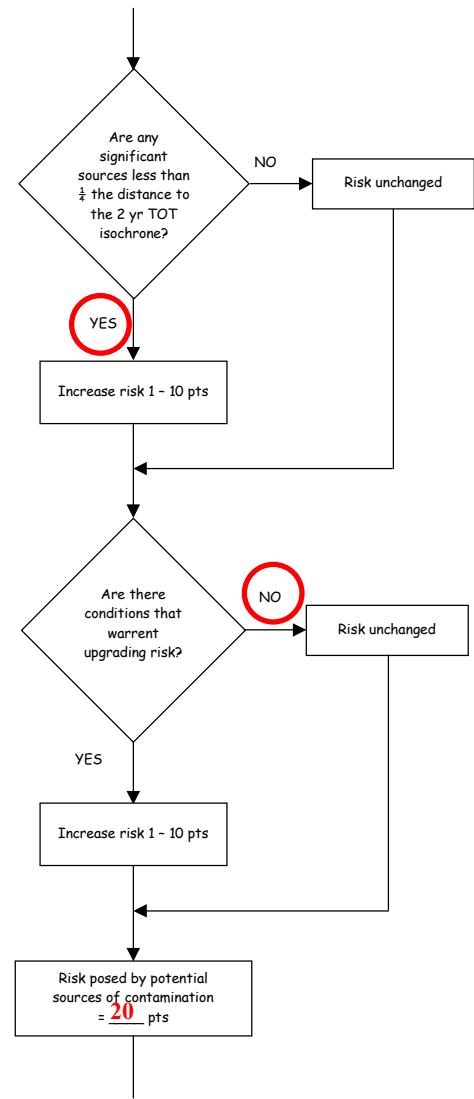
Chart 5. Contaminant risks for Palmer Church of God, Inc.– Nitrates and Nitrites (Continued)

Few septic systems, roads and residential acres  
+2 Points

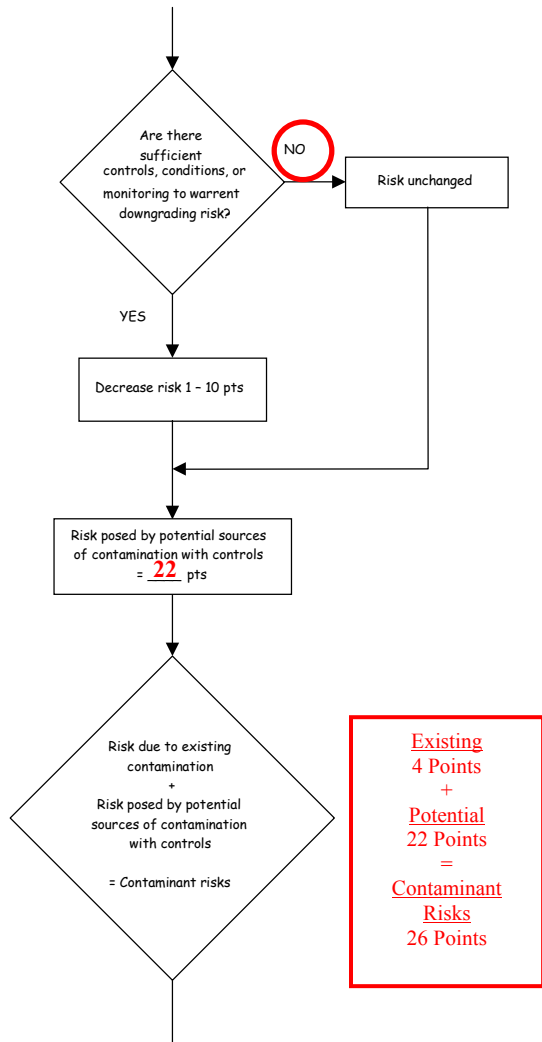
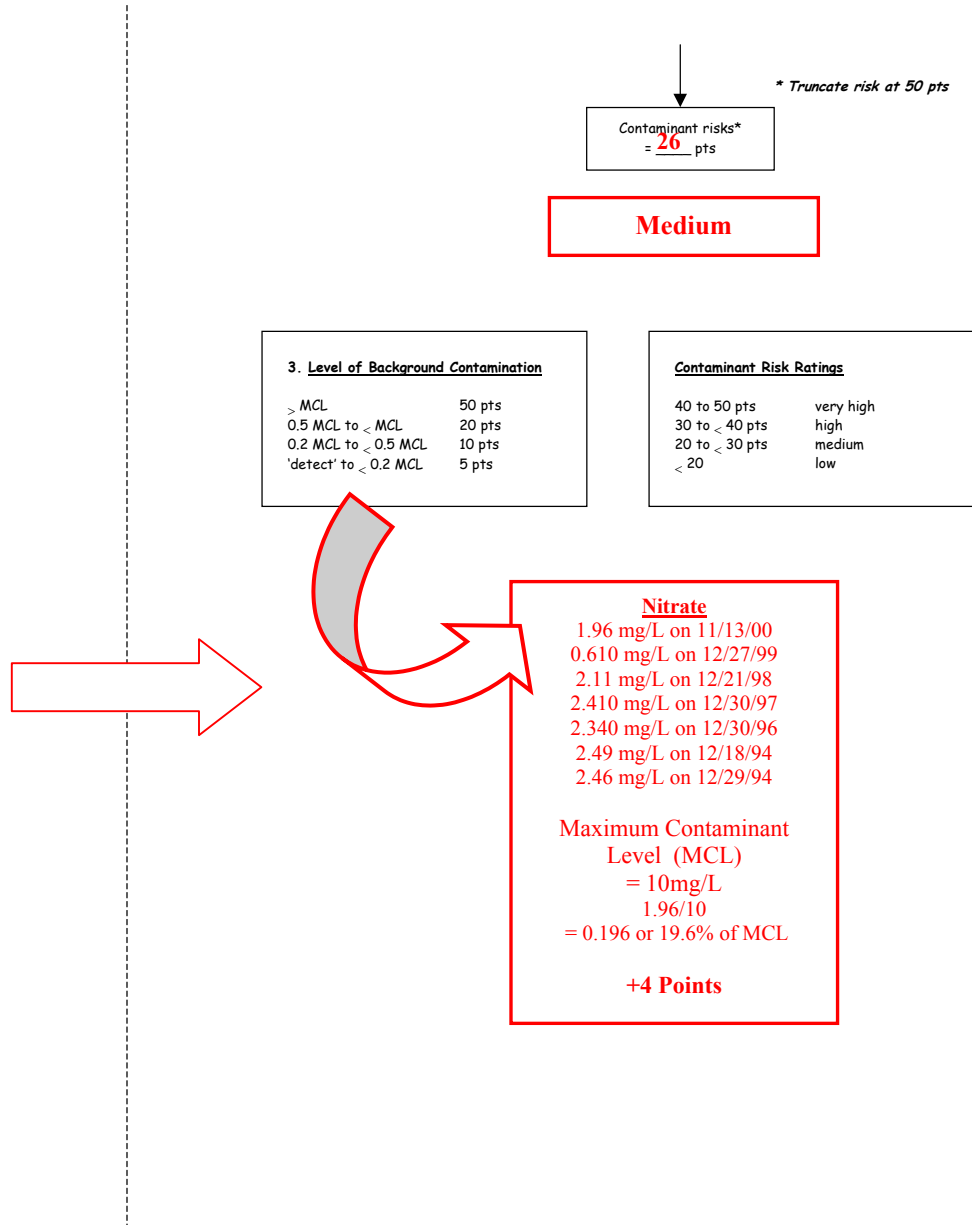
Chart 5. Contaminant risks for Palmer Church of God, Inc.– Nitrates and Nitrites (Continued)

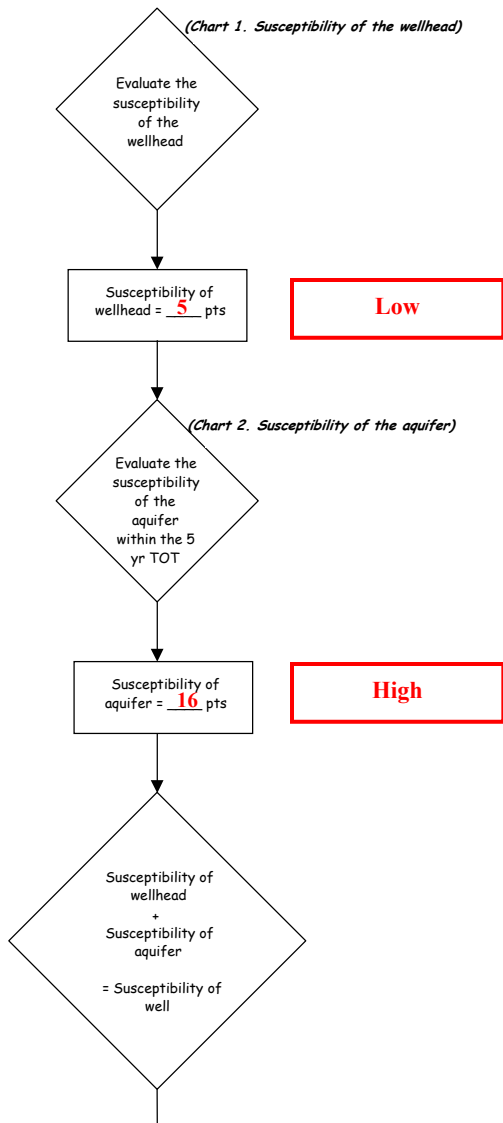
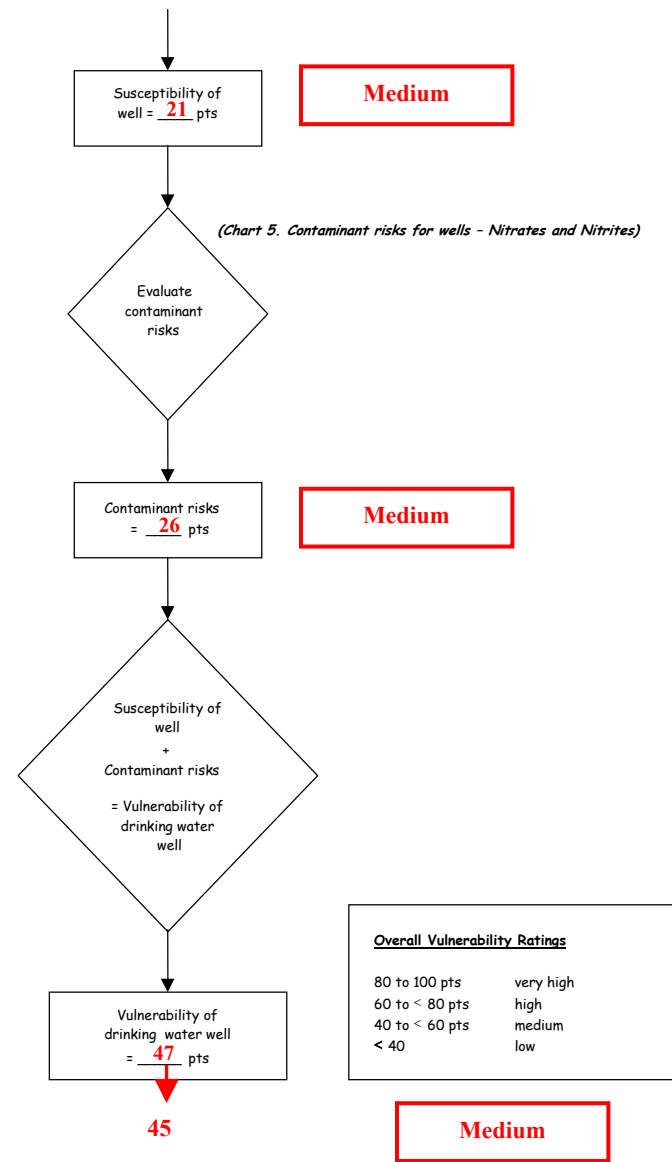
**Chart 6. Vulnerability analysis for Palmer Church of God– Nitrates and Nitrites**

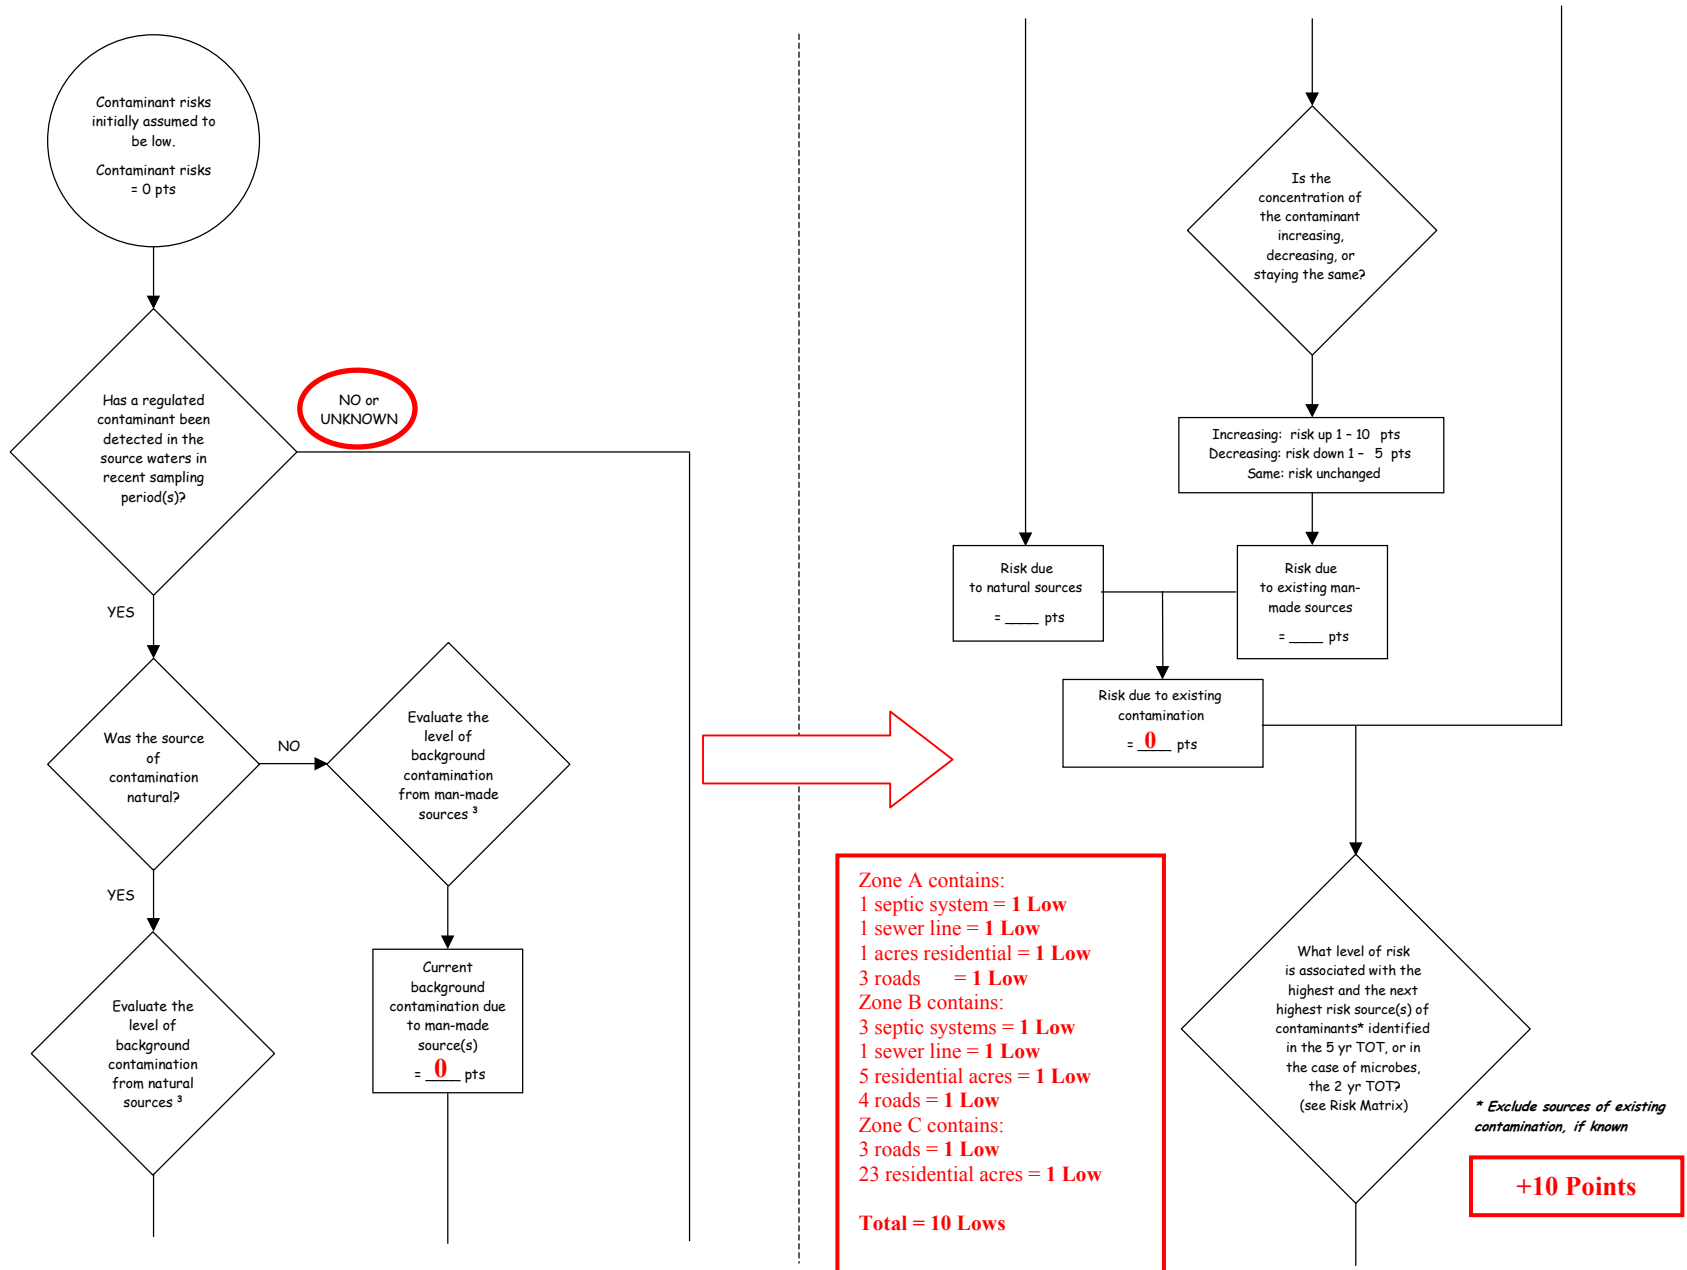
Chart 7. Contaminant risks for Palmer Church of God, Inc. – Volatile Organic Chemicals
