# Hydrogeologic Susceptibility and Vulnerability Assessment for Palmer Church of God, Inc. Drinking Water Well, Palmer, Alaska

DRINKING WATER PROTECTION PROGRAM REPORT 106

By Michael Baxter, B.E.S.T. Resource

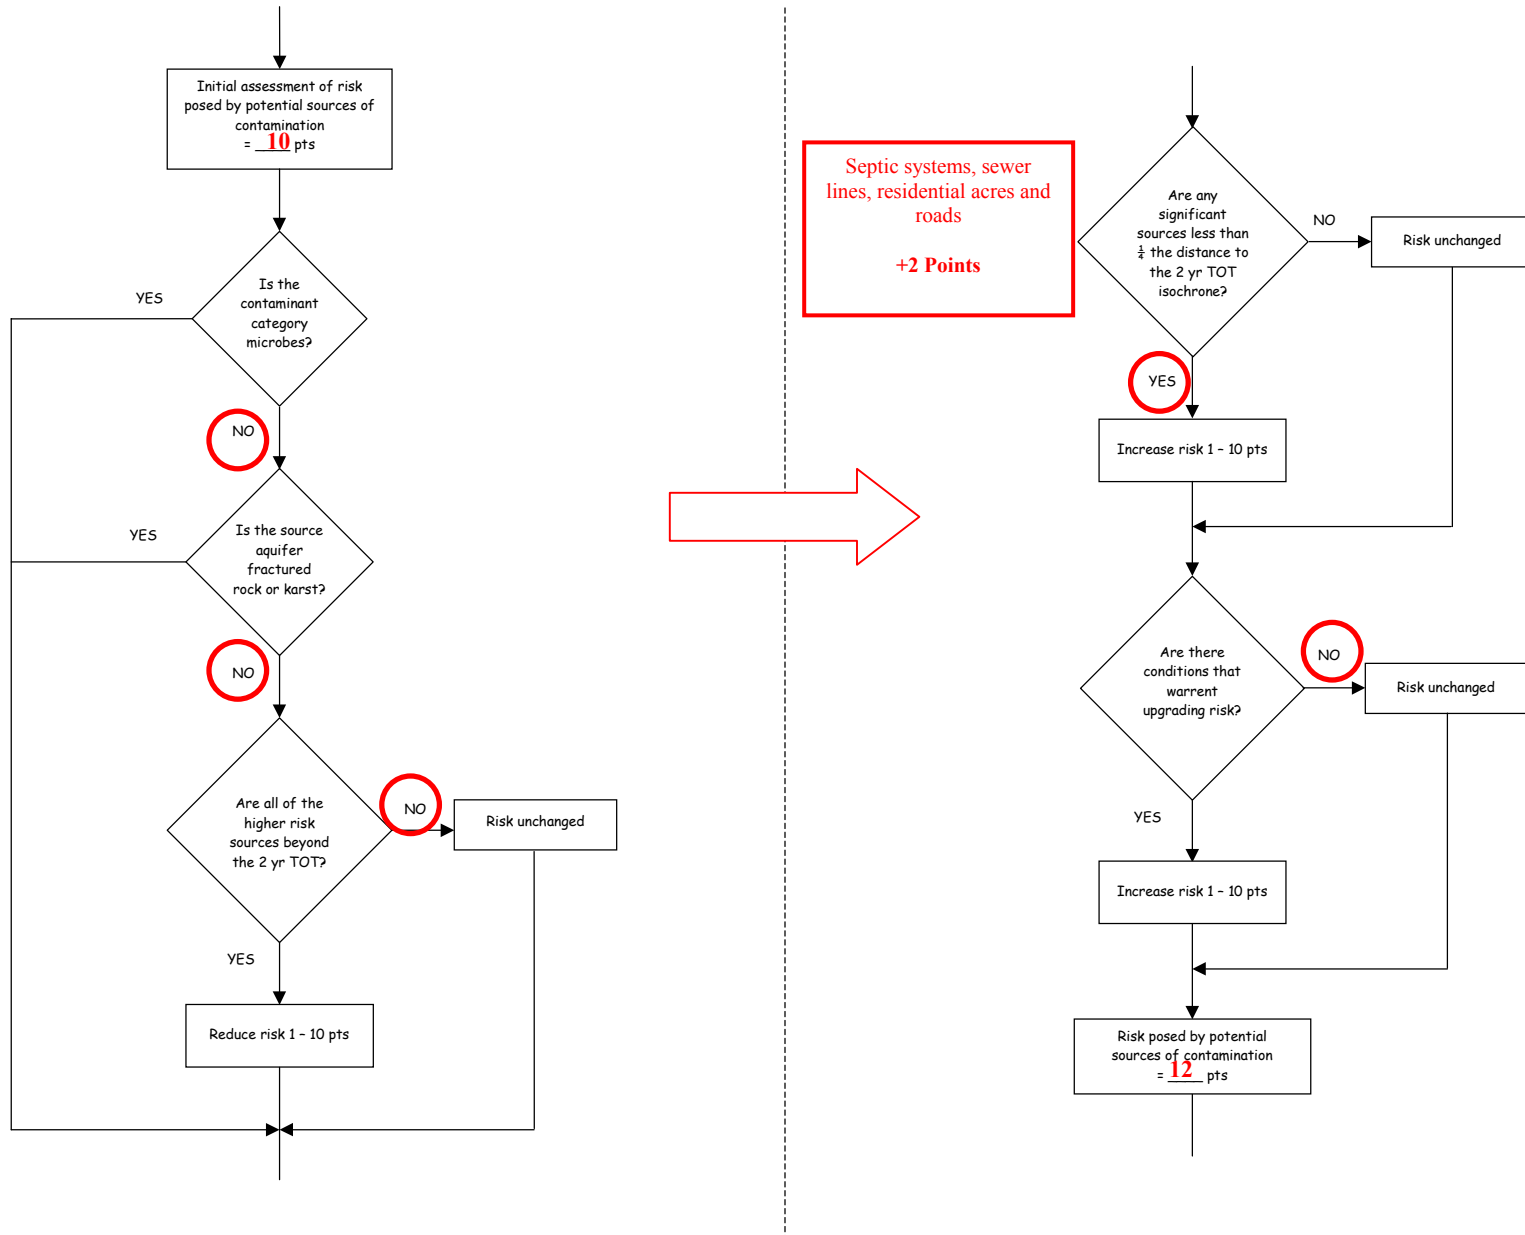
Chart 7. Contaminant risks for Palmer Church of God, Inc. – Volatile Organic Chemicals (Continued)

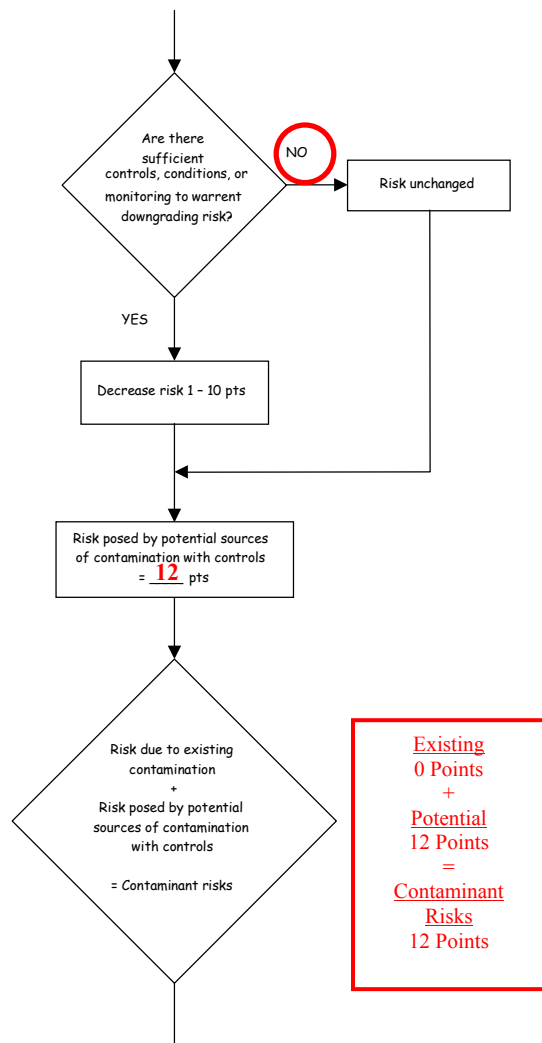
Chart 7. Contaminant risks for Palmer Church of God, Inc. – Volatile Organic Chemicals (Continued)

\* Truncate risk at 50 pts

Contaminant risks\* = 12 pts

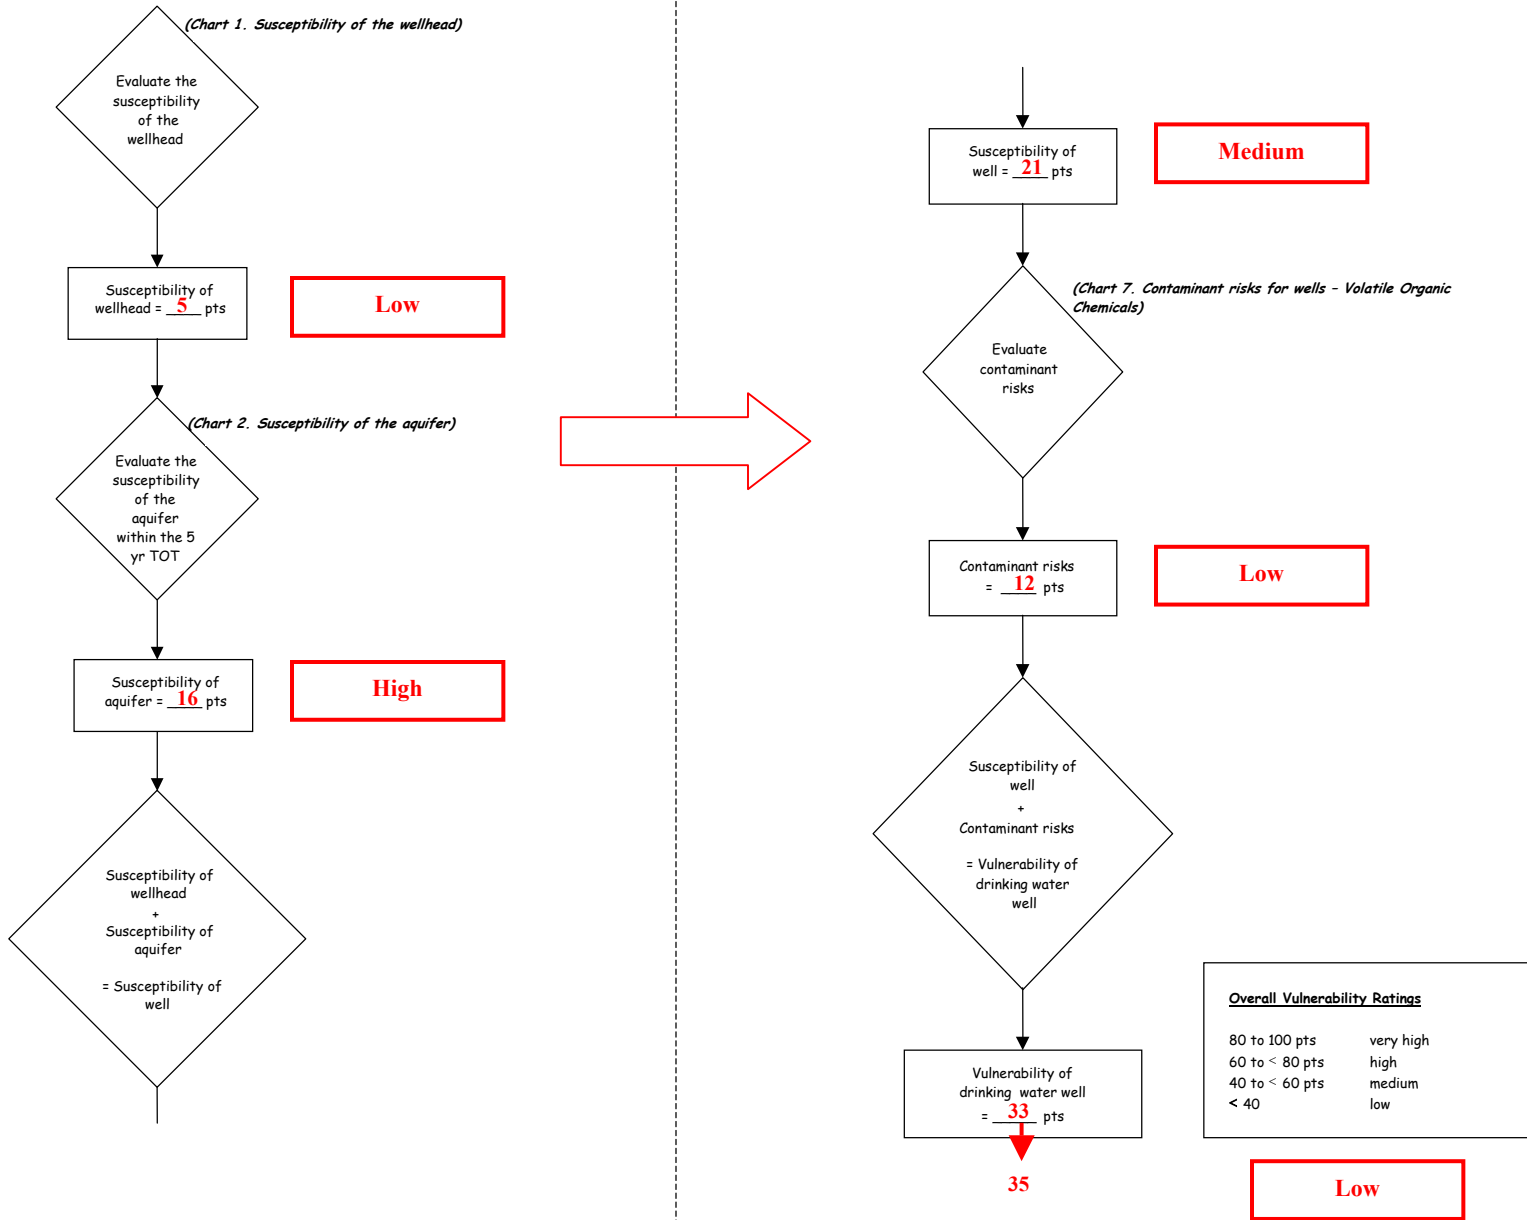
**Chart 8. Vulnerability analysis for Palmer Church of God– Volatile Organic Chemicals**
