# **Source Water Assessment** for Mountain View Estates

A Hydrogeologic Susceptibility and Vulnerability Assessment

DRINKING WATER PROTECTION PROGRAM REPORT 412 PWSID 226509.001

Alaska Department of Environmental Conservation

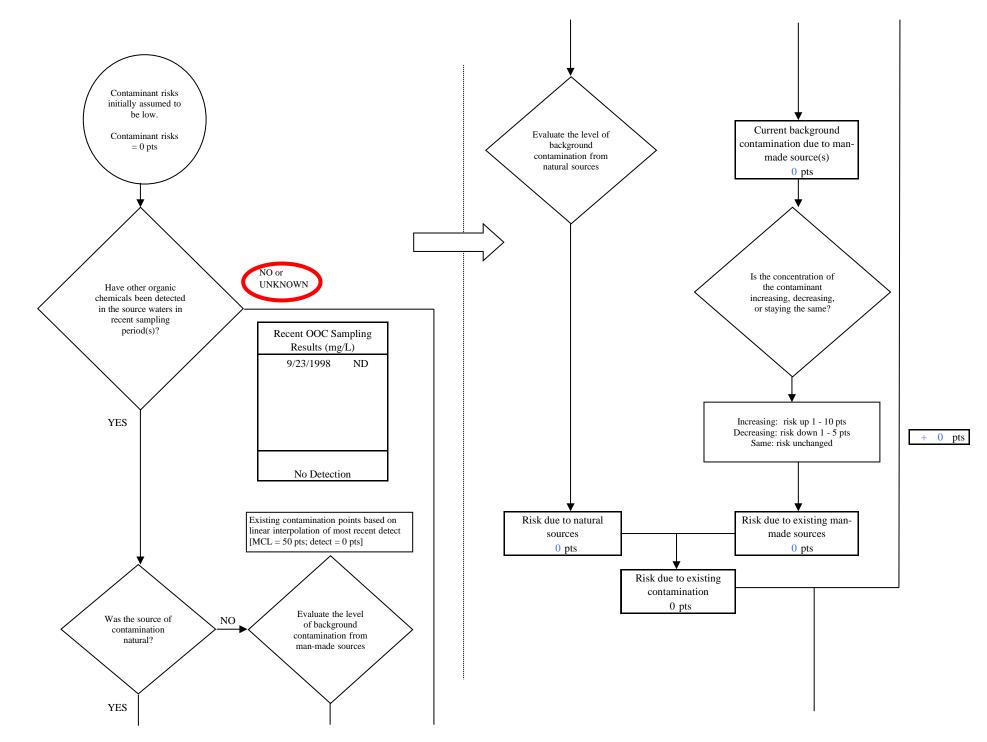
Chart 13. Contaminant risks for Mountain View Estates - Other Organic Chemicals
