Hydrogeologic Susceptibility and Vulnerability Assessment for Alaska
R&R Laundry and RV Park Drinking Water Well, Wasilla, Alaska

DRINKING WATER PROTECTION PROGRAM REPORT 80

By Shannon & Wilson, Inc.

ALASKA DEPARTMENT OF ENVIRONMENTAL CONSERVATION: OCTOBER 2001
CONTENTS

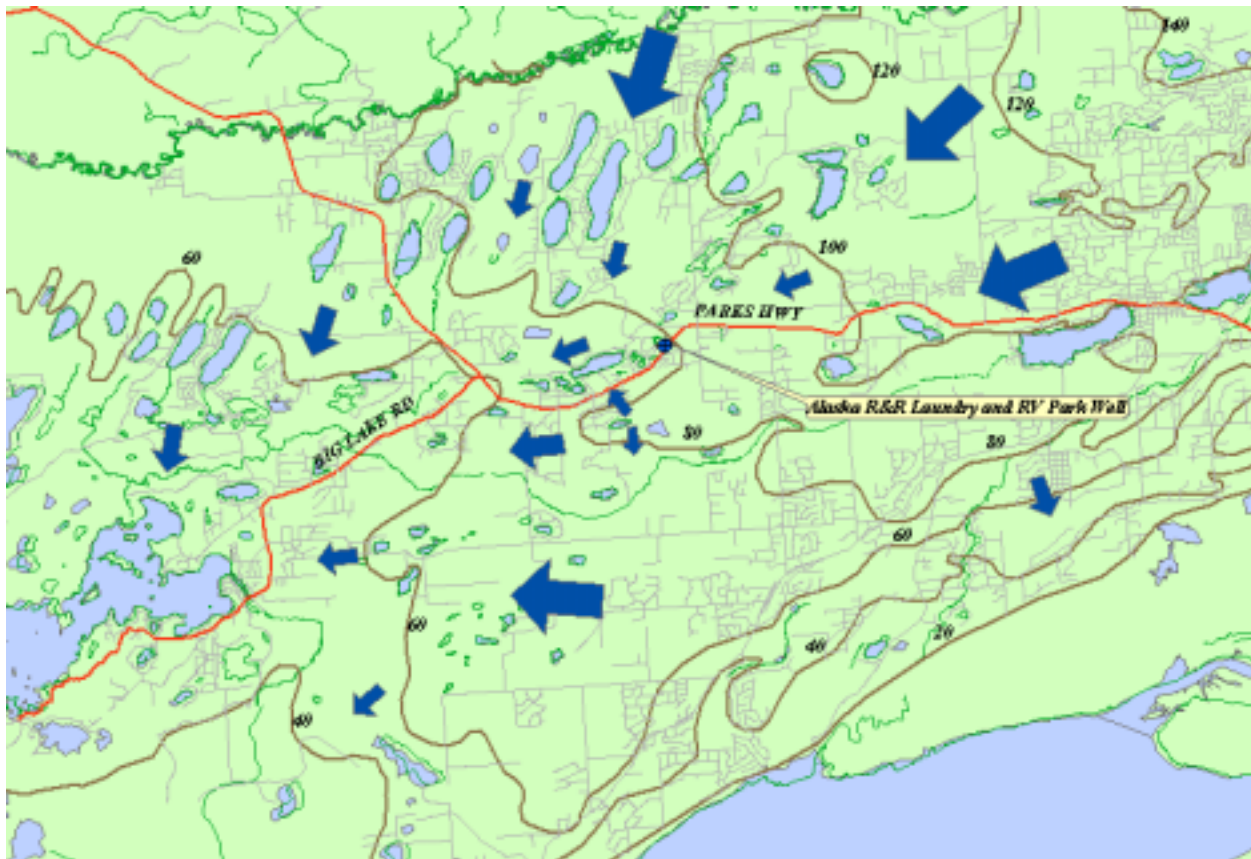
Figure 2. Map showing regional ground-water flow in Matanuska-Susitna Valley. (Jokela, Munter and Evans, 1991)

Groundwater flow in the confined aquifer is generally, north to south in the central region of the valley, toward the Matanuska River in the eastern region and the slope is predominantly northeast to northwest in the western region. The direction of groundwater flow in the upper unconfined aquifer's are more variable due to the influence from surficial topography as well as its close connection with surface water bodies. (*Jokela, Munter and Evans, 1991*) (Figure 2).
