Source Water Assessment for
Southside Church of God
Anchorage, Alaska

A Hydrogeologic Susceptibility and Vulnerability Analysis

DRINKING WATER PROTECTION PROGRAM REPORT 163
PWSID 214023.001

December 2001

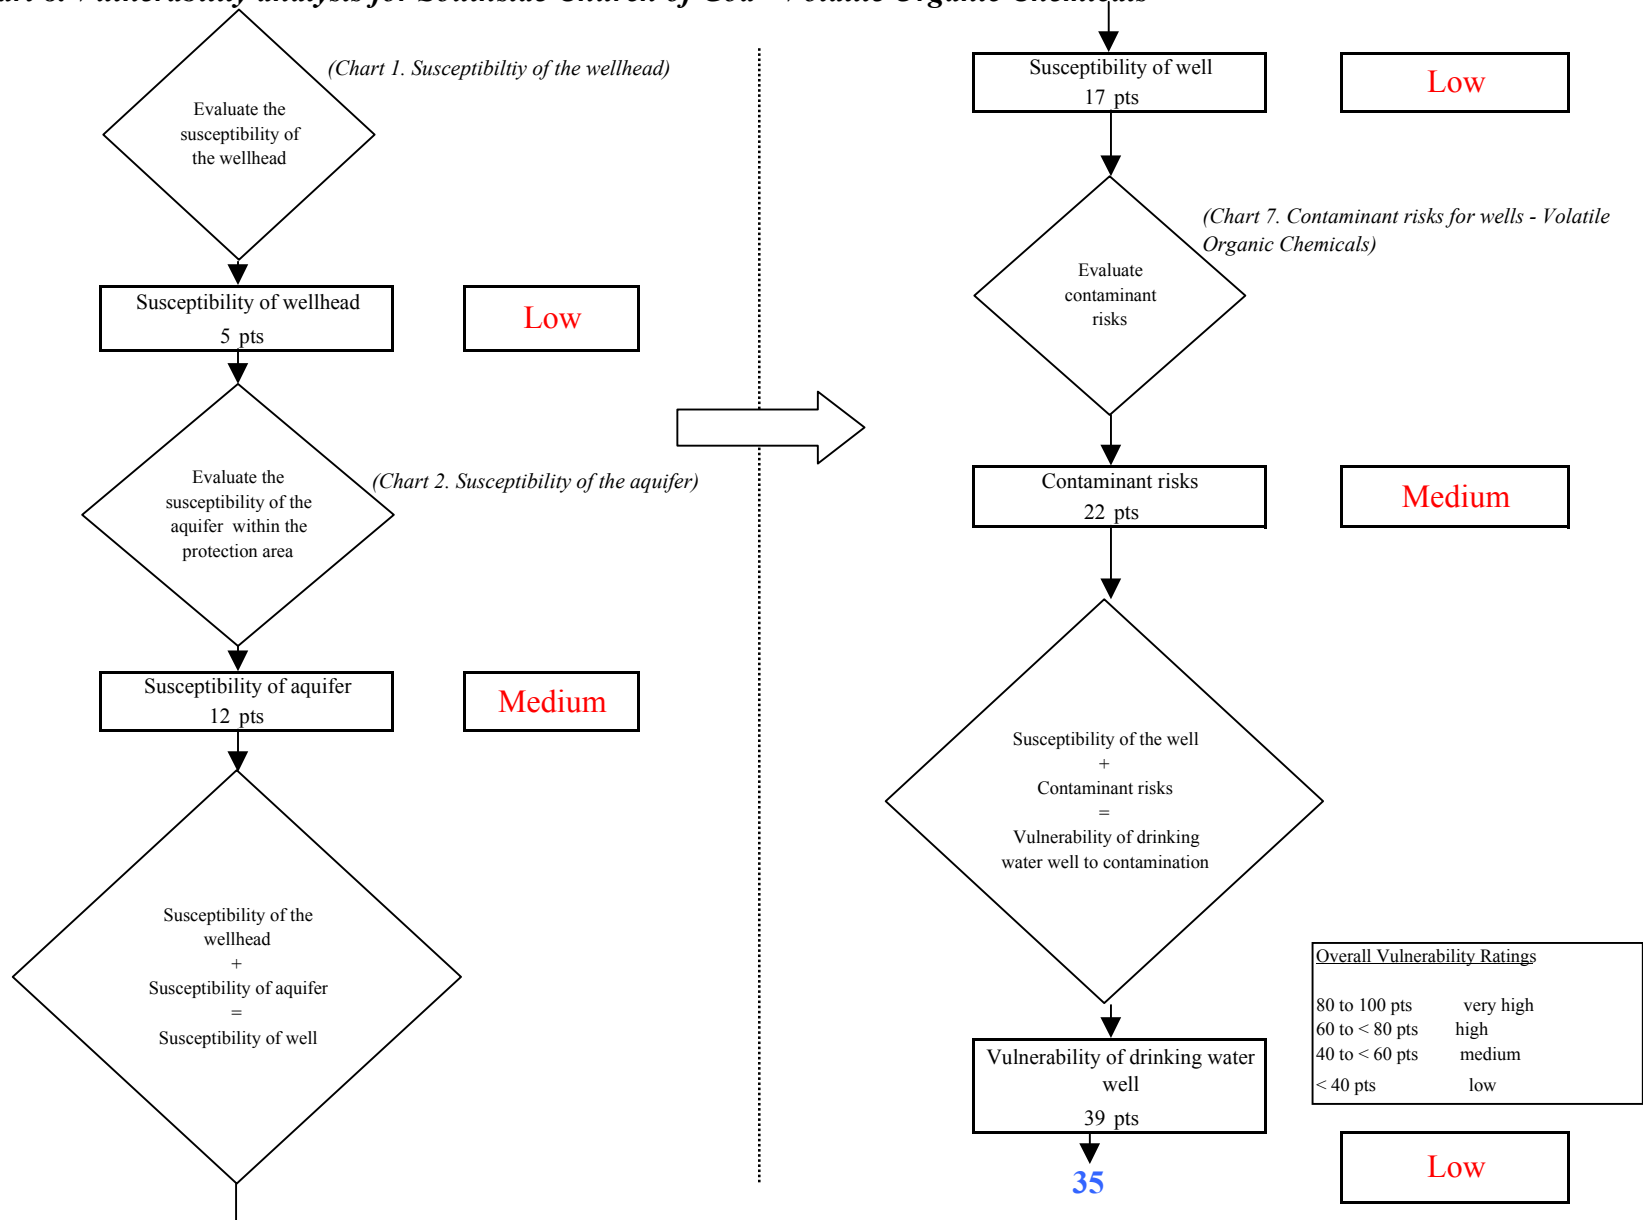
Chart 8. Vulnerability analysis for Southside Church of God - Volatile Organic Chemicals

Combining this potential volatile organic chemical contamination risk with the natural susceptibility of the well leads to an overall vulnerability to contamination of low.
