Source Water Assessment

A Hydrogeologic Susceptibility and Vulnerability Assessment for Anchor Point Church of Nazarene Drinking Water System, Anchor Point, Alaska PWSID # 245074 June 2003

DRINKING WATER PROTECTION PROGRAM REPORT # 645 Alaska Department of Environmental Conservation

By Ecology & Environment, Inc.

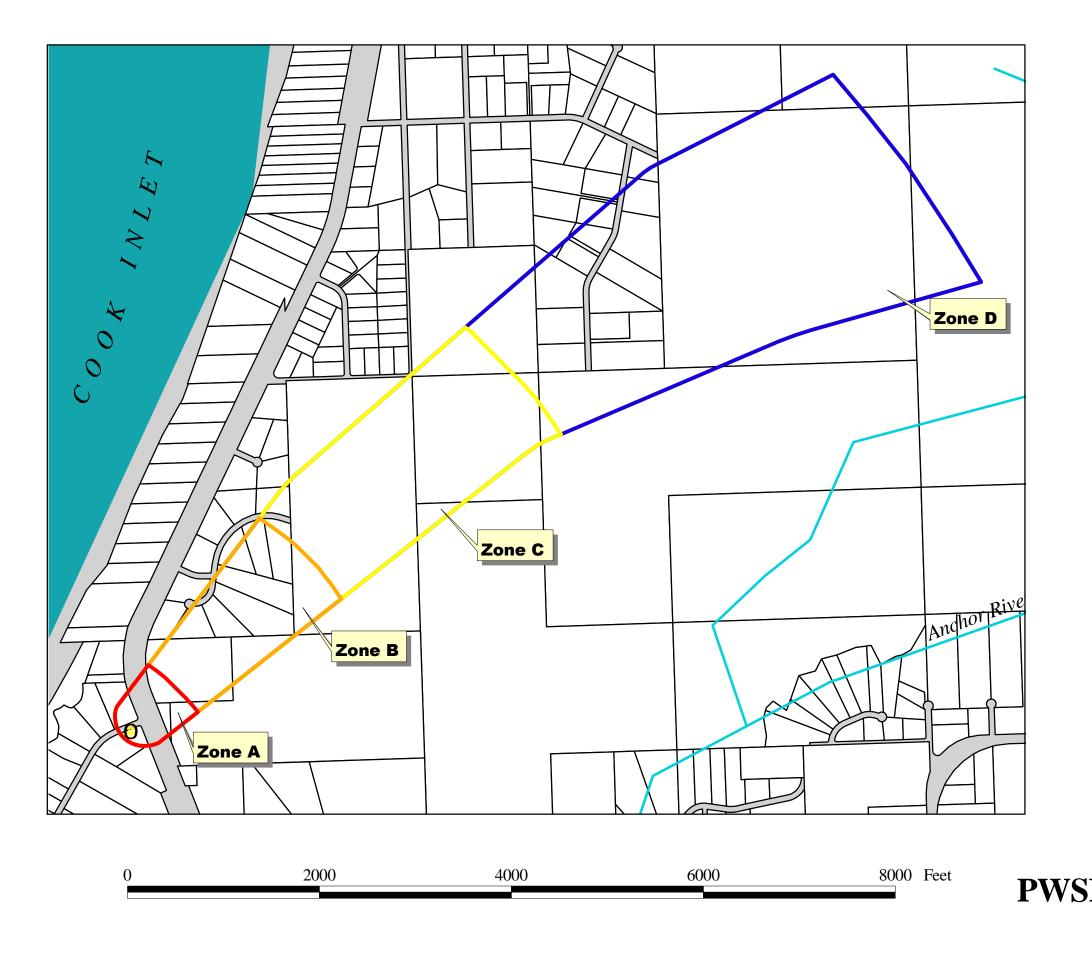
Anchor Point Church of Nazarene Drinking Water Protection Area (Map 1)

Drinking Water Protection Area for Anchor Point Church of Nazarene

Anchor Point Church of Nazarene Well

- Zone A (Few Months Travel Time)
- Zone B (Less Than 2 Years Travel Time)
- Zone C (Less Than 5 Years Travel Time)
- Zone D (Less Than 10 Years Travel Time)

The Anchor Point area is located at mile 156 of the Sterling Highway near the confluence of the North and South forks of the Anchor River (see Inset of Map 1 of Appendix A).

The DWPAs established for wells by the ADEC are separated into four zones. These zones correspond to differences in the time-of-travel (TOT) of the water moving through the aquifer to the well. The time of travel for contaminants within the water varies and is dependent on the physical and chemical characteristics of each contaminant. The following is a summary of the four DWPA zones and the calculated time-of-travel for each:

А	¹ / ₄ the distance to the 2-year time-of-travel
В	Less than the 2-year time-of-travel
С	Less than the 5-year time-of-travel
D	Less than the 10 year time-of-travel

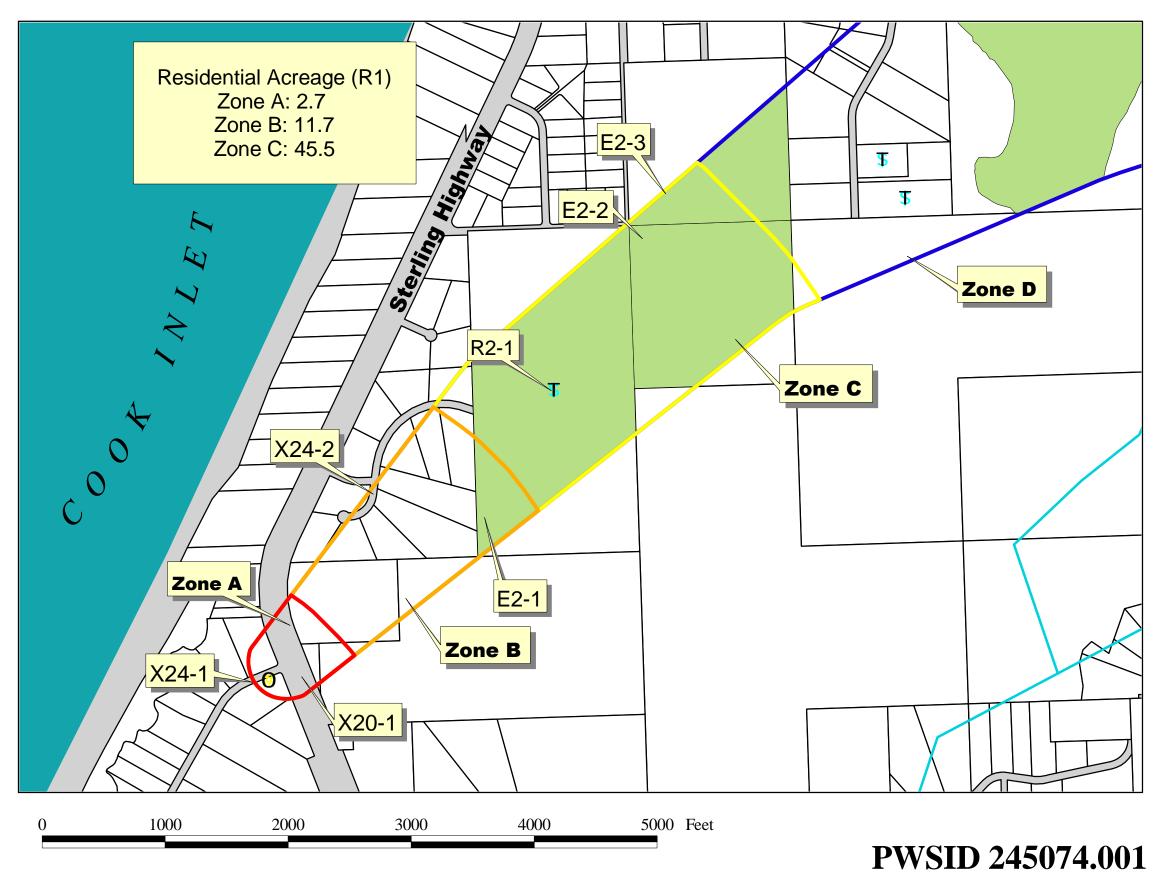
Anchor Point Church of Nazarene Drinking Water Protection Area and Potential and Existing Contaminant Sources (Map 2)

Drinking Water Protection Area for Anchor Point Church of Nazarene and Existing and Potential Sources of Contamination

Anchor Point Church of Nazarene Well Septic Systems-R2
Zone A (Few Months Travel Time)
Zone B (Less Than 2 Years Travel Time)
Zone C (Less Than 5 Years Travel Time)
Zone D (Less Than 10 Years Travel Time)
Logging (Past and Present)-E2

Inventoried potential sources of contamination within the drinking water protection area were associated with residential and light industrial type activities. The sources are displayed on Map 2 of Appendix C and summarized in the tables in Appendix B.

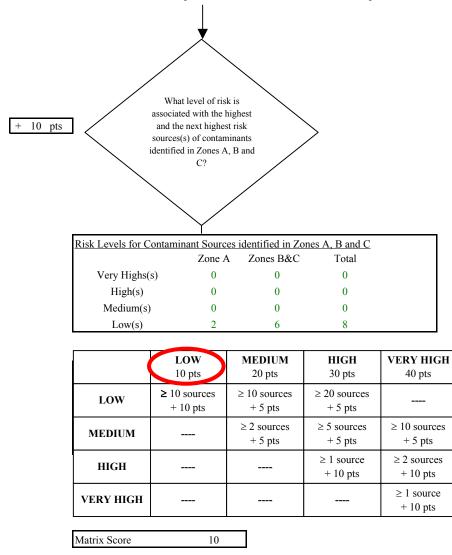
Chart 5. Contaminant risks for -Anchor Point Church of the Nazarene-Nitrates and Nitrites

Note: Septic systems, sewerlines, and roads are each assigned a risk ranking for each individual contaminant source in the CSI. The VA, however, counts these contaminant sources as a group and assigns a calculated number of either "lows" or "mediums" based on the density.

The contaminant risk for nitrates and nitrites is Low with the roads, residential areas, septic systems and active logging areas representing the risk to this source of public drinking water (See Chart 5 - Contaminant Risks for Nitrates and/or Nitrites in Appendix D). Nitrates are very mobile, moving at approximately the same rate as water.
