Source Water Assessment

A Hydrogeologic Susceptibility and
Vulnerability Assessment for
CH2M Hill Beluga Lodge
Public Drinking Water System,
Beluga, Alaska
PWSID # 249387.001

DRINKING WATER PROTECTION REPORT 1731

January, 2009

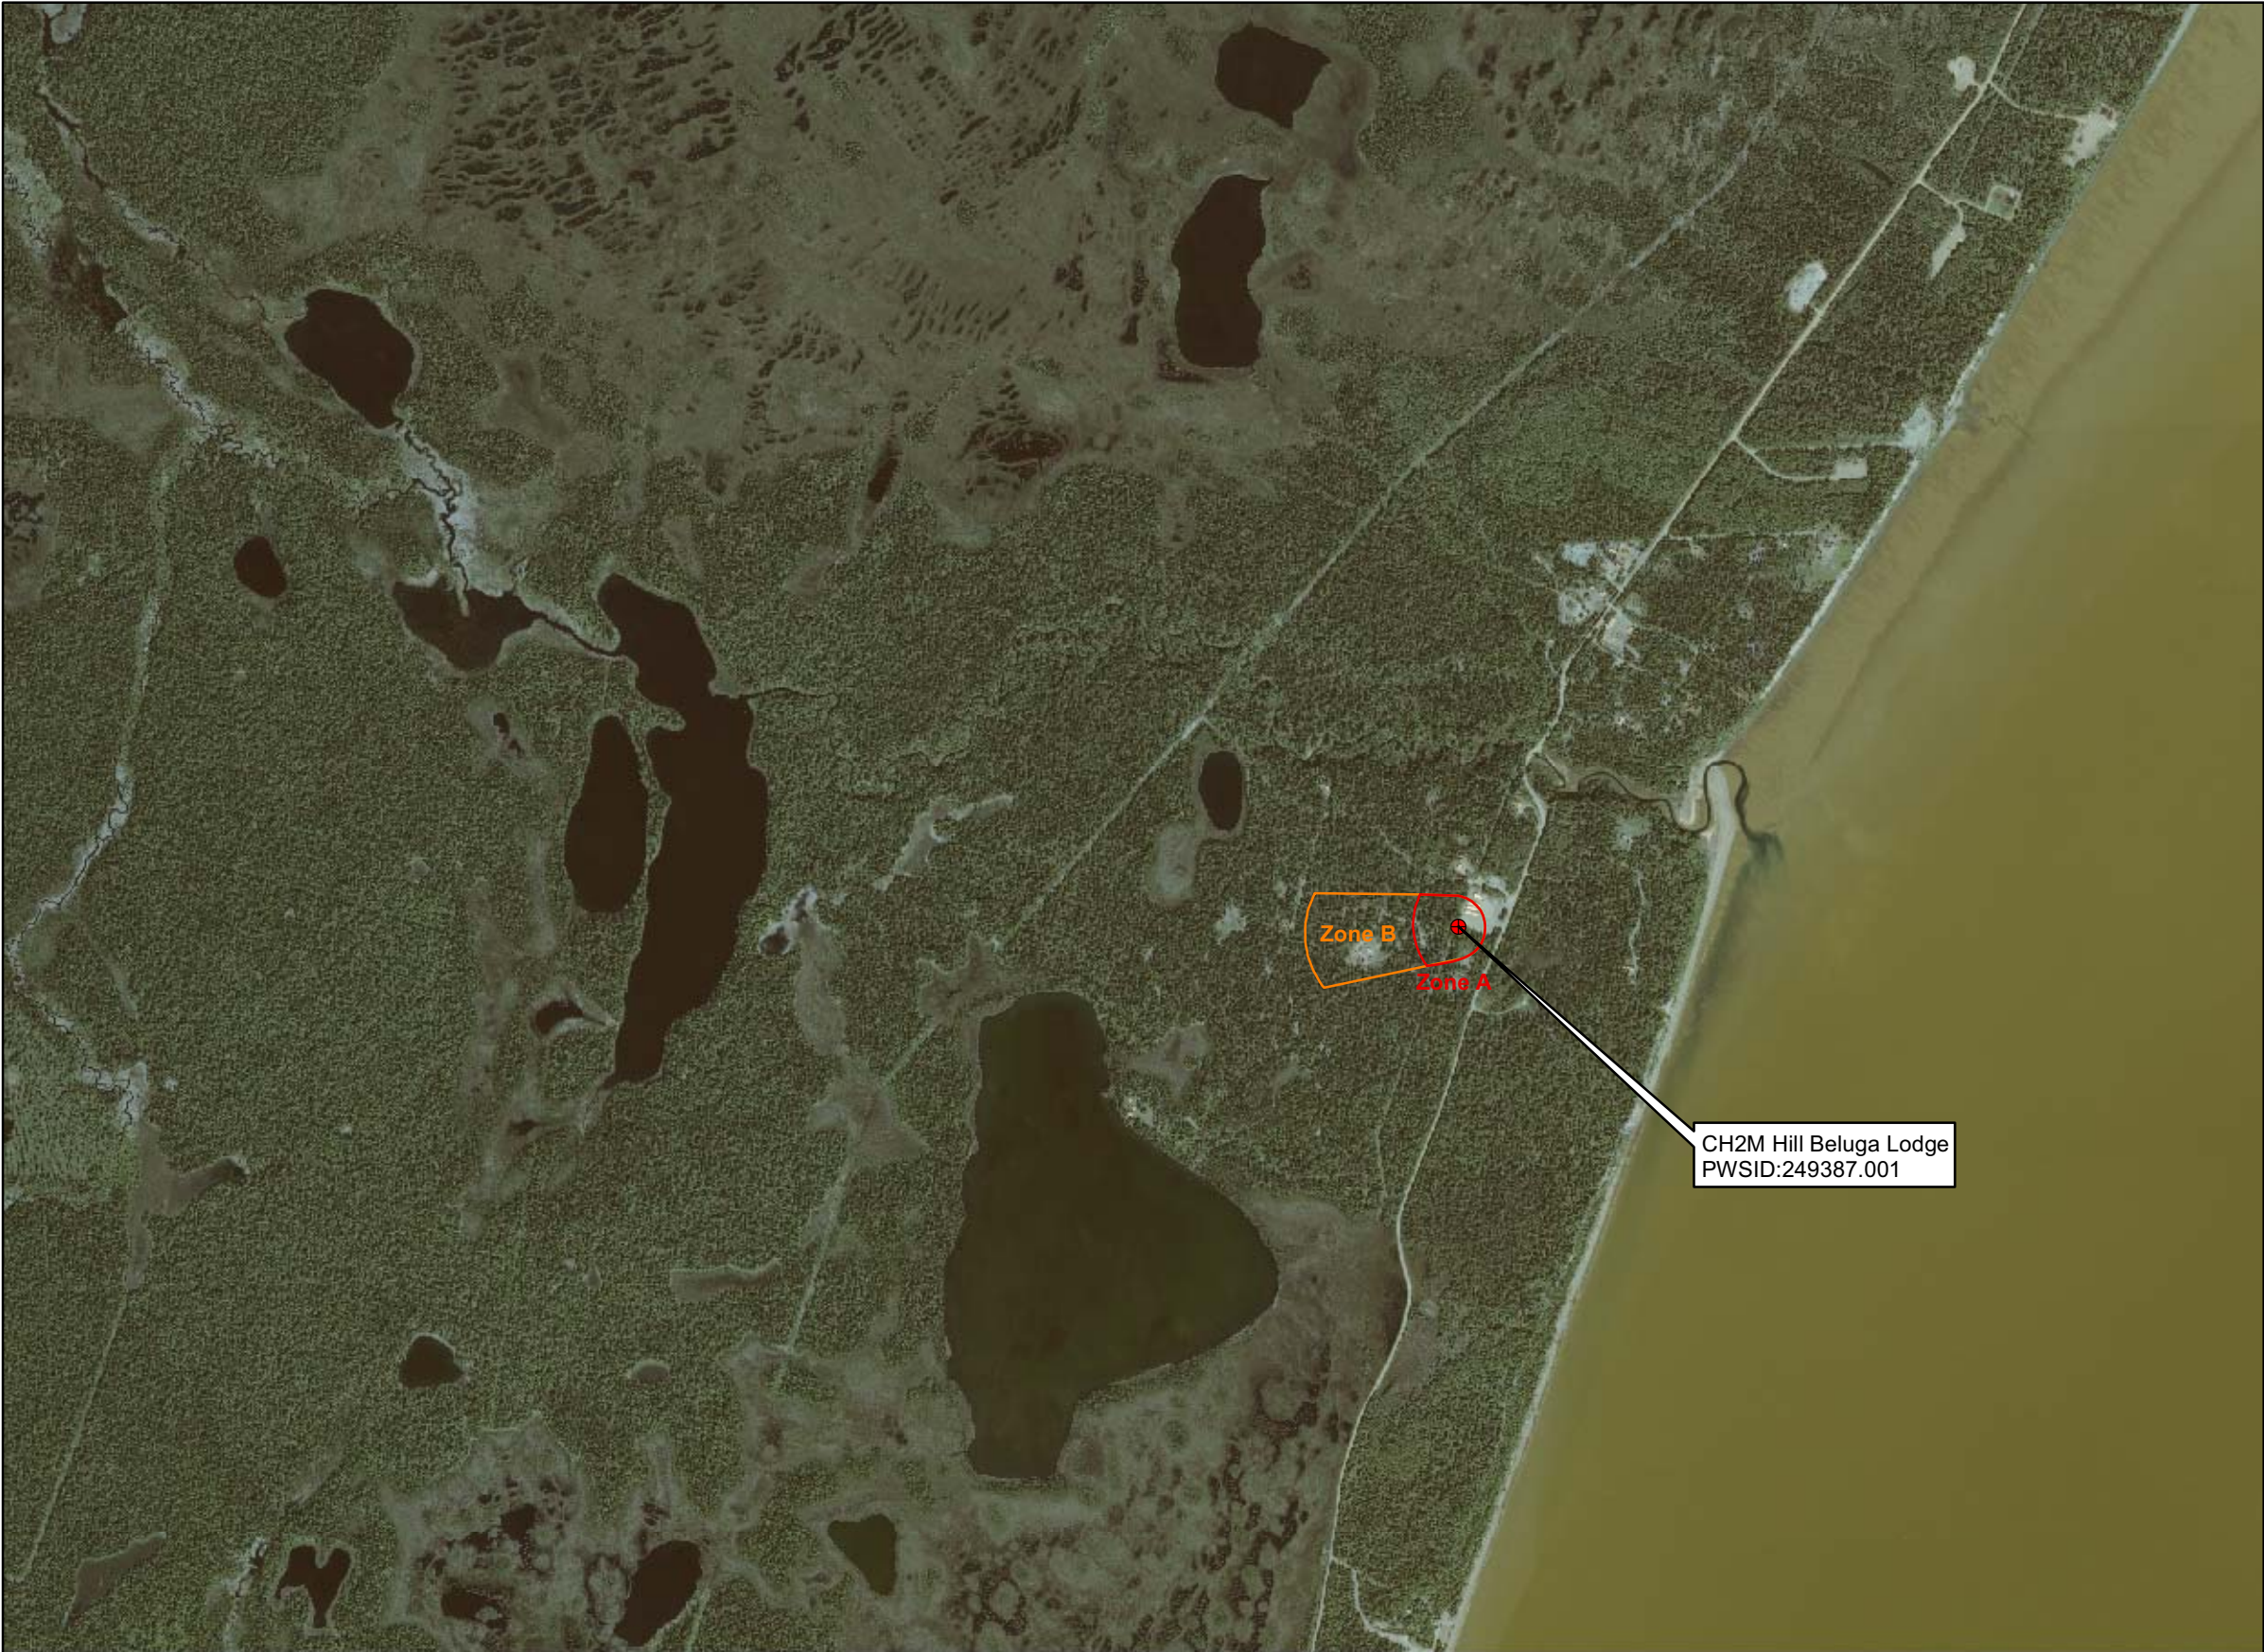
Appendix A Map A

CH2M Hill Beluga Lodge Drinking Water Protection Area Location Map (Map A)

Public Water Well System for PWS #249387.001 CH2M Hill Beluga Lodge

The CH2M Hill Beluga Lodge public water system is a Class B (transient/non-community) water system. The system consists of one well located on Three Mile Creek near Beluga, Alaska (see Map A in Appendix A). The community of Beluga (population 19) is located along the western coast of Cook inlet, approximately 40 air miles west of Anchorage. It lies within the Kenai Peninsula Borough, which has a population of approximately 50,000 and encompasses an area of more than 25,600 square miles (KPB, 2008).

The drinking water protection area for CH2M Hill Beluga Lodge was determined using an analytical calculation and includes Zones A and B (see Map A in Appendix A).

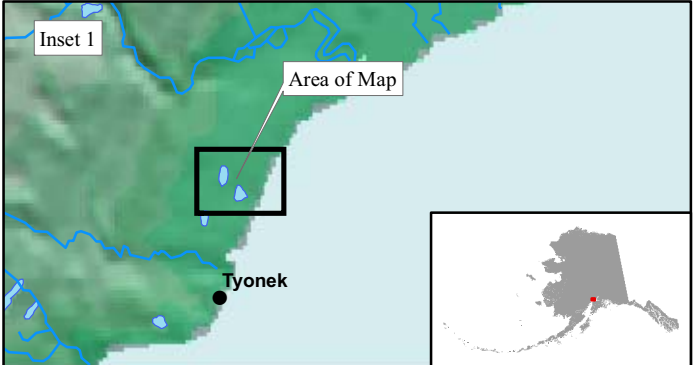
Drinking Water Protection Areas based on "Alaska Drinking Water Protection Program - Guidance Manual for Class B Public Water Systems" published by ADEC

CH2M Hill Beluga Lodge
PWS 249387.001

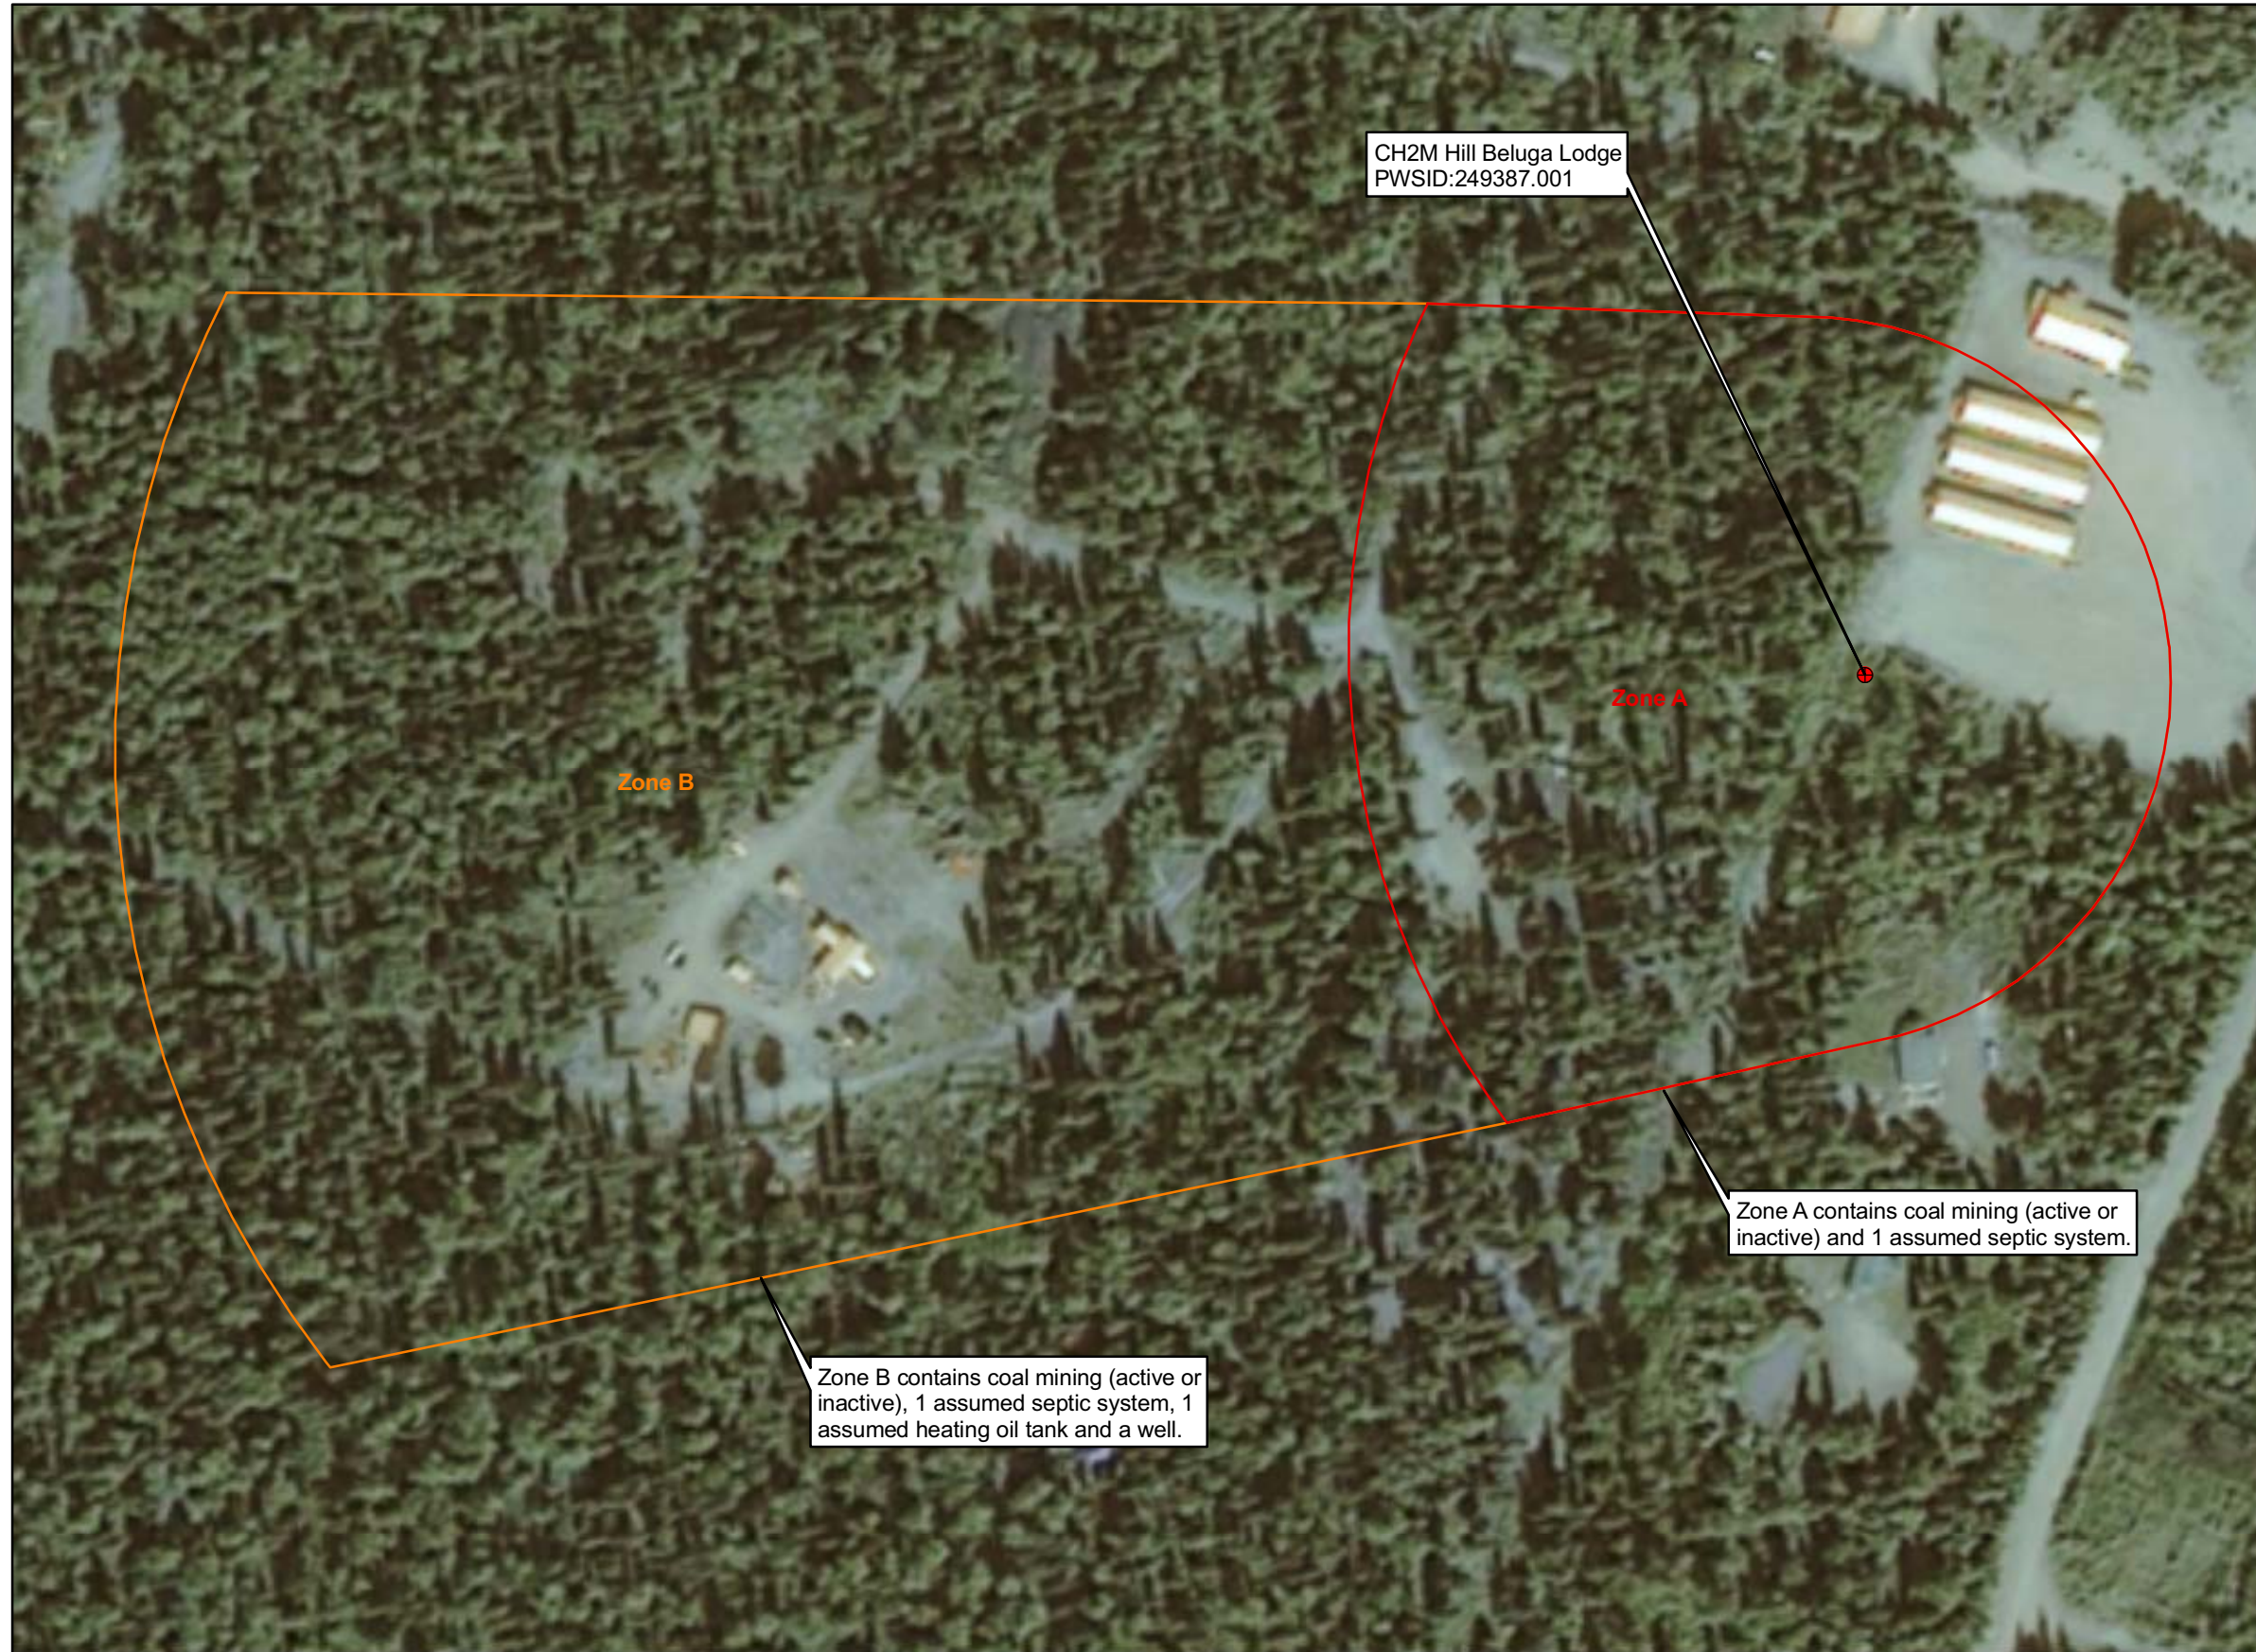
CH2M Hill Beluga Lodge Drinking Water Protection Area and Potential and Existing Contaminant Sources (Map C)

**Public Water Well System for PWS # 249387.001 CH2M Hill Beluga Lodge
Showing Potential and Existing Sources of Contamination**

The sources are displayed on Map C of Appendix C and summarized in Table 1 of Appendix B.
