# Source Water Assessment

A Hydrogeologic Susceptibility and  
Vulnerability Assessment for  
USFWS Yukon Delta Headquarters  
Drinking Water System,  
Bethel, Alaska

PWSID # 271538.001

DRINKING WATER PROTECTION PROGRAM REPORT 1473  
Alaska Department of Environmental Conservation

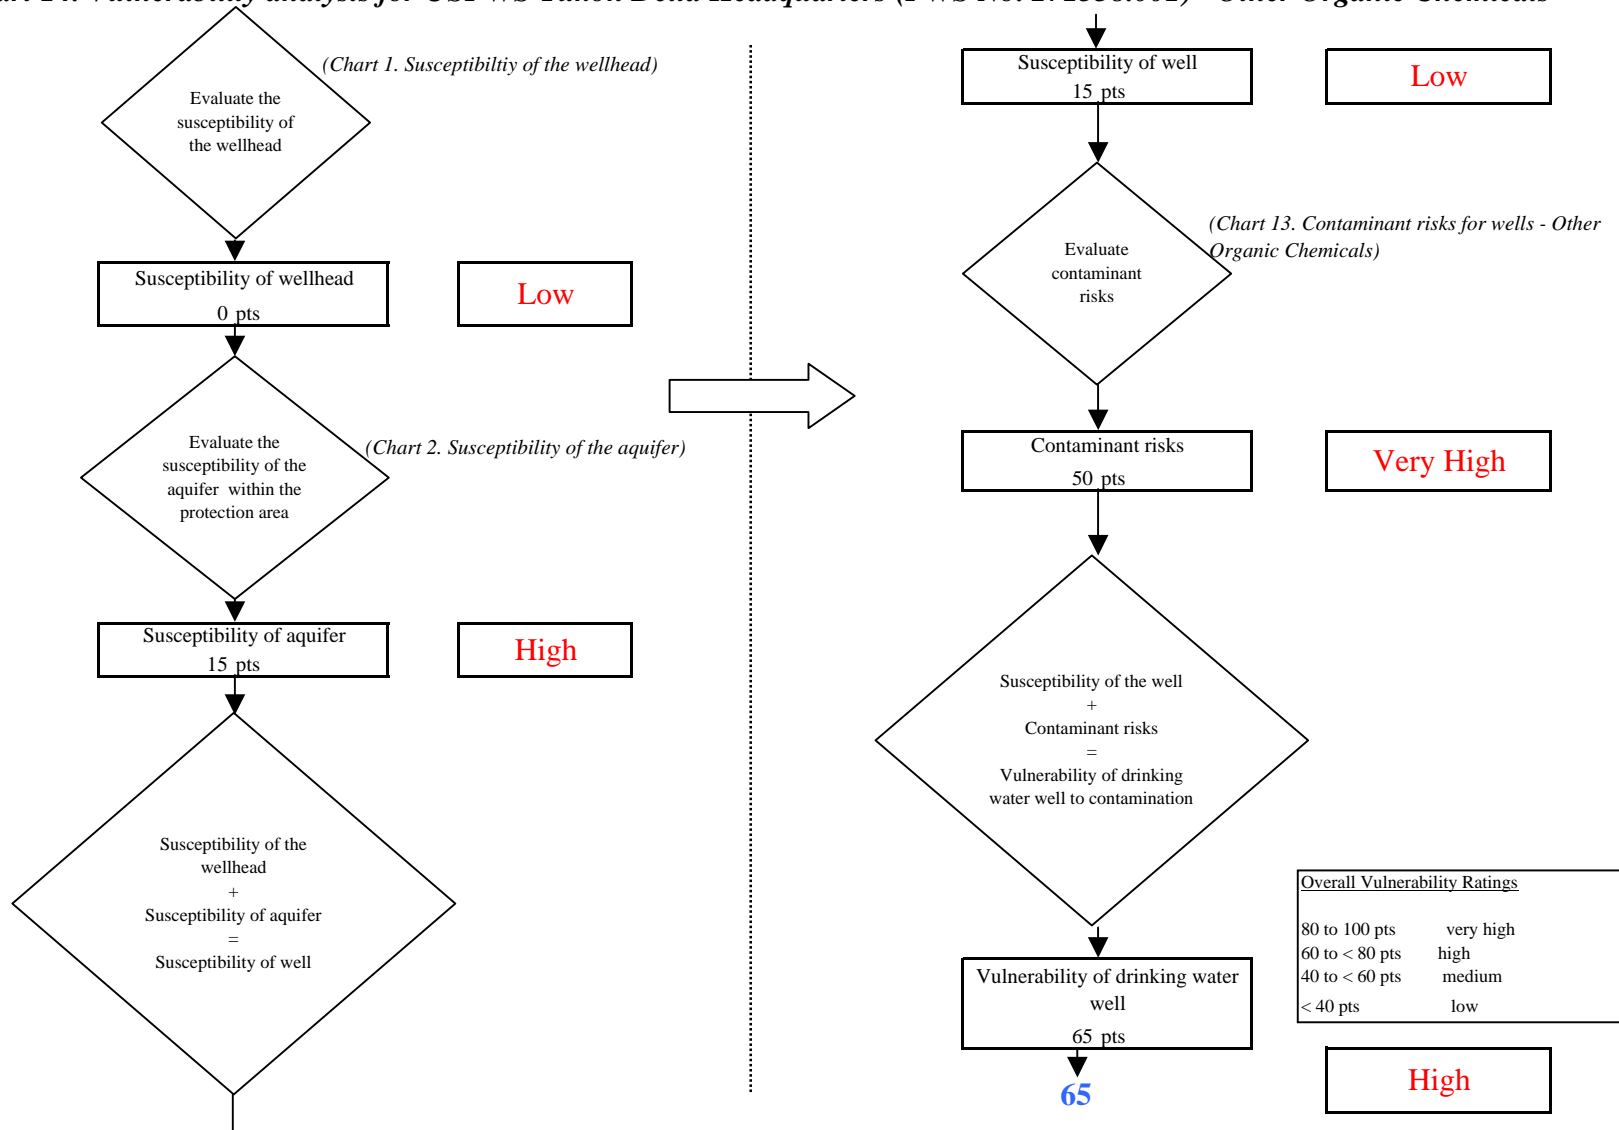
**Chart 14. Vulnerability analysis for USFWS Yukon Delta Headquarters (PWS No. 271538.001) - Other Organic Chemicals**
