A Hydrogeologic Susceptibility and Vulnerability Assessment for YKHC Bethel Hospital Drinking Water System, Bethel, Alaska

PWSID # 271083.001

May 2004

DRINKING WATER PROTECTION PROGRAM REPORT 1119 Alaska Department of Environmental Conservation

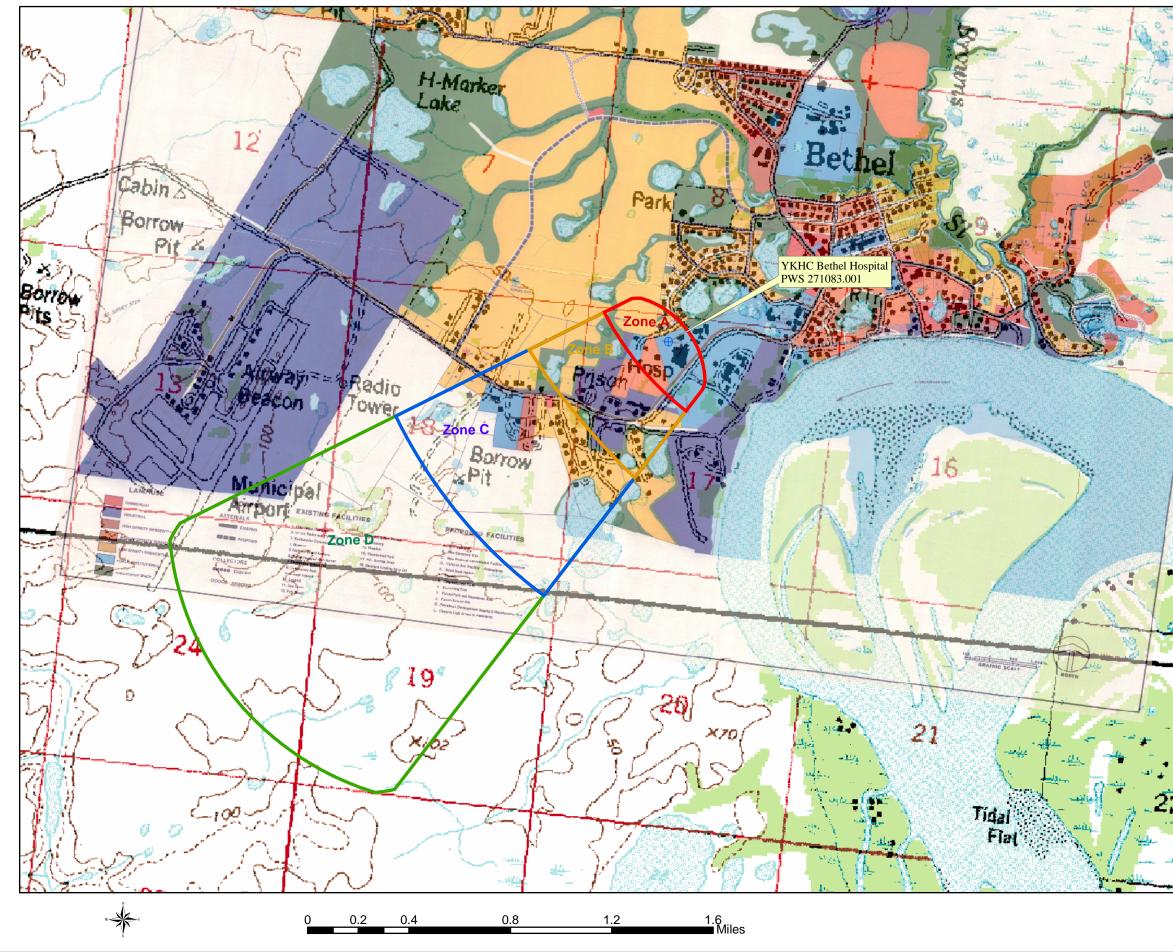
YKHC Bethel Hospital PWS 271083.001 Appendix A Map A

Public Water Well System for PWS #271083.001 YKHC Bethel Hospital

The DWPA for the YKHC Bethel Hospital PWS was determined using an analytical calculation and includes Zones A, B, C, and D (See Map A of Appendix A).

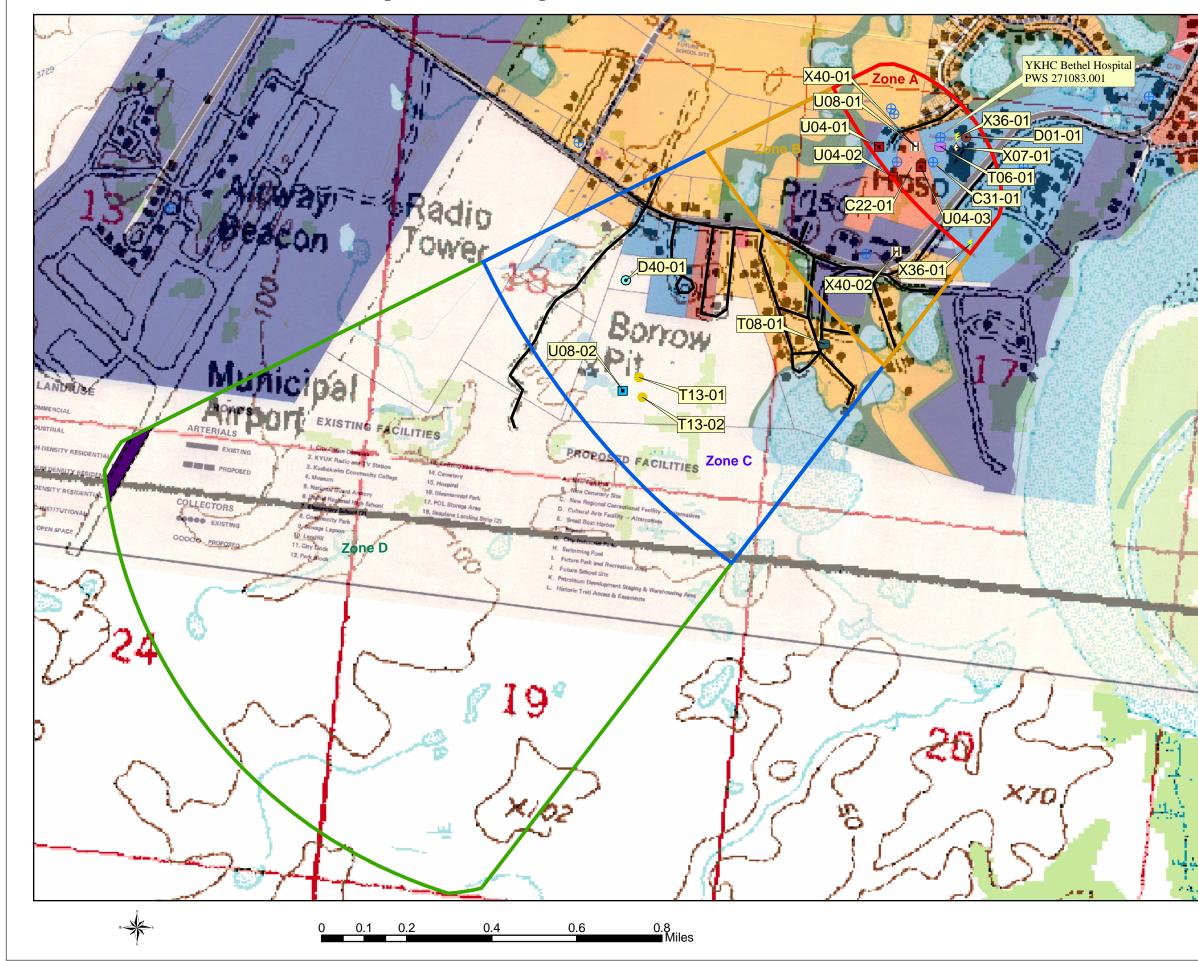
Public Water Well System for PWS #271083.001 YKHC Bethel Hospital

Showing Potential and Existing Sources of Contamination

The sources are displayed on Map C of Appendix C and summarized in Table 1 of Appendix B.

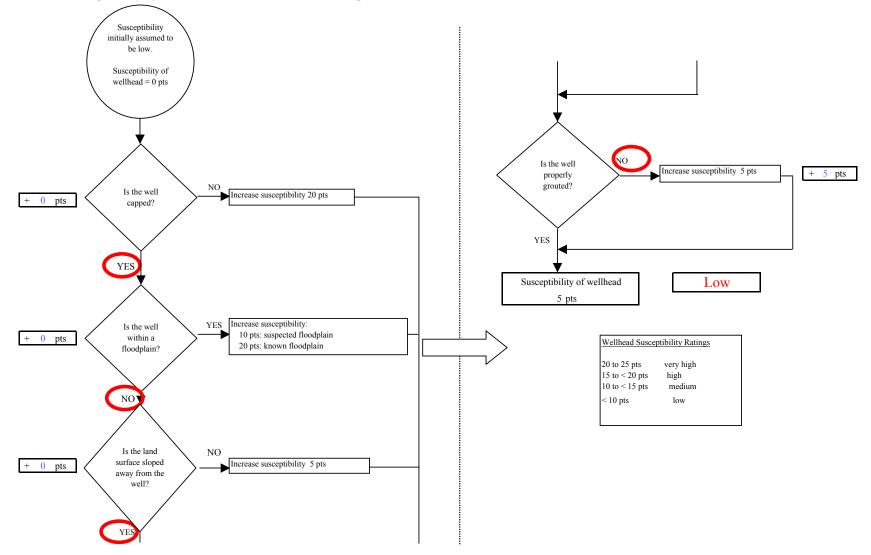
Chart 1. Susceptibility of the wellhead - YKHC Bethel Hospital (PWS No. 271083.001)

Susceptibility of the Wellhead (0 – 25 Points) (Chart 1 of Appendix D)

Score	Rating
Susceptibility of the	5	Low
Wellhead		
Susceptibility of the	15	High
Aquifer		
Natural Susceptibility	20	Medium

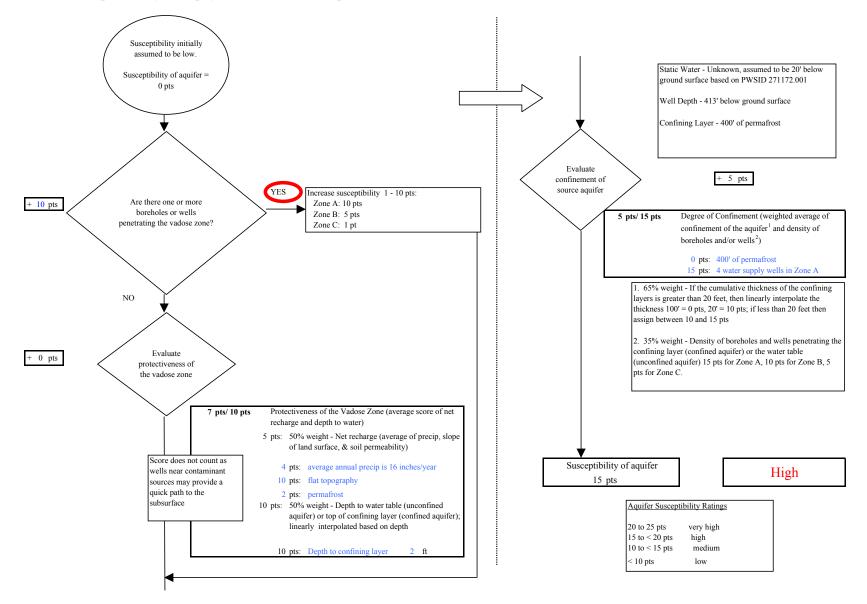
Chart 2. Susceptibility of the aquifer YKHC Bethel Hospital (PWS No. 271083.001)

Susceptibility of the Aquifer (0 – 25 Points) (Chart 2 of Appendix D)

The YKHC Bethel Hospital's water well is in a confined aquifer. Confined aquifers are less susceptible to potential groundwater quality impacts posed by the migration of surface water contaminants downward from the surface. Table 2 shows the susceptibility scores and ratings for this PWS.

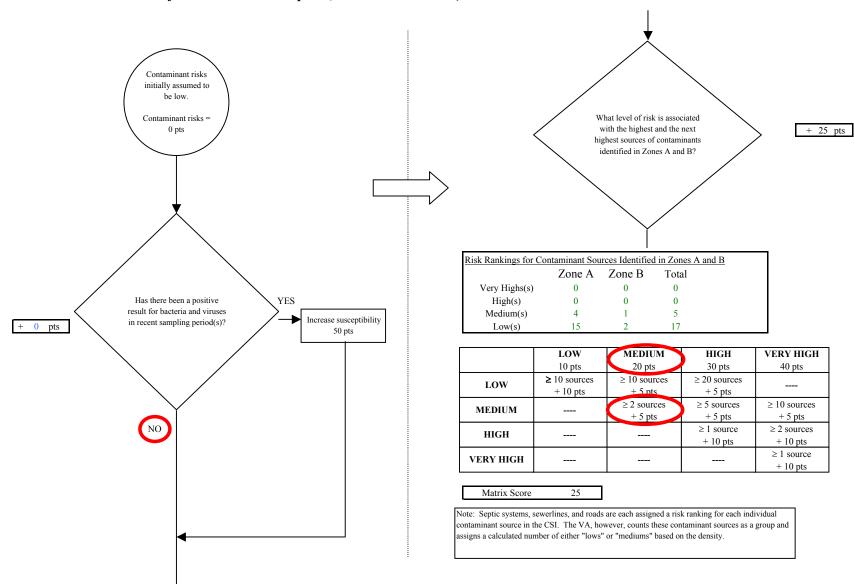
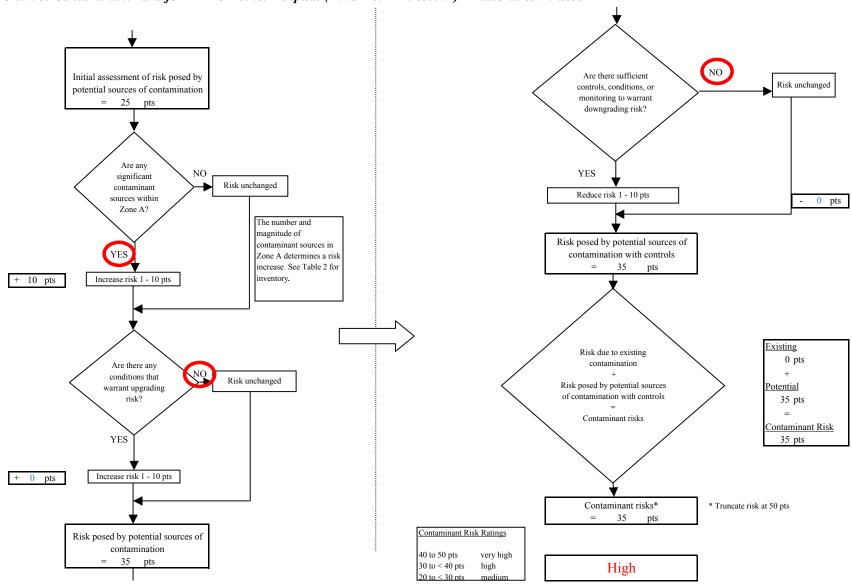
Chart 3. Contaminant risks for YKHC Bethel Hospital (PWS No. 271083.001) - Bacteria & Viruses

The contaminant risk for bacteria and viruses is **High**. The risk is primarily attributed to the presence of injection wells in Zone C (see Table 2 – Appendix B).

A positive bacteria count has not been reported in recent (within five years) sampling events (See Chart 3 – Contaminant Risks for Bacteria and Viruses in Appendix D). Only a small amount of bacteria and viruses are required to endanger public health.

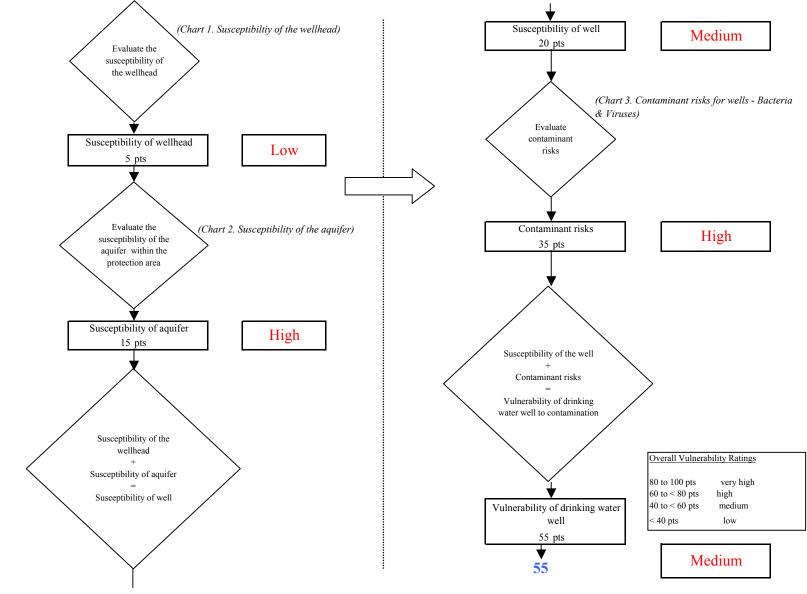
Chart 4. Vulnerability analysis for YKHC Bethel Hospital (PWS No. 271083.001) - Bacteria & Viruses

After combining the contaminant risk for bacteria and viruses with the natural susceptibility of the well, the overall vulnerability of the well to contamination is **Medium**.

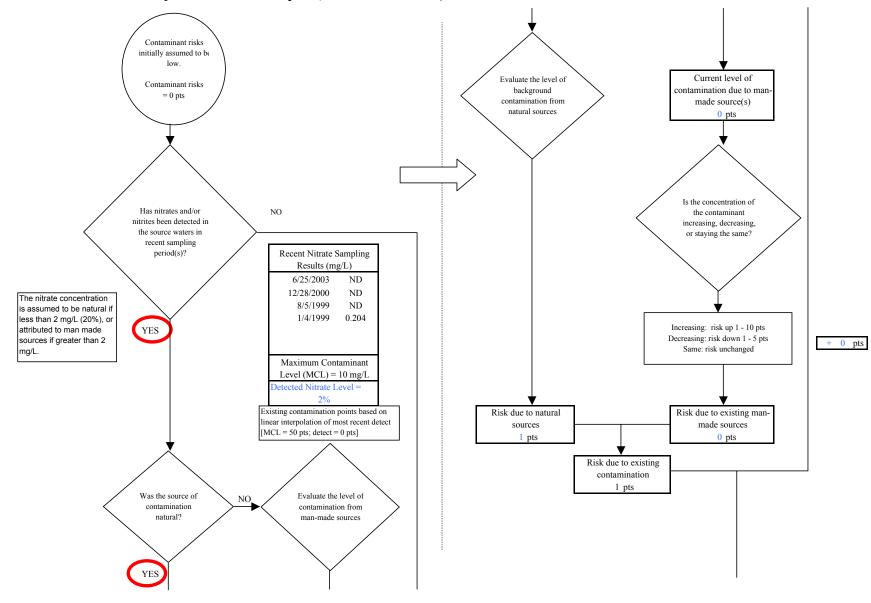
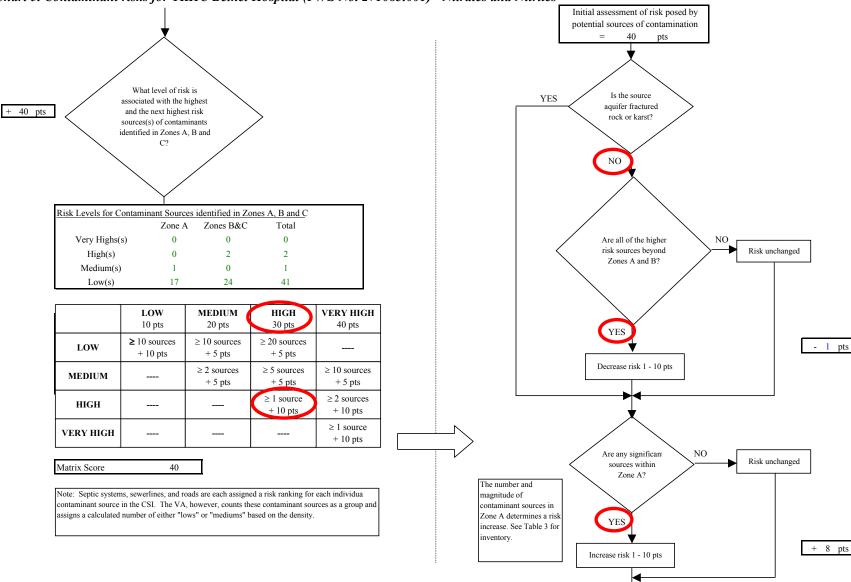
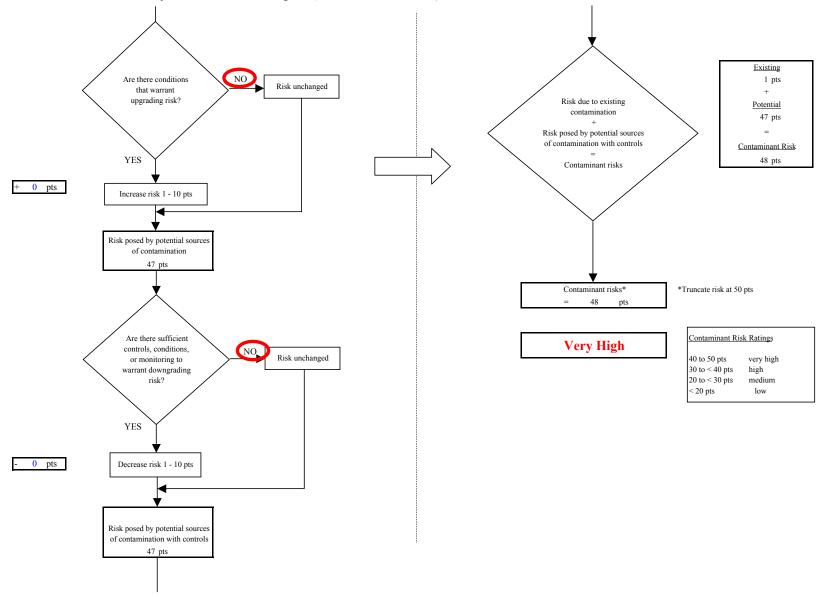
Chart 5. Contaminant risks for YKHC Bethel Hospital (PWS No. 271083.001) - Nitrates and Nitrites

The contaminant risk for nitrates and nitrites is **Very High**. The risk to this source of public drinking water is primarily attributed to the presence of injection wells in Zone C (see Table 3– Appendix B).

Nitrates are very mobile, moving at approximately the same rate as water. The sampling history for this well indicates that low levels of nitrates have been detected in recent sampling events. However, the reported concentrations of nitrates do not exceed the maximum contaminant level (MCL) of 10 mg/L. Nitrate concentrations in uncontaminated groundwater are typically less than 2 mg/L; therefore, nitrate concentrations above 2 mg/L may be indicative of man-made sources (See Chart 5 -Contaminant Risks for Nitrates and/or Nitrites in Appendix D).

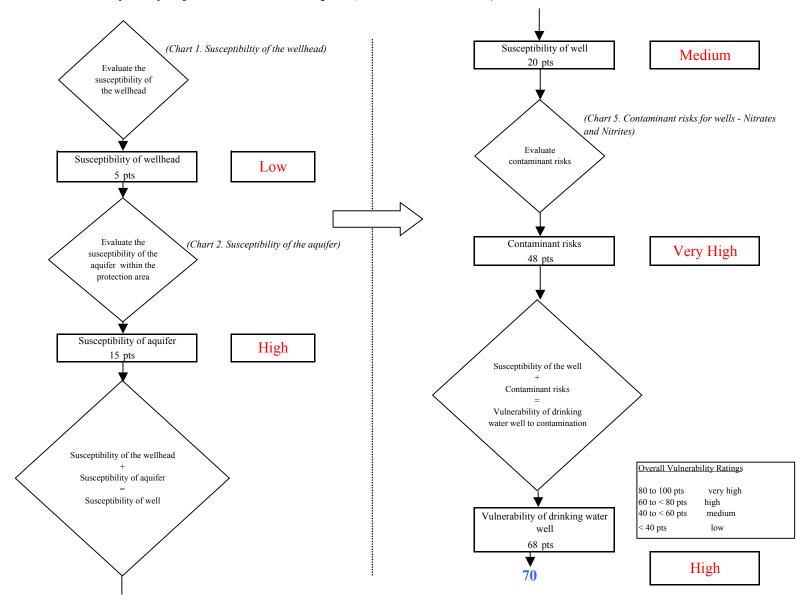
Chart 6. Vulnerability analysis for YKHC Bethel Hospital (PWS No. 271083.001) - Nitrates and Nitrites

Nitrate levels are often derived from the decomposition of organic matter in soils. Although the nitrate source is unknown, such occurrences may be attributed to septic systems or other sources. After combining the contaminant risk for nitrates and nitrites with the natural susceptibility of the well, the overall vulnerability of the well to nitrate and nitrite contamination is **High**.

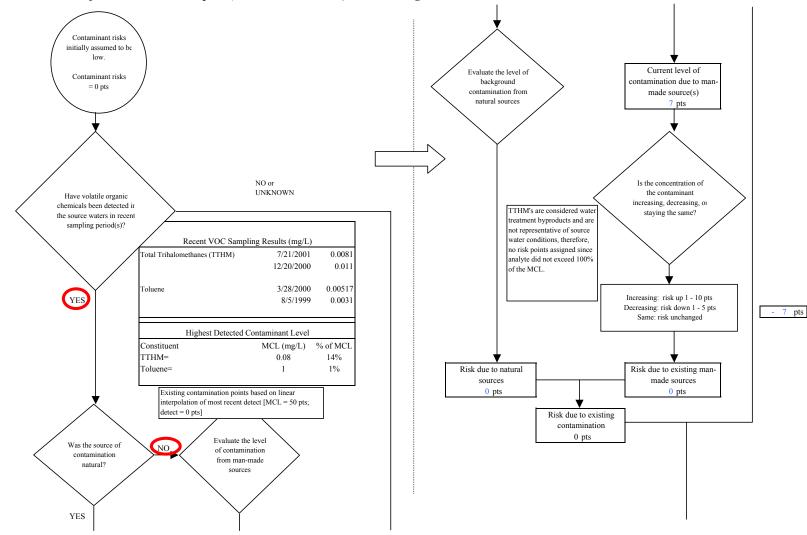
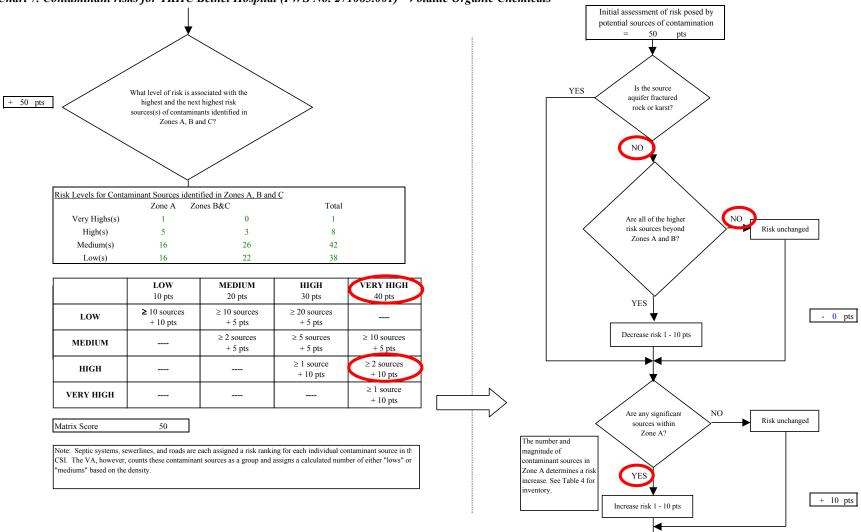
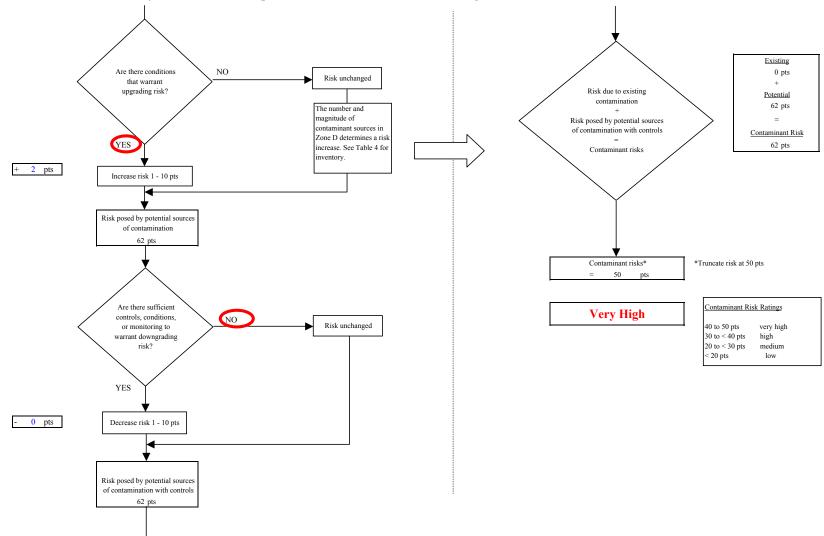
Chart 7. Contaminant risks for YKHC Bethel Hospital (PWS No. 271083.001) - Volatile Organic Chemicals

The contaminant risk for volatile organic chemicals is **Very High**. The risk is primarily attributed to the presence of ADEC recognized contaminated sites and LUST sites, petroleum product bulk station/terminals, injection wells, underground fuel tanks, and an airport in Zones A, C, and D. Numerous other potential contaminant sources are also found within the protection area (see Table 4 – Appendix B).

Detectable concentrations of trihalomethanes and toluene were reported in sampling events for this public water system. However, the detectible concentrations of trihalomethanes reported in 2001 and 2000 were well below the MCL of 0.08 mg/L and the detectible concentrations of toluene reported in 1999 and 2000 were below the MCL of 1.0 mg/L. Trihalomethanes are considered byproducts of the water treatment process and are not from the source waters. Since the reported concentration of TTHM's and toluene in recent sampling events did not exceed the applicable MCLs, risk points were not retained.

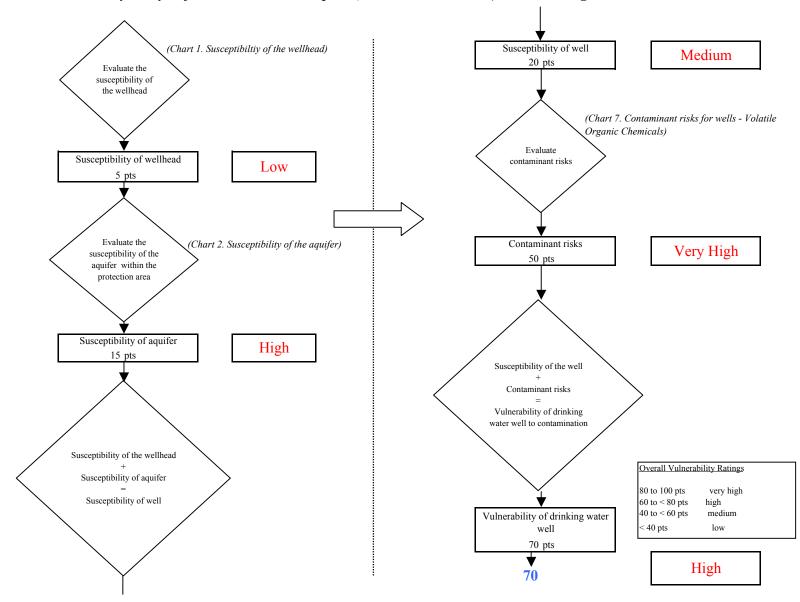
Chart 8. Vulnerability analysis for YKHC Bethel Hospital (PWS No. 271083.001) - Volatile Organic Chemicals

After combining the contaminant risk for volatile organic chemicals with the natural susceptibility of the well, the overall vulnerability of the well to contamination is **High**.

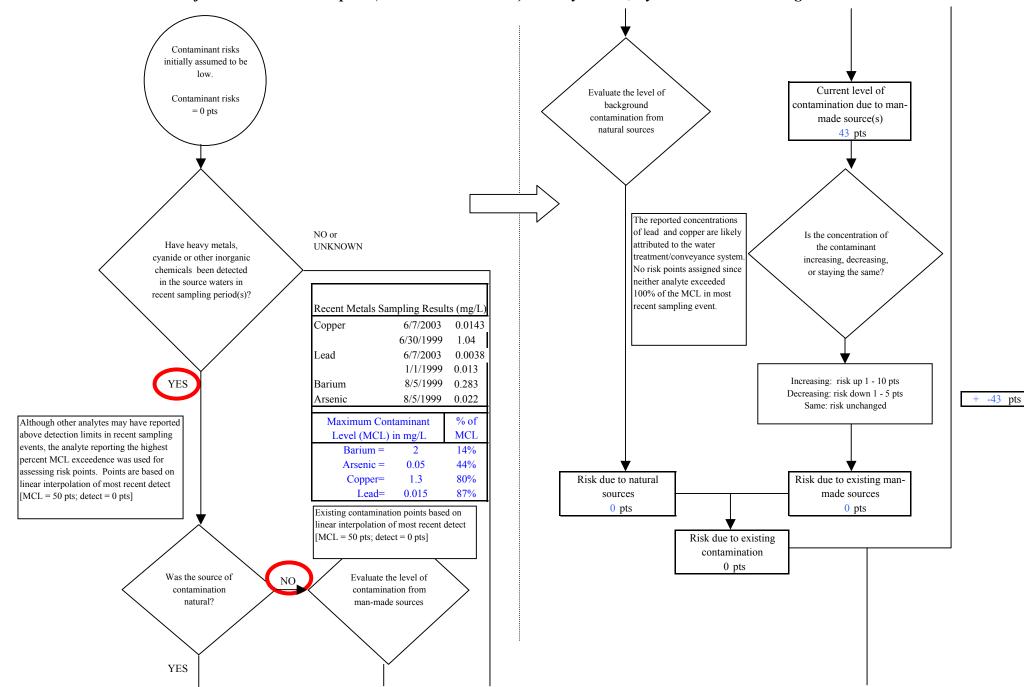
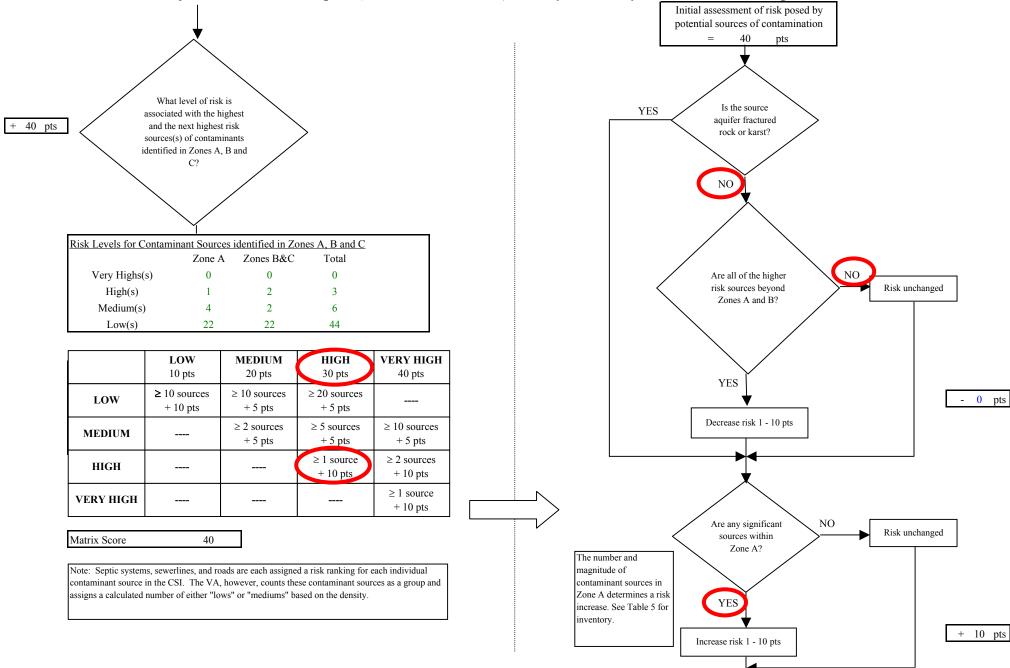
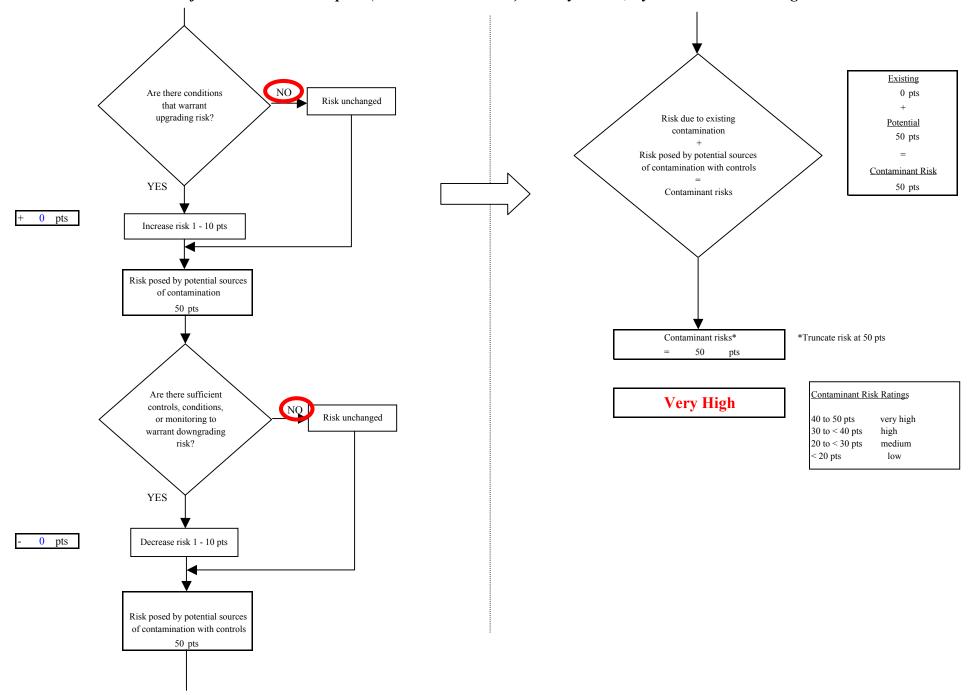
Chart 9. Contaminant risks for YKHC Bethel Hospital (PWS No. 271083.001) - Heavy Metals, Cyanide and Other Inorganic Chemicals

The contaminant risk for heavy metals, cyanide and other inorganic chemicals is **Very High**. The risk is primarily attributed to the presence of an incinerator and injection wells in Zones A and C. Numerous other potential contaminant sources are also found within the protection area (see Table 5 – Appendix B).

Based on review of recent sampling records for this public water system, lead, copper, barium, and arsenic have been detected. However, each analyte did not exceed their respective MCLs (see Chart 9 – Contaminant Risks for Heavy Metals, Cyanide, and Other Inorganic Chemicals in Appendix D). The reported concentrations of copper and lead in recent sampling events are not likely to be representative of source water conditions. These two analytes are likely attributed to either the water treatment process or water distribution network; therefore, no risk points were assigned based on the presence of thes e analytes.

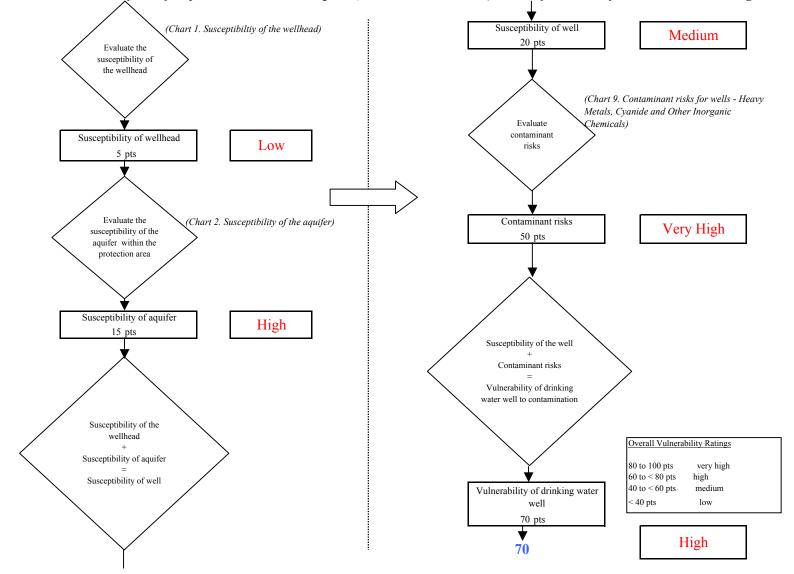
Chart 10. Vulnerability analysis for YKHC Bethel Hospital (PWS No. 271083.001) - Heavy Metals, Cyanide and Other Inorganic Chemicals

After combining the contaminant risk for heavy metals, cyanide and other inorganic chemicals with the natural susceptibility of the well, the overall vulnerability of the well to contamination is **High**.

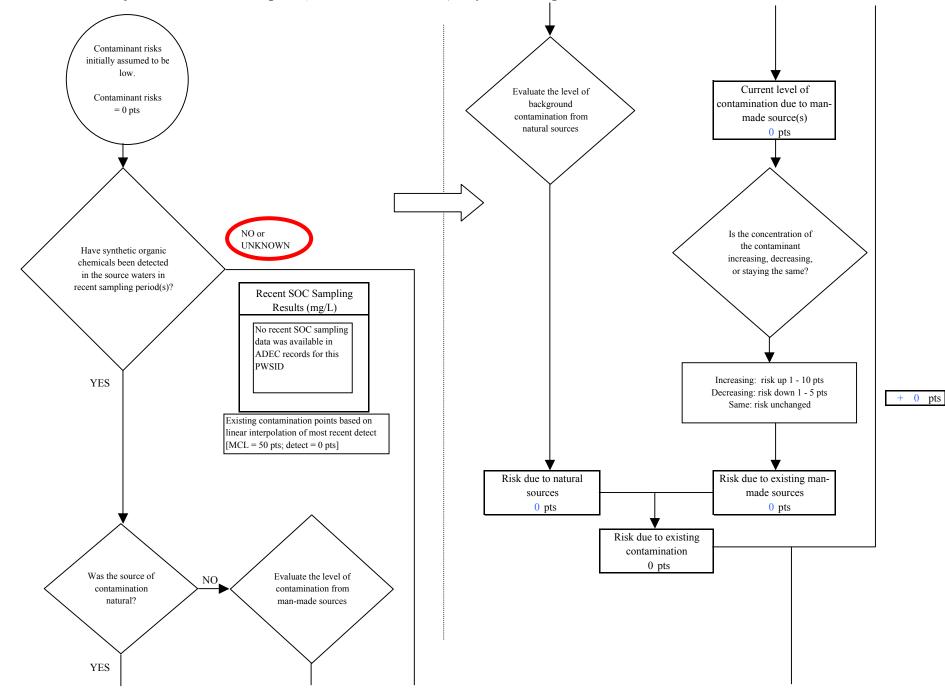
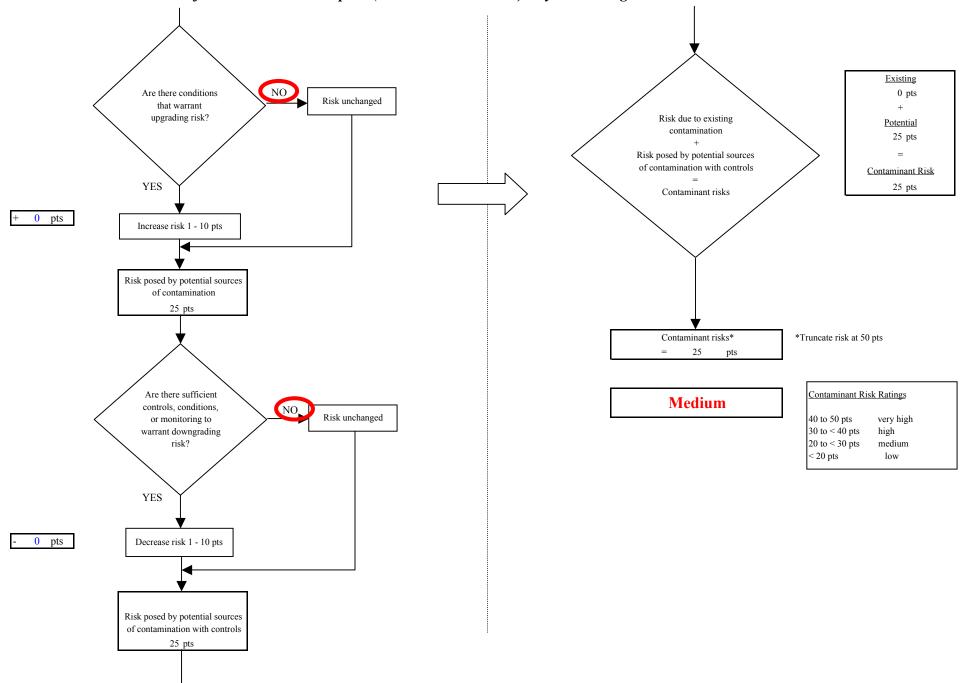
Chart 11. Contaminant risks for YKHC Bethel Hospital (PWS No. 271083.001) - Synthetic Organic Chemicals

The contaminant risk for synthetic organic chemicals is **Medium**. The risk is primarily attributed to the presence of an incinerator and an airport in Zones A and D (see Table 6 – Appendix B).

No recent sampling data was available in ADEC records for the YKHC Bethel Hospital (See Chart 11 – Contaminant Risks for Synthetic Organic Chemicals in Appendix D).

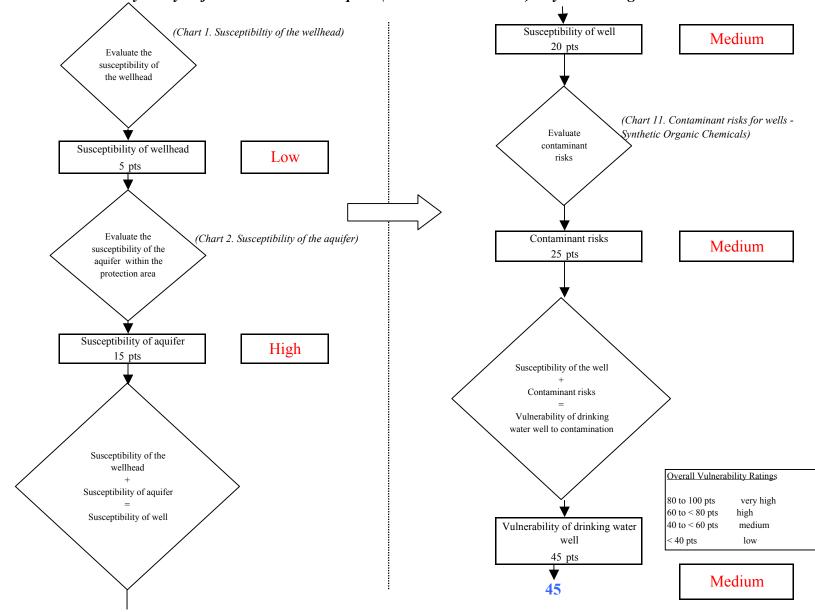
Chart 12. Vulnerability analysis for YKHC Bethel Hospital (PWS No. 271083.001) - Synthetic Organic Chemicals

After combining the contaminant risk for synthetic organic chemicals with the natural susceptibility of the well, the overall vulnerability of the well to contamination is **Medium**.

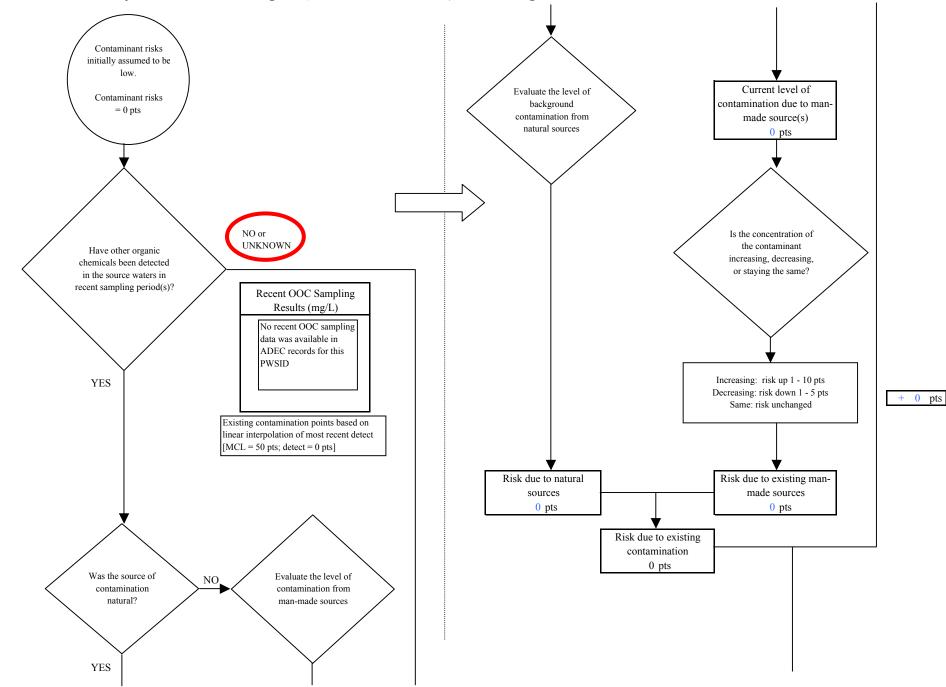
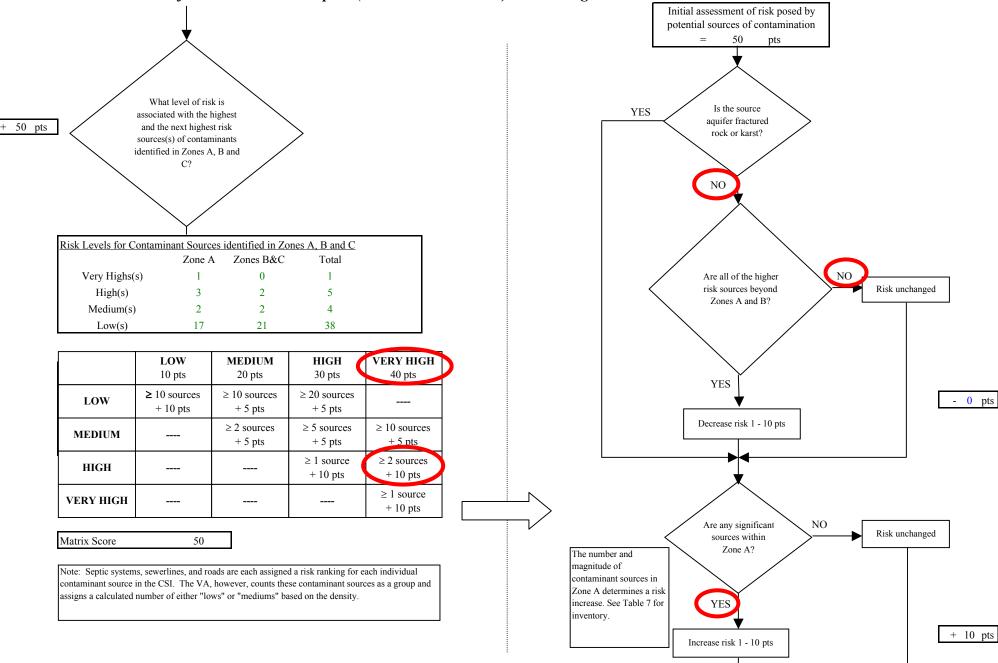
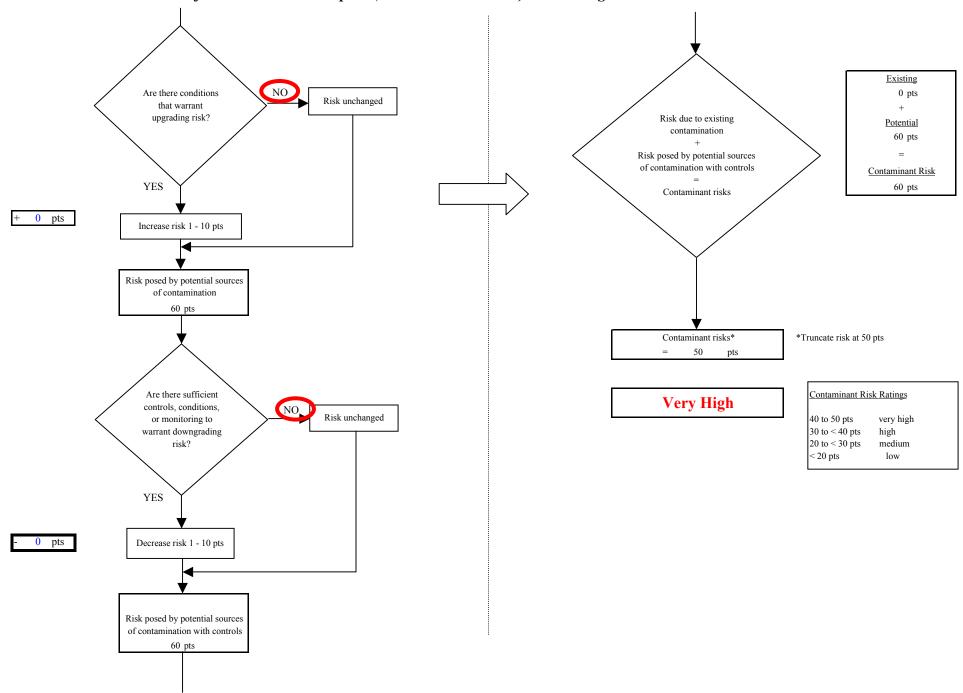
Chart 13. Contaminant risks for YKHC Bethel Hospital (PWS No. 271083.001) - Other Organic Chemicals

The contaminant risk for other organic chemicals is **Very High**. The risk is primarily attributed to the presence of an incinerator, petroleum product bulk station/terminals, electric power generation, and injection wells in Zones A and C. Numerous other potential contaminant sources are also found within the protection area (see Table 7 – Appendix B).

No recent sampling data was available in ADEC records for the YKHC Bethel Hospital (See Chart 13 – Contaminant Risks for Other Organic Chemicals in Appendix D).

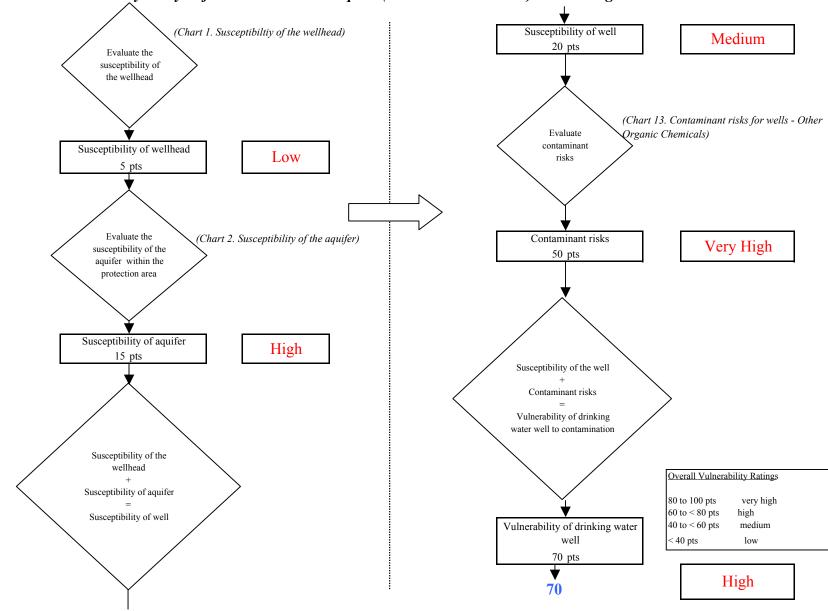
Chart 14. Vulnerability analysis for YKHC Bethel Hospital (PWS No. 271083.001) - Other Organic Chemicals

After combining the contaminant risk for other organic chemicals with the natural susceptibility of the well, the overall vulnerability of the well to contamination is **High**.
