# Source Water Assessment

A Hydrogeologic Susceptibility and  
Vulnerability Assessment for  
Bird Creek Scenic Overlook  
Drinking Water System,  
Bird Creek, Alaska  
PWSID # 218644.001

DRINKING WATER PROTECTION PROGRAM REPORT # 328A  
Alaska Department of Environmental Conservation

By URS Corporation

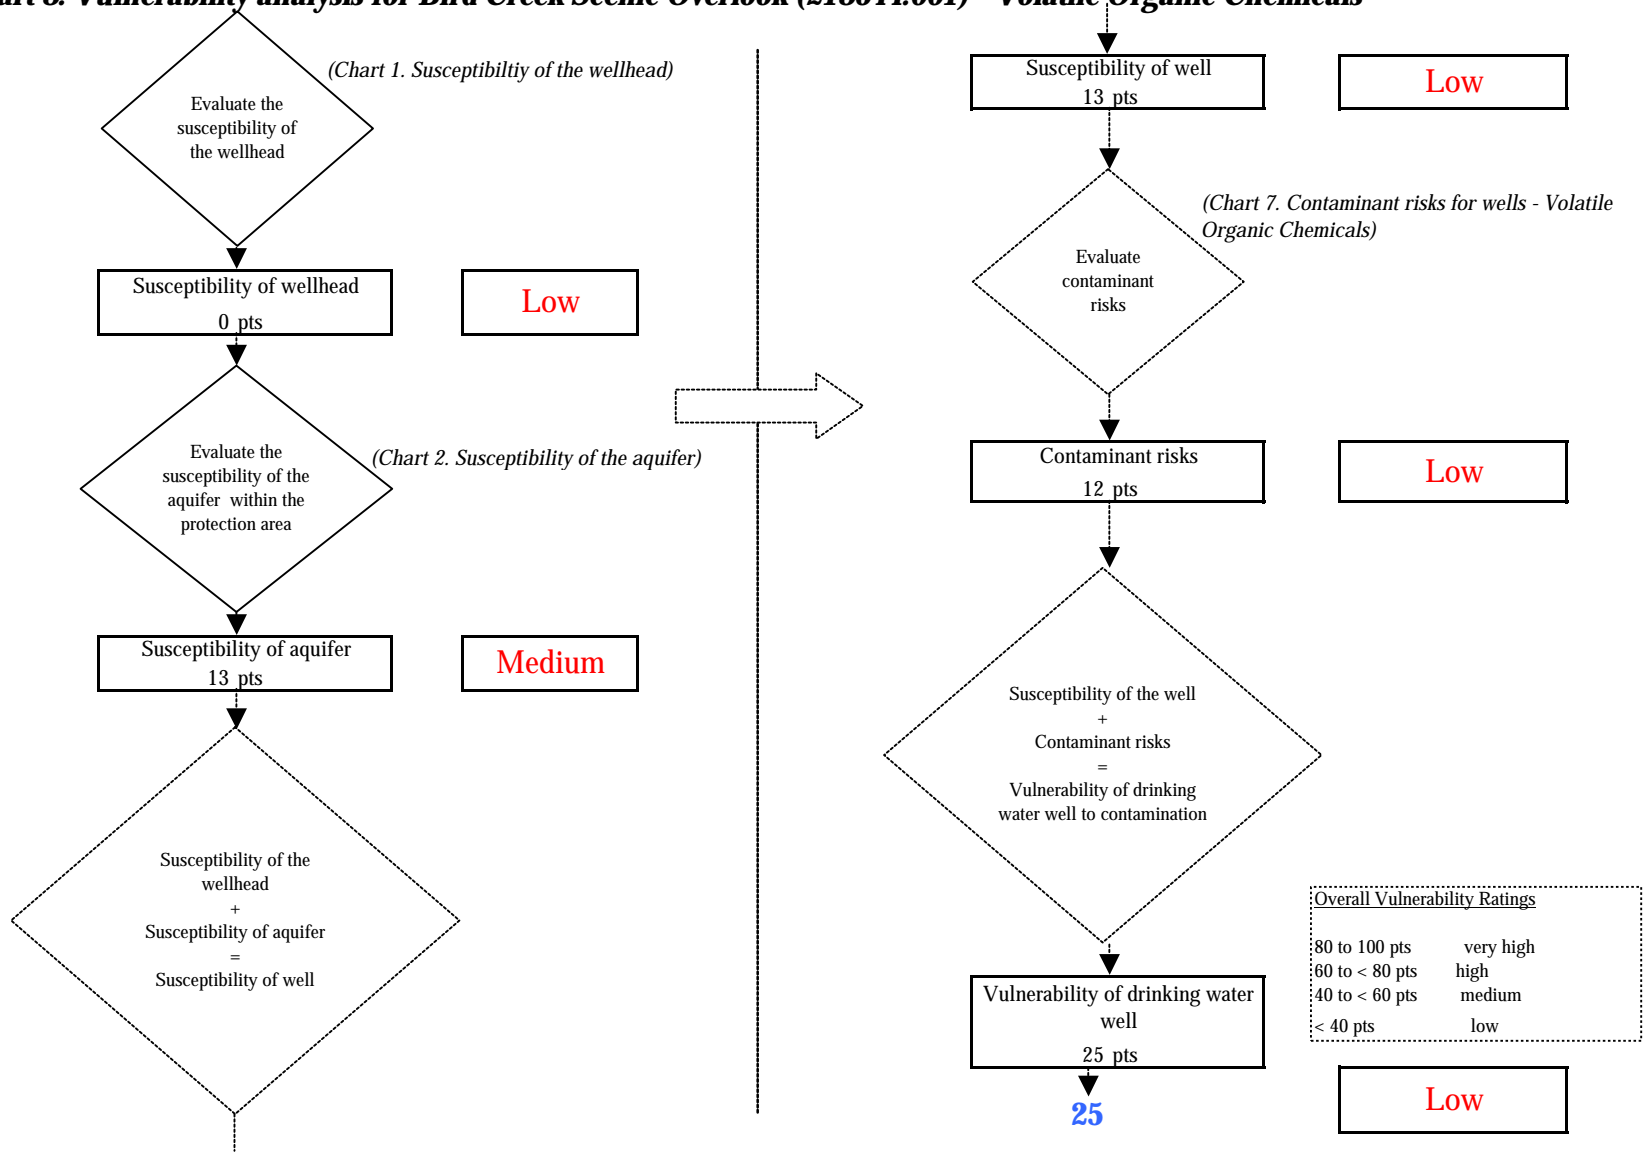
**Chart 8. Vulnerability analysis for Bird Creek Scenic Overlook (218644.001) - Volatile Organic Chemicals**
