Source Water Assessment

A Hydrogeologic Susceptibility and
Vulnerability Assessment for
Sheep Mountain Lodge
Drinking Water System,
Chickaloon, Alaska

Sheep Mountain Lodge # 226321

DRINKING WATER PROTECTION PROGRAM REPORT 248
Alaska Department of Environmental Conservation

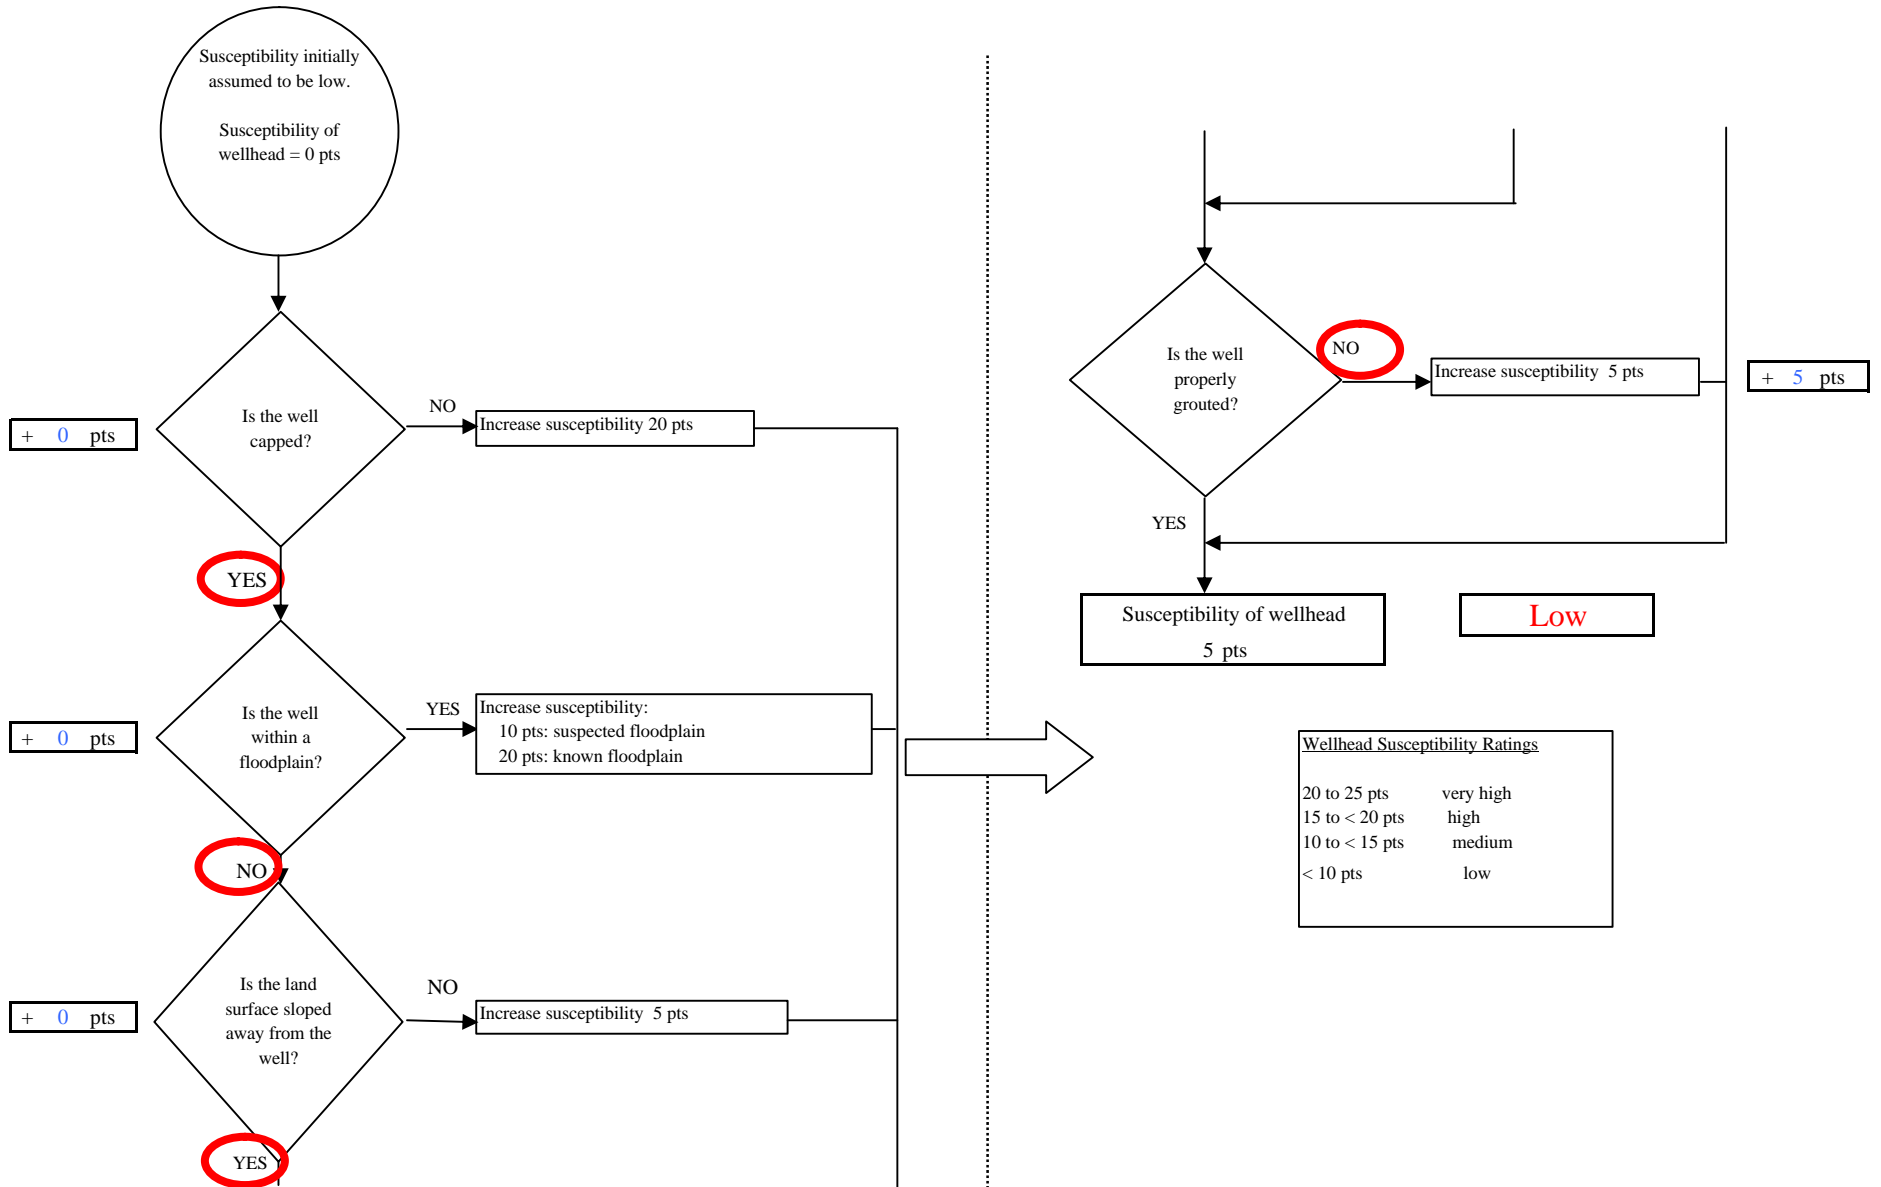
Chart 1. Susceptibility of the Wellhead - Sheep Mountain Lodge

Score	Rating
Susceptibility of the Wellhead	5	Low
Susceptibility of the Aquifer	25	Very High
Natural Susceptibility	30	Medium

The well for Sheep Mountain Lodge is completed in an unconfined aquifer setting. Because an unconfined aquifer is recharged by surface water and precipitation that migrates downward from the surface, contaminants at the surface have the potential to adversely impact this aquifer. Table 2 shows the Overall Susceptibility score and rating for Sheep Mountain Lodge.

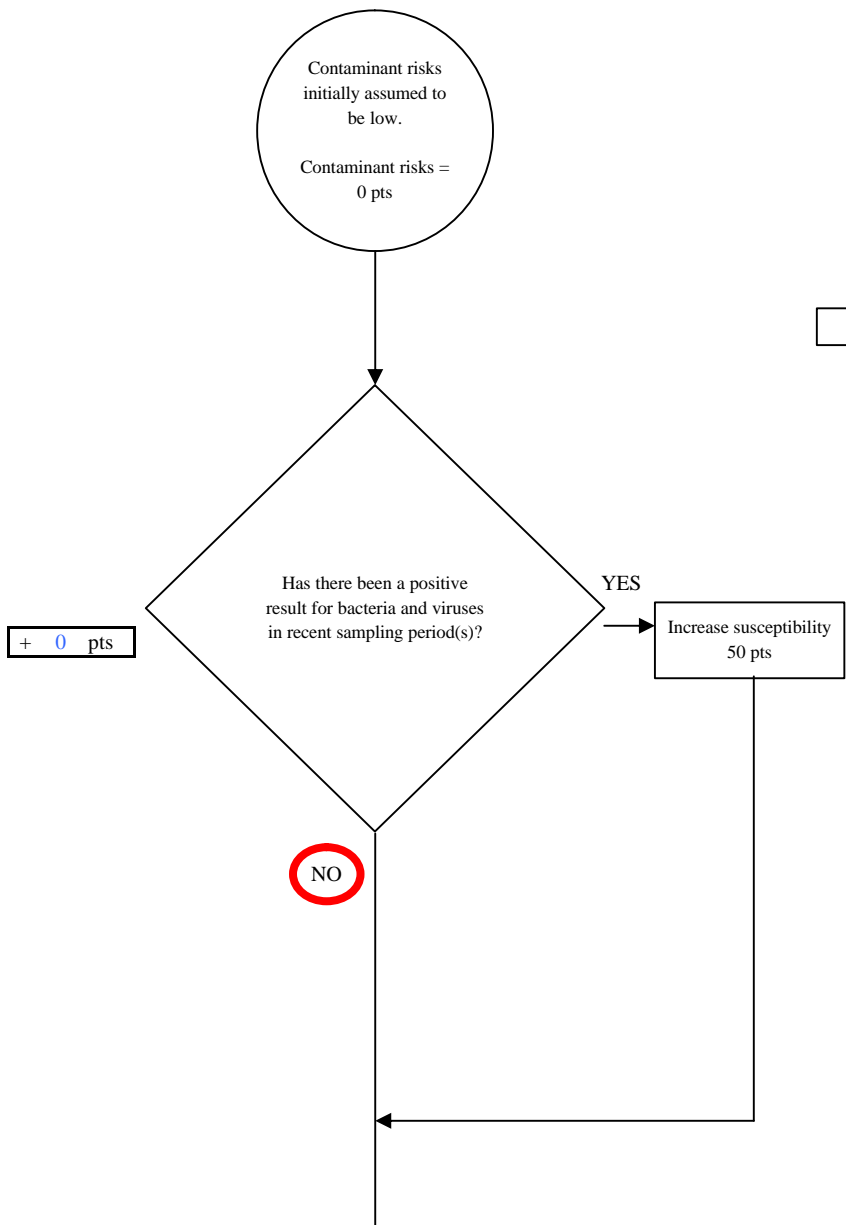
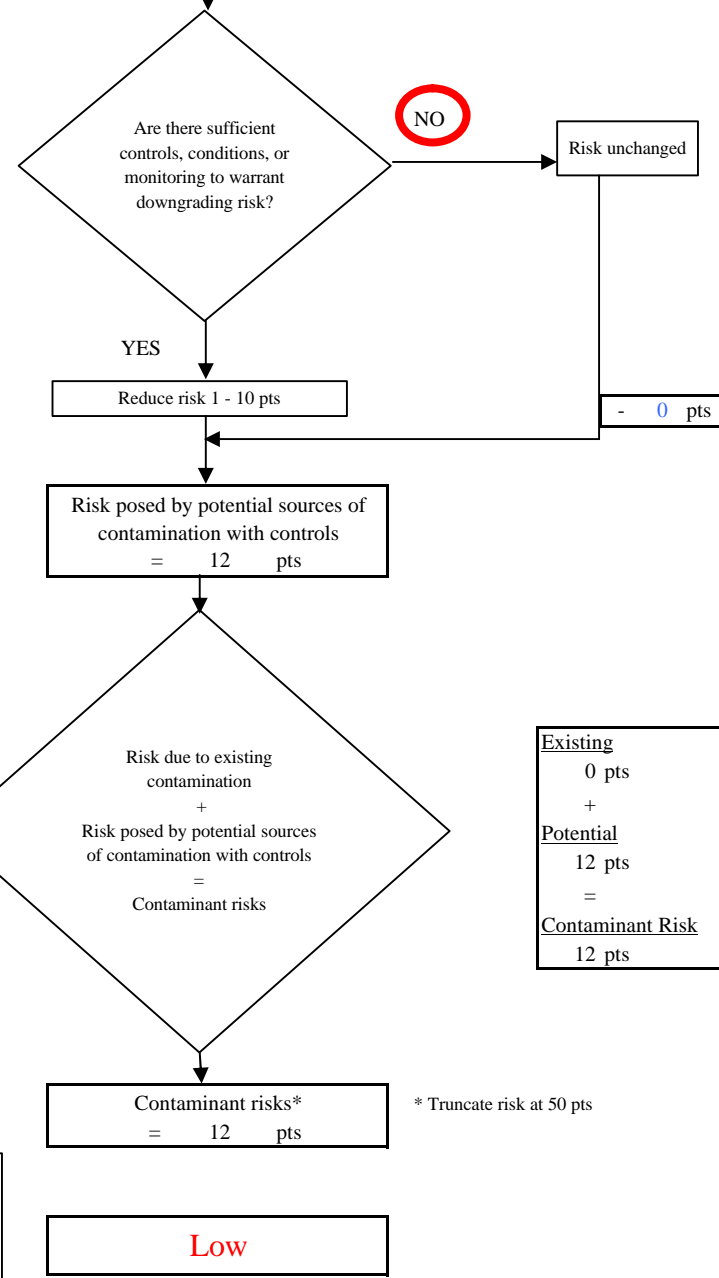
Chart 3. Contaminant Risks for Sheep Mountain Lodge - Bacteria & Viruses

Zone A	Zone B	Total
Very High(s)	0	0	0
High(s)	0	0	0
Medium(s)	0	0	0
Low(s)	3	0	3

Matrix Score 10

Existing
0 pts
+
Potential
12 pts
=
Contaminant Risk
12 pts

Only a small amount of bacteria and viruses are required to endanger public health. Bacteria and viruses have not been detected during recent water sampling of the system at Sheep Mountain Lodge.
