Source Water Assessment

A Hydrogeologic Susceptibility and
Vulnerability Assessment for
USFS Cooper Creek Campground
Drinking Water System,
Cooper Landing, Alaska
PWSID # 240202.001

DRINKING WATER PROTECTION PROGRAM REPORT # 343
Alaska Department of Environmental Conservation

By URS Corporation

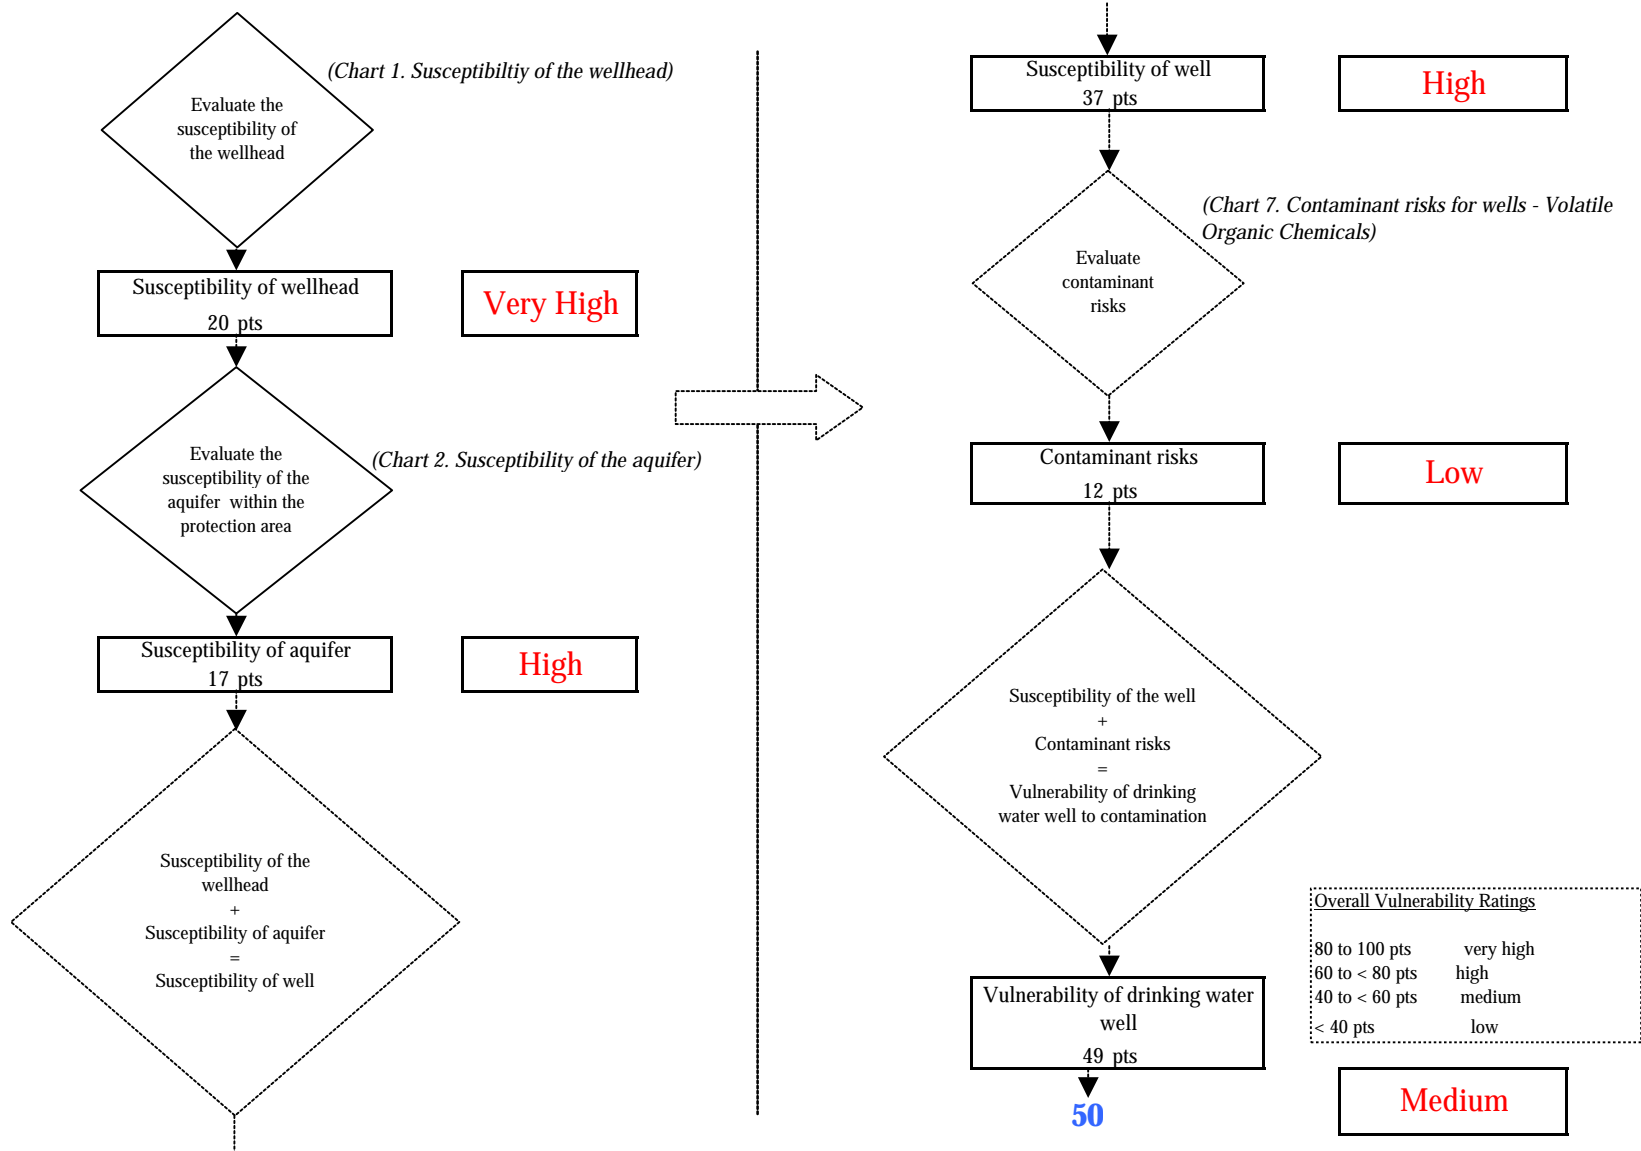
Chart 8. Vulnerability analysis for USFS Cooper Creek Campground (240202.001) - Volatile Organic Chemicals
