# Source Water Assessment

A Hydrogeologic Susceptibility and  
Vulnerability Assessment for  
USFS Cooper Creek North  
Drinking Water System,  
Cooper Landing, Alaska  
PWSID # 240210.001

By URS Corporation

DRINKING WATER PROTECTION PROGRAM REPORT # 344

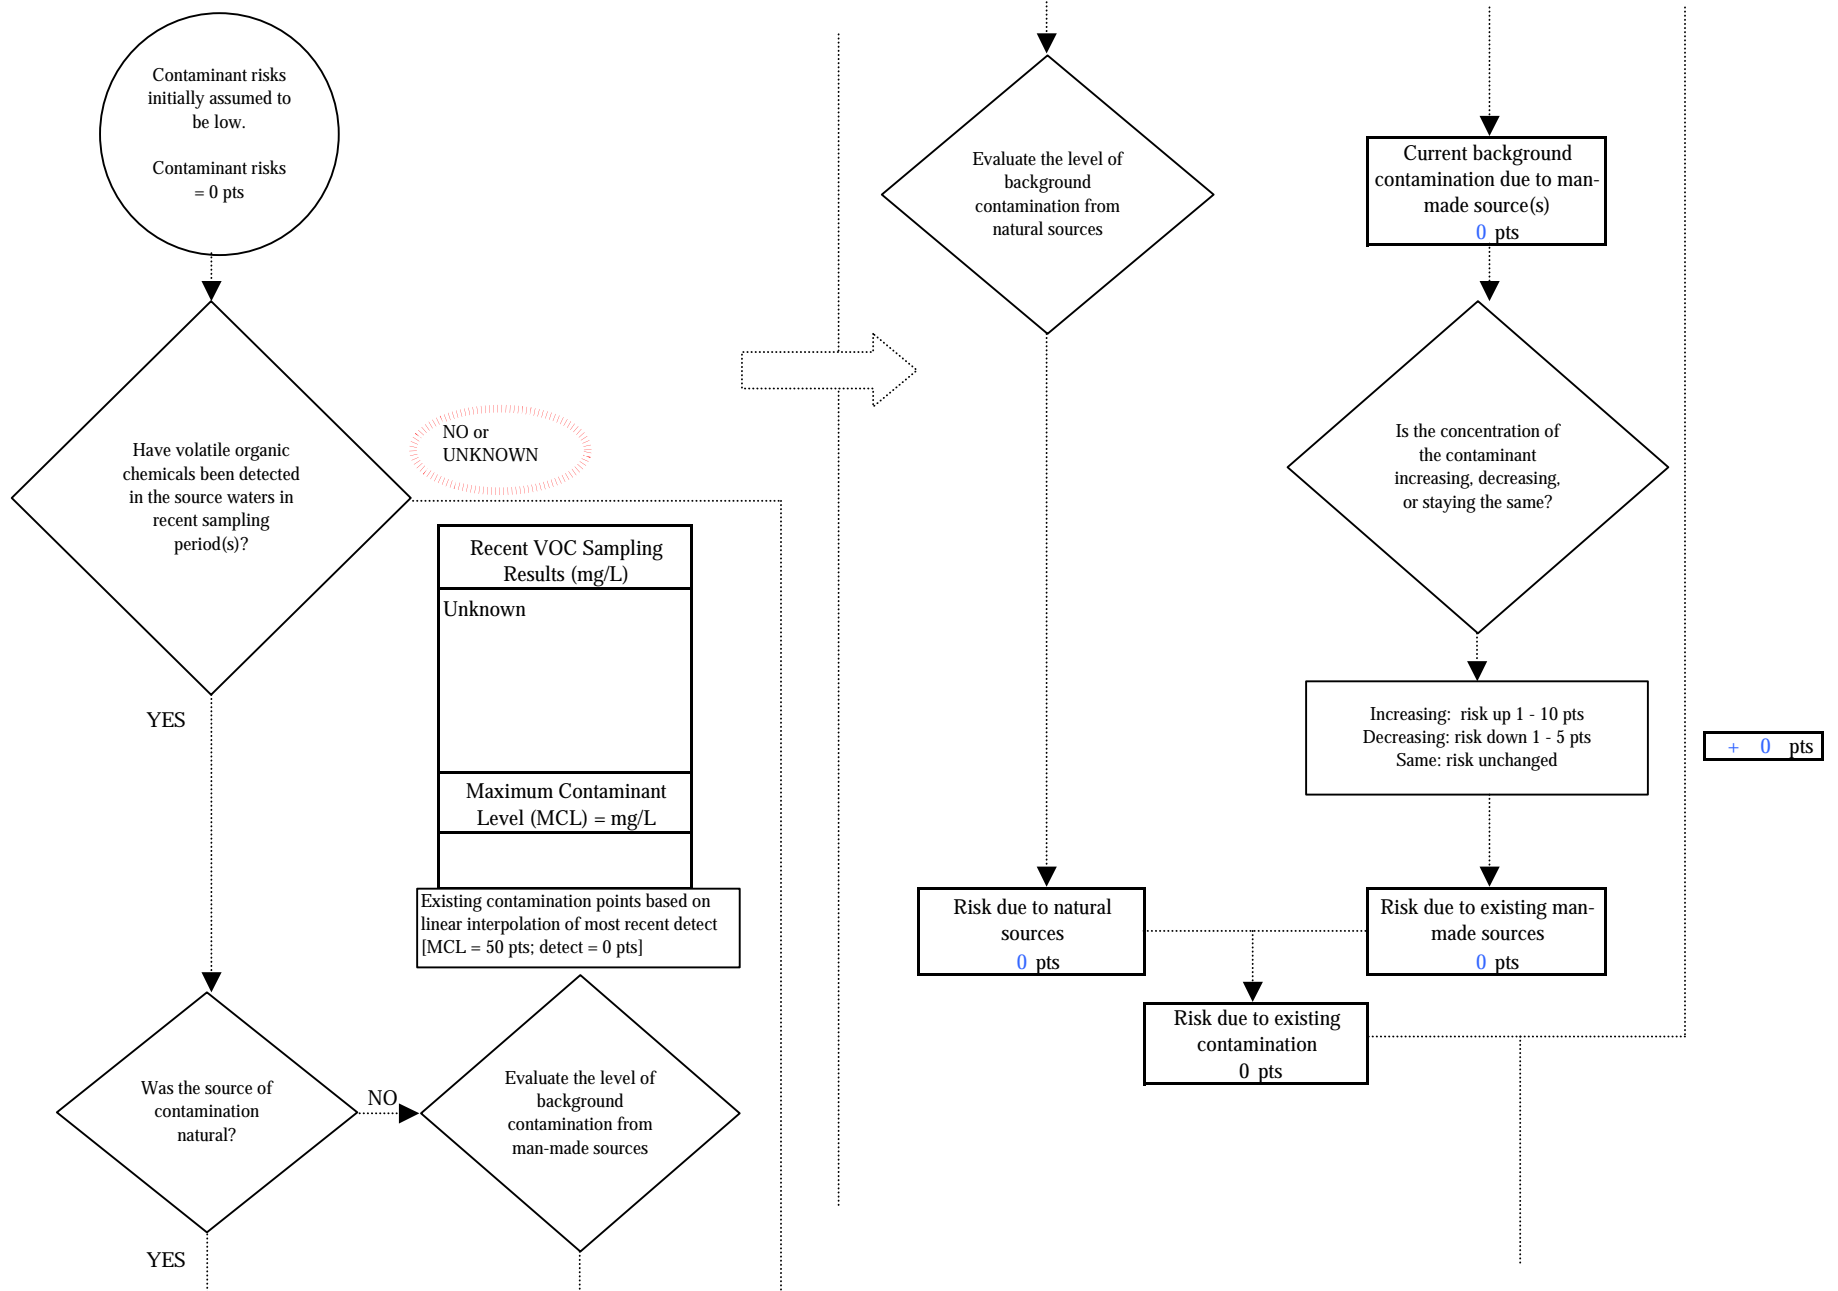
**Chart 7. Contaminant risks for USFS Cooper Creek North (240210.001) - Volatile Organic Chemicals**

What level of risk is associated with the highest and the next highest risk sources(s) of contaminants identified in Zones A, B and C?

Zone A	Zones B&C	Total
Very High(s)	0	0	0
High(s)	0	0	0
Medium(s)	0	0	0
Low(s)	2	0	2

Matrix Score      10

Appendix D contains eight charts, which together form the ‘Vulnerability Analysis’ for a source water assessment for a public drinking water source. Chart 1 analyzes the ‘Susceptibility of the Wellhead’ to contamination by looking at the construction of the well and its surrounding area. Chart 2 analyzes the ‘Susceptibility of the Aquifer’ to contamination by looking at the naturally occurring attributes of the water source and influences on the groundwater system that might lead to contamination. Chart 3 analyzes ‘Contaminant Risks’ for the drinking water source with respect to bacteria and viruses. The ‘Contaminant Risks’ portion of the analysis considers potential sources of contaminants as well as a review of contamination that has or may have occurred, but has not arrived or been detected at the well. Lastly, Chart 4 contains the ‘Vulnerability Analysis for Bacteria and Viruses’. Charts 5 through 8 contain the Contaminant Risks and Vulnerability Analyses for nitrates and nitrites and volatile organic chemicals, respectively.

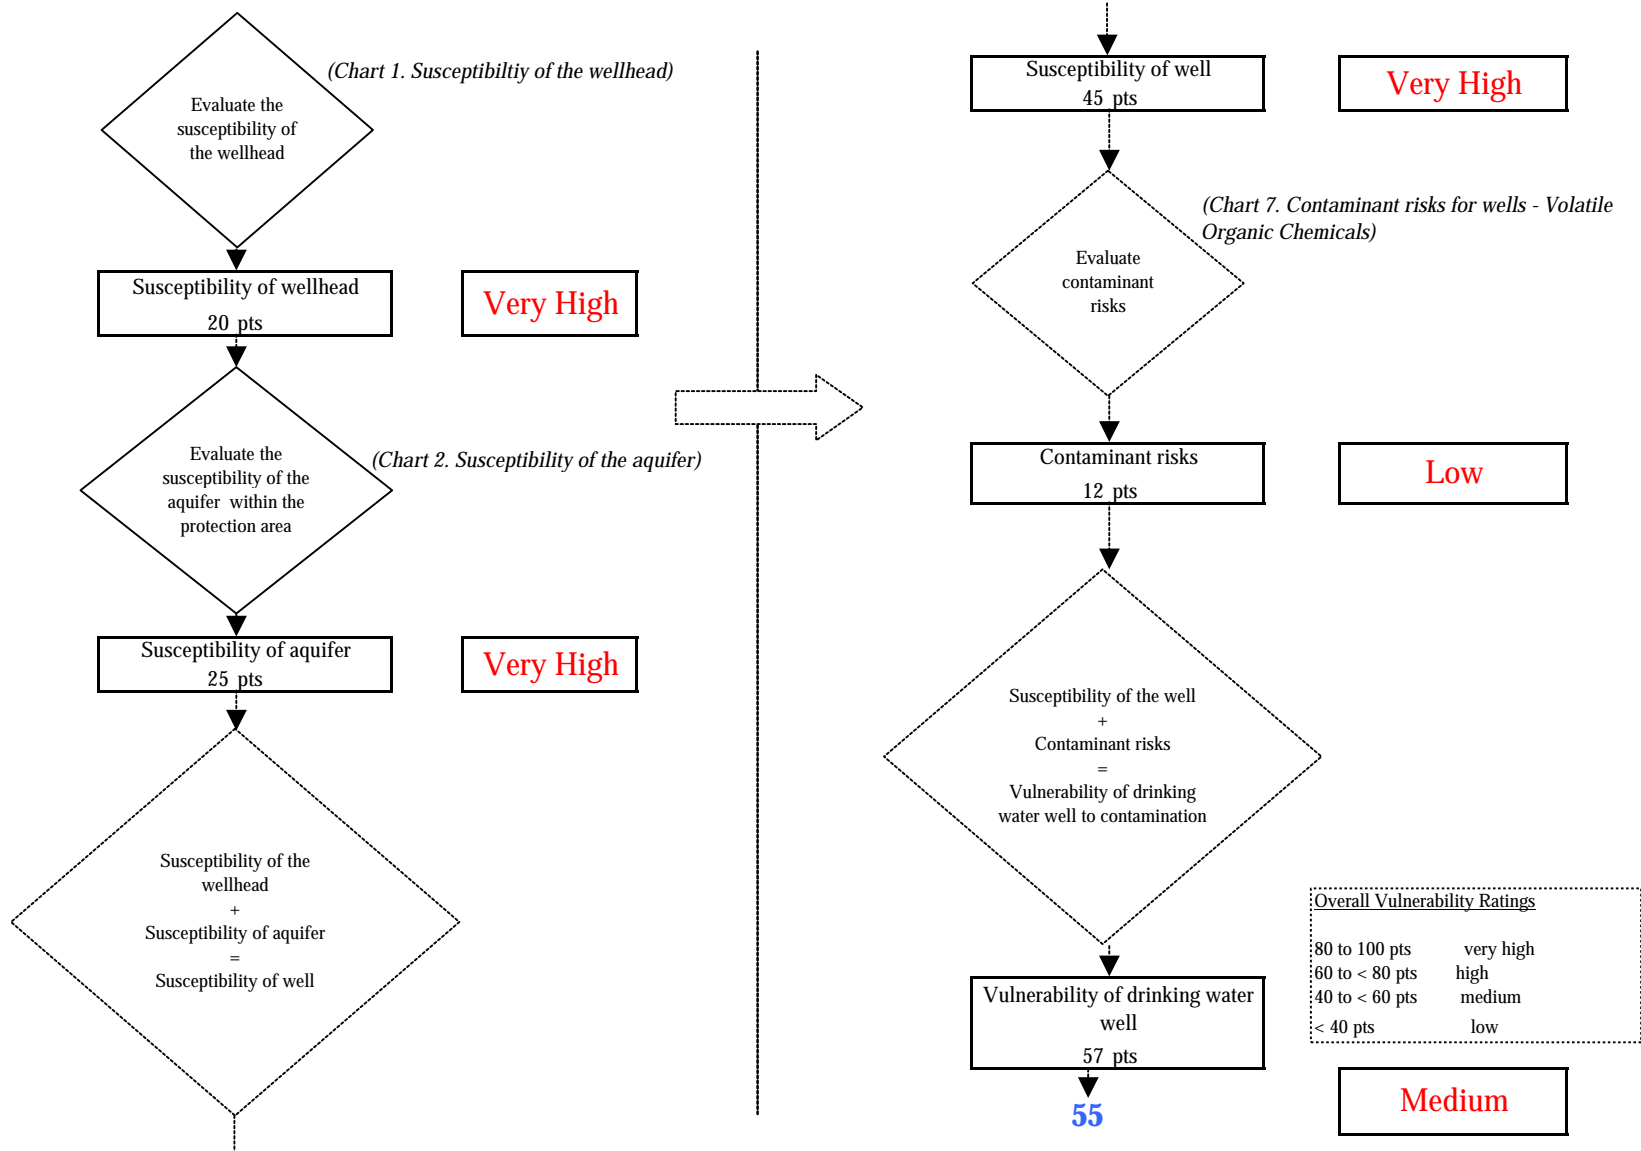
**Chart 8. Vulnerability analysis for USFS Cooper Creek North (240210.001) - Volatile Organic Chemicals**
