Source Water Assessment

A Hydrogeologic Susceptibility and
Vulnerability Assessment for
KNWR Visitors Center
Drinking Water System,
Cooper Landing, Alaska
PWSID # 248789.001

By URS Corporation

DRINKING WATER PROTECTION PROGRAM REPORT # 386

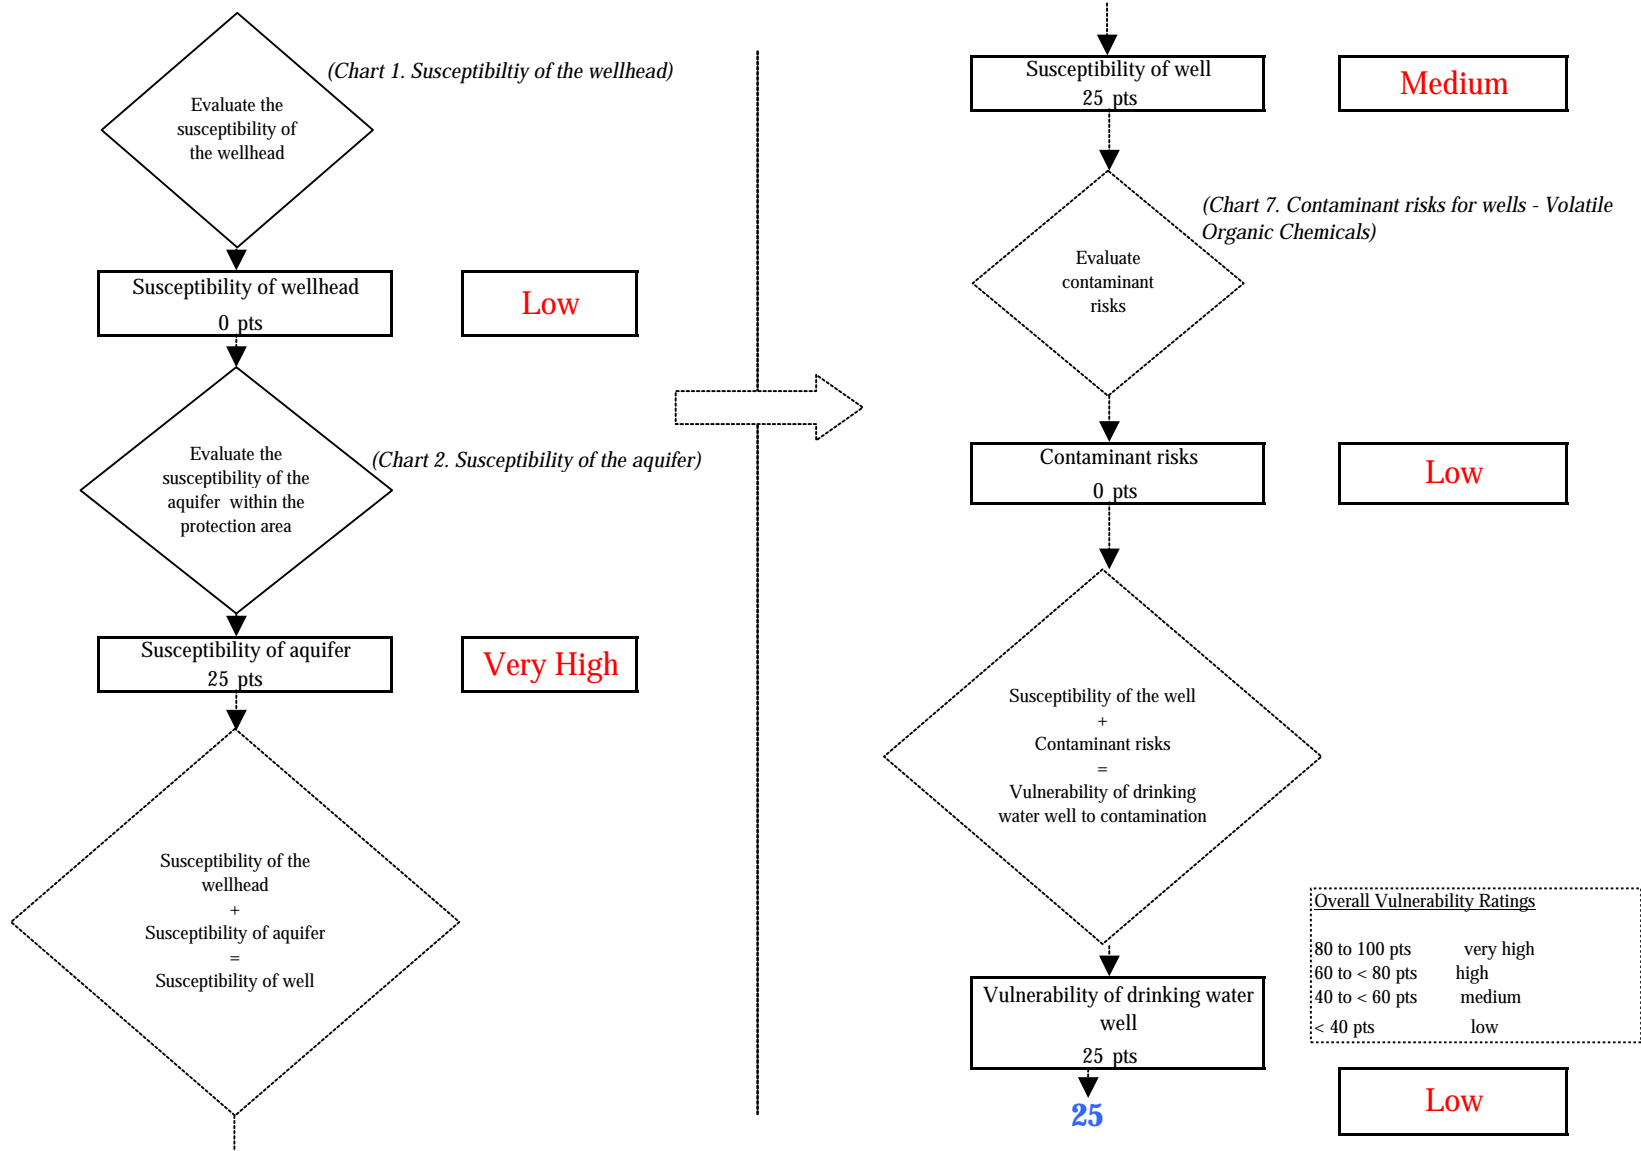
Chart 8. Vulnerability analysis for KNWR Visitors Center (248789.001) - Volatile Organic Chemicals
