Source Water Assessment

A Hydrogeologic Susceptibility and
Vulnerability Assessment for
Copper Center Lodge – New Well
Public Drinking Water System,
Copper Center, Alaska
PWSID # 292801.001

DRINKING WATER PROTECTION REPORT 1769

Alaska Department of Environmental Conservation

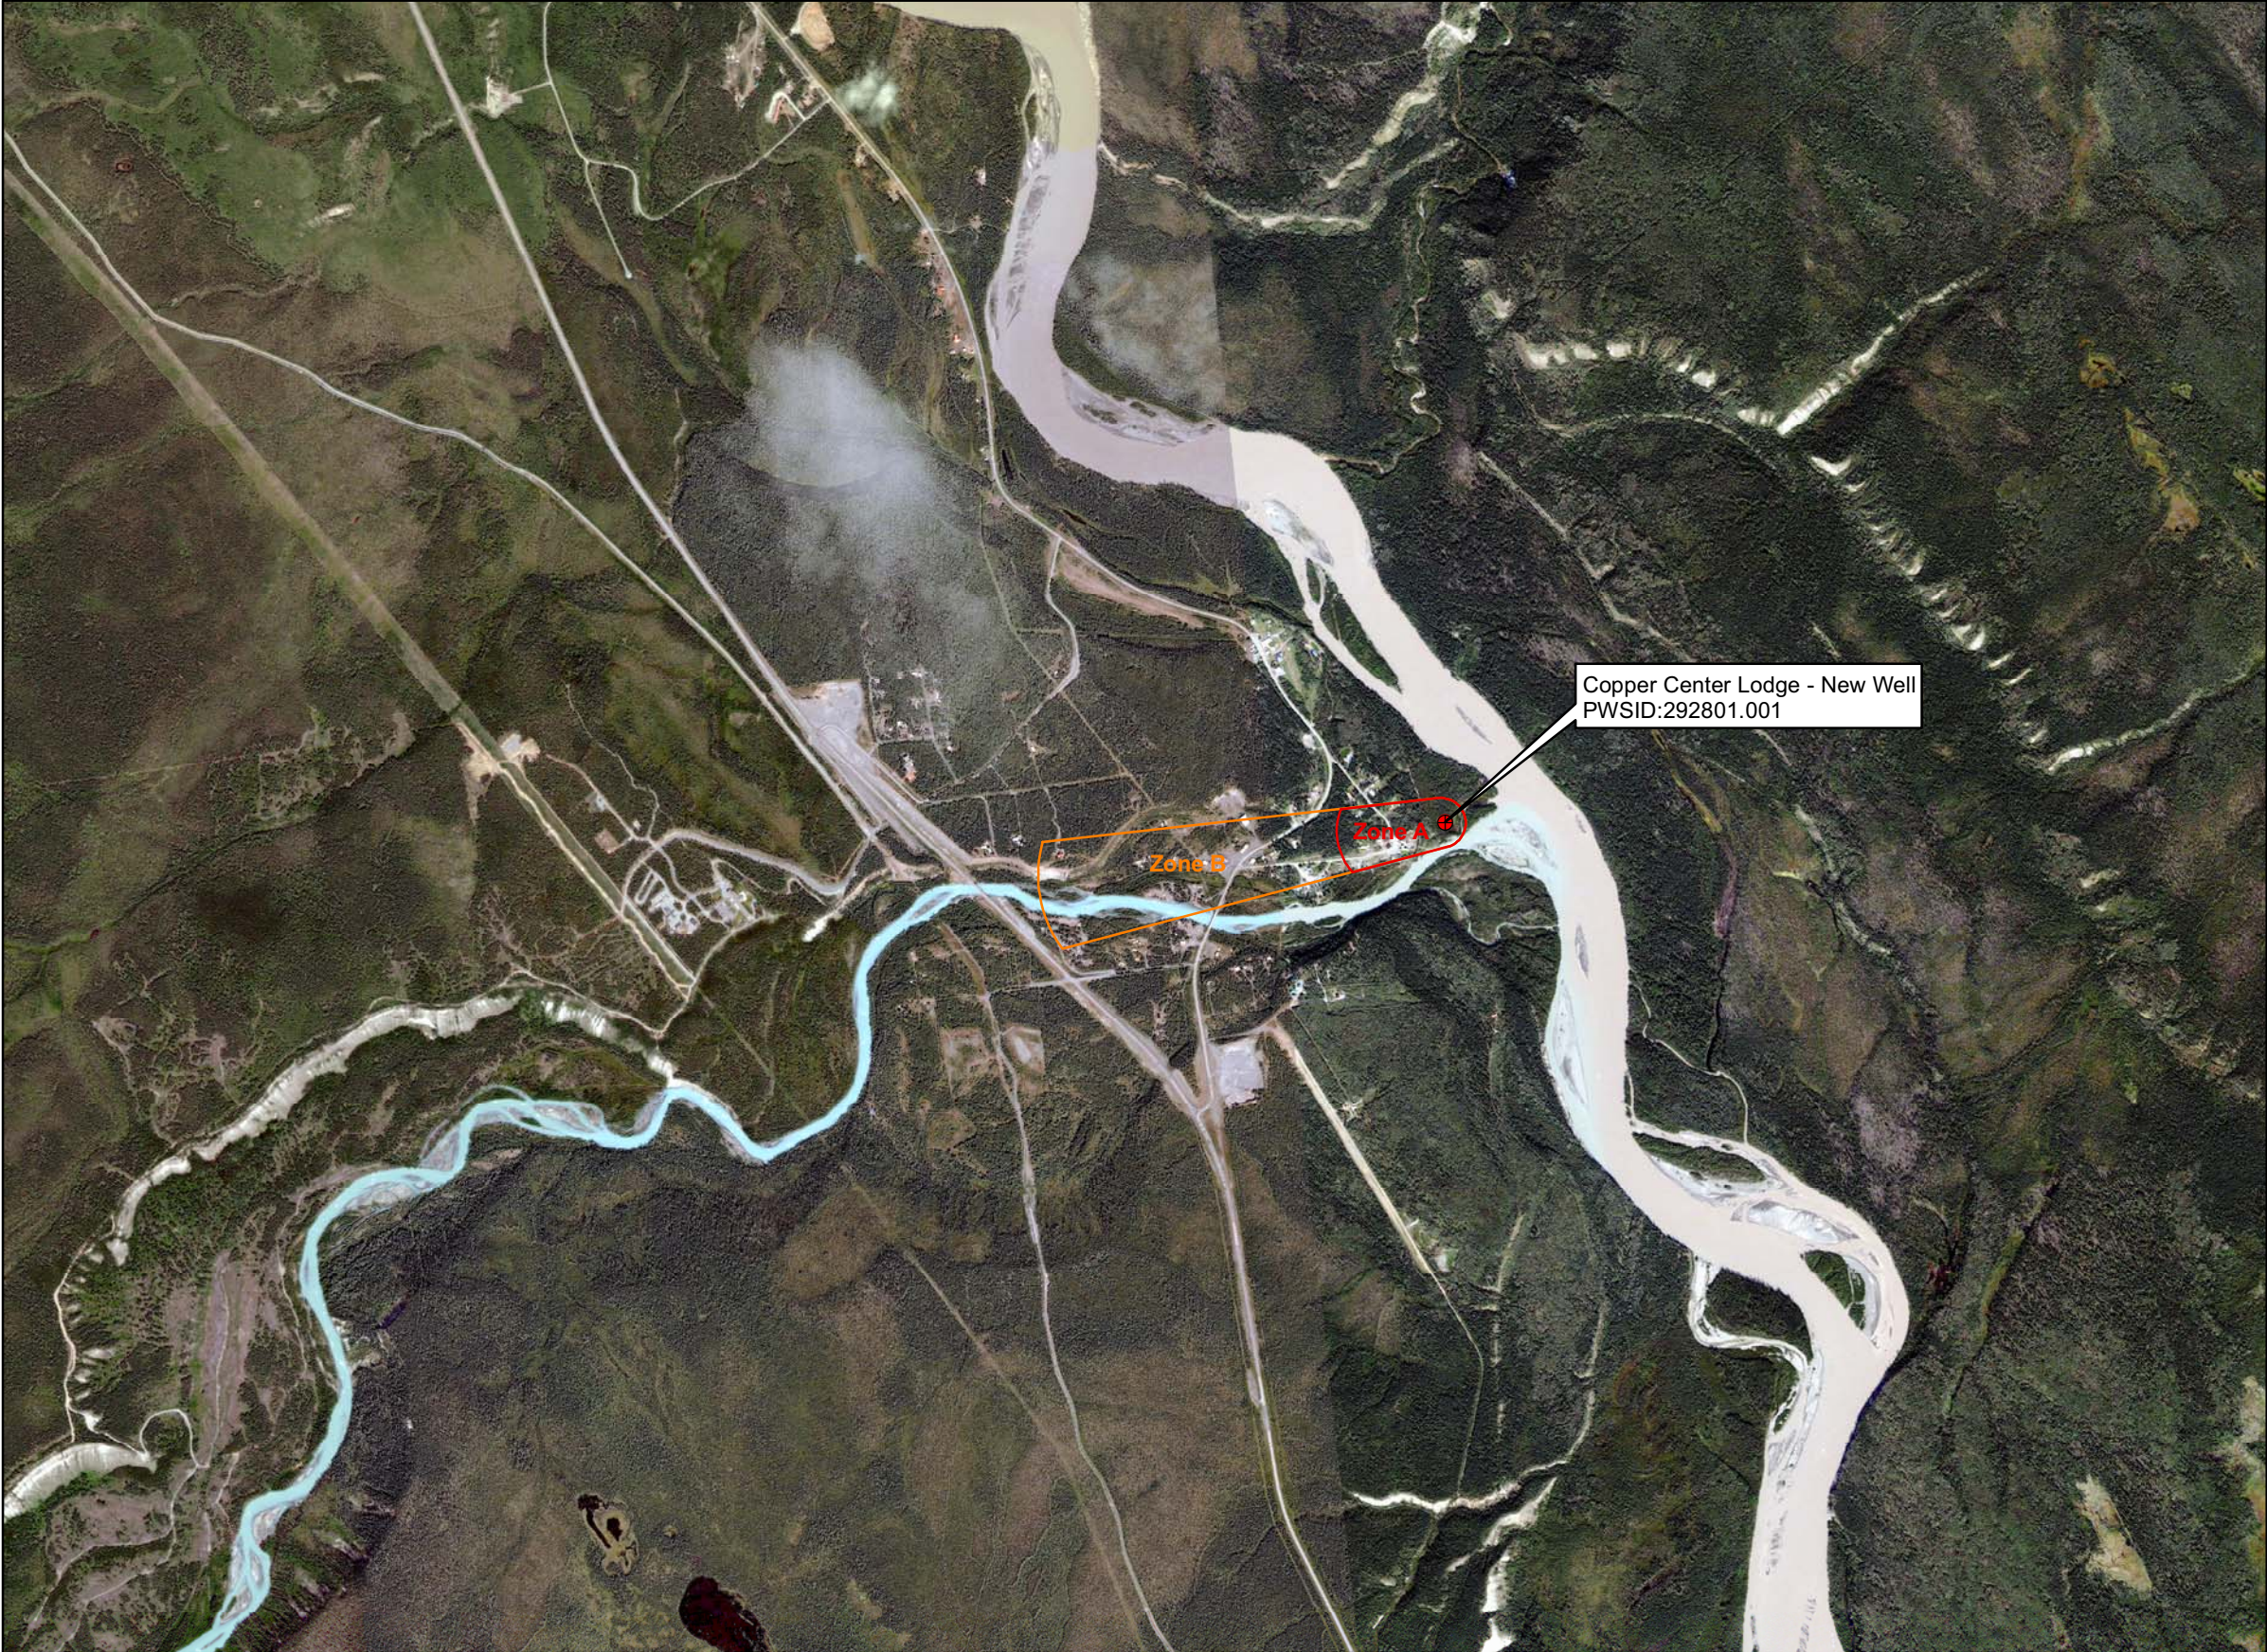
Appendix A Map A

The drinking water protection area for the New Well at the Copper Center Lodge was determined using an analytical calculation and includes Zones A and B (see Map A in Appendix A).

Copper Center Lodge – New Well Drinking Water Protection Area Location Map (Map A)

Public Water Well System for PWS #292801.001 Copper Center Lodge - New Well

The Copper Center Lodge public water system is a Class B (transient/non-community) water system. The system consists of two wells located at Mile 101 of the Old Richardson Highway, on Loop Road in Copper Center, Alaska (see Map A in Appendix A). This Source Water Assessment applies only to PWSID 292801.001, also known as the New Well. The community of Copper Center (population 337) lies on the west bank of the Copper River, at its confluence with the Klutina River. It is located between Mile 101 and Mile 105 of the Richardson Highway, approximately 200 road miles east of Anchorage, and incorporates the Native Village of Kluti-Kaah. The area receives 9 inches of precipitation annually, and average temperatures reach -10 degrees Fahrenheit in January and 56 degrees Fahrenheit in July (ADCCED, 2009).
