Source Water Assessment

A Hydrogeologic Susceptibility and
Vulnerability Assessment for
USFS Ptarmigan Creek
North Campground
Drinking Water System,
Crown Point, Alaska
PWSID # 240309.001

DRINKING WATER PROTECTION PROGRAM REPORT # 350

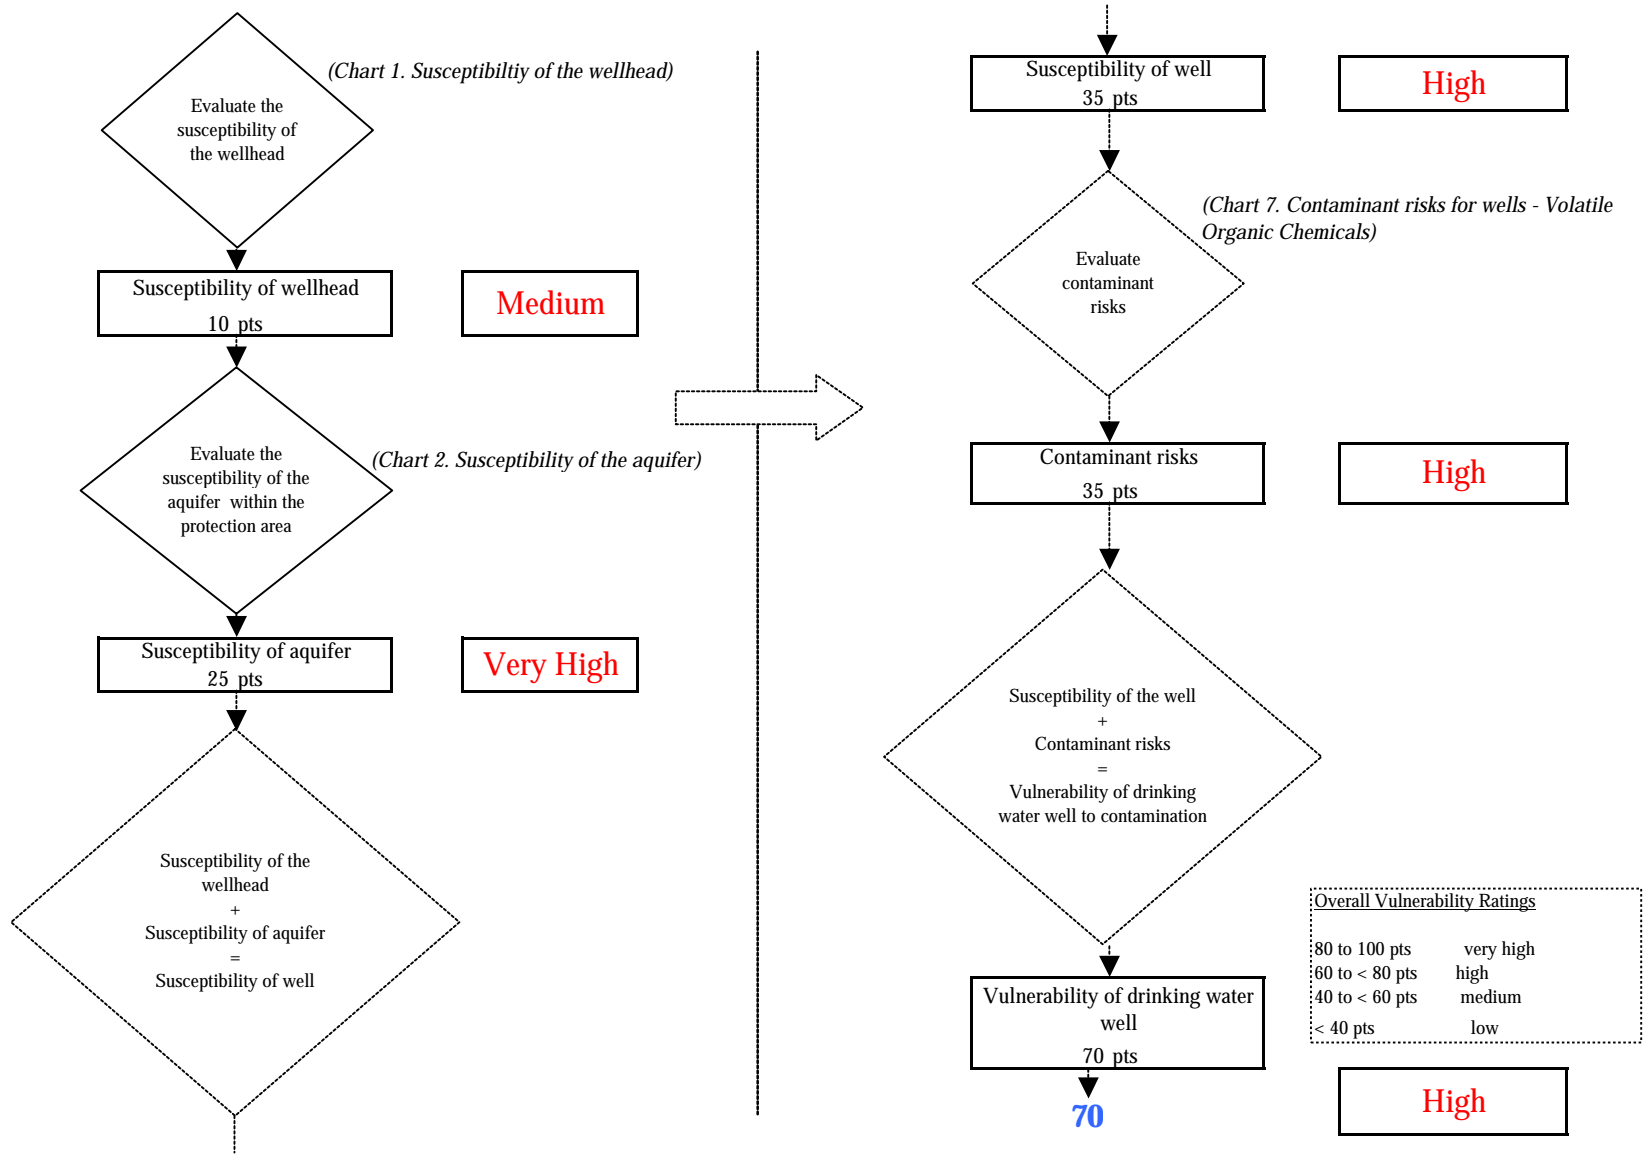
Chart 8. Vulnerability analysis for USFS Ptarmigan Creek North (240309.001) - Volatile Organic Chemicals
